# S.B. Knit composite ( 6 storied Dyeing & printing)

Delpara, Fatullah, Narayanganj.

15<sup>th</sup> October 2018

# Observations

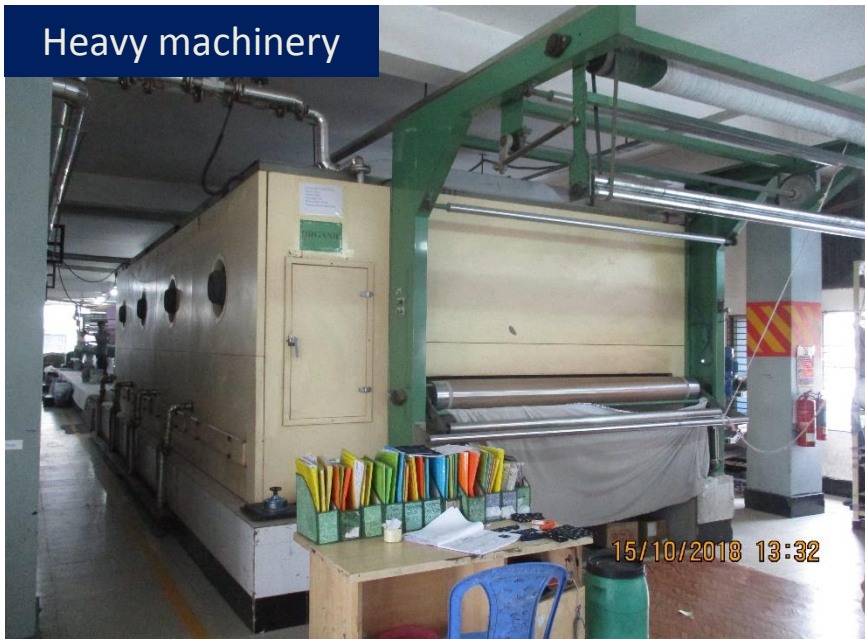
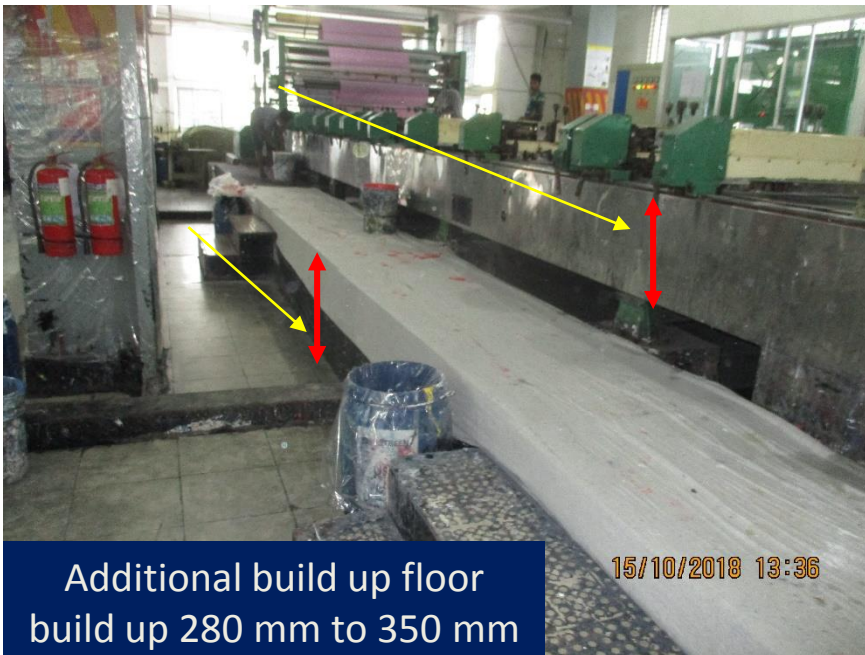
## Heavy machinery

# Heavy loading on 1st floor slab

Heavy machinery with additional build up  
observed in 1<sup>st</sup> floor slab. Building engineer  
is required to check the flexure capacity of  
the slab.

| Item No. | Observation | Recommended Action Plan | Recommended Timeline |
|---|---|---|---|
| 1 | Heavy loading on 1st floor slab (6-Storied Building) | Building engineer is required to check the flexural capacity of slab due to heavy loading. | 6-weeks |
| 2 | Heavy loading on 1st floor slab (6-Storied Building) | Produce and actively manage a loading plan for all floor plates within the factory giving consideration to floor capacity and column capacity. | 6-weeks |
| 3 | Heavy loading on 1st floor slab (6-Storied Building) | Carry out remedial works where necessary. | 6-months |

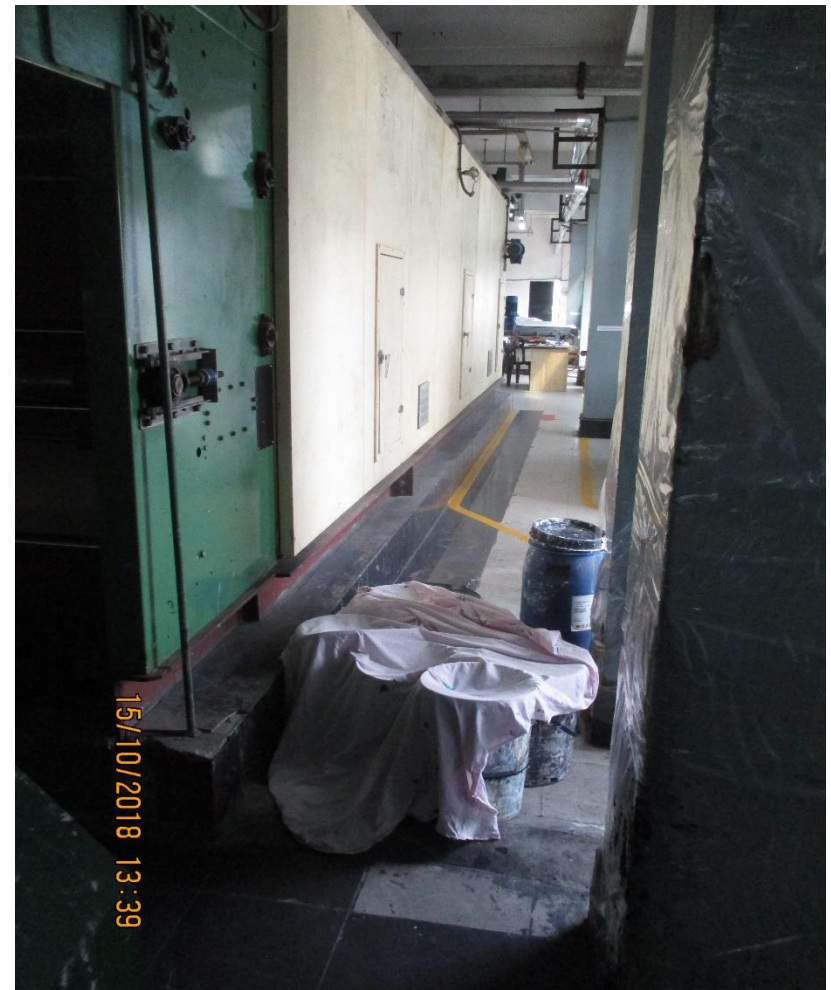
Additional build up floor  
build up 280 mm to 350 mm

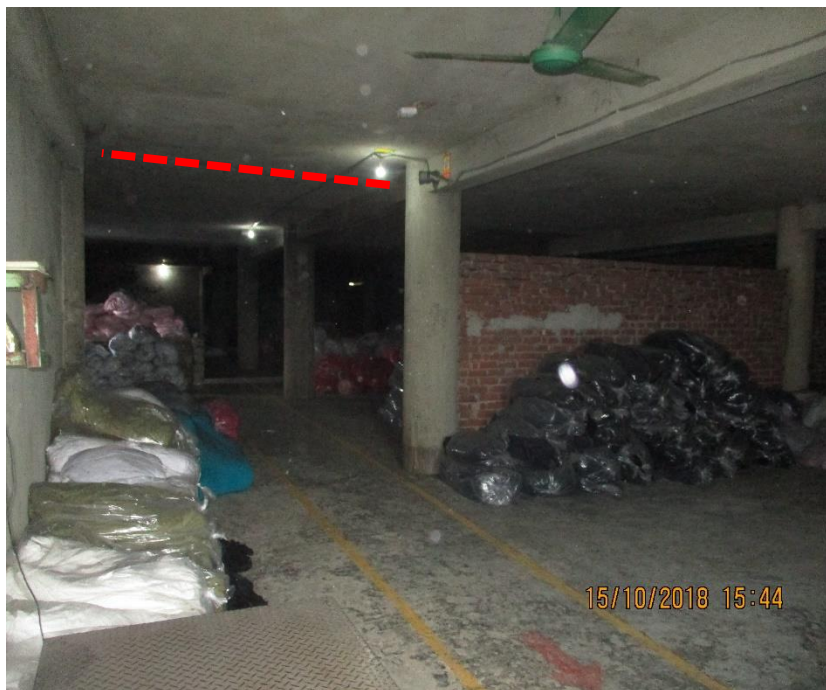
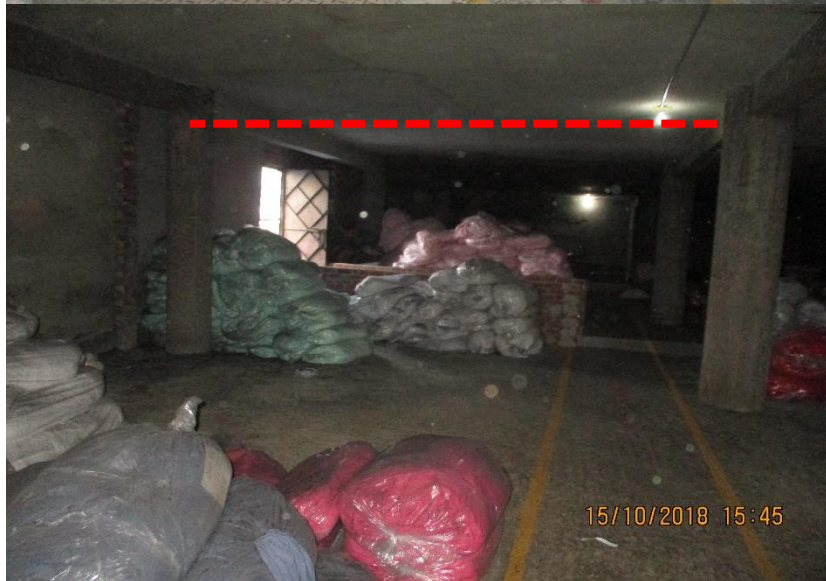
**Building appears to be non-engineered**

Missing beams in short direction

The building has very long span slabs and a missing downstandbeam. Weak in lateral stability in short direction.

| Item No. | Observation | Recommended Action Plan | Recommended Timeline |
|---|---|---|---|
| 4 | Building appears to be non-engineered (Utility Building) | Adequacy of slabs and beams to be confirmed as part of Detailed Engineering Assessment. | 6-weeks |
| 5 | Building appears to be non-engineered (Utility Building) | Detailed Engineering Assessment to be completed and any remedial measures implemented. See attached Scope. | 6-weeks |
| 6 | Building appears to be non-engineered (Utility Building) | Carryout remedial works where required. | 6-months |

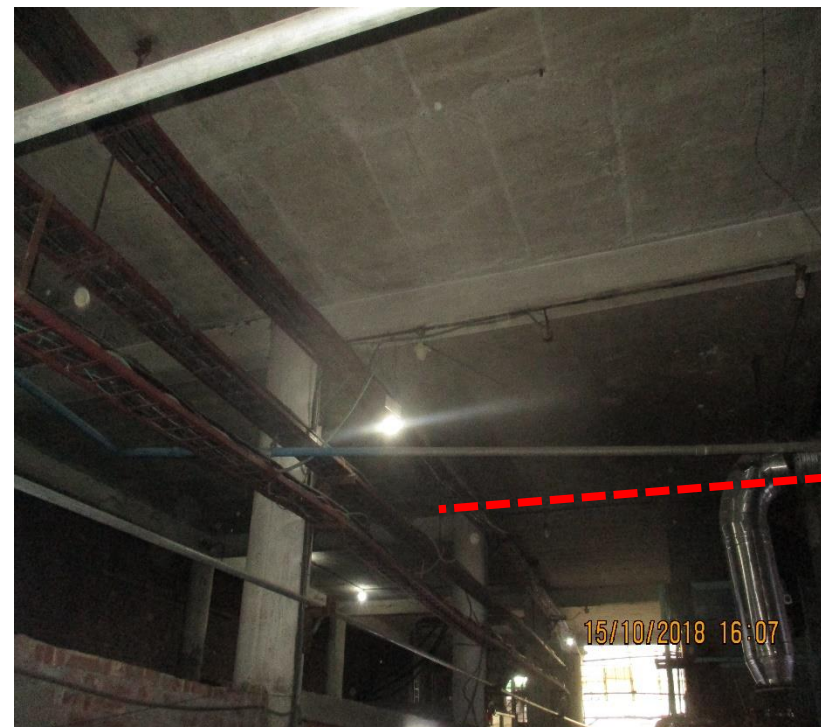
Missing beam in short direction

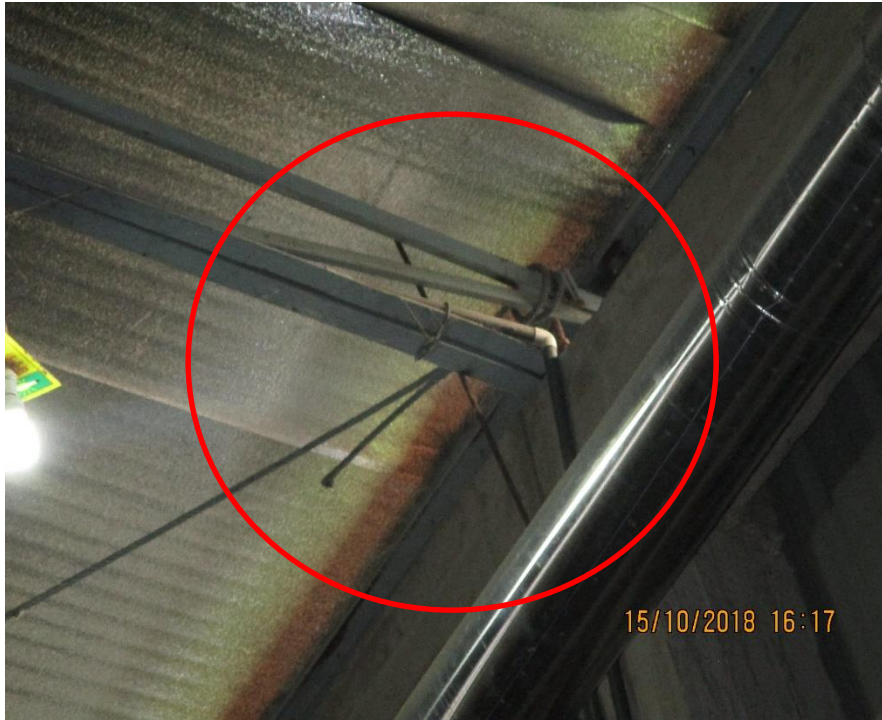
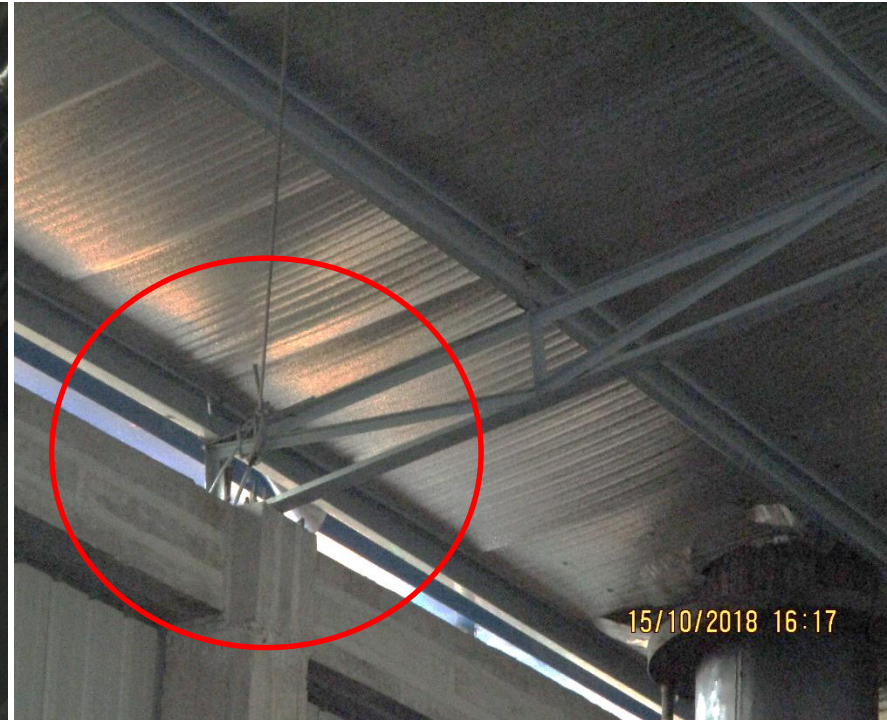
# Poor bracing connection

Poor bracing connection observed in the building shed. Building engineer is required to check & update the connection of the roof bracing.

| Item No. | Observation | Recommended Action Plan | Recommended Timeline |
|---|---|---|---|
| 7 | Poor bracing connection (Boiler Shed) | Building engineer is required to check the lateral stability of the shed and adequacy of the bracing connection. | 6-weeks |
| 8 | Poor bracing connection (Boiler Shed) | Carry out remedial works where necessary. | 6-months |
