# SQ Celsius Limited (Unit 2)

Jamirdia, Bhaluka, Mymensingh  
(24.2849521N, 90.3946713E)  
11<sup>th</sup> November 2018

# Observations

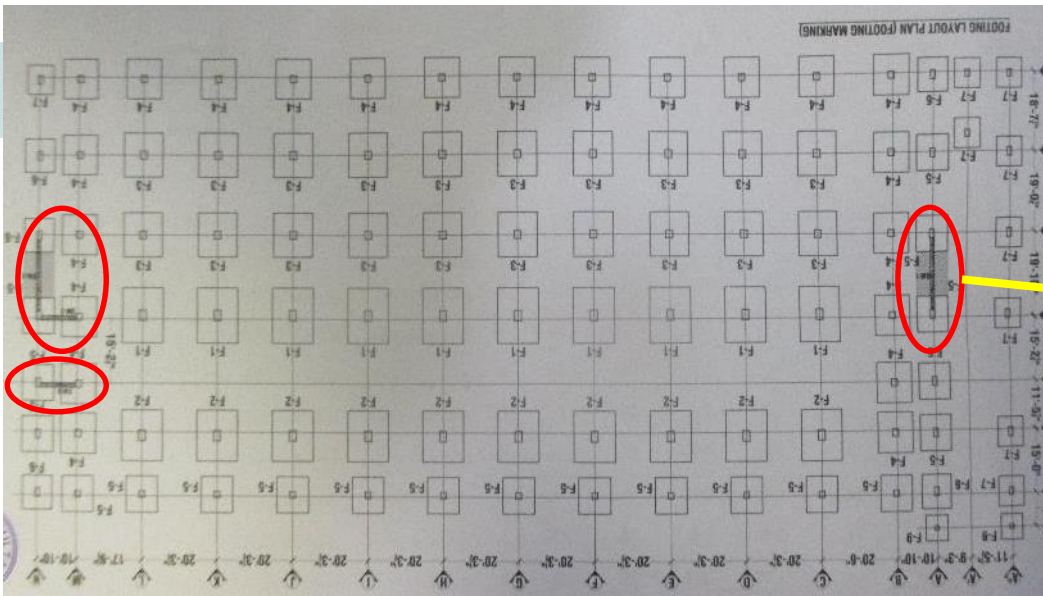
New shear wall construction layout

Three new shear walls were proposed in the structure drawing for improving the lateral stability of the building. Among them, one shear wall is being constructed by top to bottom method. The design report is required to evaluate by ACCORD for assessing the advisability of the shear walls.

| Item No. | Observation | Recommended Action Plan | Recommended Timeline |
|---|---|---|---|
| 1 | Design report is required to be reviewed | Factory is required to submit design report for review. | 6-weeks |
| 2 | Design report is required to be reviewed | Make structural alterations as advised by Engineer where necessary. | 6-months |

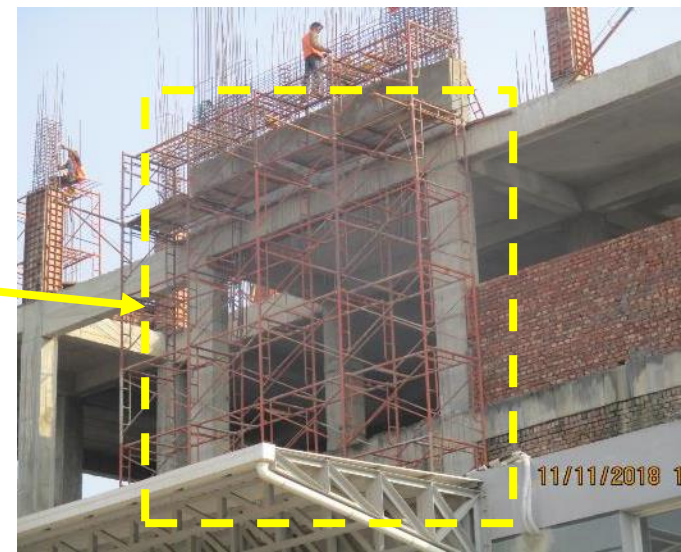
New shear wall is being constructed by top to bottom method

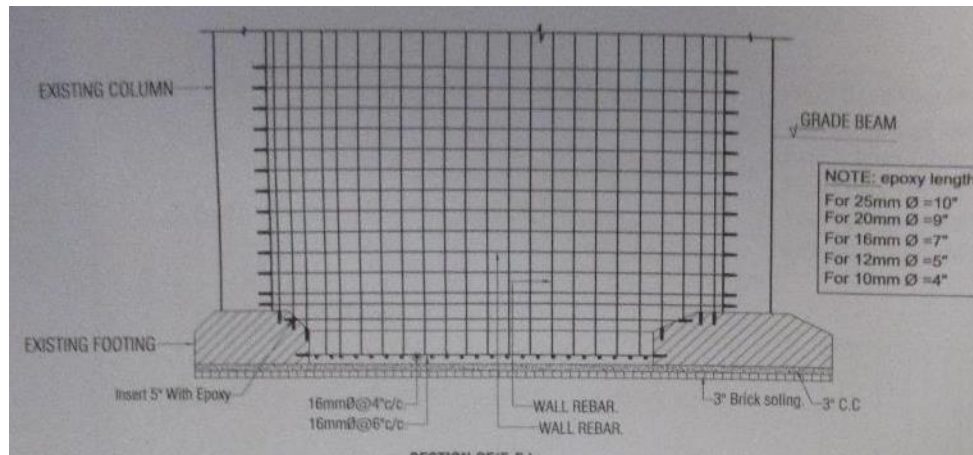
Rebar connection detail of new shear wall with existing columns

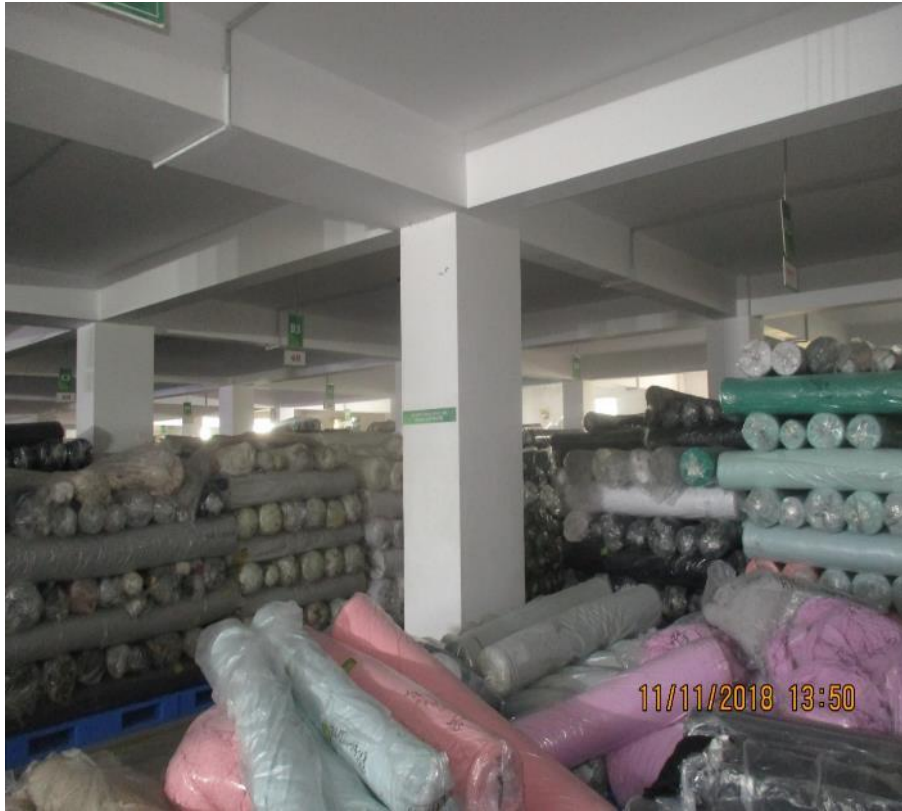
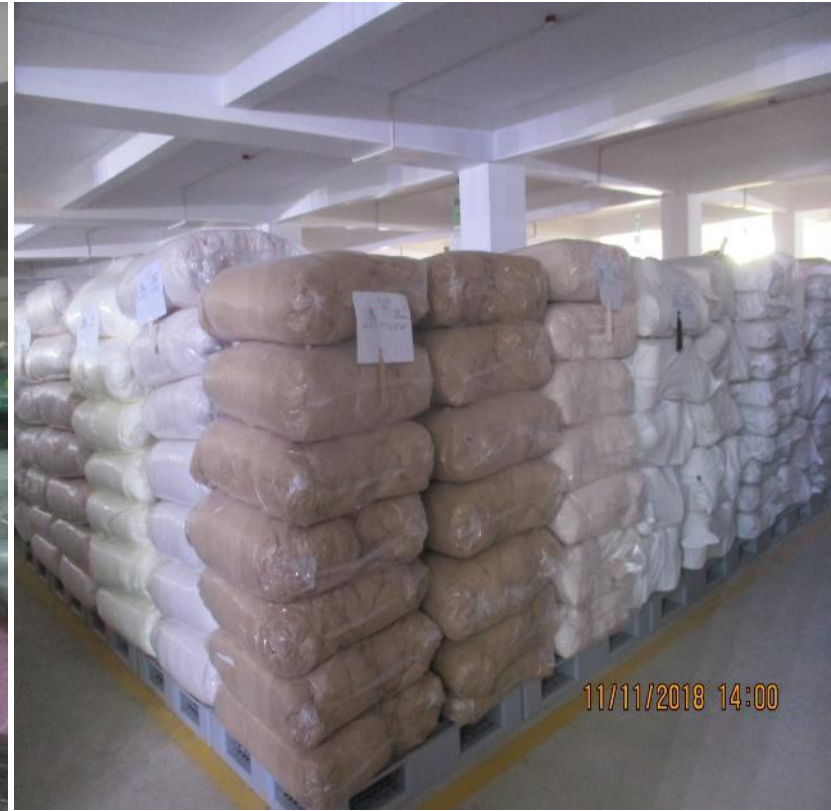
Load plan with load marking was visible on store area on 1<sup>st</sup> and 2<sup>nd</sup> floor. Factory is required to implement load management program as per its floor loading capacity. The load plans for all floors of the buildings must be maintained and the workers must understand the loading requirements.

| Item No. | Observation | Recommended Action Plan | Recommended Timeline |
|---|---|---|---|
| 3 | Implement floor load management program | Factory is required to implement load management program (signage, load restriction height marking) as per its floor load plan. | 6-weeks |
| 4 | Implement floor load management program | Continue to implement load plan. | 6-months |

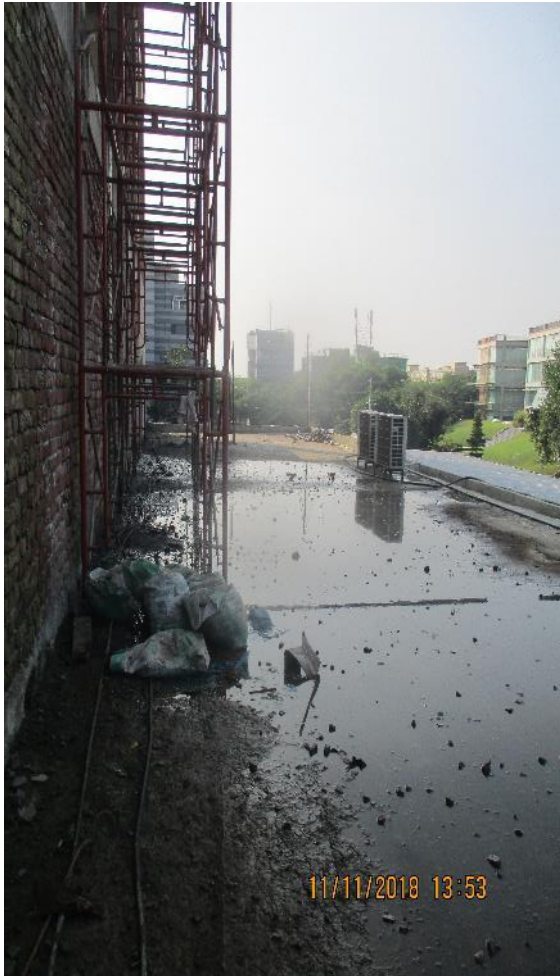
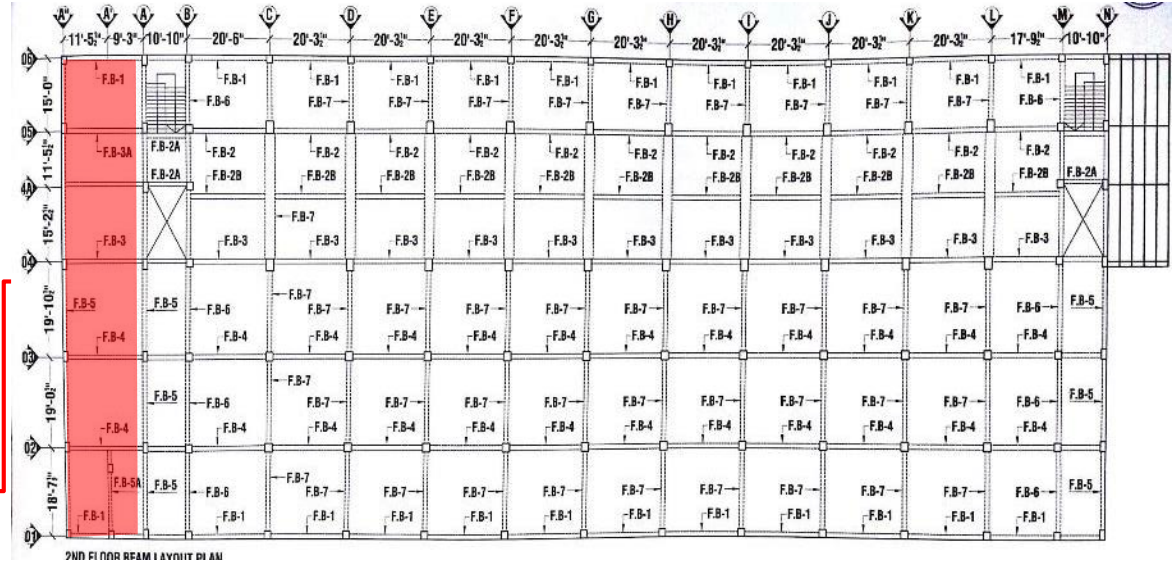
Water ponding was observed on second floor open space which indicates improper slope and poor drainage system. Factory engineer is required to provide water proofing material with appropriate sloping and improve drainage system.

| Item No. | Observation | Recommended Action Plan | Recommended Timeline |
|---|---|---|---|
| 5 | Water ponding and lack of drainage system | Factory is required to provide proper drainage system and other remedial measures to prevent water ponding. | 6-weeks |

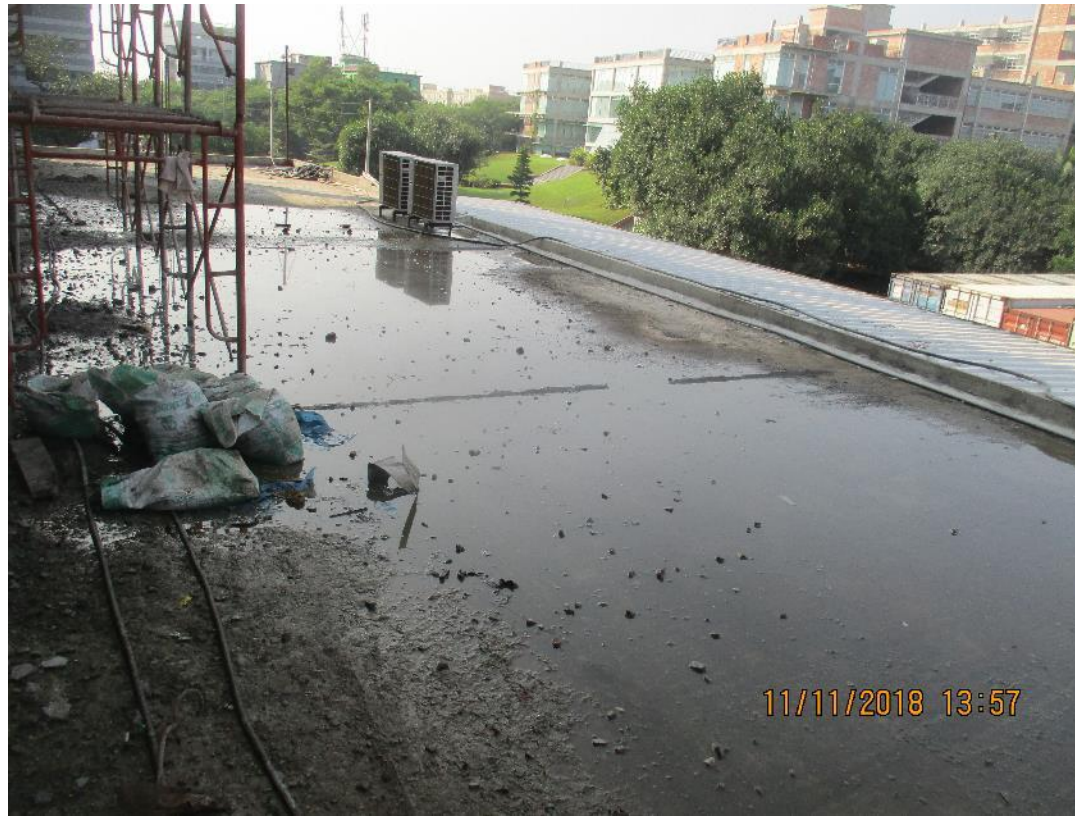
No edge protection was observed against falling hazard.  
Necessary protection to be provided to prevent falling hazard.

| Item No. | Observation | Recommended Action Plan | Recommended Timeline |
|---|---|---|---|
| 6 | Falling hazard | Secure the adjacent areas of hazards by taking appropriate safety measure. | 6-weeks |
