# Arrow Fabrics (Pvt) Ltd.

Plot 50-51, Sector-3, KEPZ, North Patenga, EPZ Thana, Chittagong  
(22.276046, 91.794600)

07<sup>th</sup> November 2018

# Observations

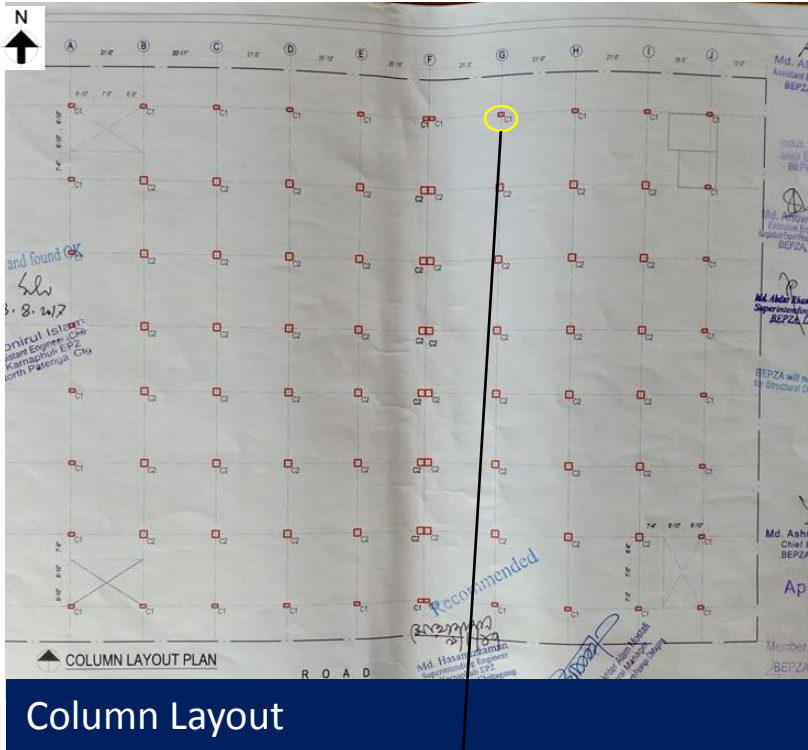
At C-1 type column, 10 nos. rebar was found instead of 12nos. by ferro scanning on 3<sup>rd</sup> floor. On the other hand, sectional details shown 12 nos. of rebar whereas statement shows 14 nos. of rebar.

| Item No. | Observation | Recommended Action Plan | Recommended Timeline |
|---|---|---|---|
| 1 | Discrepancies between provided drawing and on site condition. (Production building) | Building engineer to survey the building and produce as-built documentation reflecting the as constructed condition. | 6-weeks |

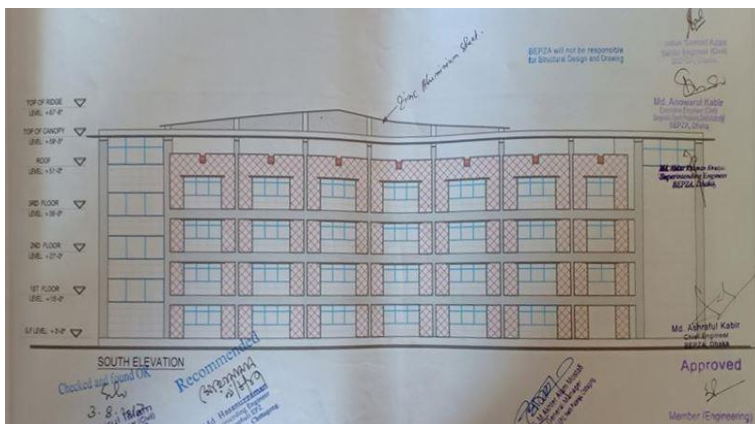
This building is permitted for 5 (G+4) storied from BEPZA. Currently the building is 3 storied. Factory has a future plan to built a shed on current roof. Proposed drawings were available during inspection. Factory engineer is required to carried out a Detail Engineering Assessment considering BNBC provision prior to any extension work.

BEPZA Permit drawing shown 5 storied

| Item No. | Observation | Recommended Action Plan | Recommended Timeline |
|---|---|---|---|
| 2 | Possible vertical extension (Production building) | In case of extension, factory engineer to be carried out further analysis and update design report following BNBC requirement. | 6-weeks |

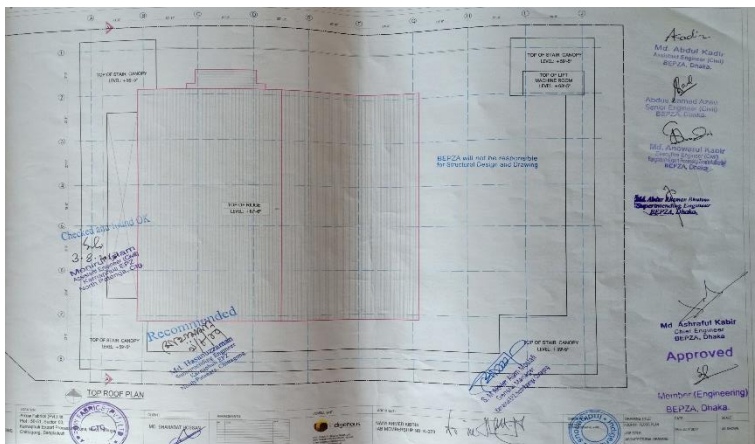
Proposed roof

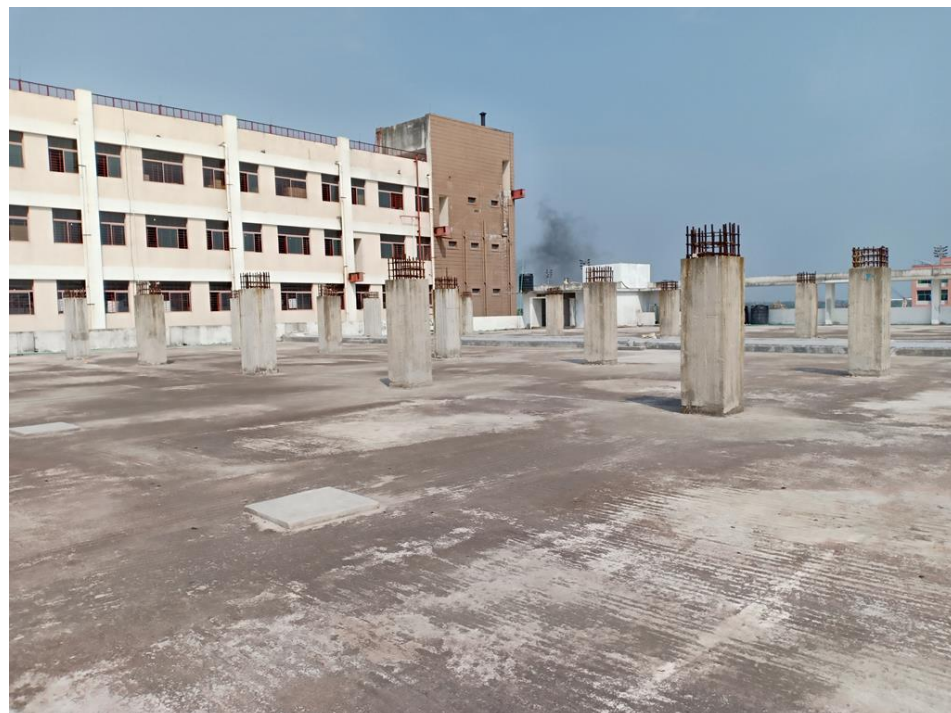
Current roof of factory building

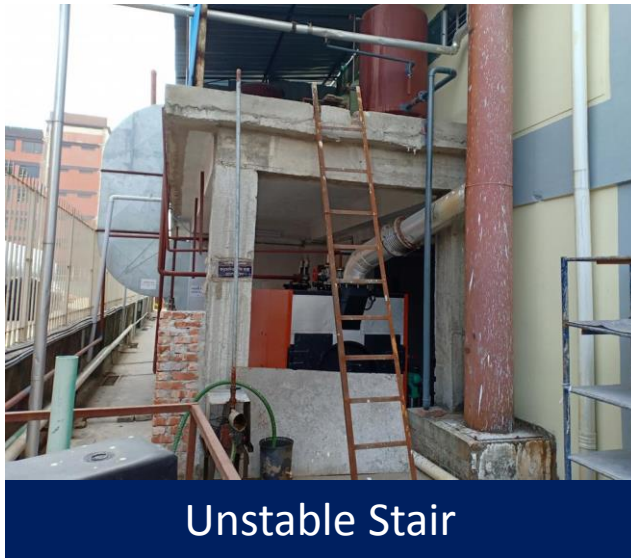
Apparently non-engineered shed above utility building at west. Poor connection between support and rafter. Building engineer to check the stability of the lightweight steel roofs against lateral loading. Also, replace the stair with a stable one.

Unstable Stair

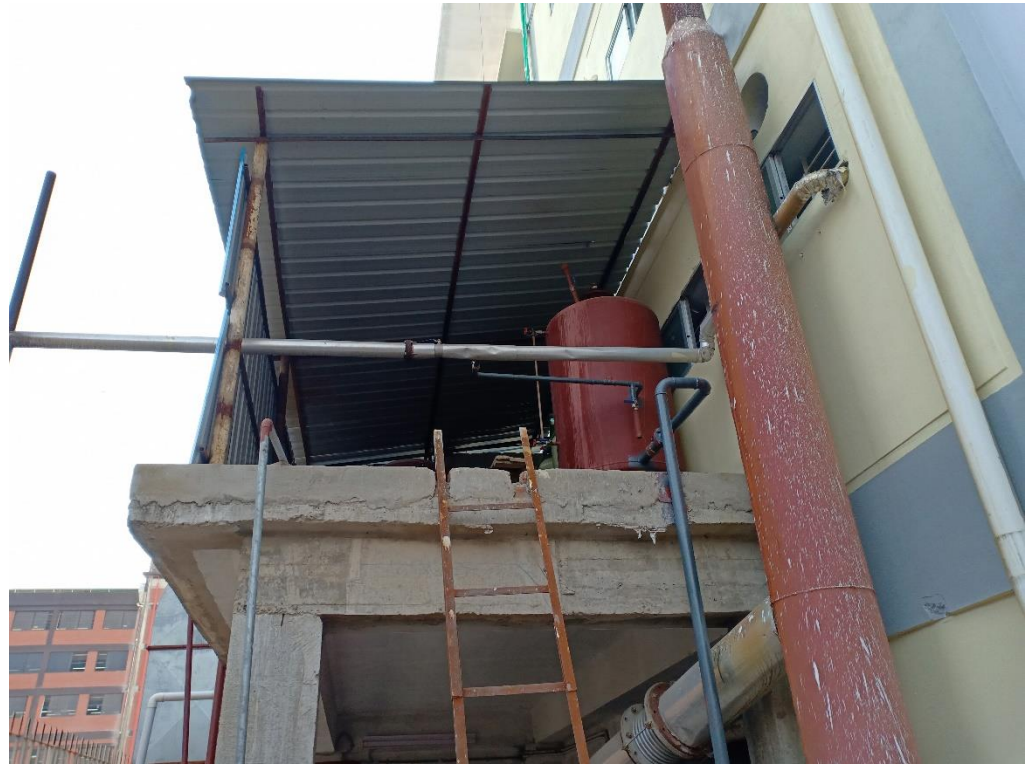
Light weight roof supported by Bamboo

| Item No. | Observation | Recommended Action Plan | Recommended Timeline |
|---|---|---|---|
| 3 | Non-engineered shed above utility Building. (Utility Building) | Prepare an “as constructed” drawings which reflect the actual site dimensions with complete structural information. | 6-weeks |
| 4 | Non-engineered shed above utility Building. (Utility Building) | Building engineer to check the capacity of the lightweight steel roof against lateral loading. | 6-weeks |
| 5 | Non-engineered shed above utility Building. (Utility Building) | Carry out remedial works resulting from engineering assessment if necessary. | 6-months |
