# Apex Fashion Wear Limited

Chandora, Post Shafipur, Thana, Kailakoir District, Gazipur.

23<sup>rd</sup> October 2018 & 24<sup>th</sup> November 2018

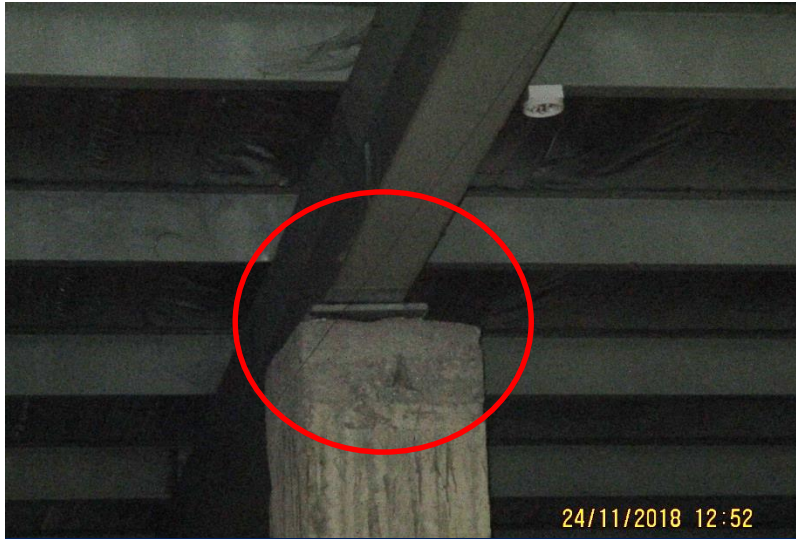
Apparently inadequate bearing area in joint

Poor connection detail between steel baseplate and RCC column. Also gap between baseplate & column observed. Building engineer is required to check the connection adequacy for uplift pressure.

| Item No. | Observation | Recommended Action Plan | Recommended Timeline |
|---|---|---|---|
| 1 | Gap & poor detail between steel baseplate and RCC column. (Building#15 -Store Shed) | Building engineer is required to check the connection adequacy for the uplift pressure. | 6-weeks |
| 2 | Gap & poor detail between steel baseplate and RCC column. (Building#15 -Store Shed) | Carryout remedial works where necessary. | 6-months |

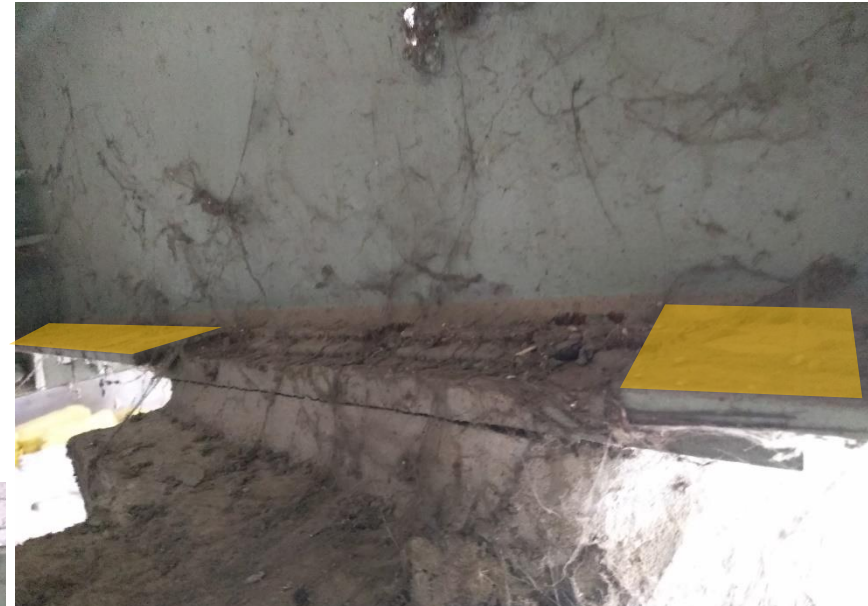
Flange discontinued joint connection

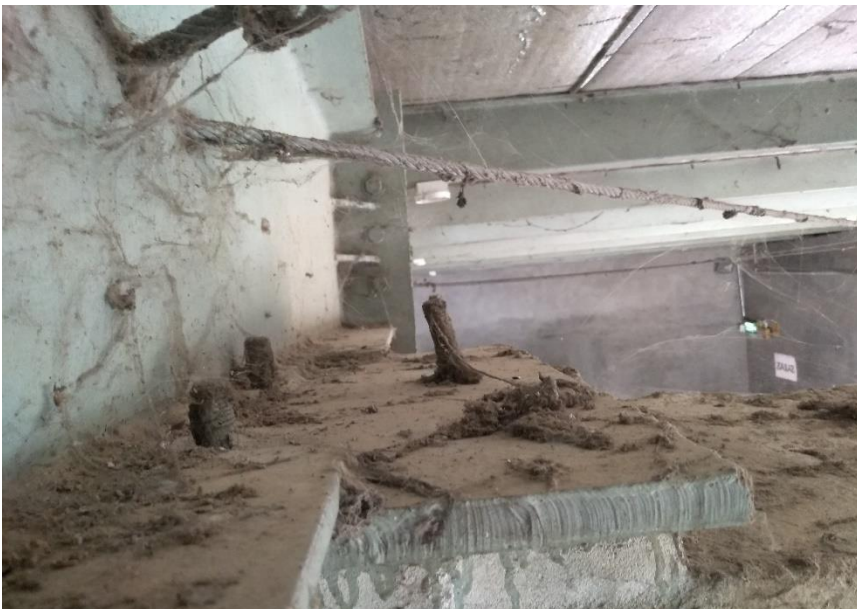
Two bolts connected in other side of the flange

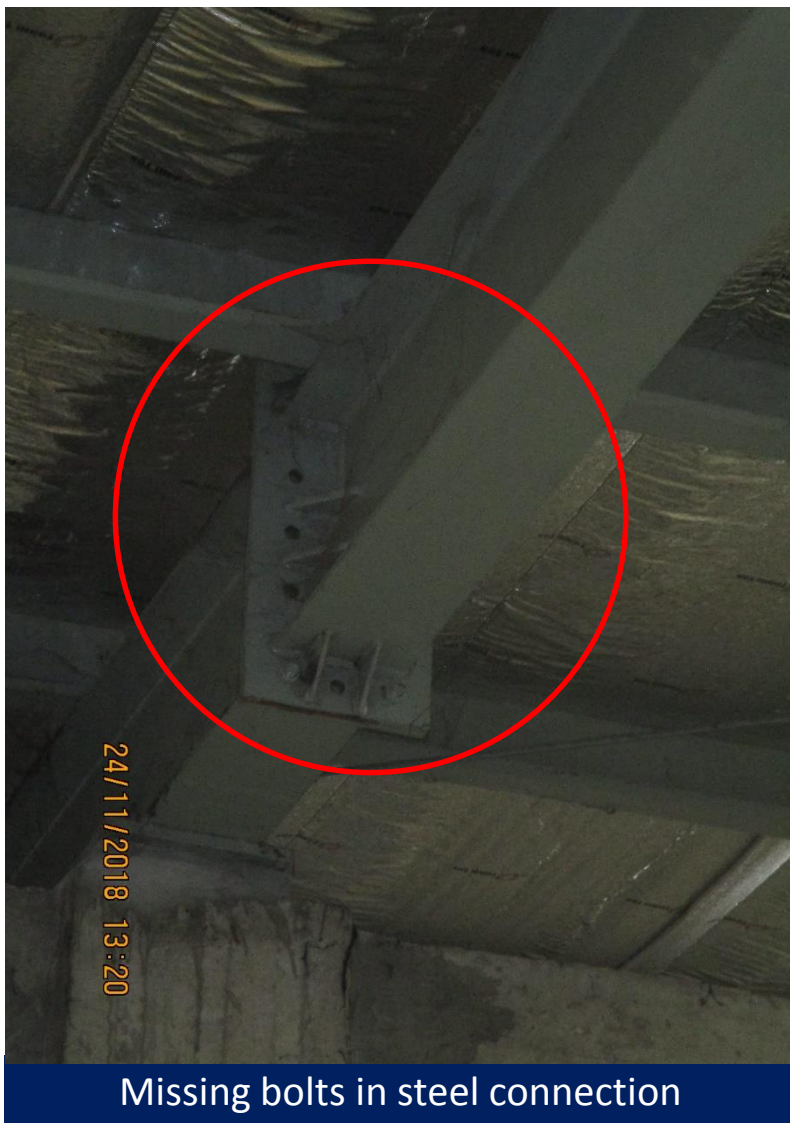
Missing bolts in steel connection

Significant gaps & missing bolts were observed in rafter connections. Building engineer is required to carry out suitable remedial works.

| Item No. | Observation | Recommended Action Plan | Recommended Timeline |
|---|---|---|---|
| 3 | Existence of gaps & bolt missing in steel connection. (Building#15 -Store Shed) | Identify the defected areas and carry out suitable remedial works. | 6-weeks |

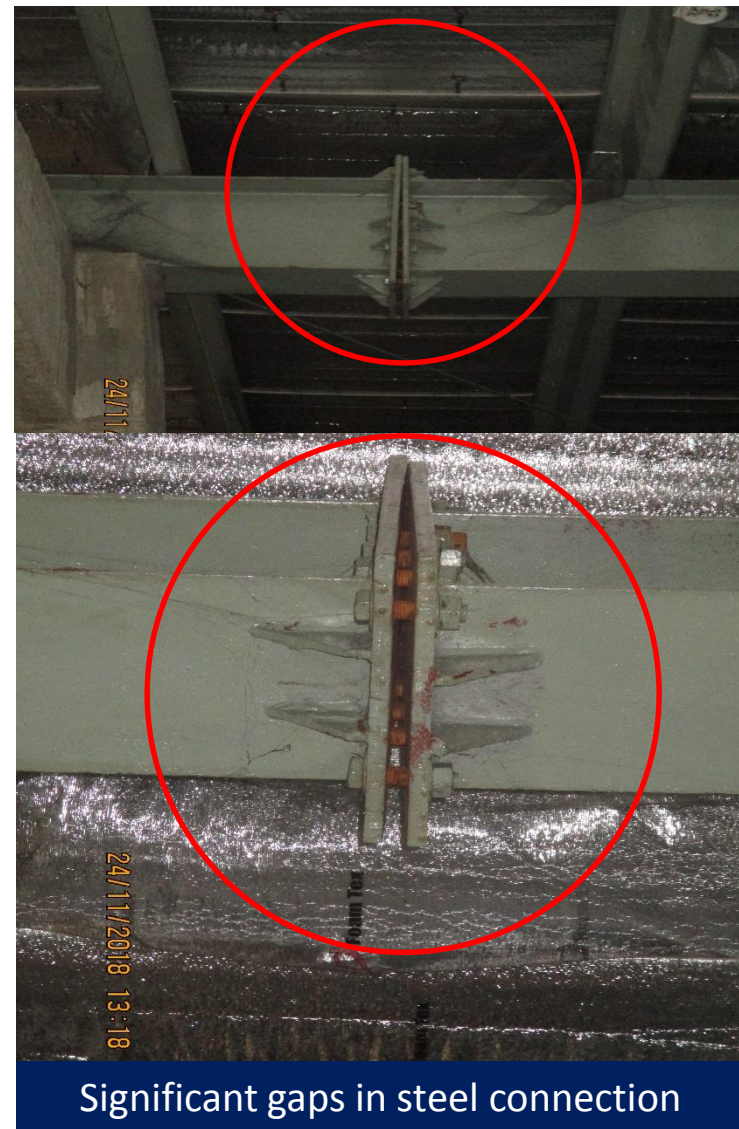
Significant gaps in steel connection

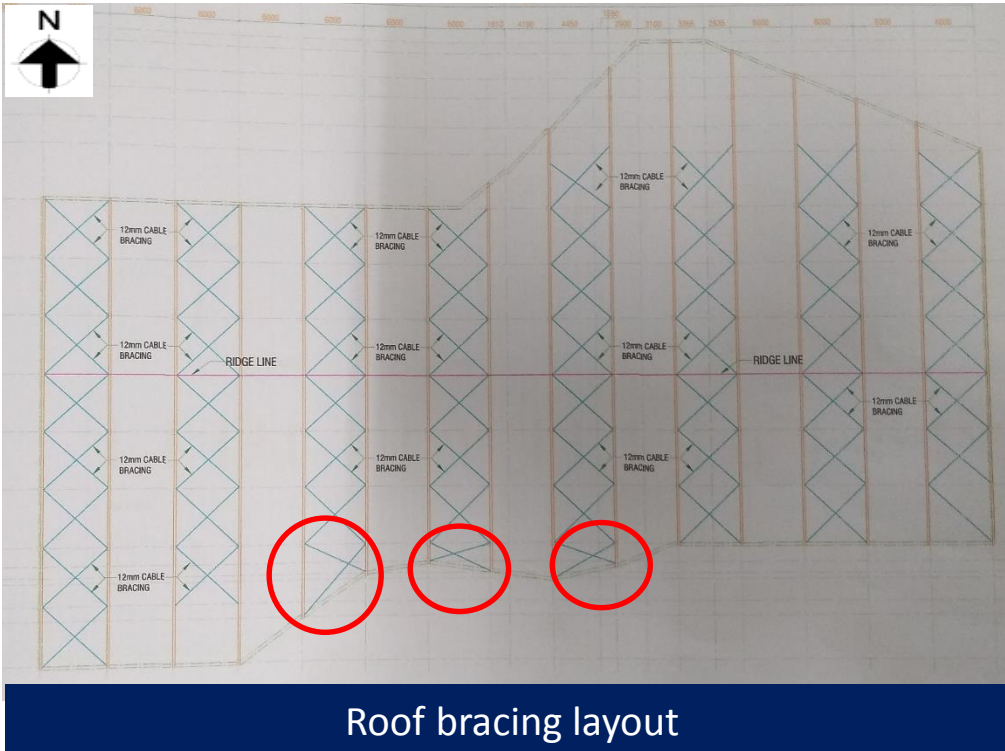
Roof bracing layout

Loose & missing cable bracings were observed in Store Shed. Building engineer is required to install & upgrade the bracing.

| Item No. | Observation | Recommended Action Plan | Recommended Timeline |
|---|---|---|---|
| 4 | Loose & Missing cable bracing. (Building#15 -Store Shed) | Reinstalled the missing bracing as per specification. | 6-weeks |
| 5 | Loose & Missing cable bracing. (Building#15 -Store Shed) | Tighten the existing bracing. | 6-weeks |

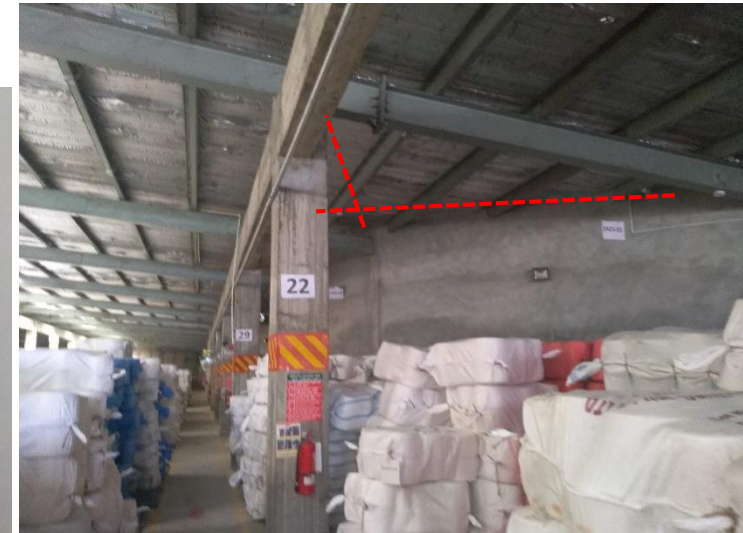
Missing roof bracing

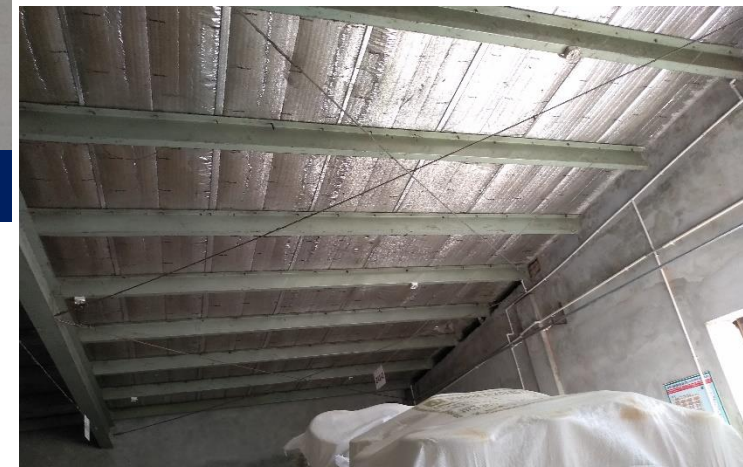
Loose cable bracing

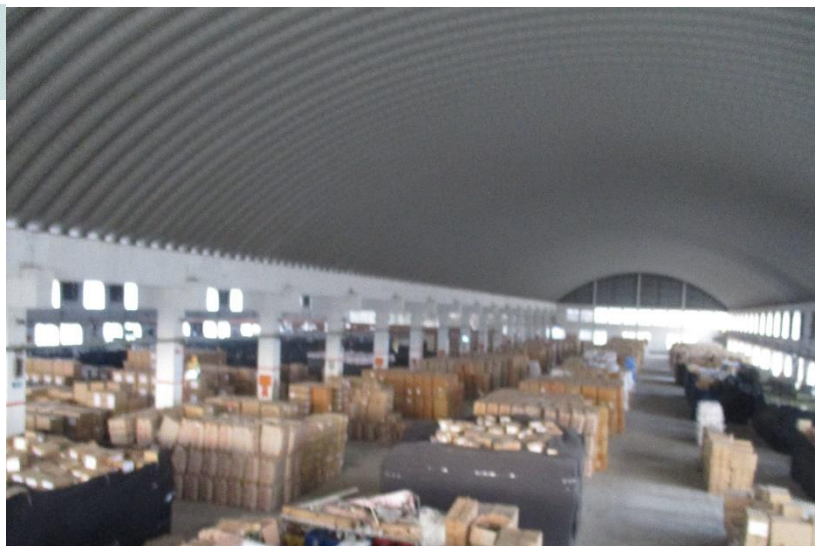
Gable frame

No obvious lateral loading system was observed.  
Building engineer is required check the lateral loading system & the connection adequacy.

| Item No. | Observation | Recommended Action Plan | Recommended Timeline |
|---|---|---|---|
| 6 | No obvious lateral stability system. (Building#6-Processing Hall) | Building engineer is required to check the lateral stability system, connection adequacy against lateral loading. | 6-weeks |
| 7 | No obvious lateral stability system. (Building#6-Processing Hall) | Carry out remedial works where required. | 6-months |

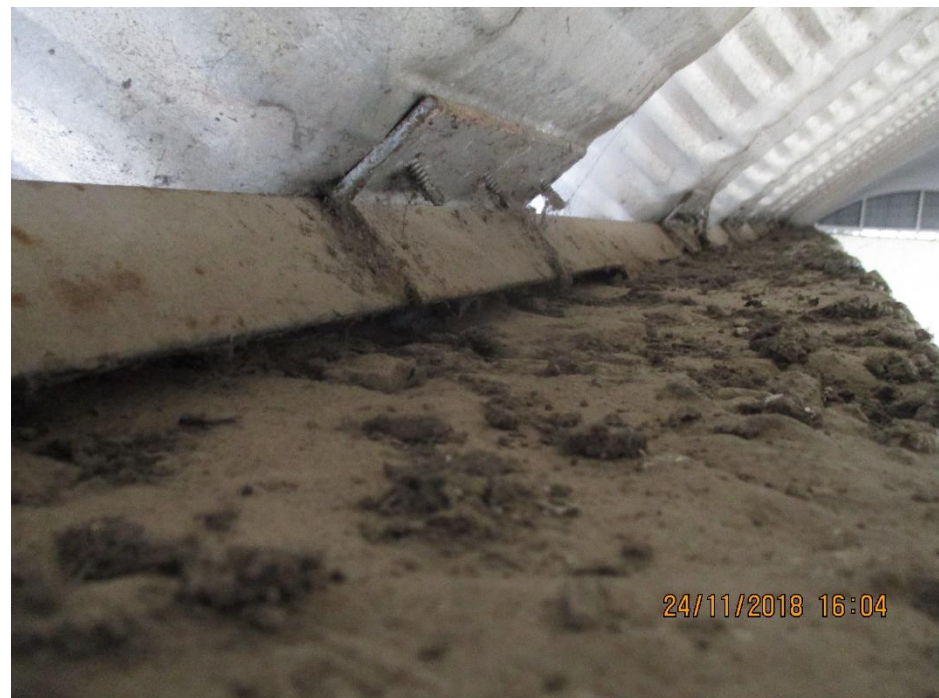
Connection between profiled roofing & support.

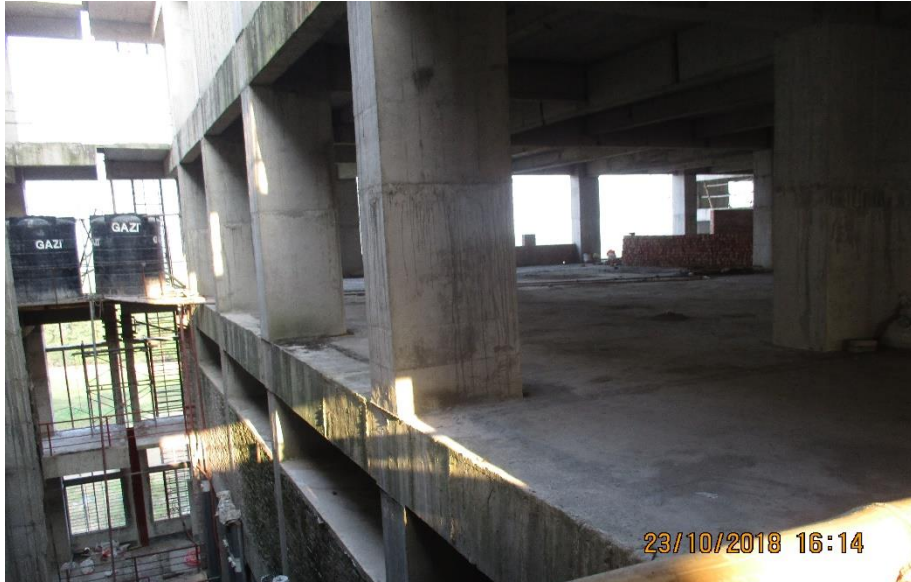
Parapet missing in Garments Building

| Item No. | Observation | Recommended Action Plan | Recommended Timeline |
|---|---|---|---|
| 8 | Parapet missing & Exposed rebar. | Install parapet to prevent falling hazard. | 6-weeks |

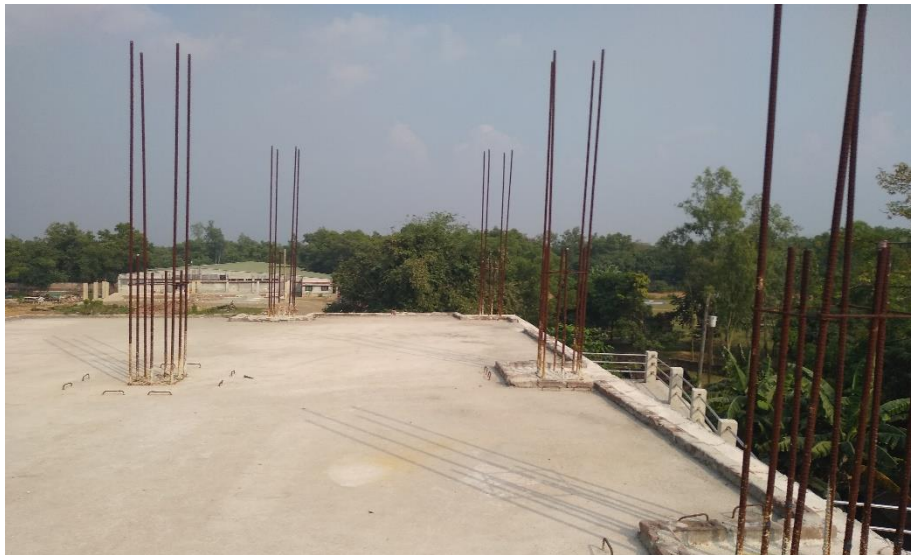
Parapet missing & Exposed rebar at Utility Building

| Item No. | Observation | Recommended Action Plan | Recommended Timeline |
|---|---|---|---|
| 9 | Parapet missing & Exposed rebar. | Rust proof coating is required applied on exposed rebar. | 6-weeks |

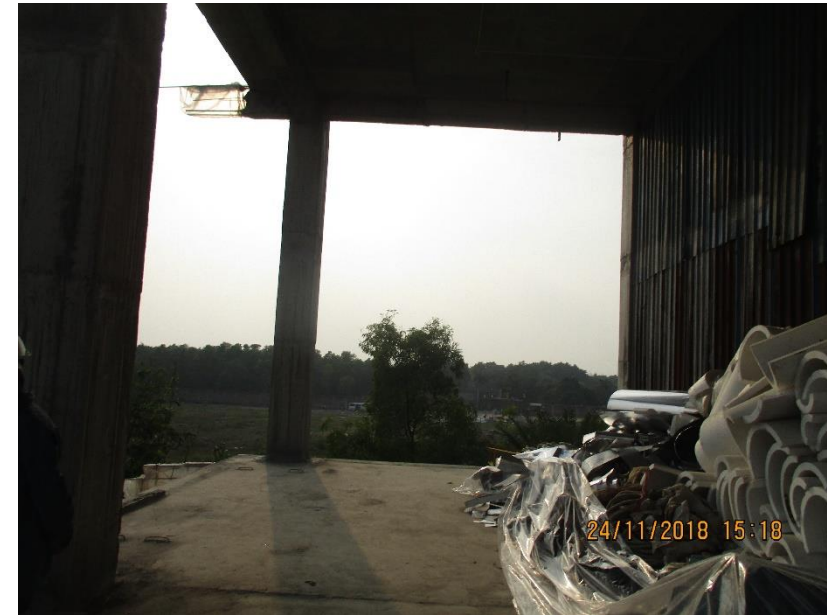
Parapet missing at Generator & Chiller Building
