Cute Dress Industry Limited

Bathuli, Shaha Belissor, Dhamrai, Dhaka

31st October 2018

Observations

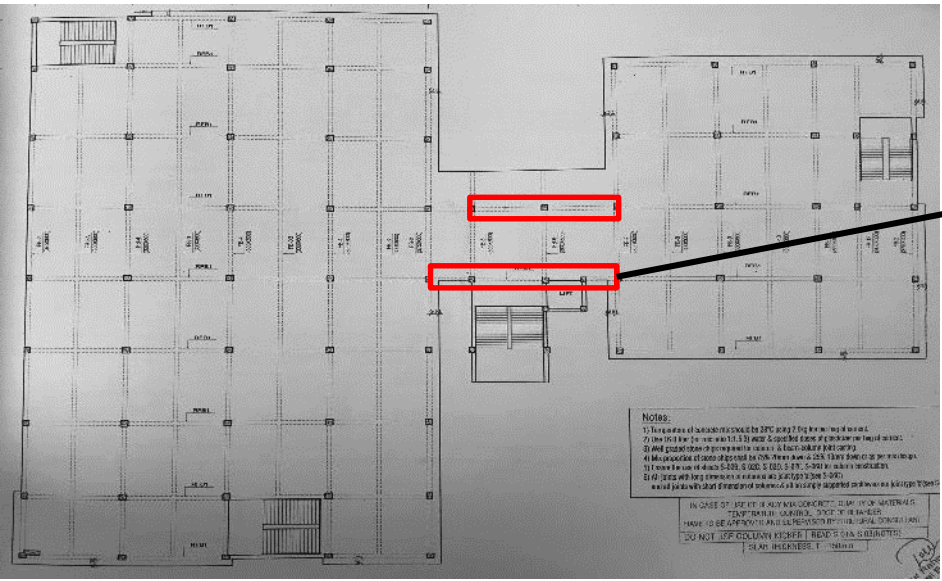
Retrofitted beam layout of 1st floor

According to the design report, some beams were required to be retrofitted. But onsite, the retrofitted beams layout did not match with drawing. Factory is required to revise the design report as per on site condition.

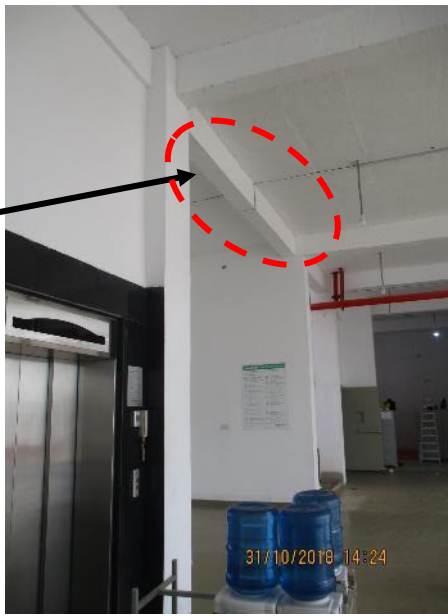
1st floor beam which was suppose to be retrofitted

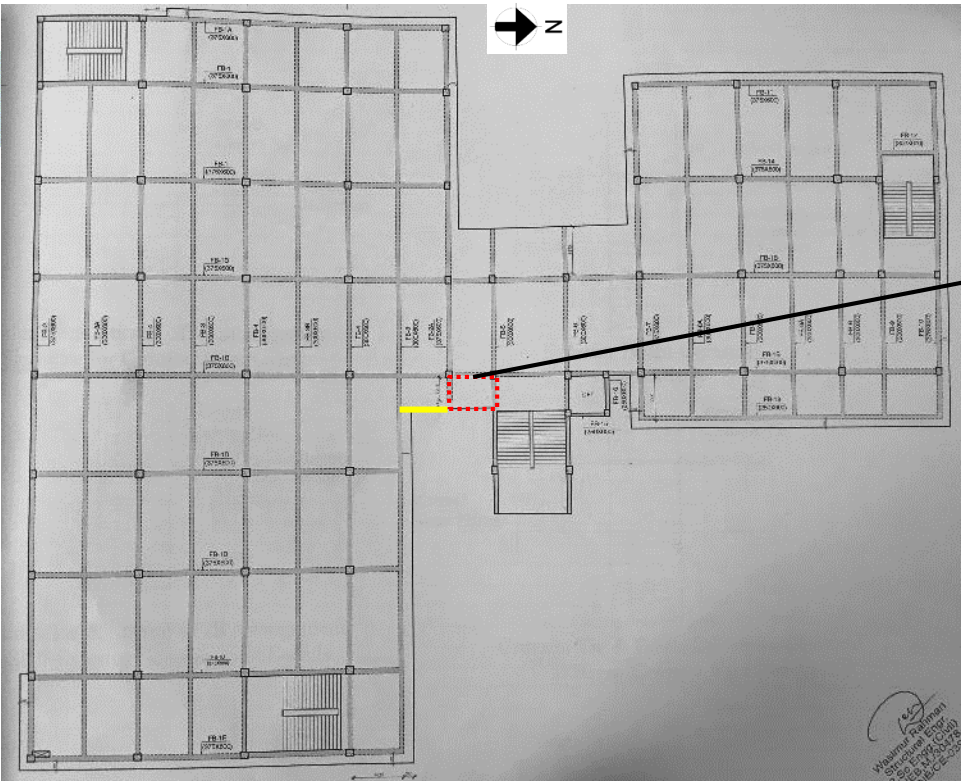
Roof beam layout

The red marked zone on floor plan, the slab was not present on site. Also, one new beam was found which was marked as yellow

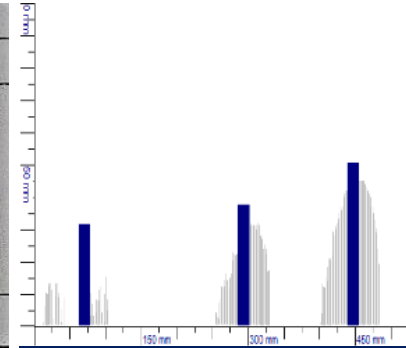
3 rebars were found in short direction of C4 columns instead of 4 rebars

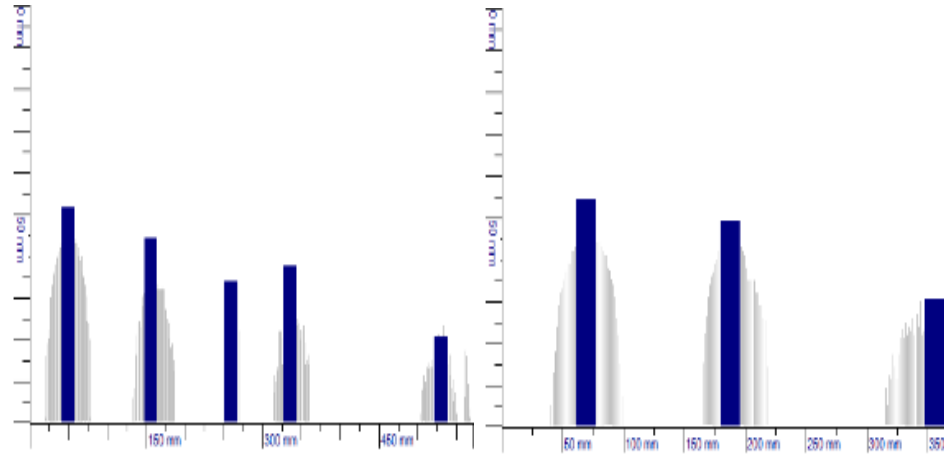
12 nos. Rebars (5x3) were found in C-3 column instead of 16 nos. rebars

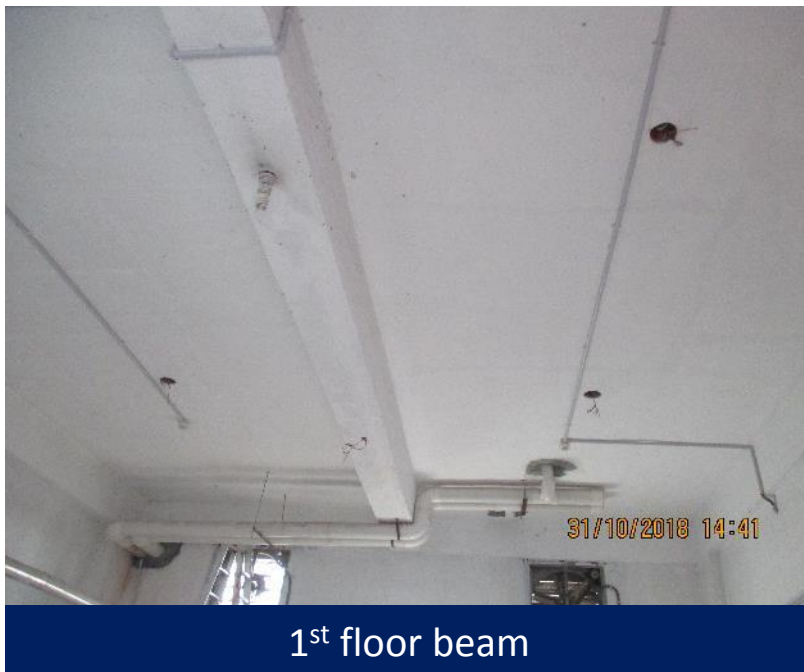
Down stand depth of beam was measured 475 mm. If flat slab depth was considered as 200 mm as per as-built drawing then total depth of beam will be 675 mm instead of 600mm which was shown in as-built drawing. But if beam was 600mm then the slab thickness is 125mm. In this situation, the depth of slab is required to be ensured.

Factory is required to produce accurate as-built drawings reflecting actual on site condition.
