# Four Brothers Fashion - Unit 2 (Ref. 9235)

66-68 Haji Deen Mohammad Road, Dhaka Uddyan, Beribadh, Mohammadpur, Dhaka

15.MARCH.2014

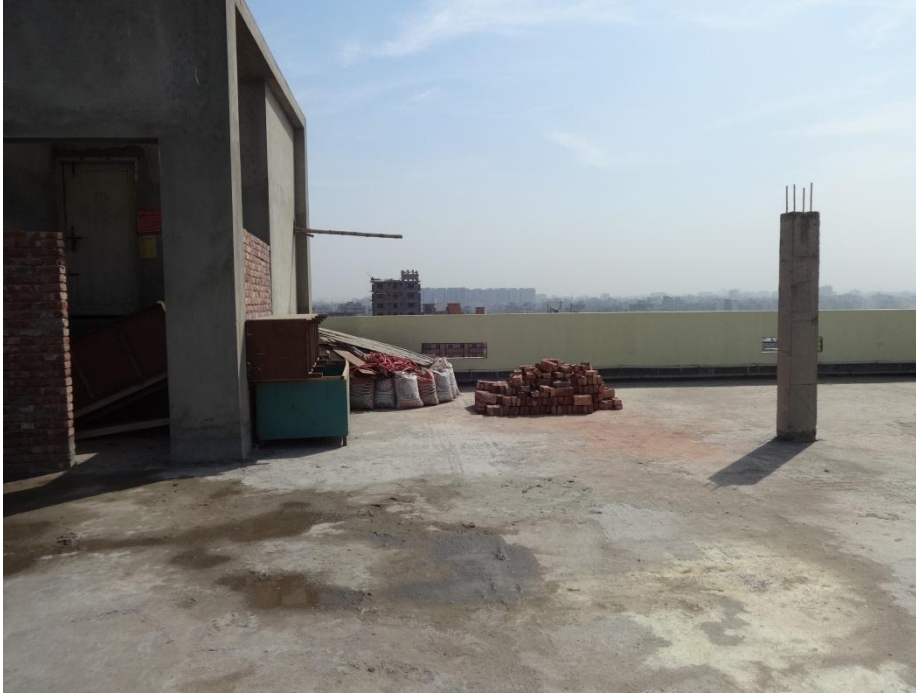
Lack of waterproofing layer has led to small amount of ponding at roof level.

No signs of water ingress were visible from within, however the ponding witnessed (during the dry season) suggests that it is a potential problem for the future if left untreated.

Lack of waterproofing layer at roof level. No current signs of water ingress, but ponding suggests the potential for future problems if left untreated.

- Apply a waterproofing membrane to roof level, with appropriate perimeter drainage.
- Monitor soffit of 8<sup>th</sup> floor to ensure that signs of water ingress do not develop.

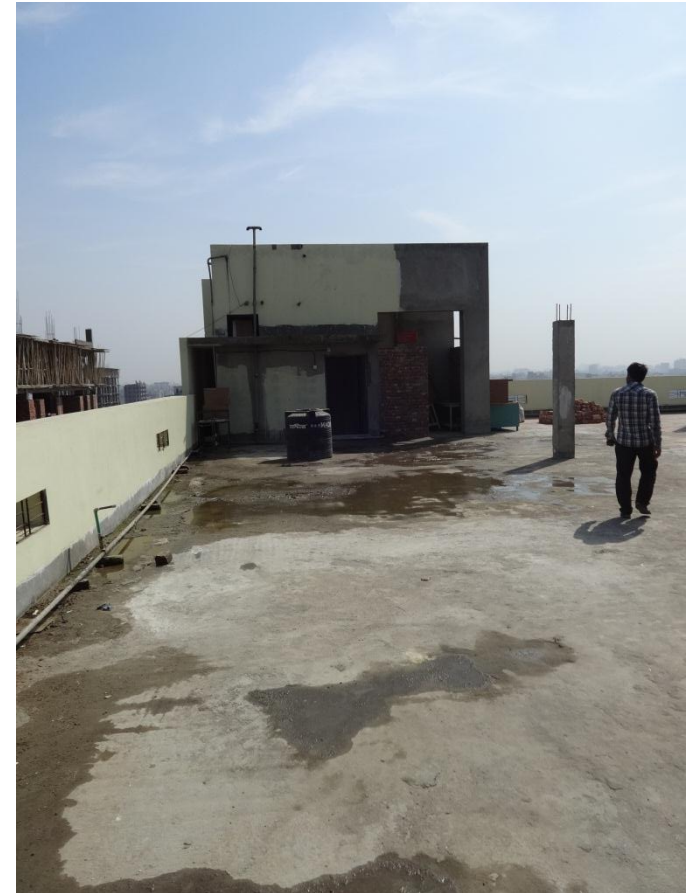
Note also the small pile of bricks. This load is not immediately concerning, but should be removed and prevented in future.

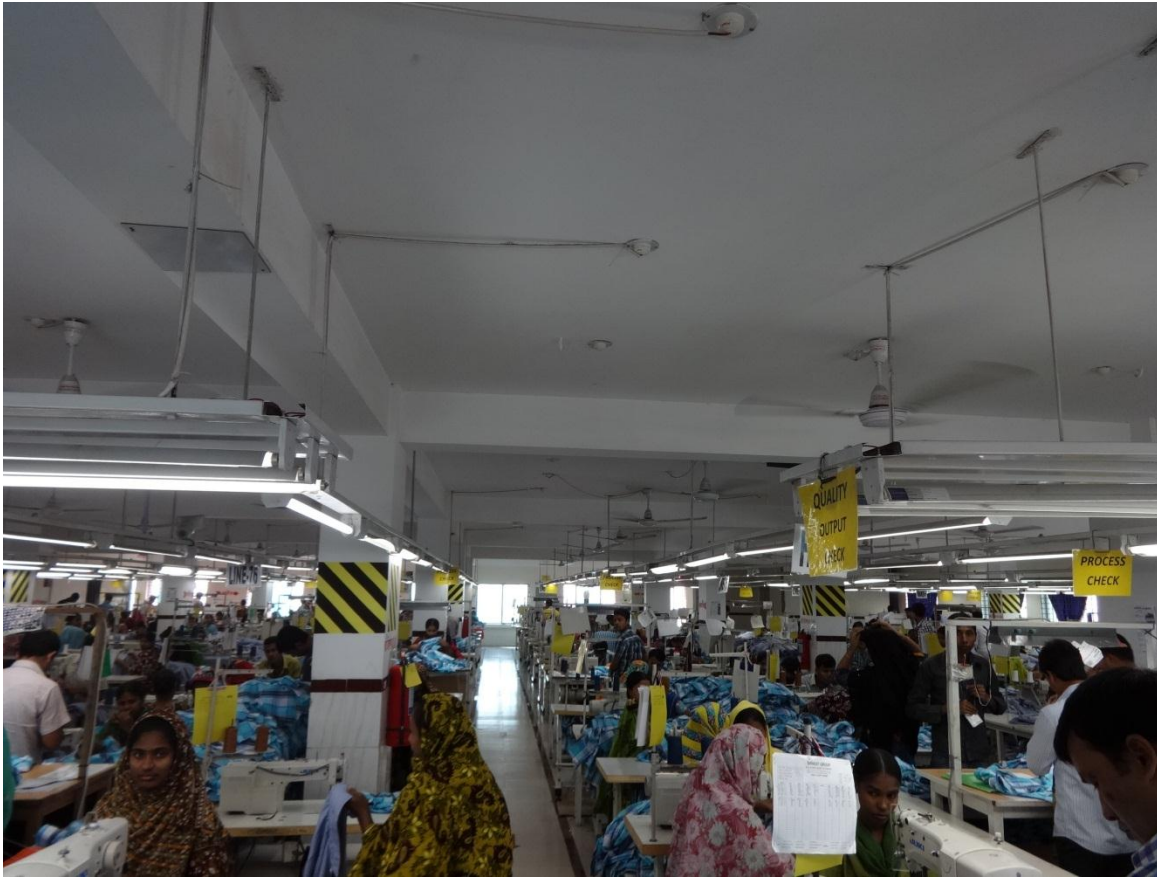
# Water Ingress at Roof Level

No signs of water ingress visible on the soffit above 8<sup>th</sup> floor level.

Note that, as mentioned in the Priority Actions list, the lack of waterproofing at roof level leaves the potential for water ingress to develop over the long-term future of the building.
