# Mimo Cotton Zone Textile Ltd.

Holding # 97, Sayatol Market, Surabari, Kashimpur, Gazipur

13<sup>th</sup> November 2018

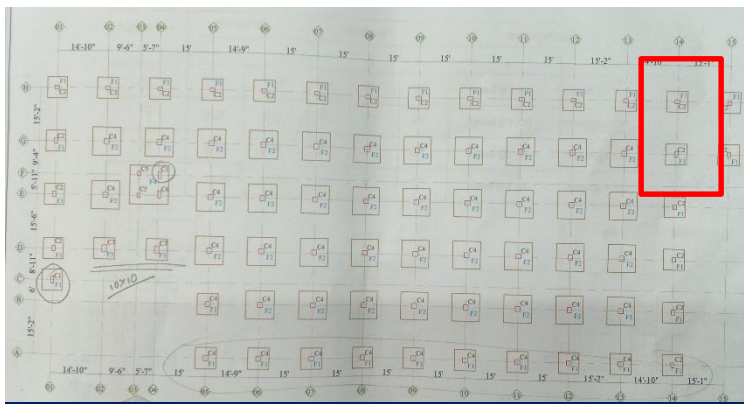
Foundation Schedule(Set-2 Drawing)

**Bearing capacity of foundation exceeds  
normal design limit**

As per provided soil test report, the factor of safety for isolated footing was found to be less than 2.5 which is below the BNBC standard. Factory is required to check the adequacy of the foundation. Moreover, depth of footing is not clear because EGL level is not mentioned in the drawing and on site EGL height is found almost 2 feet down from GB at East side.

| Item No. | Observation | Recommended Action Plan | Recommended Timeline |
|---|---|---|---|
| 1 | Bearing capacity of foundation exceeds normal design limit. (Factory Building) | Factory engineer to investigate the actual depth & size of the footing and check the adequacy of the existing foundation. | 6-weeks |
| 2 | Bearing capacity of foundation exceeds normal design limit. (Factory Building) | Implement remediation work if required. | 6-months |

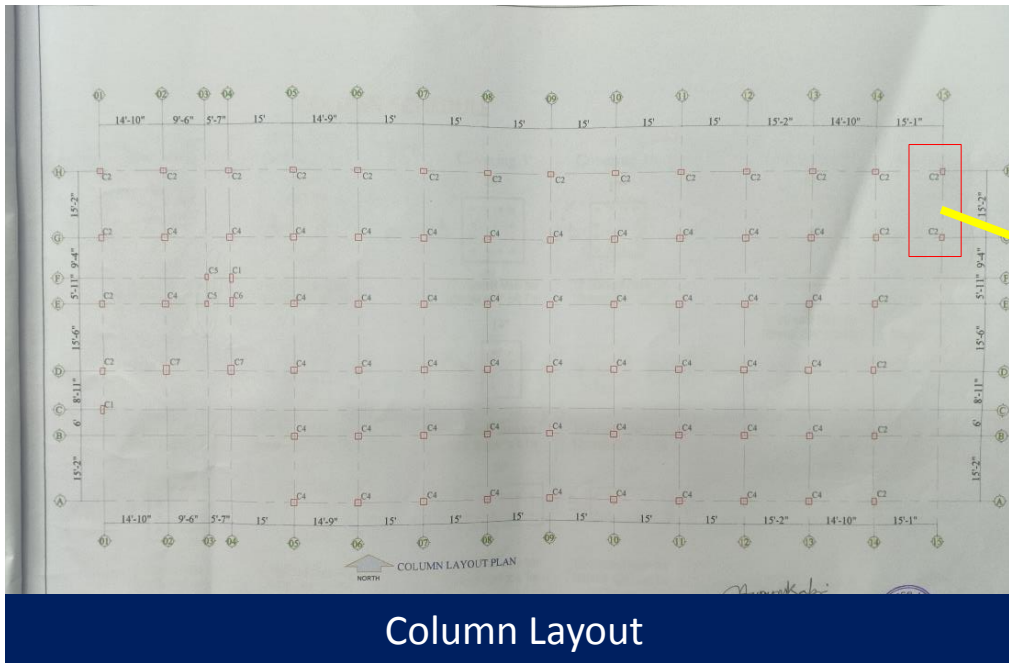
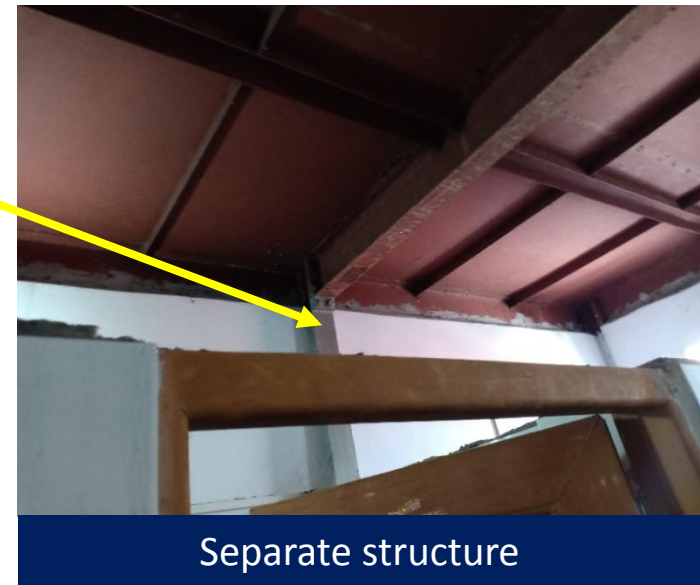
The column layout did not match with as-built structural drawing. On grid-15, two extra columns were observed on column layout in as-built structural drawing which were not found on site.  
Separate steel structural was found on that grid.

| Item No. | Observation | Recommended Action Plan | Recommended Timeline |
|---|---|---|---|
| 3 | Discrepancy between provided drawing and on-site condition (Factory Building) | Engage an Engineer to produce an “as constructed” drawings which reflect the actual site conditions with complete structural information. | 6-weeks |

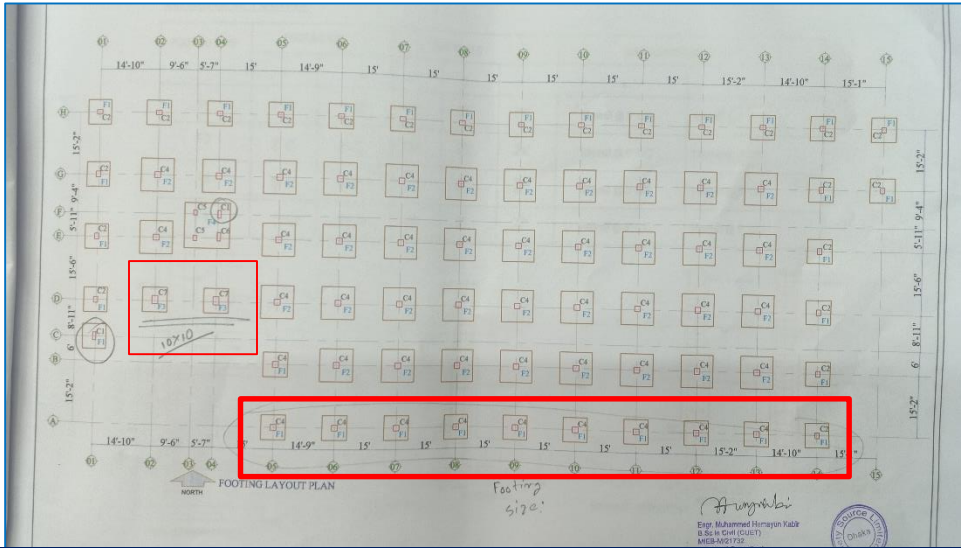
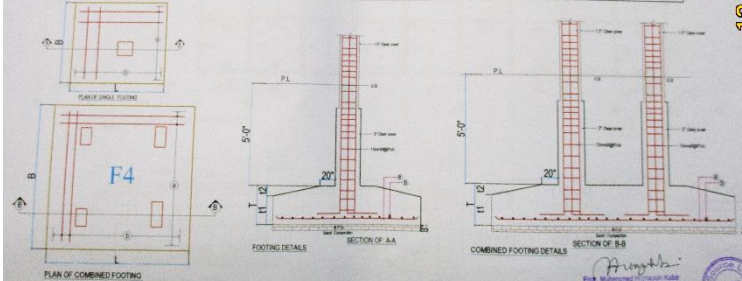
## Footings Schedule of as-built drawings

Footings sizes are found different in construction drawings and as-built drawings. Red marked footing sizes are found less on as-built drawings than the construction drawings. Factory engineer is required to check the actual size of the footing and revised the as-built drawings accordingly.

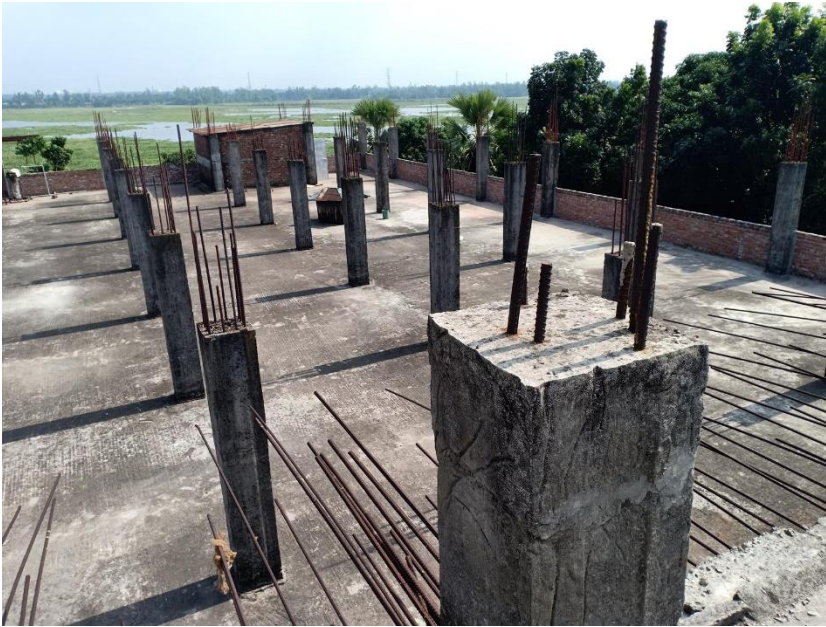
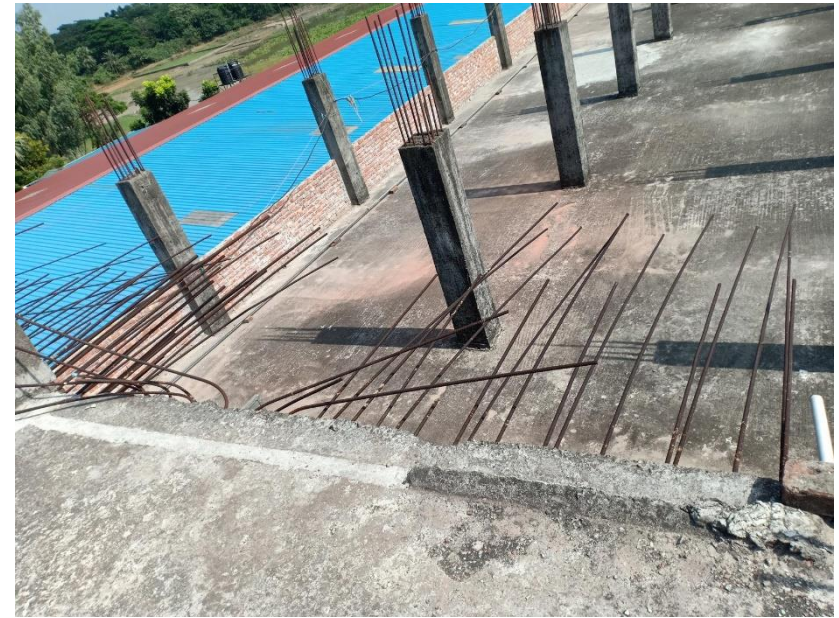
## Exposed rebar at roof

All exposed reinforcement to be protected from corrosion. Currently the exposed reinforcement is prone to corrosion.

| Item No. | Observation | Recommended Action Plan | Recommended Timeline |
|---|---|---|---|
| 4 | Expose rebar on roof (Factory Building) | All exposed reinforcement is required to protect from corrosion with suitable method. | 6-weeks |

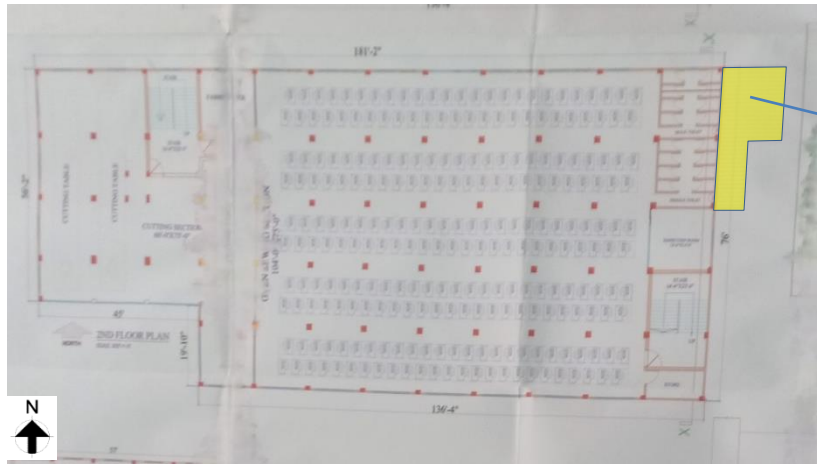
Floor layout plan of factory building

At east side of factory building, a two storied steel structure was found which not structurally connected with factory building. Structural and architectural drawings were not available for the two storied structure.

| Item No. | Observation | Recommended Action Plan | Recommended Timeline |
|---|---|---|---|
| 5 | Lack of documents for Extension portion (Extension of Factory building) | produce an “as constructed” drawings which reflect the actual site conditions with complete structural information. | 6-weeks |

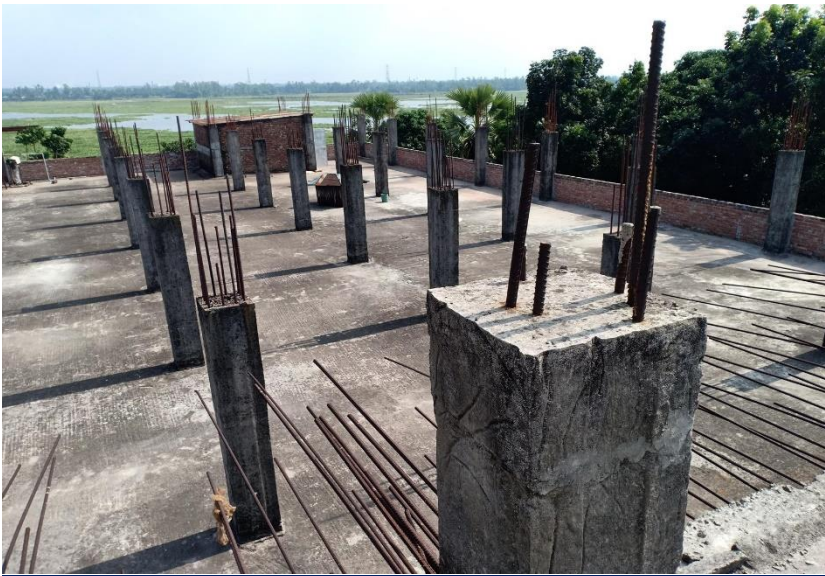
Current roof of factory building

This building is permitted for 6 (G+5) storied from local authority. Currently the building is partial 3 storied. Factory engineer is required to carried out a Detail Engineering Assessment considering BNBC provision prior to any extension work.

| Item No. | Observation | Recommended Action Plan | Recommended Timeline |
|---|---|---|---|
| 6 | Possible vertical extension (Factory building) | In case of extension, factory engineer to be carried out further analysis and update design report following BNBC provision. | 6-weeks |

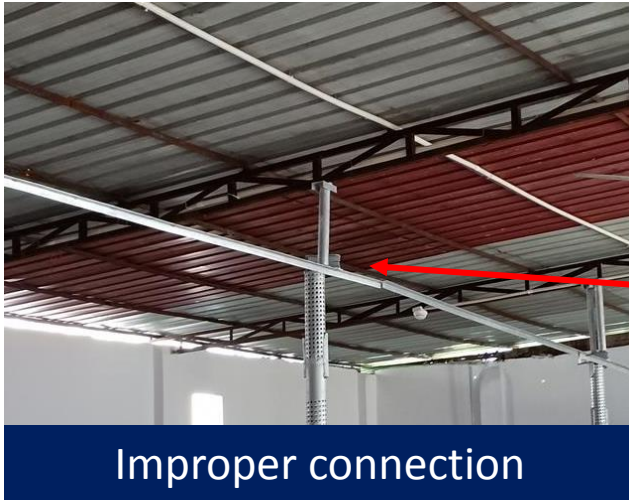
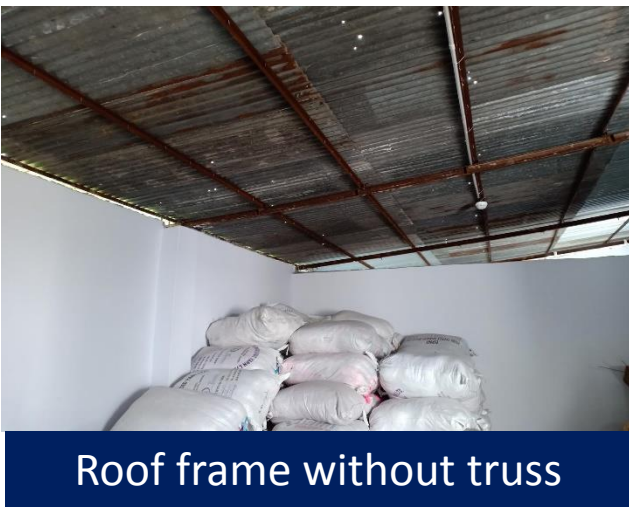
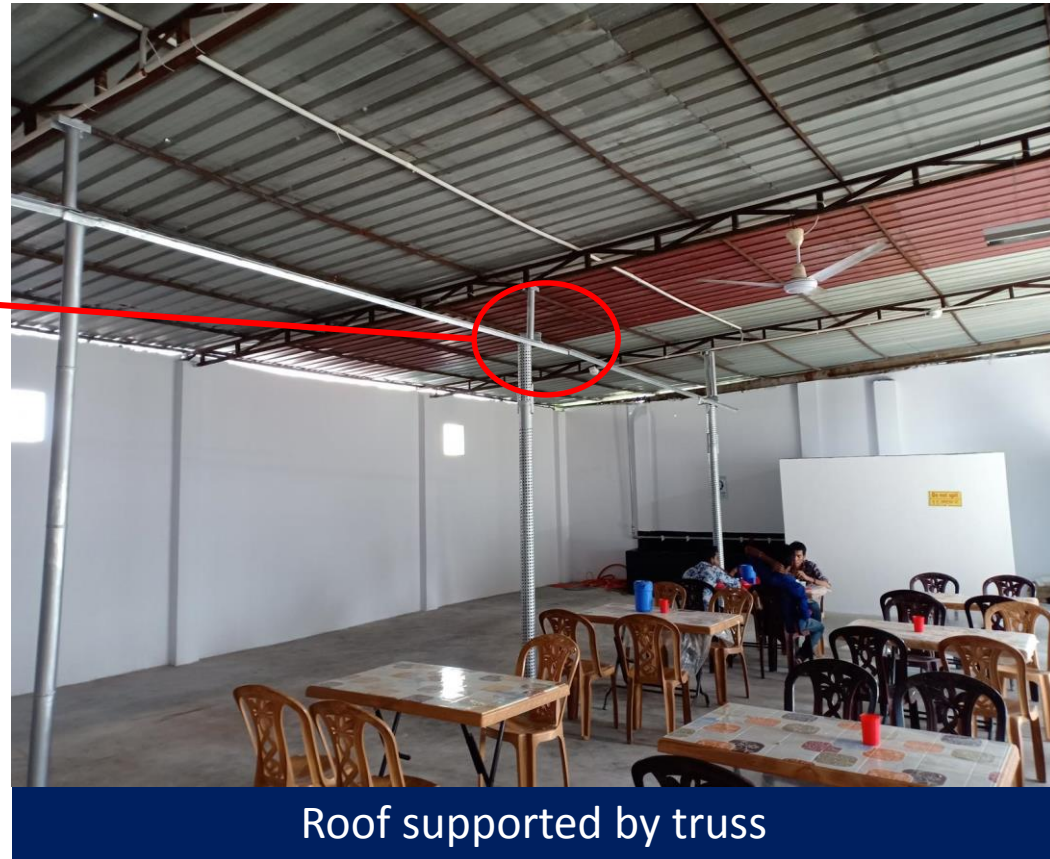
Apparently non-engineered shed due to poor connection between support and truss.  
Building engineer to check the stability of the Shed against vertical & lateral loading.

| Item No. | Observation | Recommended Action Plan | Recommended Timeline |
|---|---|---|---|
| 7 | Apparently non-engineered Shed (Shed-1) | Prepare an “as constructed” drawings which reflect the actual site conditions with complete structural information. | 6-weeks |
| 8 | Apparently non-engineered Shed (Shed-1) | Factory engineer to check the capacity of the lightweight steel roof against vertical & lateral loading. | 6-weeks |
| 9 | Apparently non-engineered Shed (Shed-1) | Carry out remedial works resulting from engineering assessment if necessary. | 6-months |
