# **FIRE SAFETY INSPECTION REPORT**

## **CRYSTAL MARTIN APPAREL BANGLADESH LIMITED**

**ACCORD ID: 11819**

February 28, 2015

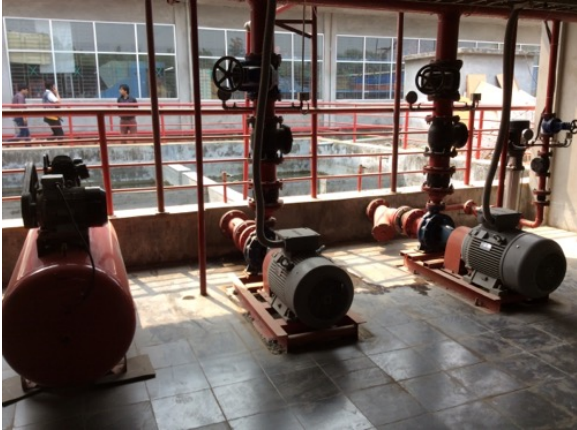
| No. | Category | Finding | Recommendation | Remediation Timeframe |
|---|---|---|---|---|
| F-1 | Fire Rated Construction | The fire pump room is not provided with adequate fire rated separation on the utility shed. | Provide fire pump room with 2 hr. rated fire separation when not sprinklered in accordance with NFPA 20. | Within 3 months |

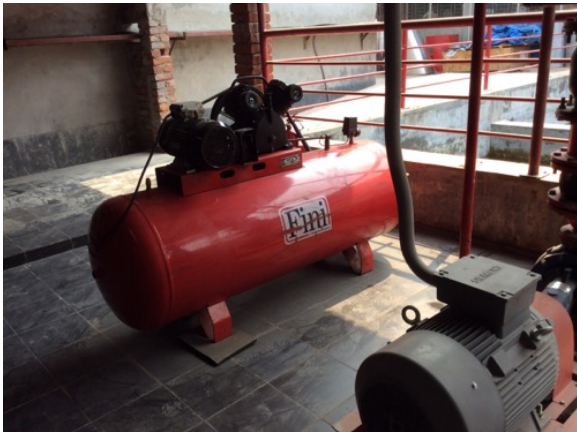
| No. | Category | Finding | Recommendation | Remediation Timeframe |
|---|---|---|---|---|
| F-2 | Fire Rated Construction | The compressor room is not separated by fire-rated construction from the fire pump. | Separate the compressor room by a minimum 1-hr fire-rated construction for non-high rise. Seal and protect all openings to maintain the required fire separations. When located to the exterior of a building, 3m (10 ft.) separation is required. Provide proper ventilation and consult a qualified engineer. | Within 3 months |

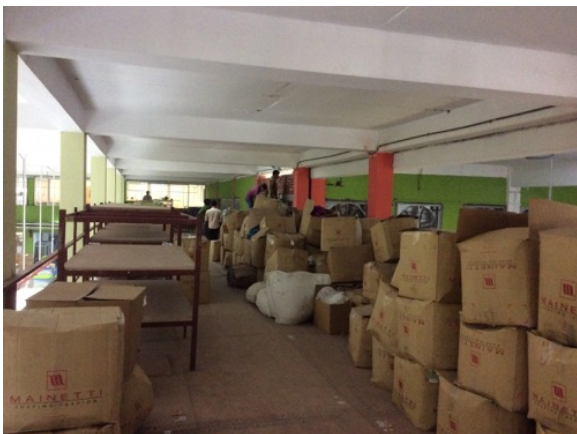
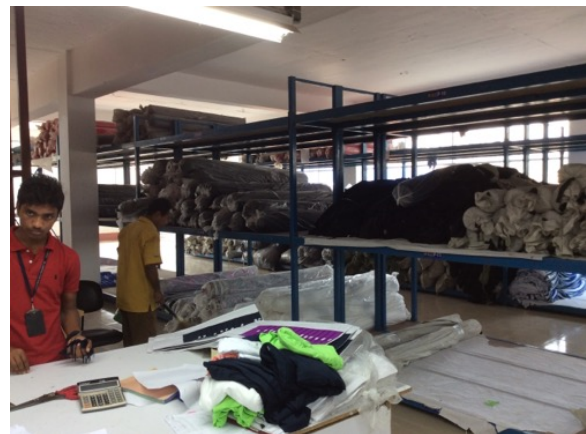
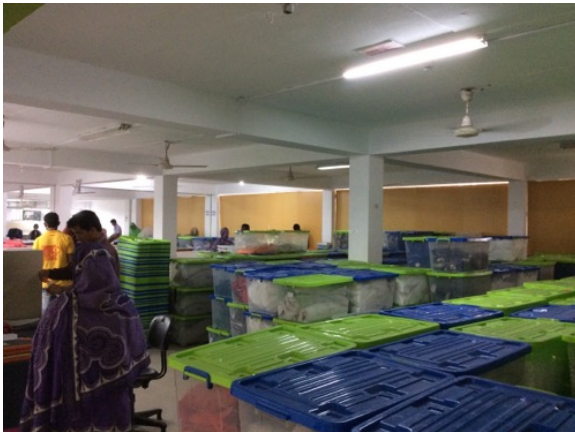
| F-3 | Fire Rated Construction | Areas used for combustible storage open to the factory are not separated by fire-rated construction on ground floor cutting and sewing area and mezzanine 4. | Provide defined storage areas and limit the storage arrangement as follows:<br>- Maximum height of 2.45m (8ft.) and maximum area of 23m <sup>2</sup> (250 ft <sup>2</sup> ).<br><br>Separate areas of unenclosed combustible storage by a minimum clear distance of 3m (10ft.). | Within 3 months |

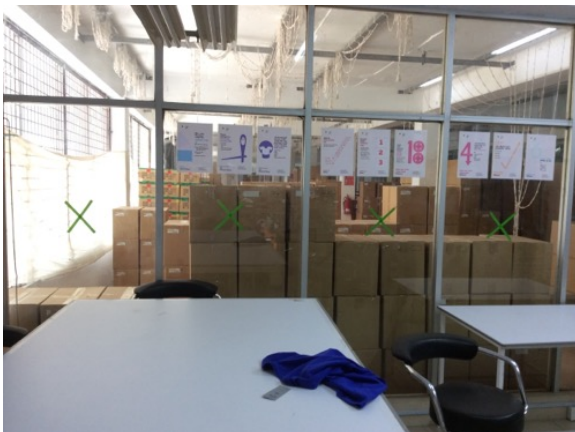
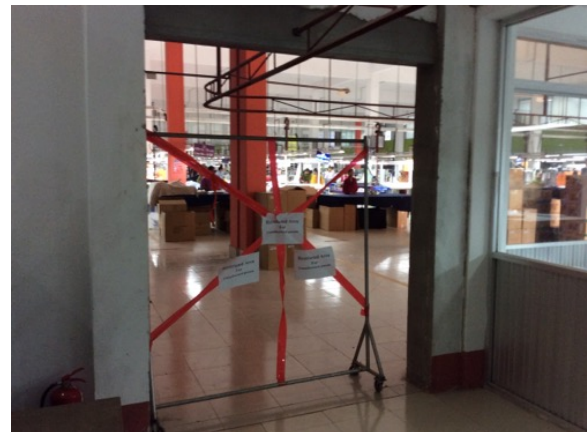
| F-4 | Fire Rated Construction | Rooms used for combustible storage are not separated by fire-rated construction on ground floor, mezzanine 2 and 3. | Provide dedicated storage rooms separated by minimum 1-hr fire-rated construction. | Within 3 months |

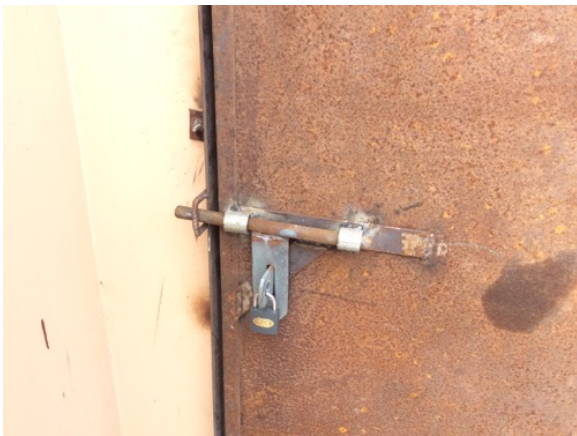
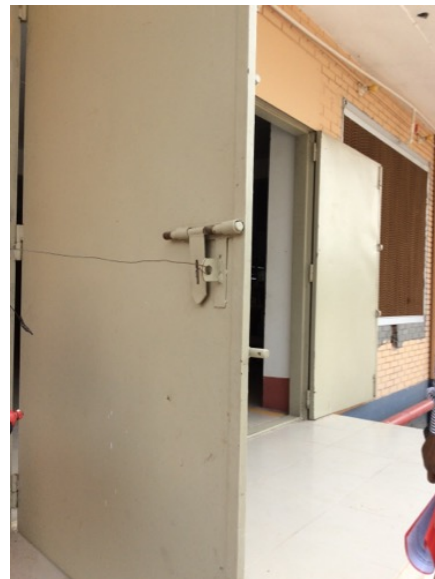
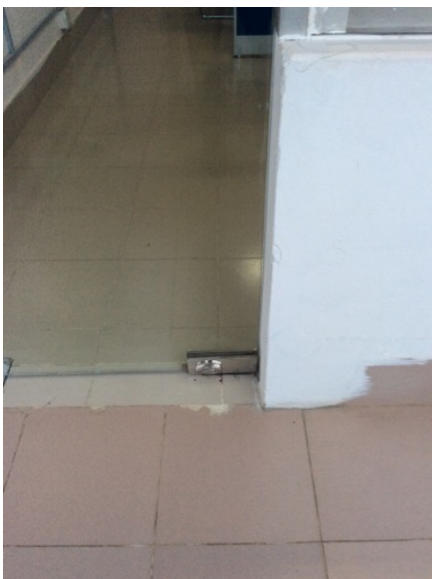
| F-6 | Egress | Egress doors with locking features are provided at building exits and along egress routes. Egress gates with locking features are provided along egress routes. All doors were not open and unlocked during the inspection. | Remove locking features from all egress doors and gates.<br><br>If locks are required for security reasons, utilize special door locking features complying with NFPA 101 and ACCORD standard 6.8.2. | Immediately |

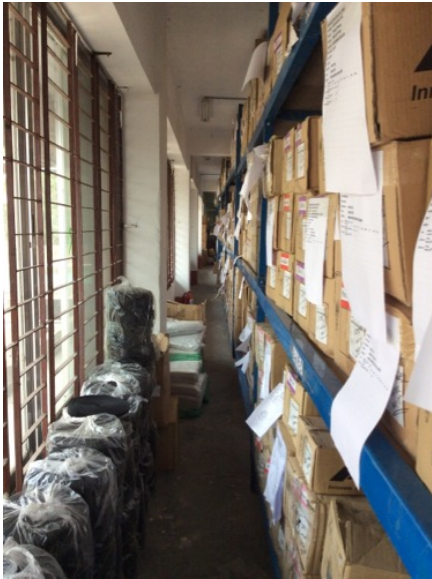
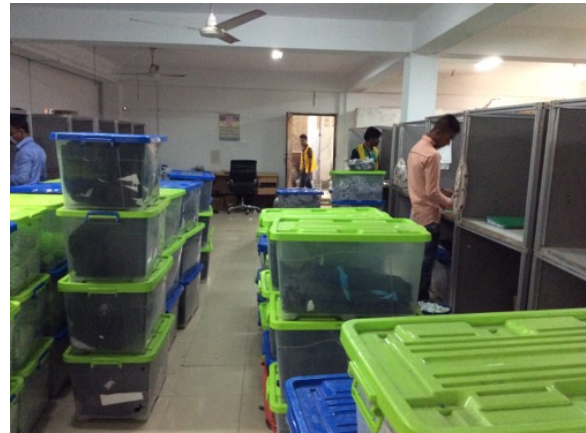
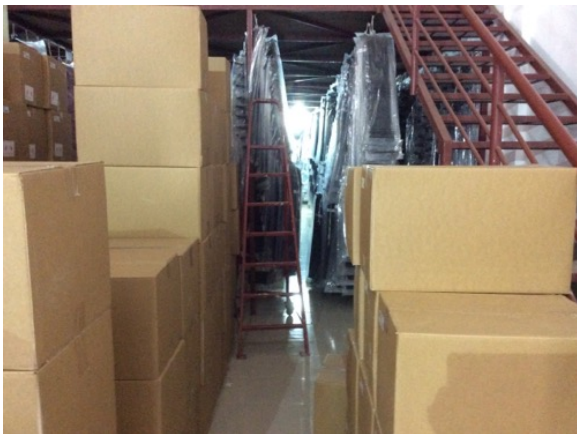
| F-7 | Egress | Storage was located in the egress path on the ground floor storage, cutting section and mezzanine 3. | Keep egress paths and stairs clear of storage. | Immediately |

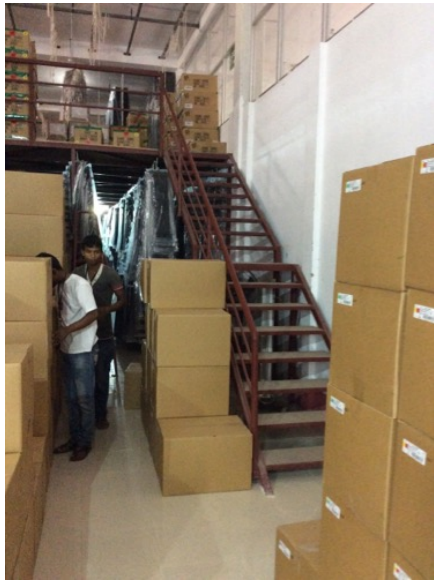
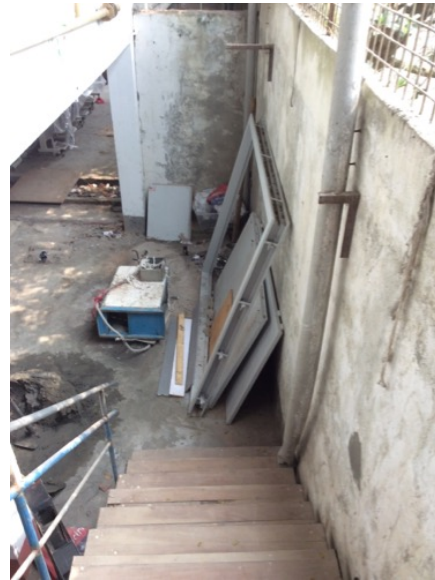
| F-8 | Egress | Storage was located in the exit stairs from mezzanine 2 and 4. | Remove all storage from exit stairs and egress paths. | Immediately |

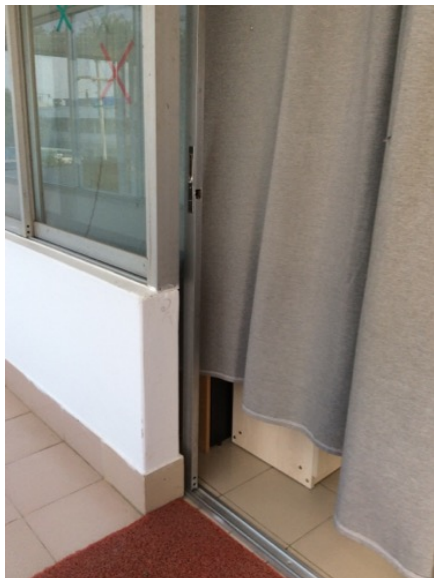
| F-9 | Egress | Sliding doors are provided along egress routes. | Replace all sliding doors along the means of egress with side-hinged, swinging egress doors in accordance with ACCORD standard 6.8.1. | Within 1 month |

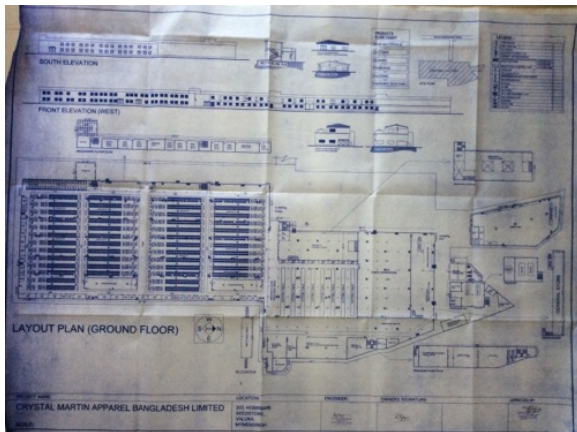
| F-10 | Egress | Dead-end aisle exceeds 15 m (50 ft.) on the mezzanine 1. | Reconfigure the egress arrangement to reduce the maximum dead-end distance to not more than 15 m (50 ft.). | Within 3 months |

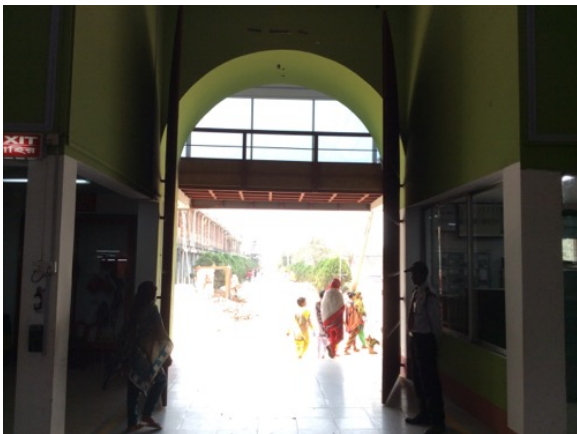
| F-11 | Egress | West exit door serving more than 500 occupants does not swing in the direction of egress travel. | Modify the egress door to swing in the direction of egress travel. | Within 3 months |

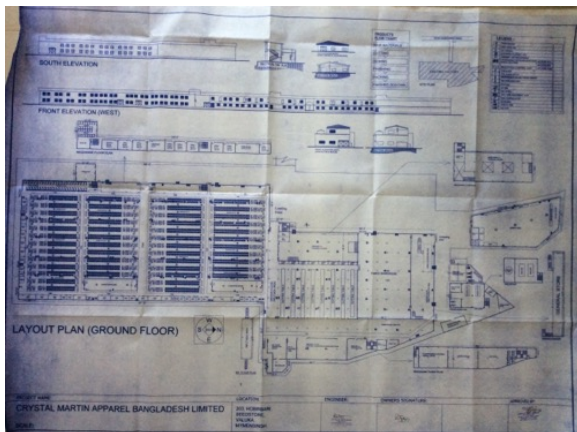
| F-12 | Egress | Travel distance of egress exceeds limit from ground floor sewing and cutting area and mezzanine 4. | Reconfigure the egress arrangement or provide an additional exit to reduce the maximum travel distance to not more than 60 m (200 ft.) when a complete automatic fire alarm, portable fire extinguishers, and standpipe are present. Or reduce the maximum travel distance to 45 m. (150 ft.) if the above requirements are not met. | Within 3 months |

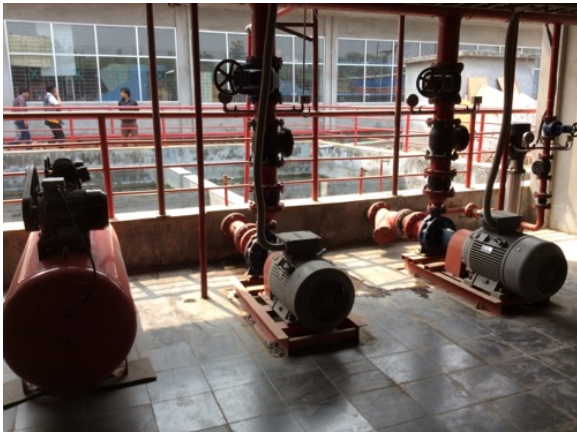
| F-18 | Fire Protection | Fire pump did not meet ACCORD standard 5.5.1 and 5.5.1.1. | Update current fire pump or provide a new fire pump that meets ACCORD standard 5.5. | Within 6 months |

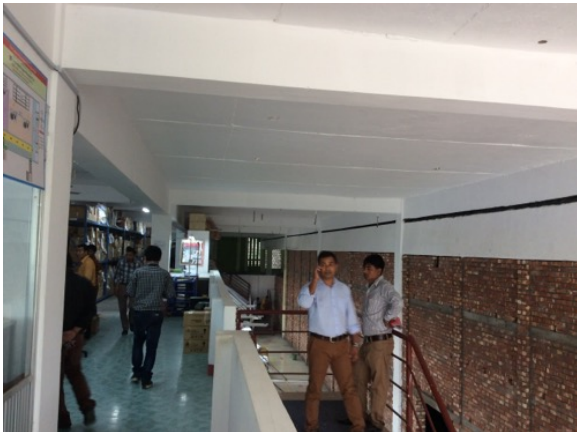
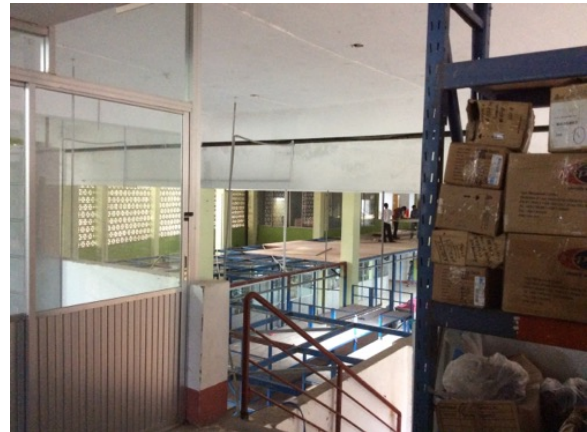
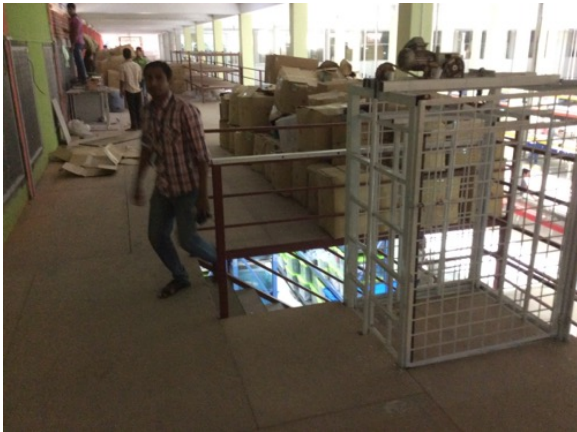
| F-19 | Egress Lighting | Exit signage was not provided at exit stairs from the mezzanine floors. | Provide exit signs above all building exits to the exterior, all doors to the exit stairs and along all paths of travel where a change of direction is not obvious. | Within 1 month |

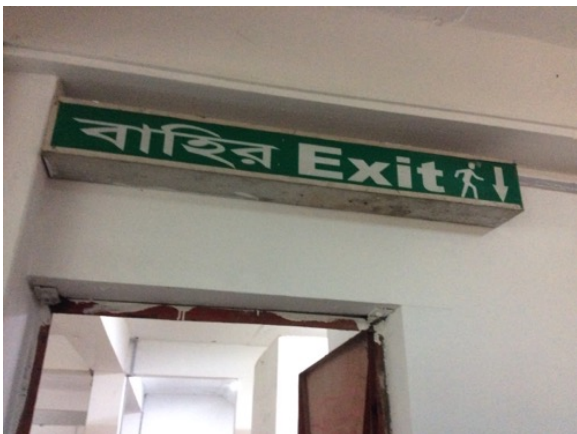
| F-20 | Egress Lighting | Exit signage not illuminated at the exit from mezzanine 4. | Regularly inspect all exit signage and replace and install lights as needed to illuminate signs. The source of illumination shall provide not less than 50 lux at the illuminated surface with a contrast of not less than 0.5. Approved self luminous signs which provide evenly illuminated letters having a minimum luminance of 0.2 cd/m <sup>2</sup> may also be used. | Within 1 month |
