# Geebee (Bangladesh) Limited Extended Unit.

FS SFB 02 Karnaphuli EPZ Chittagong  
(22.278980, 91.789511)  
8<sup>th</sup> November 2018

# Observations

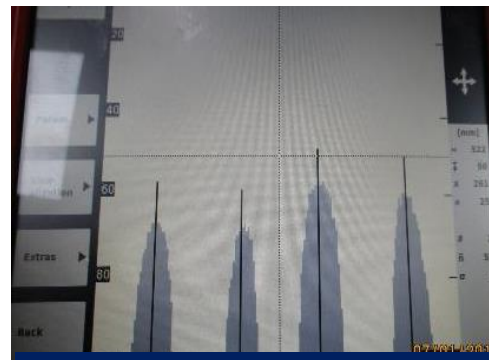
4 nos. of rebar instead of 5 nos. at C-2 type column.

Number of rebar for C-2 column does not match with column schedule. 12 nos. of rebar are found by ferro scan whereas 16 nos. of rebars are shown in column schedule. Also size of C-8 type column found 500 mm instead of 750 mm in long direction and size of C-10 & 12 type column found 260 instead of 380 mm in short direction. Also, mismatch found in beam layout.

| Item No. | Observation | Recommended Action Plan | Recommended Timeline |
|---|---|---|---|
| 1 | Discrepancies between provided drawings and on site condition.<br>(Main Production building) | Building Engineer to survey as-built structure and prepare accurate as-built survey information for the building. | 6-weeks |
| 2 | Discrepancies between provided drawings and on site condition.<br>(Main Production building) | Produce and actively manage a loading plan for giving consideration to floor capacity and column capacity. | 6-weeks |

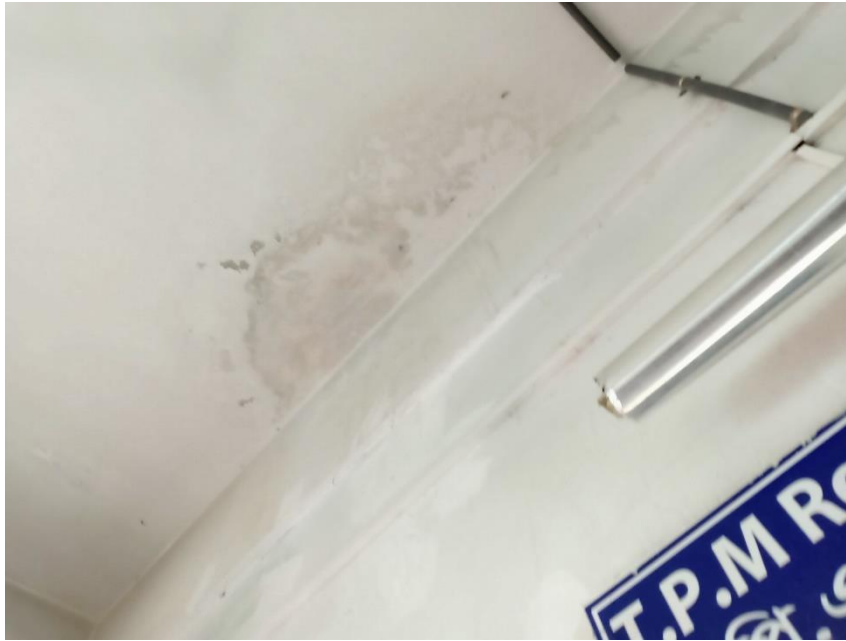
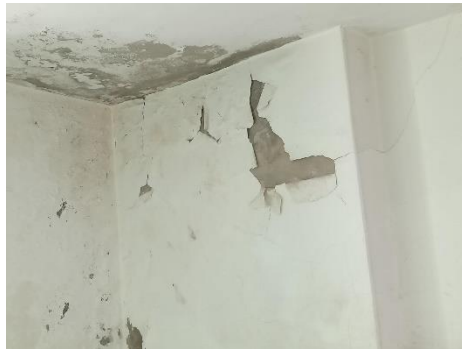
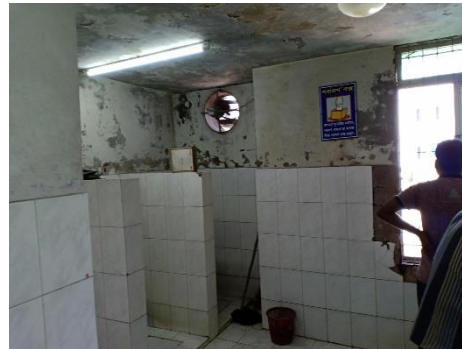
Water intrusion was found at 3<sup>rd</sup> floor ceiling .  
Dampness also observed at slab and walls at toilet

| Item No. | Observation | Recommended Action Plan | Recommended Timeline |
|---|---|---|---|
| 3 | Lack of proper drainage at roof and sign of dampness inside slab & walls.<br>(Main Production building) | Factory Engineer to inspect water damaged structures and apply a suitable method to repair. | 6-weeks |

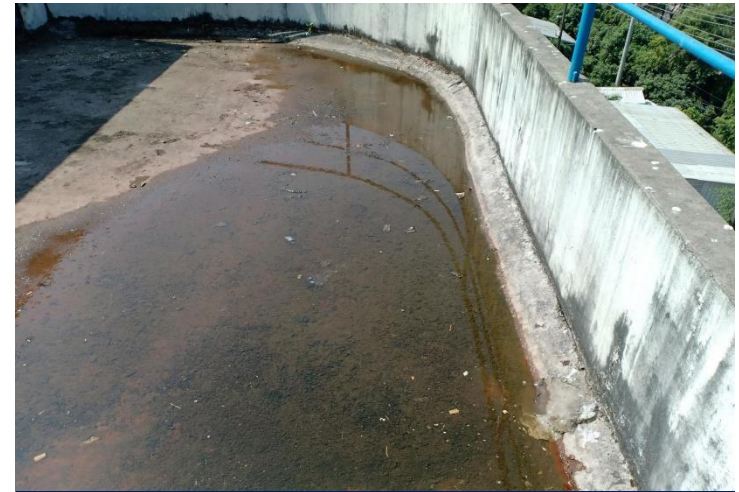
Water clogging on roof

| Item No. | Observation | Recommended Action Plan | Recommended Timeline |
|---|---|---|---|
| 4 | Lack of proper drainage at roof and sign of dampness inside slab & walls.<br>(Main Production building) | Waterproofing on the roof slab is to be applied. In addition, the roof slab drainage system should be investigated and improved if required. | 6-months |

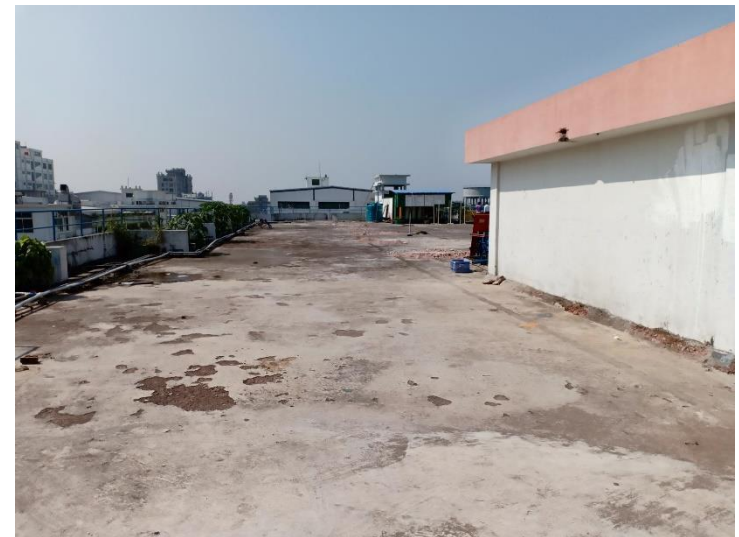
No water proofing was found at roof.

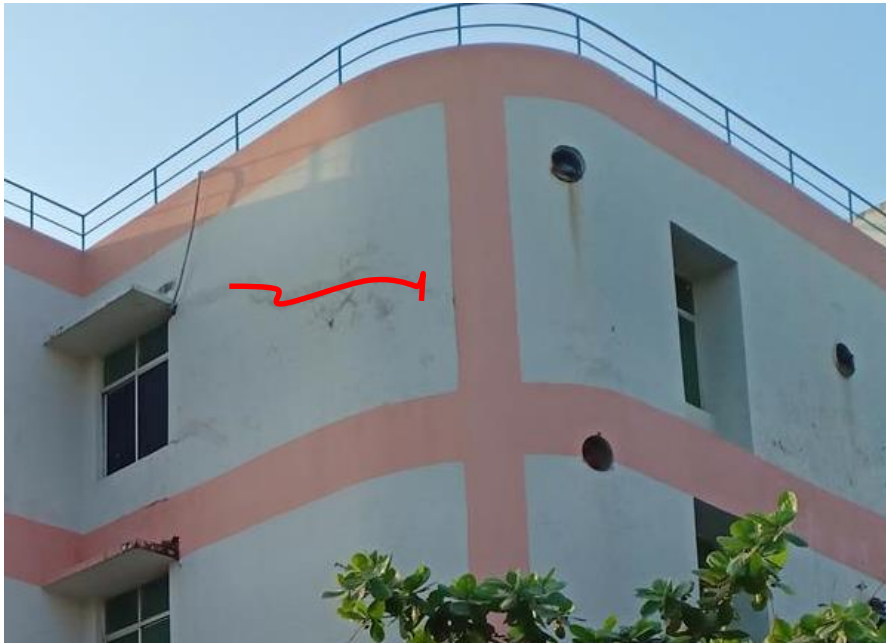
Minor cracks in facade walls were noted at a few locations. Have a qualified structural engineer provide further analysis of the identified cracks to determine the appropriate course of corrective action.

Cracks at North façade

| Item No. | Observation | Recommended Action Plan | Recommended Timeline |
|---|---|---|---|
| 5 | Visible Cracks on façade walls (Main Production building) | Have a qualified structural engineer provide further analysis of the identified cracks to determine the appropriate course of corrective action. | 6-weeks |

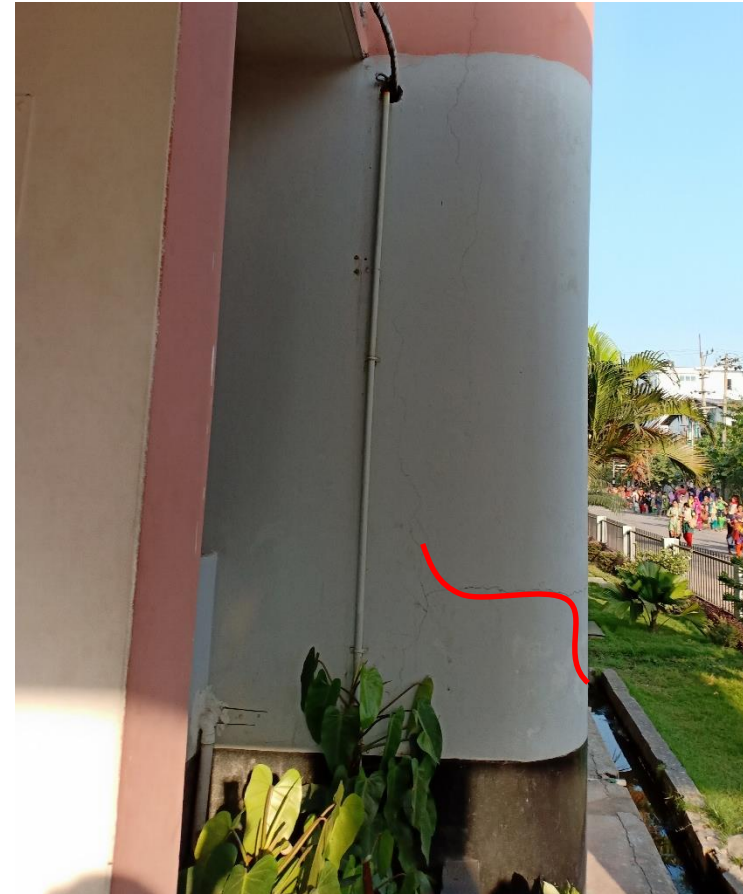
Minor cracks on wall

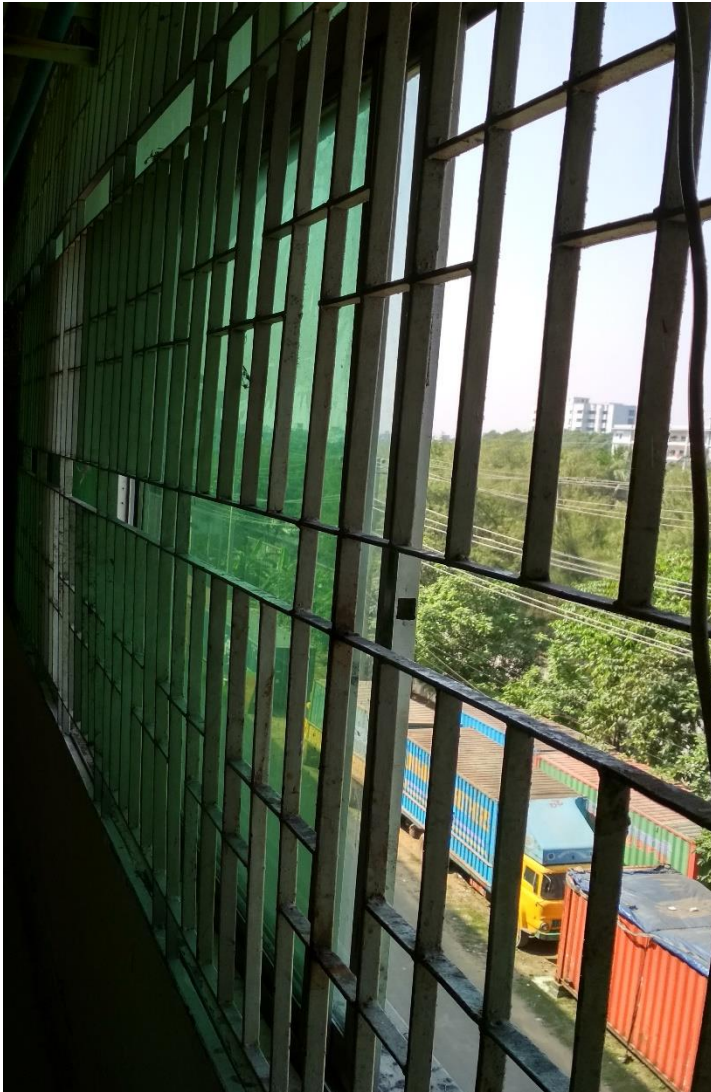
Sagged grills

Sagging was found on windows grills on the 2<sup>nd</sup> & 3<sup>rd</sup> floors. Engineering investigation is needed to determine whether it is due to the extra load imposed from BUS bar or Cable tray.

| Item No. | Observation | Recommended Action Plan | Recommended Timeline |
|---|---|---|---|
| 6 | Sagging on window grills (Main Production building) | Engineering investigation is needed to determine whether it is due to the extra load imposed from BUS bar or Cable tray. | 6-weeks |
| 7 | Sagging on window grills (Main Production building) | Carry out remedial works resulting from engineering assessment if necessary. | 6-months |

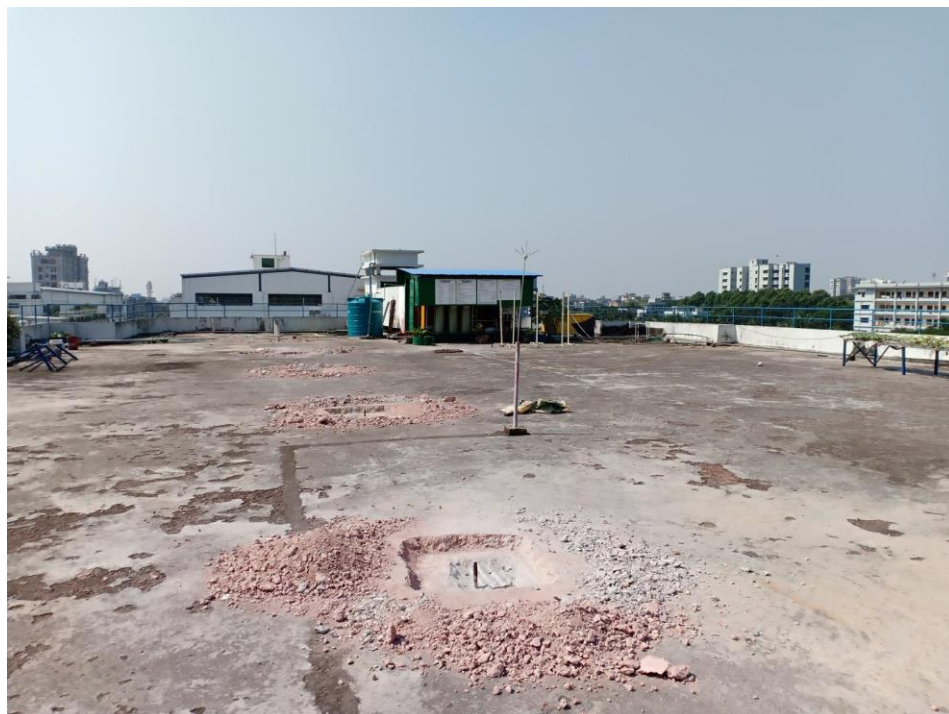
Current roof of factory building

Currently the building is 3 storied. Factory has a future plan to built a shed on current roof. Proposed drawings were available during inspection. Factory engineer is required to carried out a Detail Engineering Assessment considering BNBC provision prior to any extension work.

| Item No. | Observation | Recommended Action Plan | Recommended Timeline |
|---|---|---|---|
| 8 | Possible vertical extension (Main Production building) | In case of extension, factory engineer to be carried out further analysis and update design report following BNBC requirement. | 6-weeks |

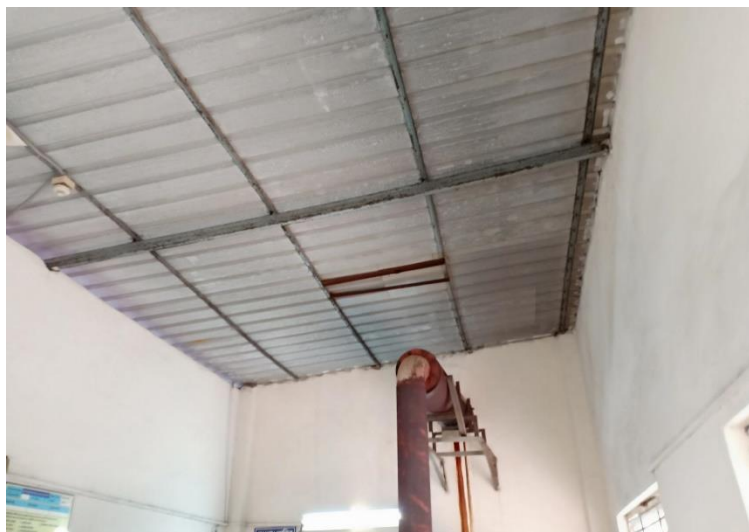
Generator Shed

No drawings were prepared for boiler & generator shed. Building engineer is required to prepare an “as constructed” drawings which reflect the actual site dimensions with complete structural information.

| Item No. | Observation | Recommended Action Plan | Recommended Timeline |
|---|---|---|---|
| 9 | Lack of as-built documents (Boiler & Generator Shed) | Prepare an “as constructed” drawings which reflect the actual site dimensions with complete structural information. | 6-weeks |
