# **FIRE SAFETY INSPECTION REPORT**

**CONSUMER KNITEX LIMITED (CMT  
BANGLADESH)  
DHAMSUR, BHALUKA, MYMENSINGH 2240**

**ACCORD**  
on Fire and Building Safety in Bangladesh

May 10, 2014

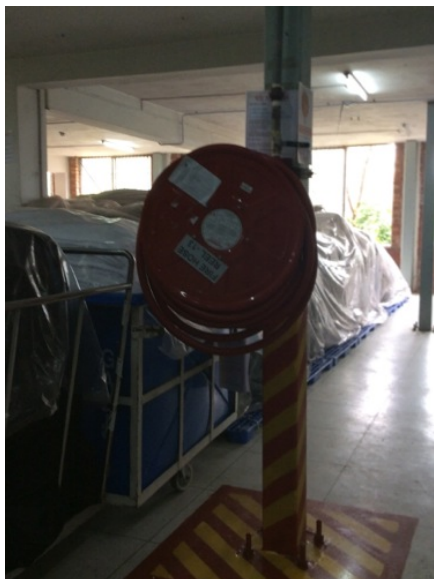
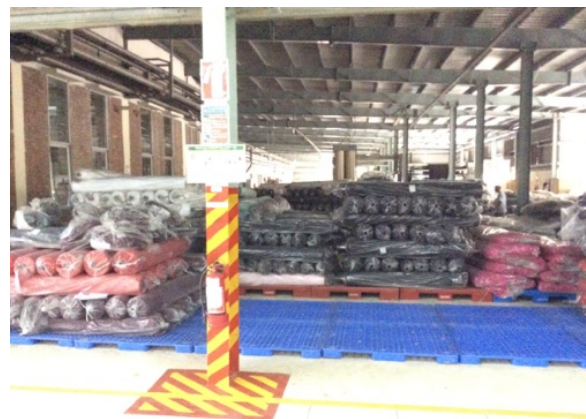
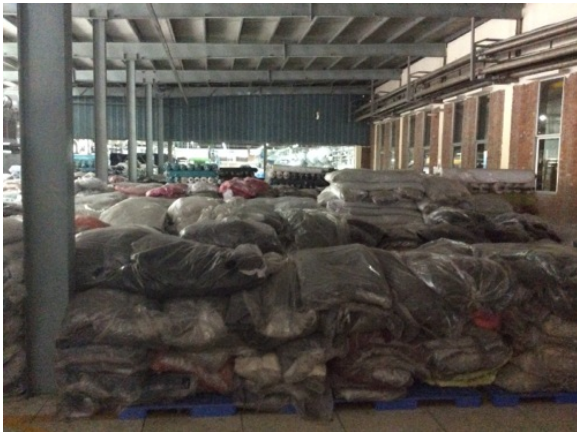
| No. | Category | Finding | Recommendation | Remediation Timeframe |
|---|---|---|---|---|
| F-1 | Fire Rated Construction | Areas used for combustible storage at the west and central areas of the factory floor are not separated by fire-rated construction. | <p>Provide dedicated storage rooms separated by minimum 1-hr fire-rated construction.</p> <p>Where separate storage rooms are not feasible, provide defined storage areas and limit the storage arrangement as follows:</p> <ul style="list-style-type: none"> <li>- Maximum height of 2.4m and maximum area of 23m<sup>2</sup></li> <li>- If sprinkler protected: maximum height of 3.66m and maximum area of 93m<sup>2</sup></li> </ul> <p>Separate areas of unenclosed combustible storage by a minimum clear distance of 3m.</p> | Within 3 months |

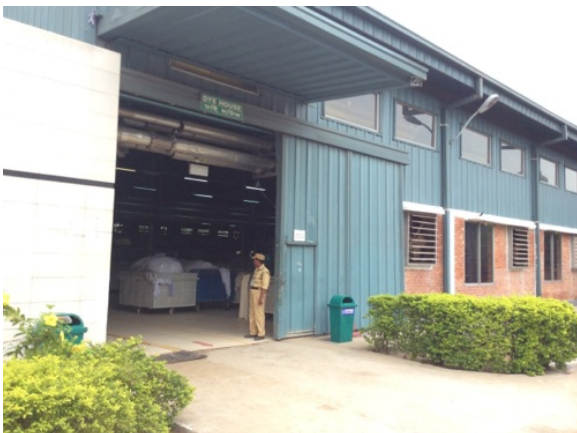
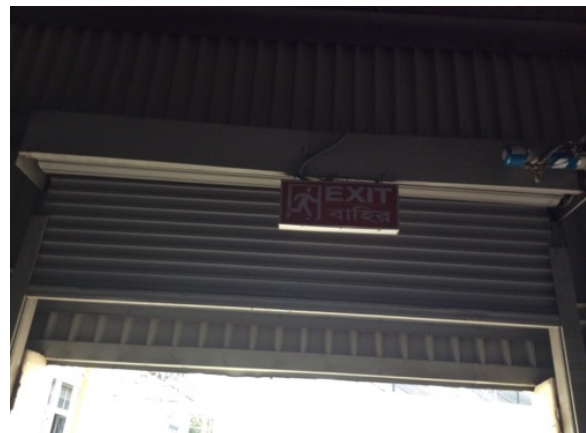
| F-2 | Egress | Sliding gate at and roll-up door are provided at north and east exits. | Replace all gates and roll-up doors along the means of egress with side-hinged, swinging egress doors. | Within 1 month |

| | | | If locks are required for security reasons, utilize special door locking features complying with NFPA 101. | |

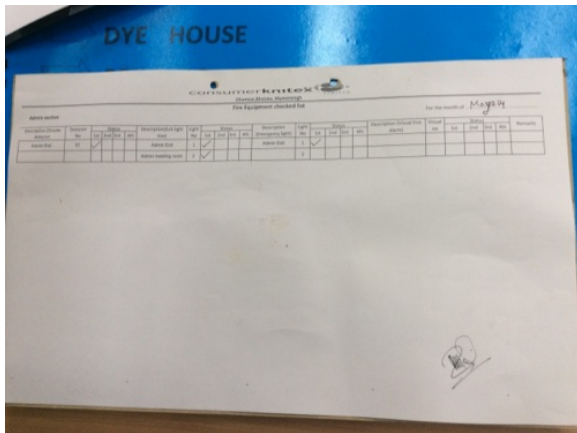
| F-4 | Fire Protection | Inspection, testing, and maintenance for the fire alarm system was not in accordance with NFPA 72. | Inspect, test and maintain the fire alarm system, and keep written records on-site, in accordance with NFPA 72. | Within 3 months |

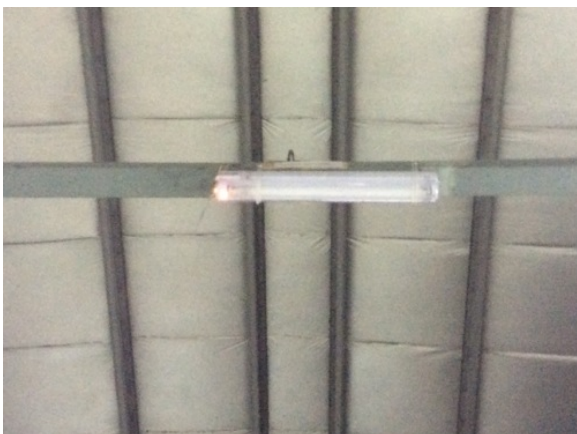
| F-5 | Egress Lighting | Inspection, testing, and maintenance records for the emergency lighting system were not available. | Inspect, test and maintain the emergency lighting system in accordance with The ACCORD standard. Keep written records on-site. | Within 3 months |

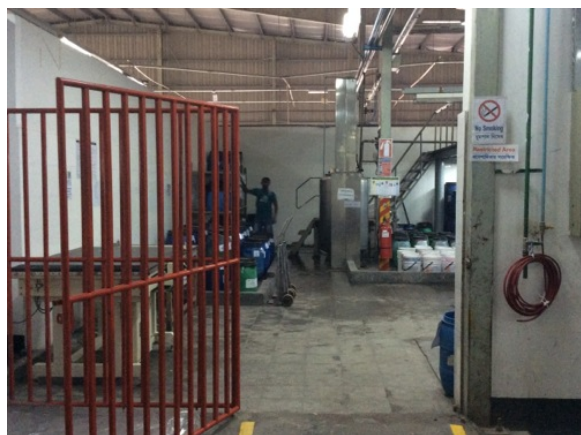
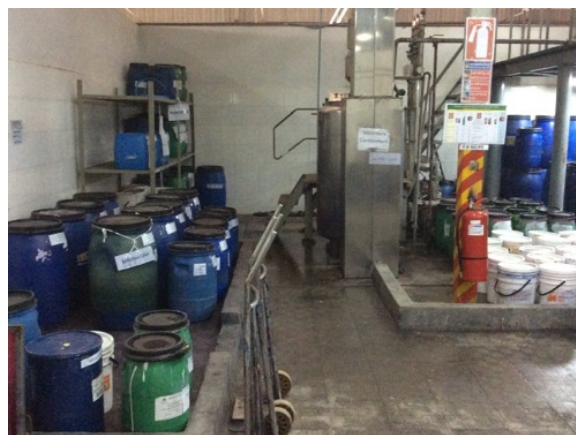
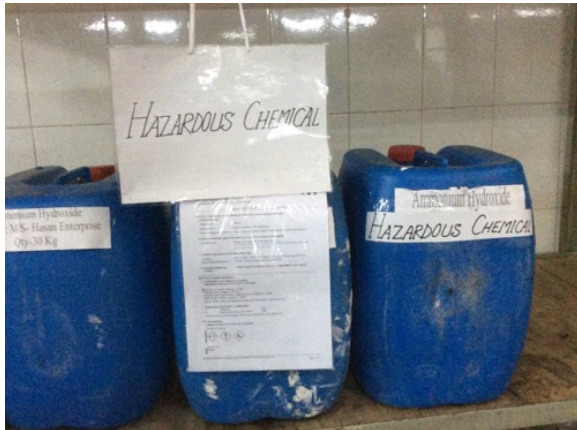
| No. | Category | Finding | Recommendation | Remediation Timeframe |
|---|---|---|---|---|
| F-1 | Fire Rated Construction | <p>Hazardous materials storage area is not separated by fire-rated construction.</p> <p>Corrosive materials were store at the middle of the factory floor without fire-rated separations.</p> | Separate the hazardous materials room per BNBC Part 3 Section 2.1.13. | Within 3 months |

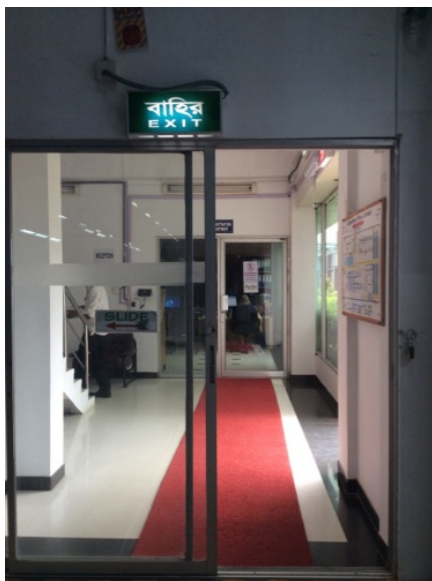
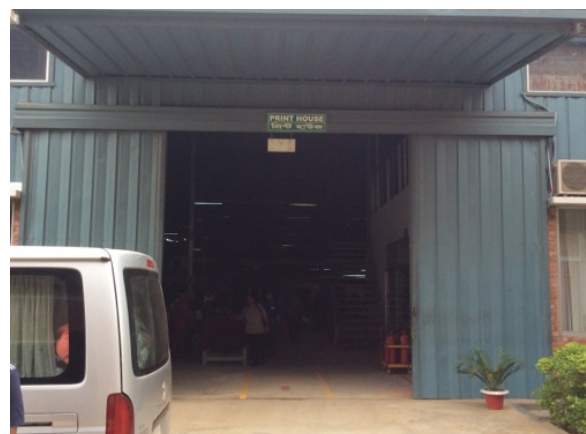
| F-2 | Egress | Sliding gate and door are provided at north and west exits. | Replace all gates and roll-up doors along the means of egress with side-hinged, swinging egress doors. | Within 1 month |

| | | | If locks are required for security reasons, utilize special door locking features complying with NFPA 101. | |

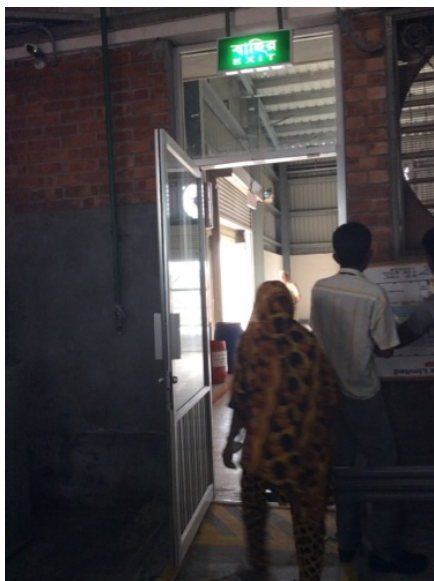
| F-3 | Egress | Exit door at south side of the building serving 50 or more occupants does not swing in the direction of egress travel. | Modify the egress door to swing in the direction of egress travel. | Within 3 months |

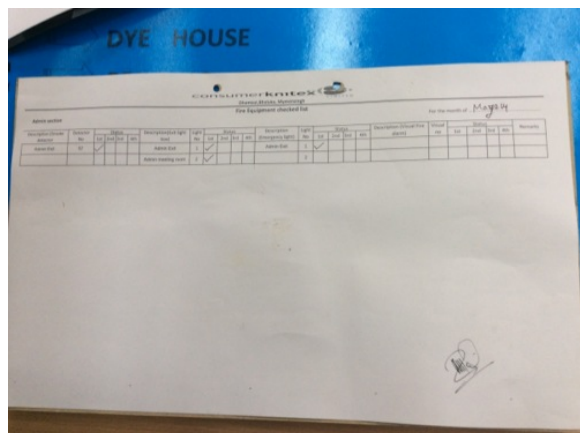
| F-4 | Fire Protection | Inspection, testing, and maintenance for the fire alarm system was not in accordance with NFPA 72. | Inspect, test and maintain the fire alarm system, and keep written records on-site, in accordance with NFPA 72. | Within 3 months |

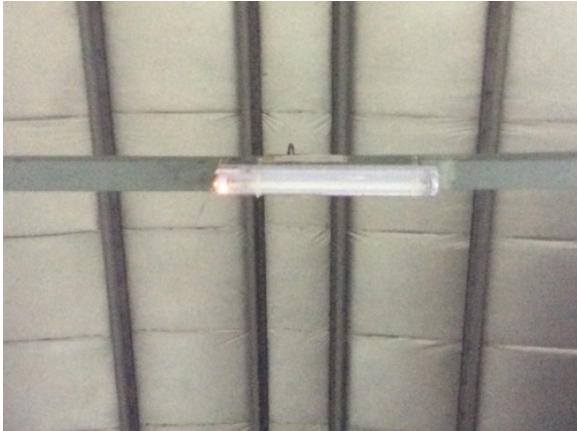
| F-5 | Egress Lighting | Inspection, testing, and maintenance records for the emergency lighting system were not available. | Inspect, test and maintain the emergency lighting system in accordance with The ACCORD standard. Keep written records on-site. | Within 3 months |

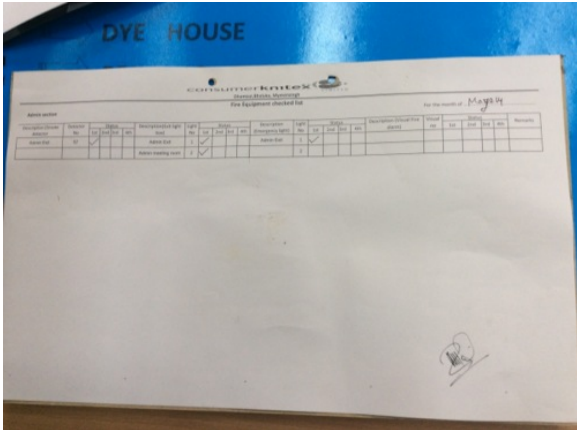
| No. | Category | Finding | Recommendation | Remediation Timeframe |
|---|---|---|---|---|
| F-1 | Fire Protection | Inspection, testing, and maintenance for the fire alarm system was not in accordance with NFPA 72. | Inspect, test and maintain the fire alarm system, and keep written records on-site, in accordance with NFPA 72. | Within 3 months |

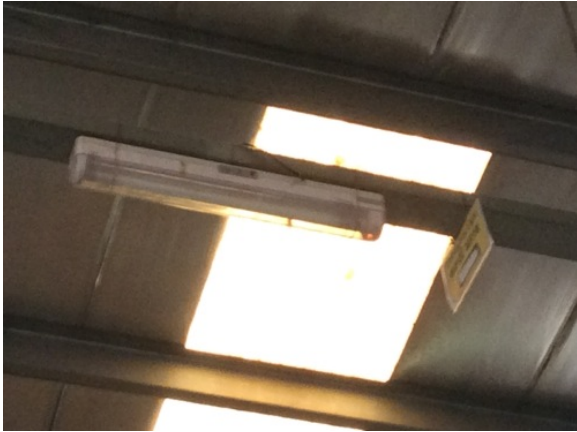
| No. | Category | Finding | Recommendation | Remediation Timeframe |
|---|---|---|---|---|
| F-2 | Egress Lighting | Inspection, testing, and maintenance records for the emergency lighting system were not available. | Inspect, test and maintain the emergency lighting system in accordance with The ACCORD standard. Keep written records on-site. | Within 3 months |

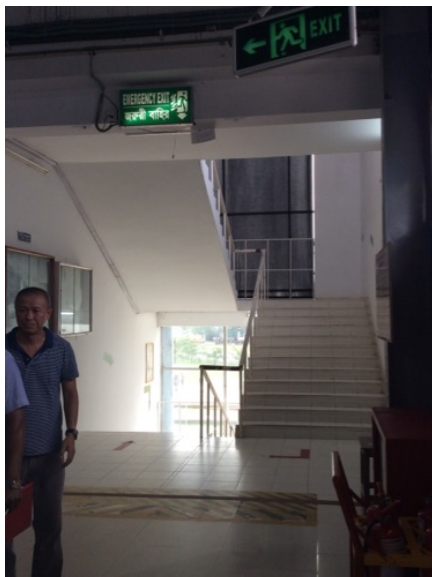
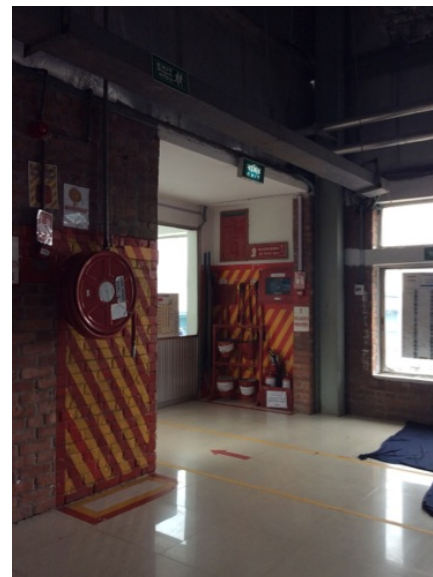
| No. | Category | Finding | Recommendation | Remediation Timeframe |
|---|---|---|---|---|
| F-1 | Fire Rated Construction | The exit stairs are not separated from work areas, on each floor by fire-rated construction. | <p>Provide minimum 1.5-hr fire rated doors and seal all unprotected openings to separate the exit stairs from work areas and other building spaces on all floor levels. Ensure that the fire doors are self-closing and positive latching and that they are provided with fire exit (panic) hardware where serving production floors.</p> <p>If fire doors are required to be held open for functional reasons, provide automatic-closing devices tied to the fire alarm system.</p> | Within 3 months |

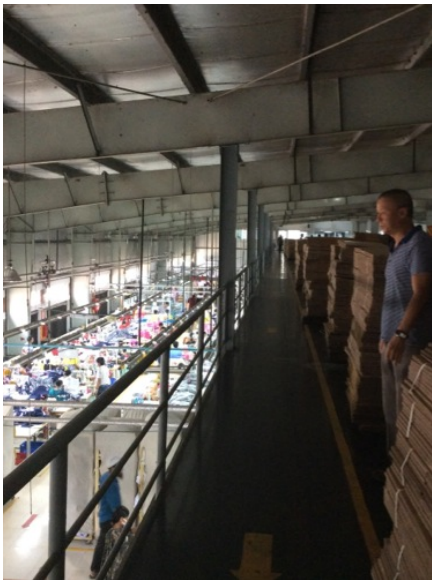
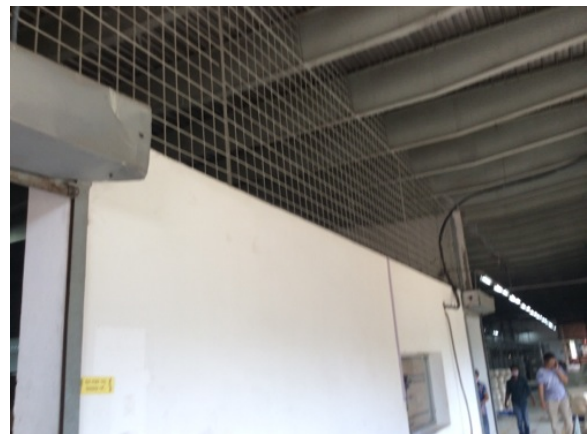
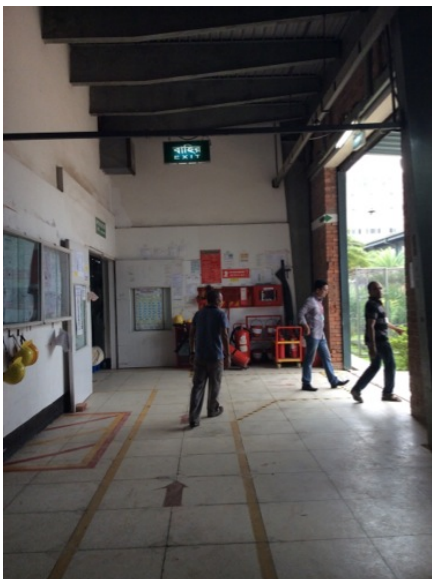
| F-2 | Fire Rated Construction | <p>Areas used for combustible storage are not separated by fire-rated construction.</p> <p>Ground floor storage rooms and mezzanine area on the 1st floor are not fire-rated separated from work areas.</p> | <p>Provide dedicated storage rooms separated by minimum 1-hr fire-rated construction.</p> | <p>Within 3 months</p> |

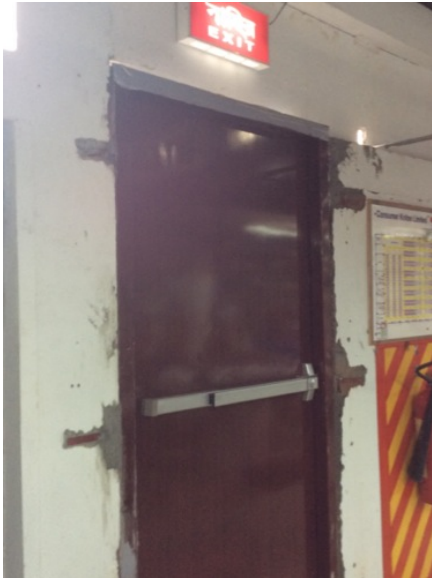
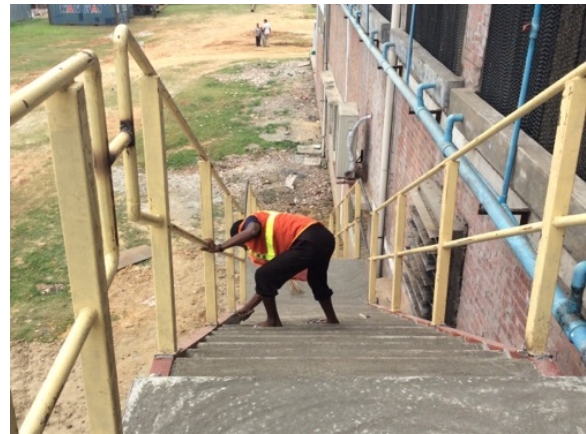
| F-3 | Egress | <p>Exit capacity is not adequate for the occupant load.</p> <p>1st floor has an exit capacity of 600 occupants with an actual occupant load of 805.</p> | <p>Reduce occupant load to not more than available exit capacity of 600 occupants and in the future provide an additional emergency exit on the northwest part of the building.</p> | Immediate |

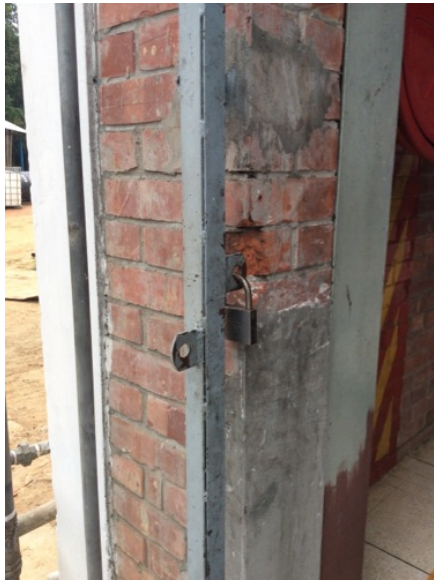
| F-4 | Egress | <p>Egress sliding gate at the west side of the ground floor had a locking feature.</p> | <p>Remove locking features from all egress doors / gates.</p> <p>If locks are required for security reasons, utilize special door locking features complying with NFPA 101.</p> | Immediate |

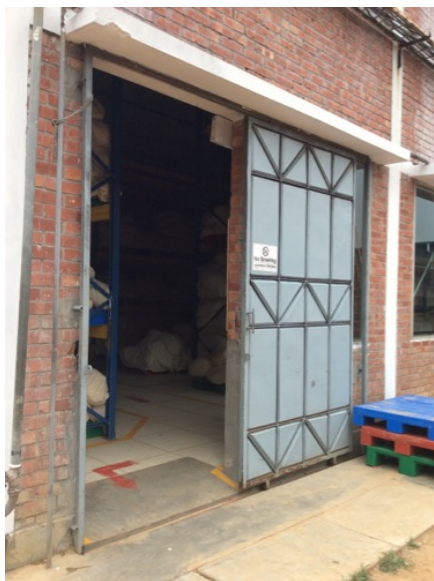
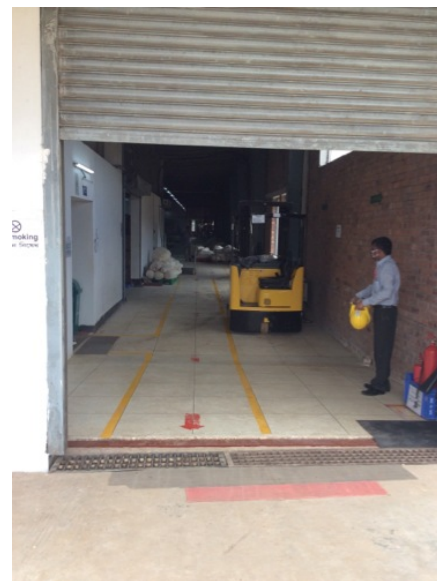
| F-5 | Egress | Sliding gates and roll-up door are provided at all three (3) exits from the ground floor. | Replace all gates and roll-up doors along the means of egress with side-hinged, swinging egress doors. | Within 1 month |

| | | | If locks are required for security reasons, utilize special door locking features complying with NFPA 101. | |

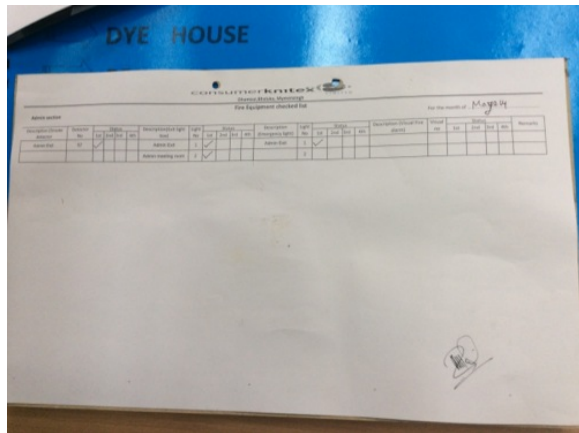
| F-6 | Fire Protection | Inspection, testing, and maintenance for the fire alarm system was not in accordance with NFPA 72. | Inspect, test and maintain the fire alarm system, and keep written records on-site, in accordance with NFPA 72. | Within 3 months |

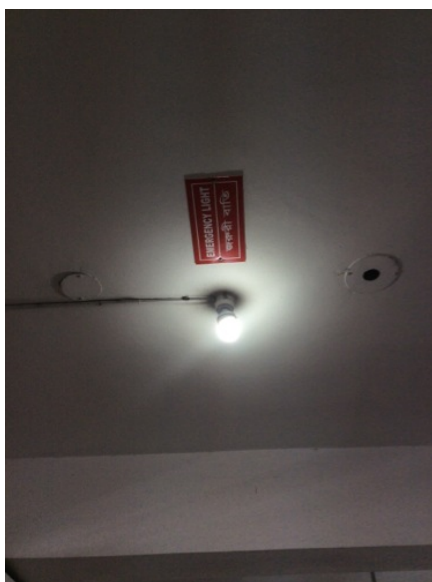
| F-7 | Egress Lighting | Inspection, testing, and maintenance records for the emergency lighting system were not available. | Inspect, test and maintain the emergency lighting system in accordance with The ACCORD standard. Keep written records on-site. | Within 3 months |
