Entrust Fashions Ltd.

46/1 Nayanagar Main Road, Chairmanbari Mor, Nayanagar, Turag, Dhaka-1230, Bangladesh.

25th October 2018

**Lack of bracings and discrepancy observed
between As built drawing and on site condition**

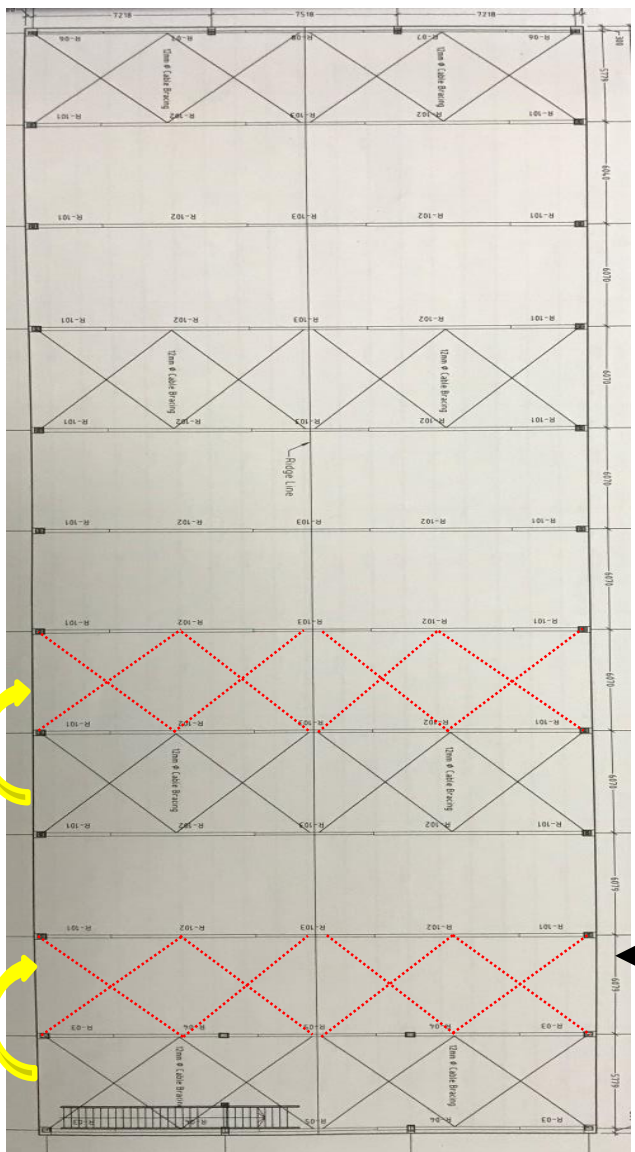
Change of roof bracing location

Onsite roof bracing location did not match with drawing

Vertical and roof bracing layout did not match with drawing and FEM model. Factory is required to revise the bracing layout in as-built drawing and FEM model accordingly.

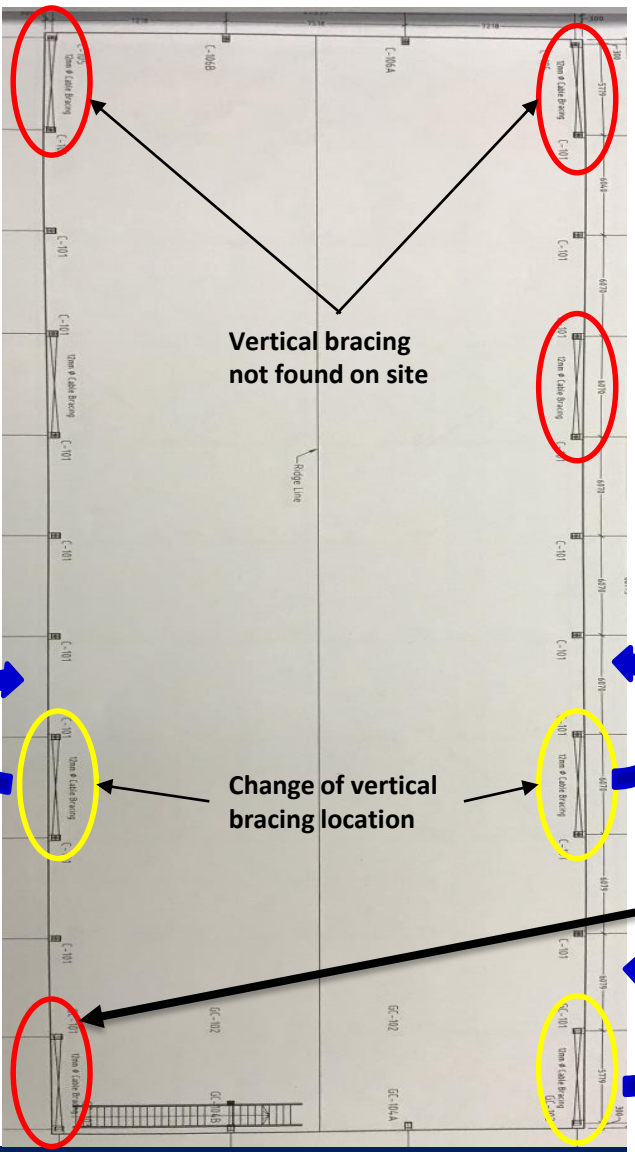
Vertical bracing not found according to the drawing

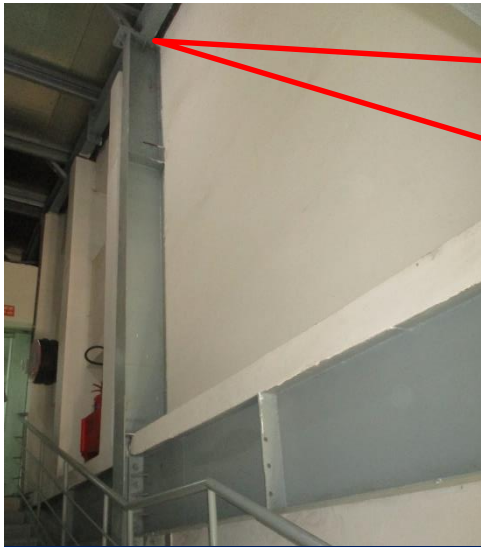
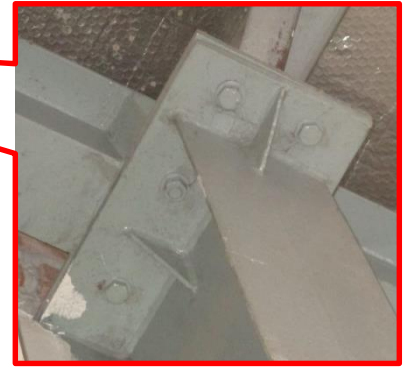
Section of Grid-12 in drawing

Connection of column and rafter was found different than drawing

10nos. Bolt was shown at column-rafter joint in grid 12-D whereas 8nos bolt was found on site. The connection is required to revise in drawing according to the on site condition

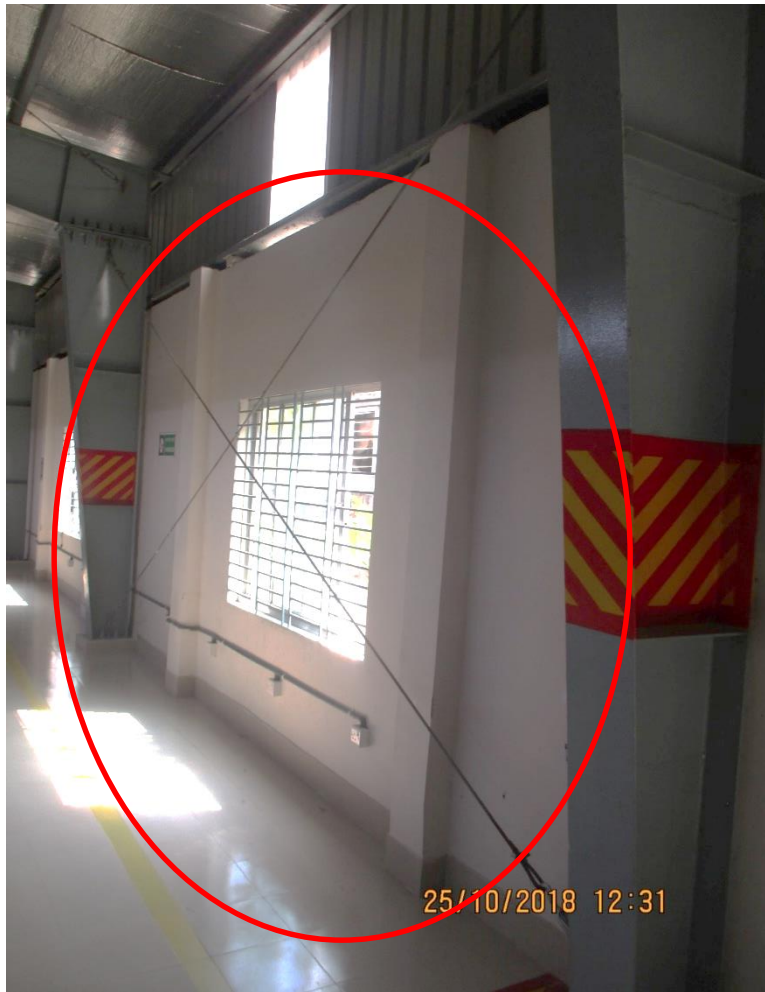
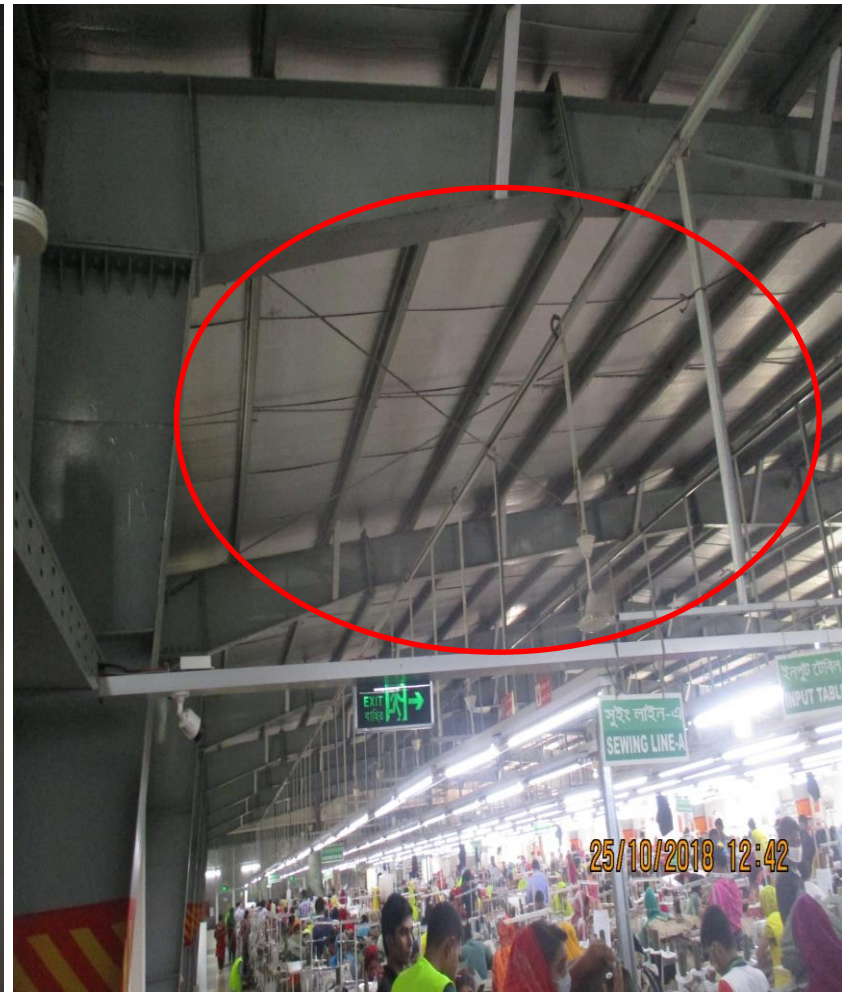
Loose cable bracing

Some of the horizontal and vertical cable bracings are appeared to be loose. Factory is required to tight the bracing for transferring lateral loads properly.

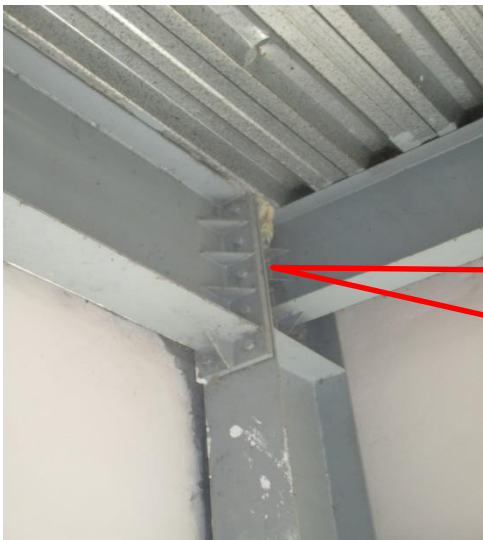
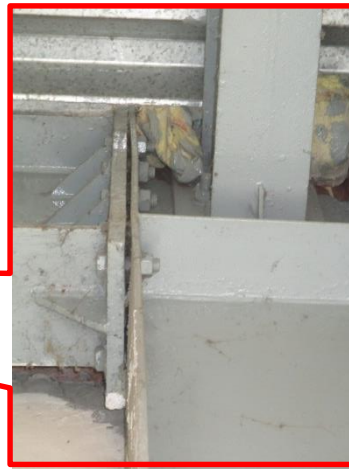
Significant gaps in connection

Gap was found in column-beam joint at stair case location

Significant gaps were found in column-beam joint. Factory engineer is required to carry out suitable remedial works.

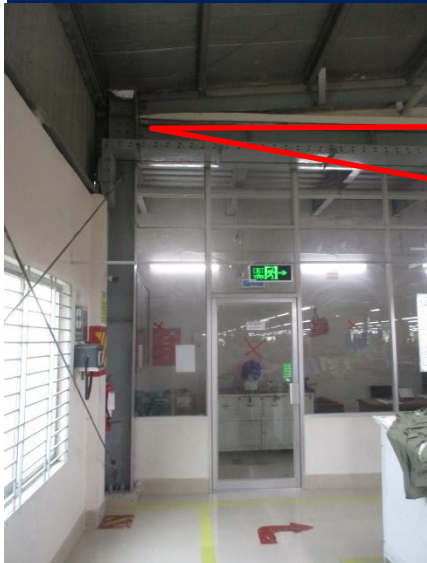
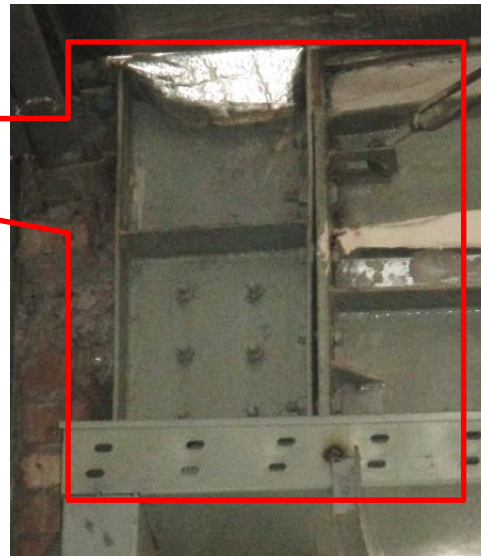
Gap was found in column-beam joint at mezzanine floor

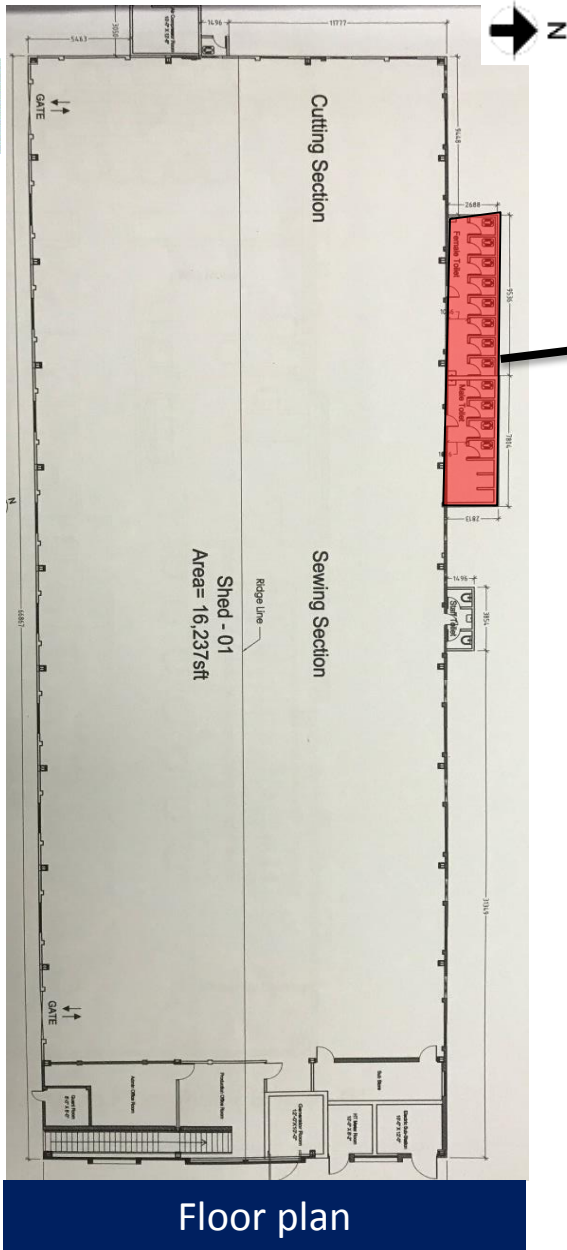
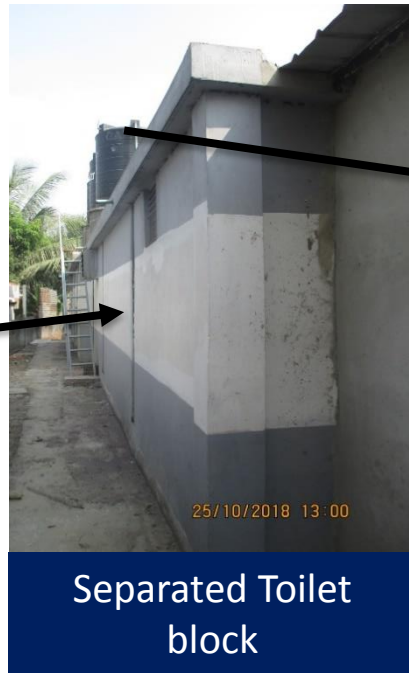
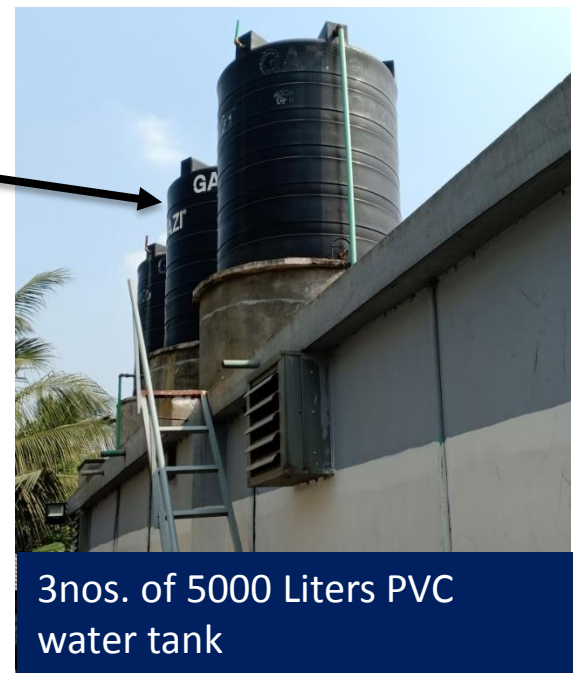
Heavy Loading observed on roof of the toilet block

3nos. 5000 Liters PVC water tanks were observed on roof of toilet block. Factory is required to check the capacity of the slab and load bearing walls for the imposed load of water tank.

7	Heavy Loading observed on roof of the toilet block (Shed-1)	Carry out remedial works resulting from assessment report if necessary.	6-months

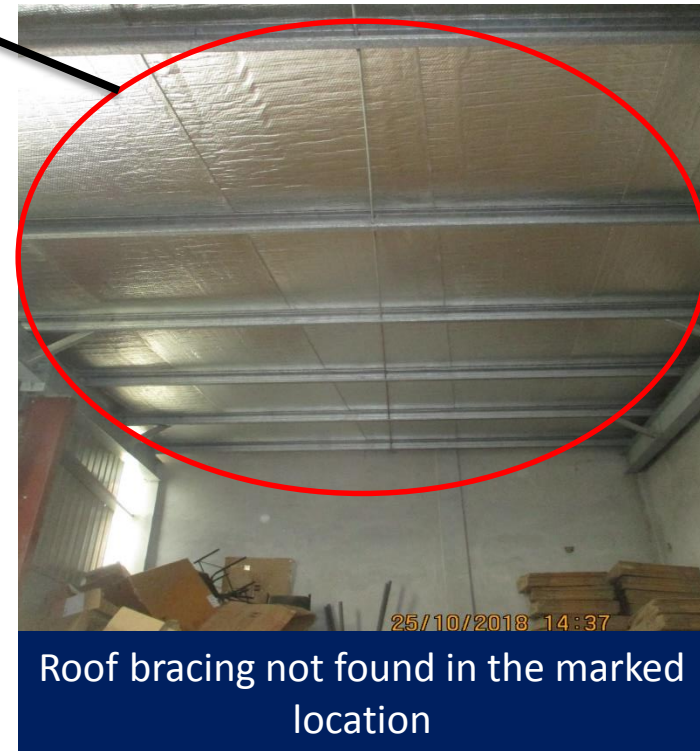
Roof bracing not found in the marked location

Vertical and roof bracing layout did not match with drawing and FEM model. Factory is required to justify the bracing requirement and install accordingly.

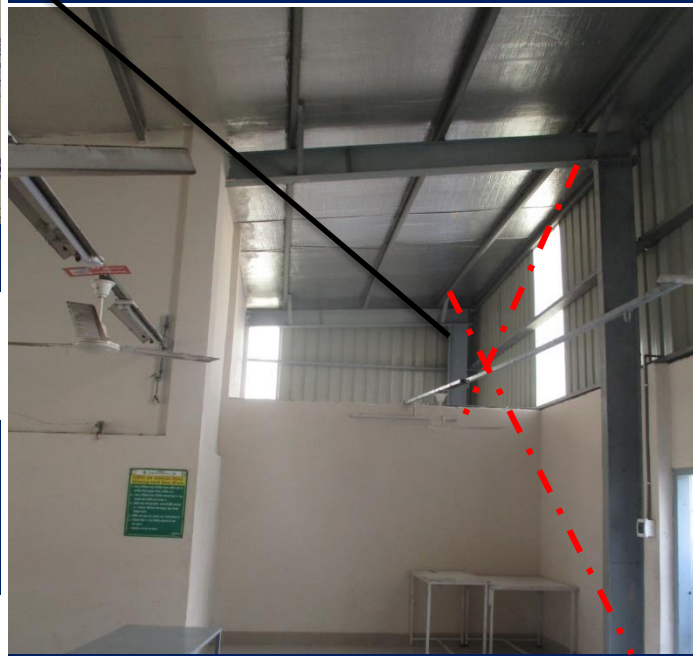
Vertical bracing not found in the marked location

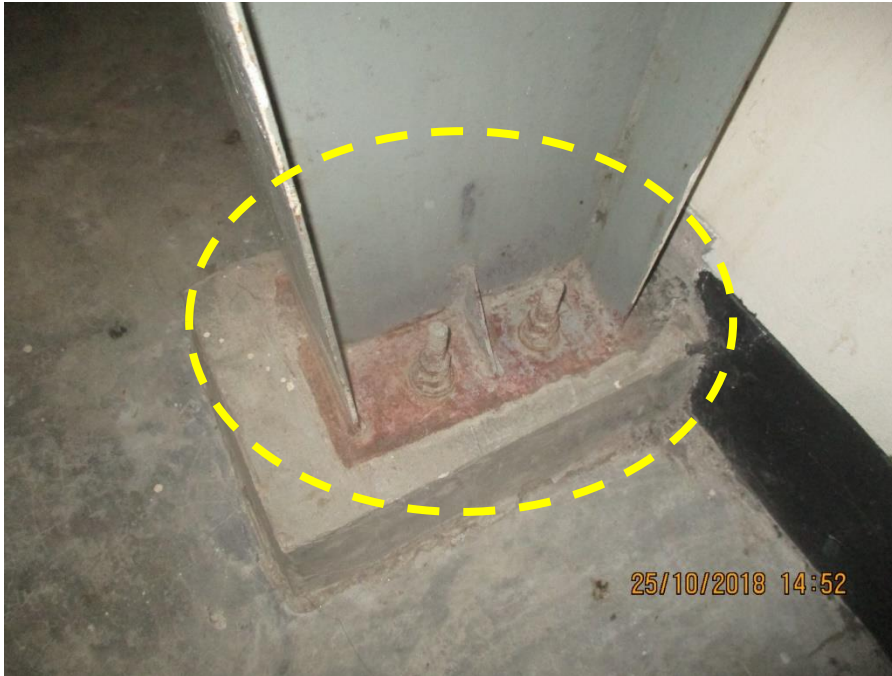
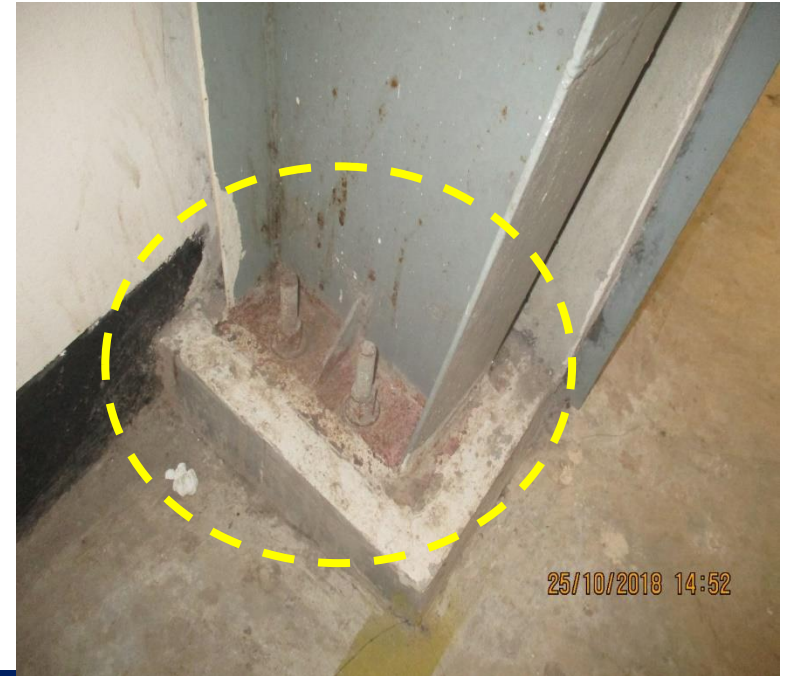
Corrosion observed at steel sections

Corrosion was observed at joint of pedestal column and steel column.

Corrosion was observed on steel columns on different locations of ground floor areas. Factory is required to identify the corroded locations and take proper remedial measures.

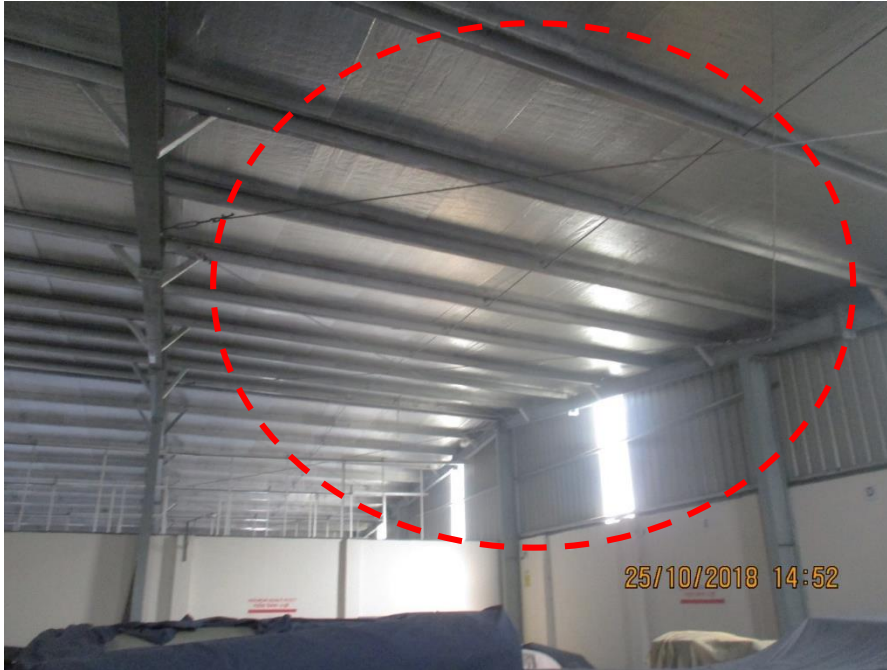
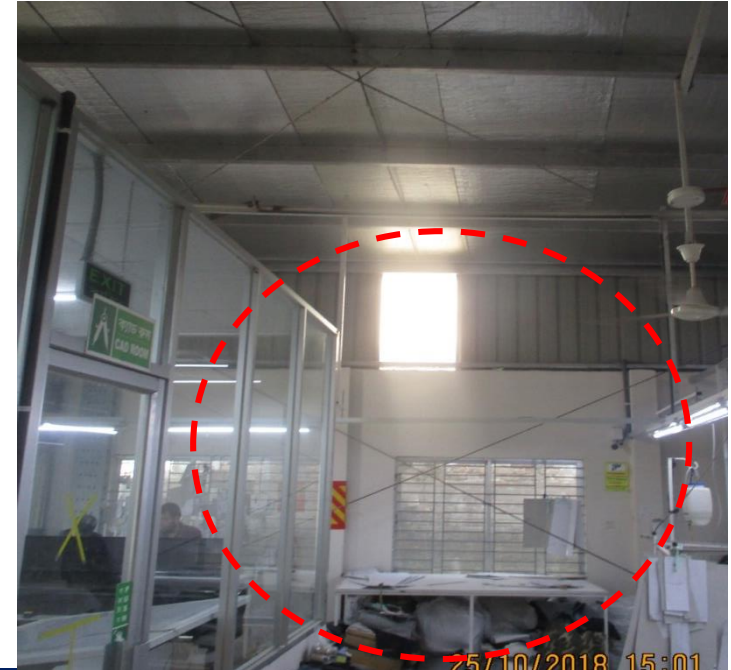
Loose cable bracing

Some of the horizontal and vertical cable bracings are appeared to be loose. Factory is required to tight the bracing for transferring lateral loads properly

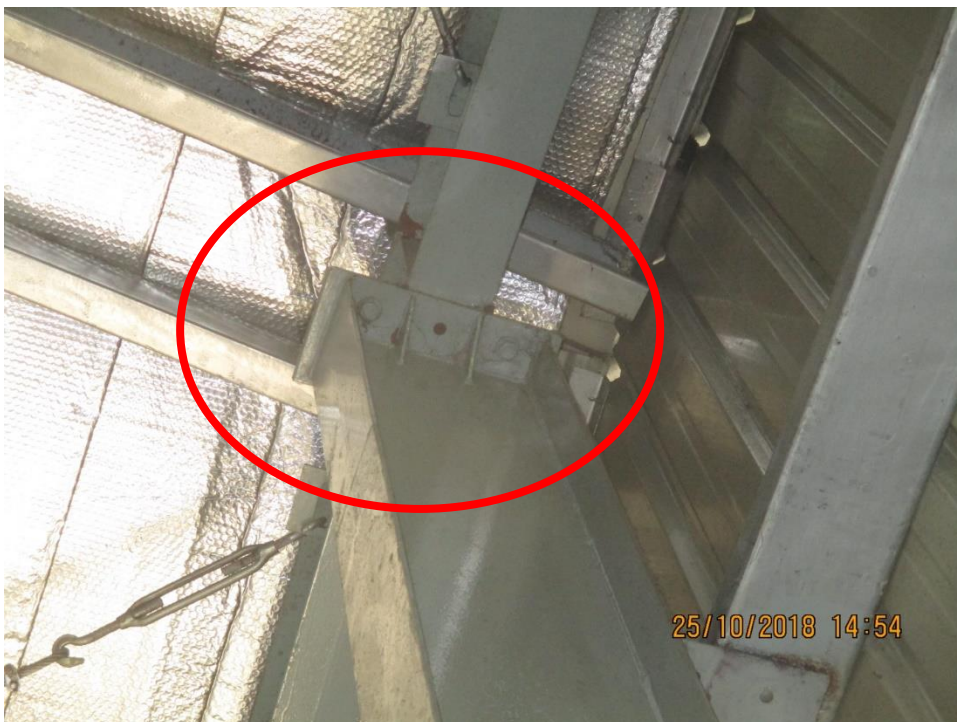
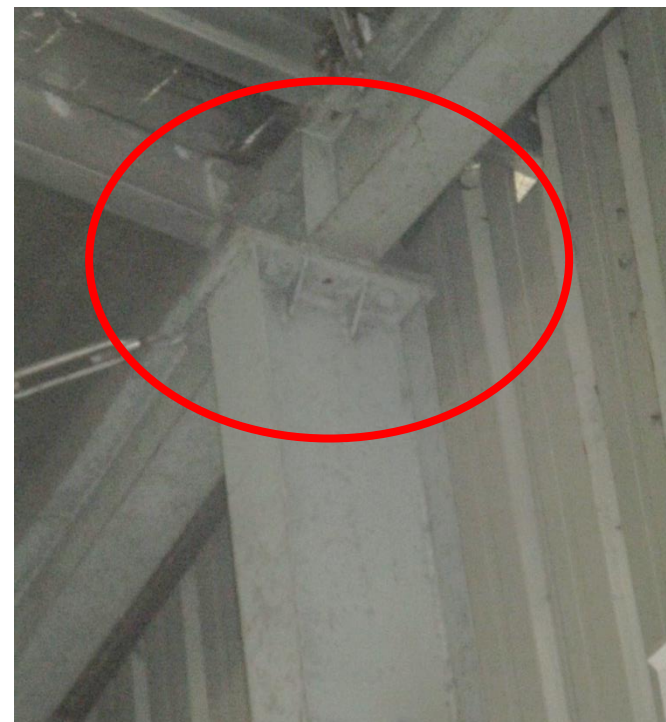
Missing Bolts

Bolts were missing on Column and rafter connection in gable frame location on different areas. Factory is required to take remedial action as per engineer's recommendation.

13	Missing Bolts (Shed-2)	Factory engineer is required to install the bolts according to the as-built drawing.	6-weeks
