FIRE SAFETY INSPECTION REPORT

Factory Name: Powertex Fashions Limited (Relocation)

ACCORD ID: 23541

Date: 06 January 2019

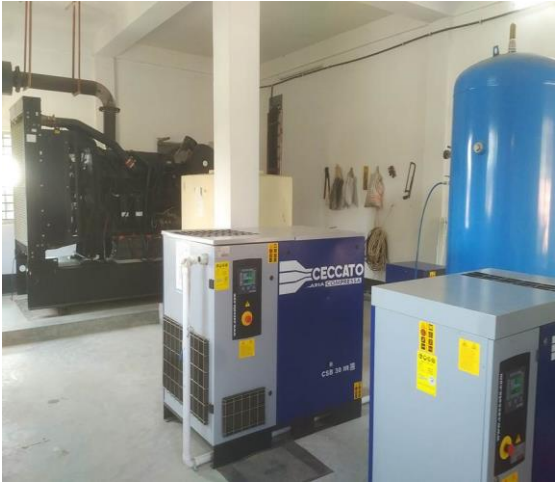
SI No.	Category	Findings	Required Action	Remediation Time Frame	Pictorial Evidence
1	Fire Rated Construction	Generator and air compressors are located in same room with out fire separation. Location: Generator Room	Generator and compressor room shall be separated from each other other by a minimum 2-hr fire rated construction (wall, floor, slab etc.). Seal all penetrations and openings (door, window etc.) should be protected by 1.5-hr fire rated materials to maintain the fire separation if required. All exhaust systems shall discharge to the exterior of the building in a safe location.	Within 03 Months

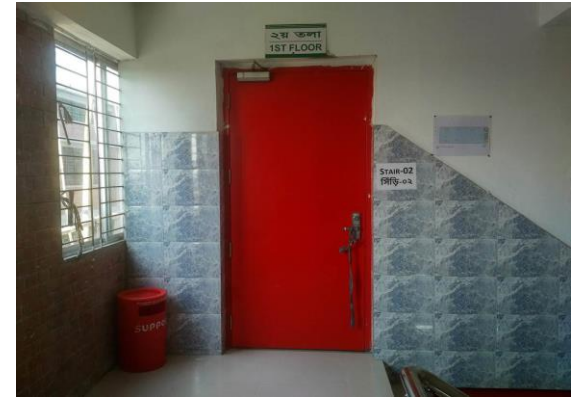
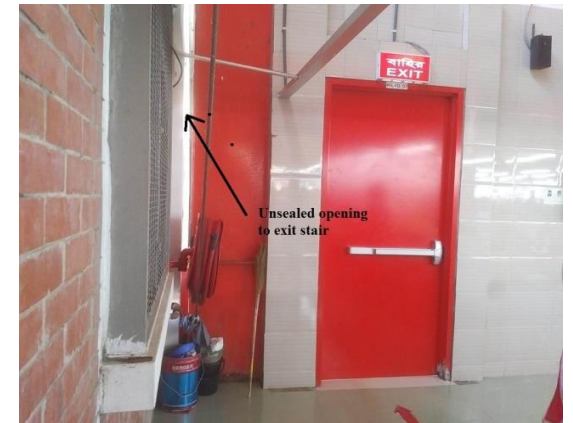
2 Fire Rated Construction

The exit stairs are not separated from [work areas, other spaces] on each floor by fire-rated construction. Fire doors have kept open by external objects/rope. Also unsealed penetrations have observed to exit enclosure.

Location: All exit stair

Stair shall be enclosed with a minimum X-hr. fire-rated construction. Seal all unprotected openings and provide minimum X-hr. fire rated doors to separate the exit stairs from work areas and other building spaces on all floor levels. Ensure that the fire doors are self-closing, positive latching and that they are provided with fire exit (panic) hardware where serving production floors.

If fire doors are required to be held open for functional reasons, provide automatic-closing devices tied to the fire alarm system.

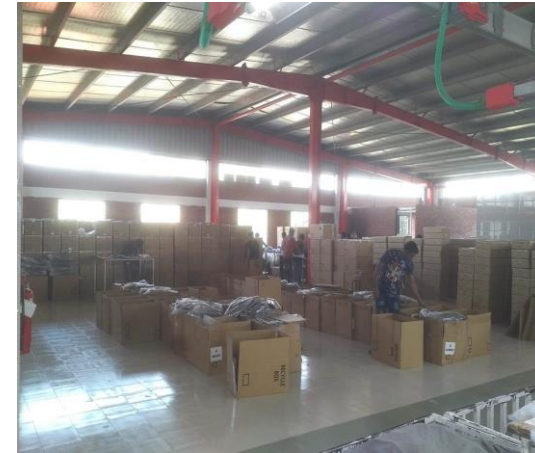
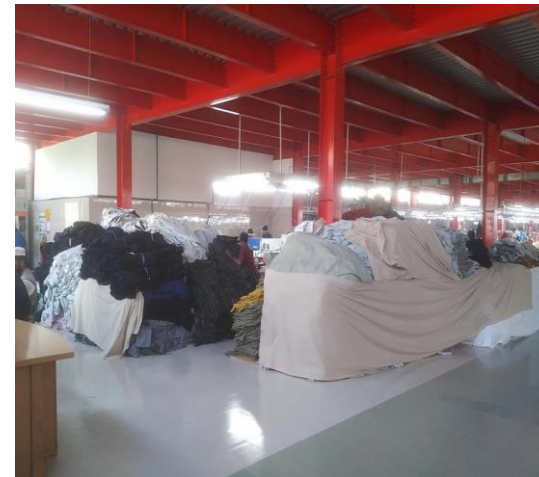
3 Fire Rated Construction

Areas used for in-process storage of combustible materials are open to the surrounding.

Location: Ground & 1st Floor, Production building

Provide defined storage areas and limit the storage arrangement as follows:-

1. General Condition:
Maximum height of 2.4m and maximum area of 23m².
Separate areas of unenclosed combustible storage by a minimum clear distance of 3m.
2. If sprinkler protected:
maximum height of 3.66m and maximum area of 93m².
Separate areas of unenclosed combustible storage by a minimum clear distance of 3m.
or
3. Enclose the storage area from the surrounding occupancy with a minimum 1 hour construction.

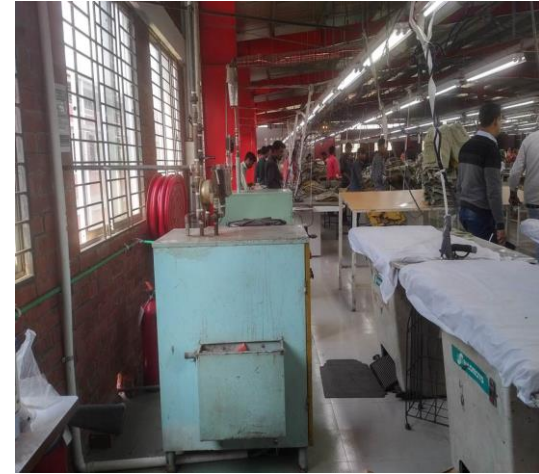
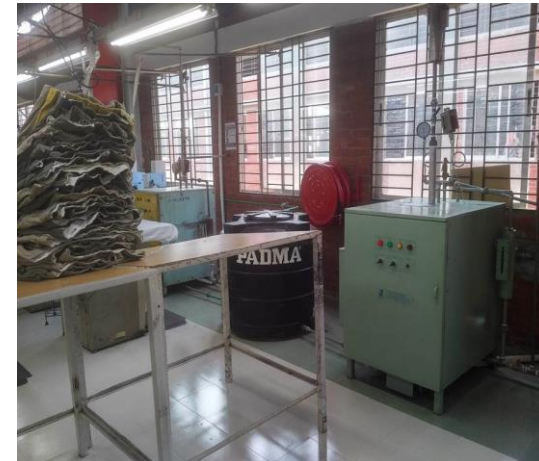
4 Fire Rated Construction

Electric boilers having a capacity of 80 Kg/Hr. and 60 Kg/Hr. are not been separated from production floor.

Location: 1st floor, West side

Boilers or other heat producing equipment shall be separated from other occupancies by a minimum 1-hr fire rated construction (wall, floor, slab etc.). Seal all penetrations and openings (door, window etc.) should be protected by 0.75-hr (45 min) fire rated materials to maintain the fire separation if required. All exhaust systems shall discharge to the exterior of the building in a safe location.

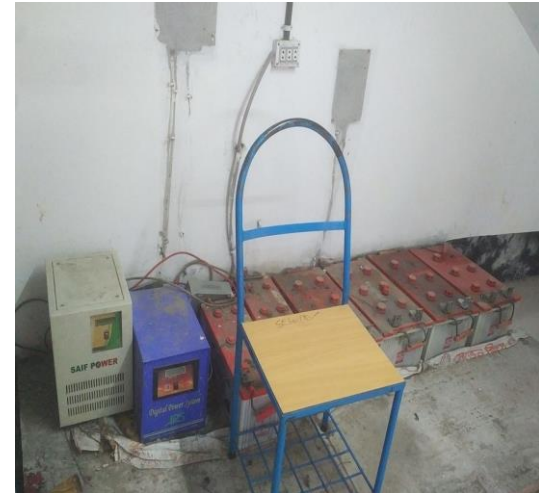
5 Egress

Storage was located in the exit stairs

Remove all storage from exit stairs.

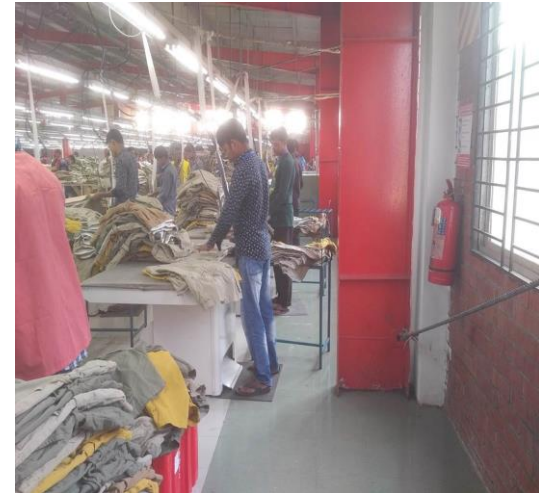
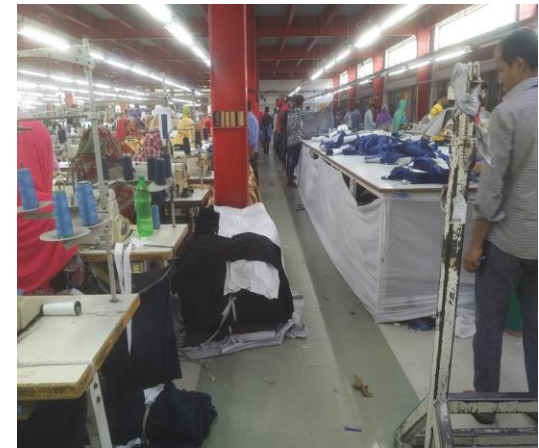
6 Egress

The egress path along means of egress has interrupted by obstruction/storage. Also in many cases dedicated aisles have not been provided.

Aisles shall be provided with a minimum unobstructed clear-width of 0.9 m (36 in.).

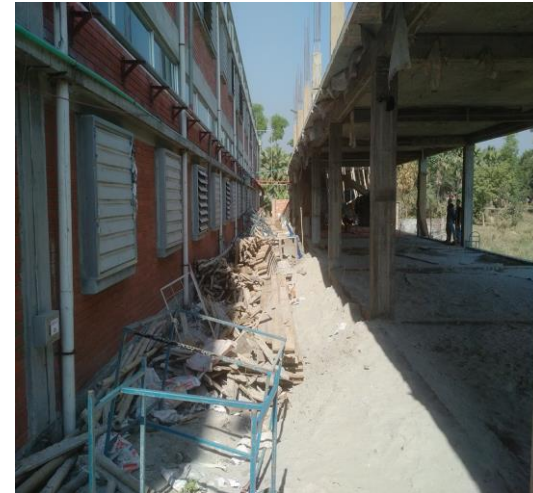
7	Egress	The egress path along means of egress has interrupted by obstruction/storage.	Means of egress shall be maintained continuously free and clear of all obstructions/storage. Or Keep egress paths and stairs clear of storage.	Immediate	
---	--------	---	--	-----------	--

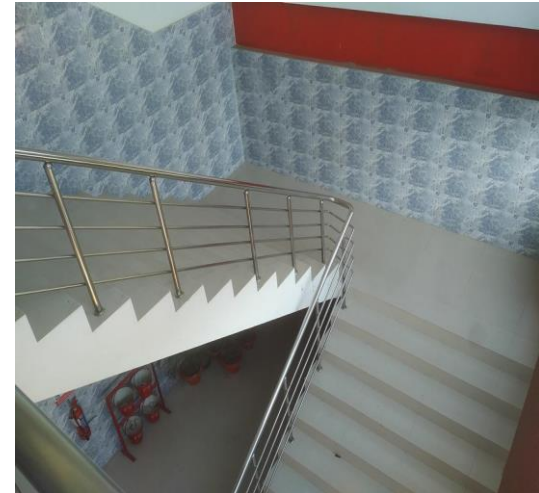
9 Egress

Handrails are not provided in the exit stair.

Provide handrails on both side of exit stair having a minimum height 34 in.

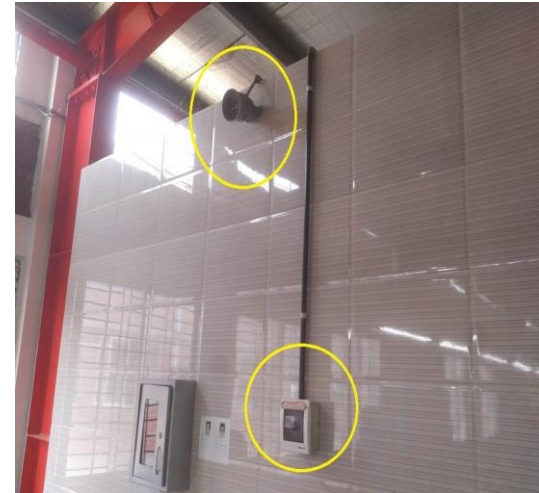
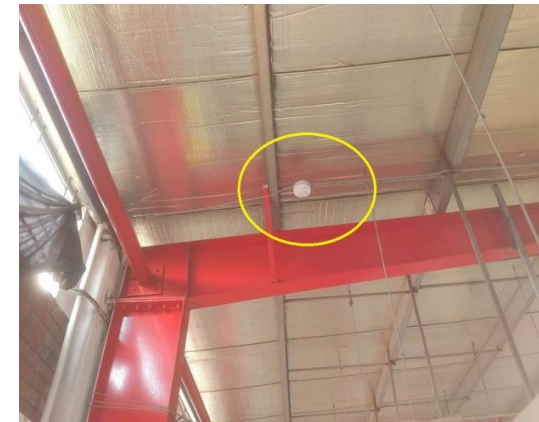
10 Fire Alarm & Detection System

The existing fire alarm system is not a listed system and does not provide automatic alarm and notification features consisted with acceptable standards.

Replace the fire alarm system with a new, listed addressable fire alarm system in accordance with NFPA 72.

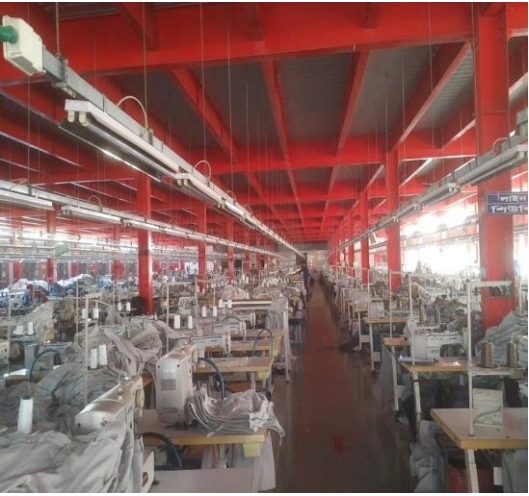
12	Egress Lighting	Based on the number and location of emergency lights observed, adequate illumination levels are not anticipated along egress routes.	Test the emergency lighting system on each floor and provide additional emergency fixtures to provide adequate illumination along the means of egress. Provide a minimum illumination of 10 lux at the floor level within exit stairs and exit discharge paths and minimum 2.5 lux along exit access aisles.	Within 01 Month

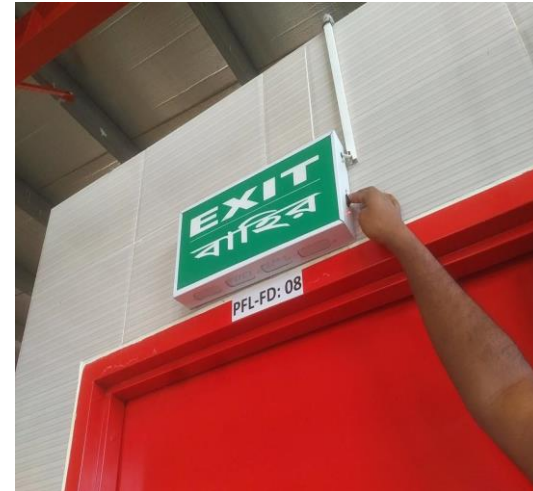
13	Egress Lighting	Manual on-off switch is provided for [emergency lighting / exit signage] units.	Remove manual on/off switches from emergency lighting / exit signage units to prevent them from being switched off.	Within 01 Month	
----	-----------------	---	---	-----------------	--

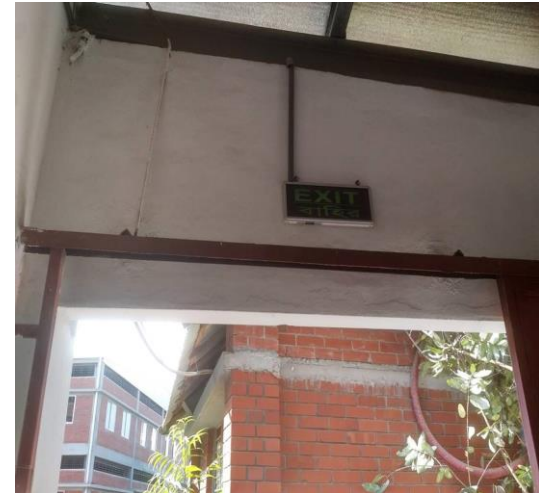
15	Egress Lighting	Exit signage not illuminated during testing (burned out, broken, etc.).	Regularly inspect all exit signage as per Accord standard and replace/install lights as needed to illuminate signs.	Immediate	
----	-----------------	---	---	-----------	--
