FIRE SAFETY INSPECTION REPORT

Laila Styles Ltd

ACCORD ID: 23622

Date: 27 January, 2019

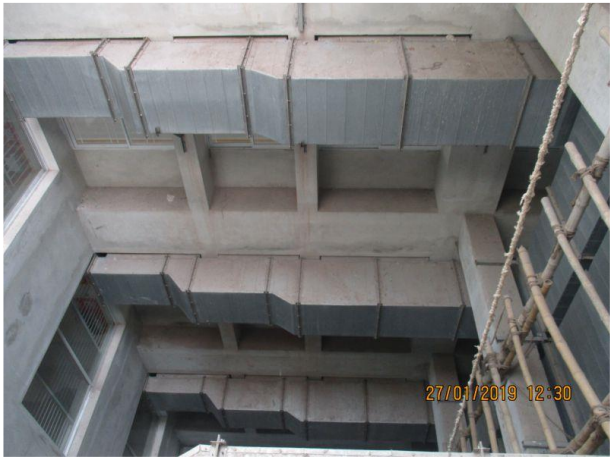
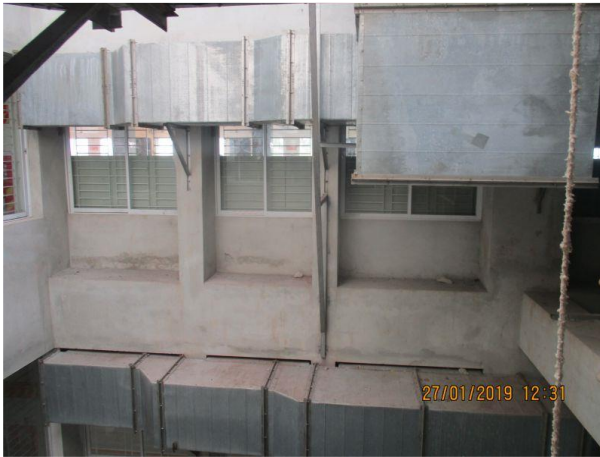
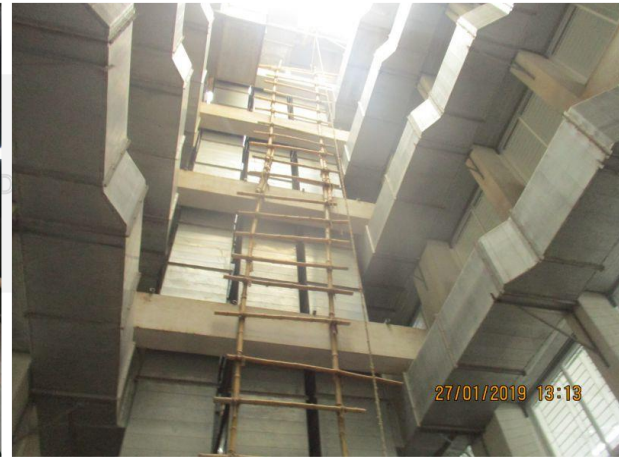
SI No.	Category	Findings	Required Action	Remediation Time Frame
1	Fire Separation	Atrium connecting 1st to 5th floor which is also used for carrying ventilation duct lines, is not properly separated by fire rated construction on each floor. Location: Building 1 : Main production building, in between stair-5 & 2.	Separate the atrium area by 2 hr. fire rated construction on each floor or provide sprinkler system as per ACCORD building standard 3.7.4. [Reference NFPA 101, 6.1.14.4.6, 8.6.7]	Within 6 months

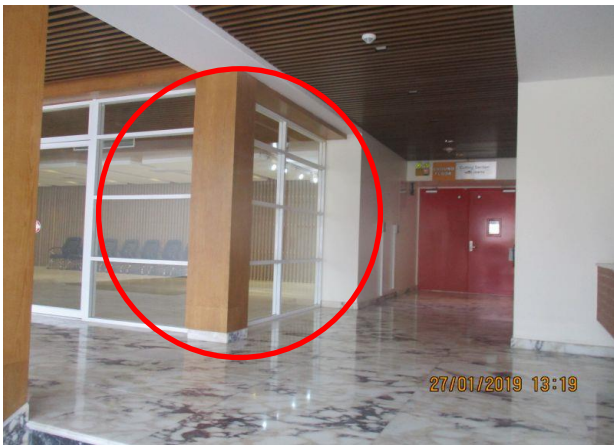
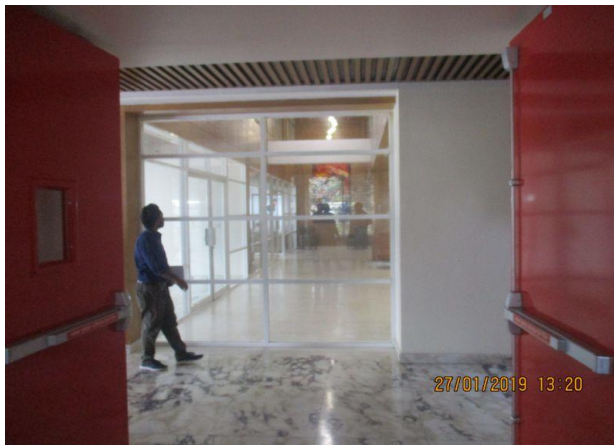
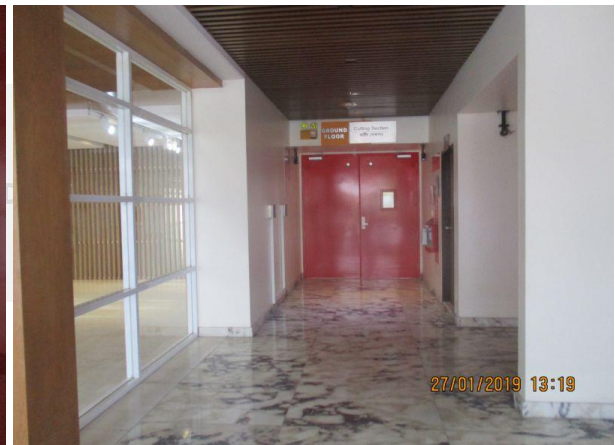
2	Fire Separation	North-East exit stair discharge the occupants inside the building. Location: Building-1, Stair-1	1. Modify stair to discharge directly outside. Or 2. Provide 2-hr fire-rated exit passageway leading directly outside (vestibules to separate any storage areas).	Within 3 months
---	-----------------	--	---	-----------------

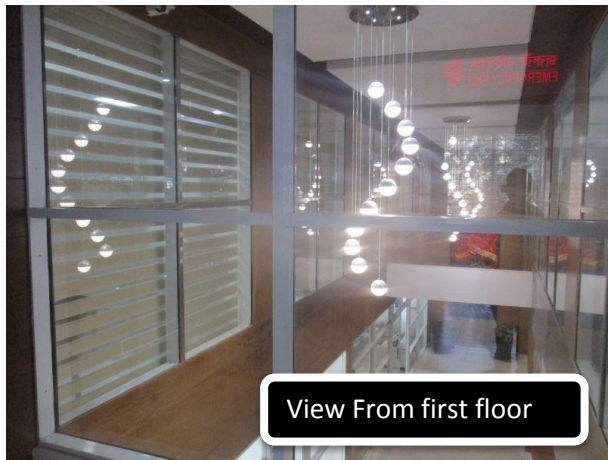
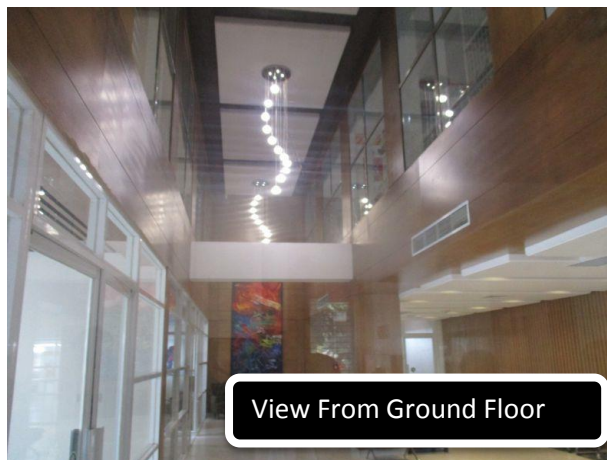
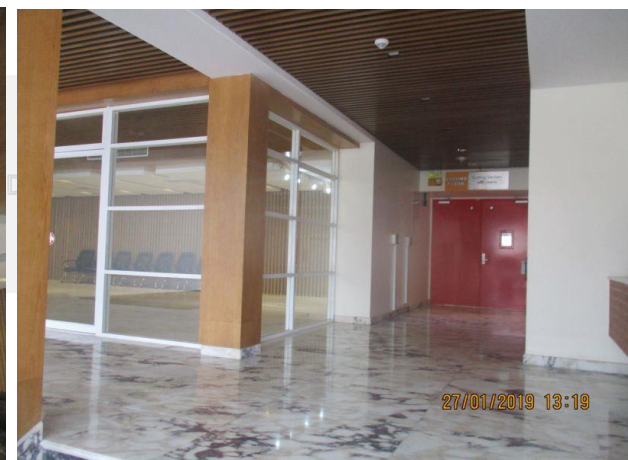
3	Fire Separation	Unsealed penetrations and openings are located in the fire rated floor/ceiling assemblies (where 1st floor is production and ground floor is used as inspection, waiting purpose). Location: Building-1, adjacent to stair-1.	Seal all the penetrations and openings in floors/ceiling/wall assemblies to maintain 2 hr. fire separation.	Within 3 months
---	-----------------	---	---	-----------------

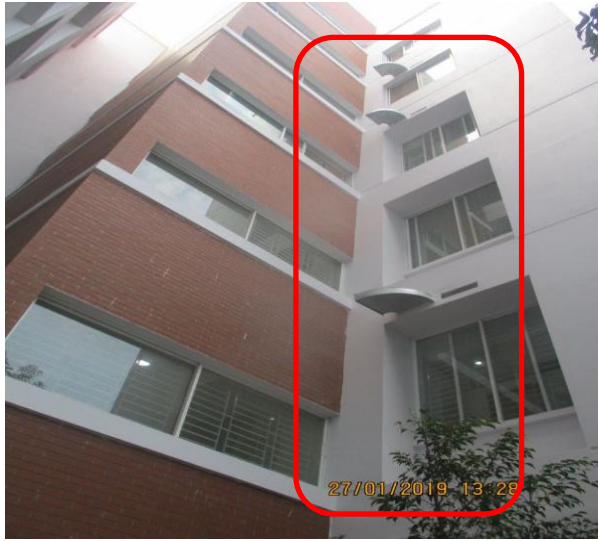
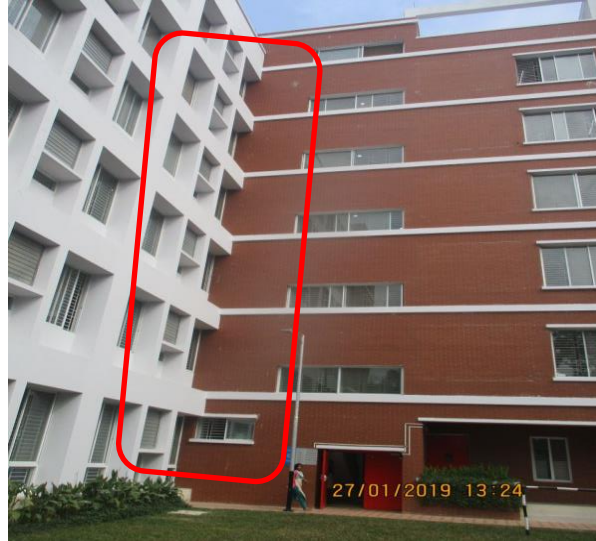
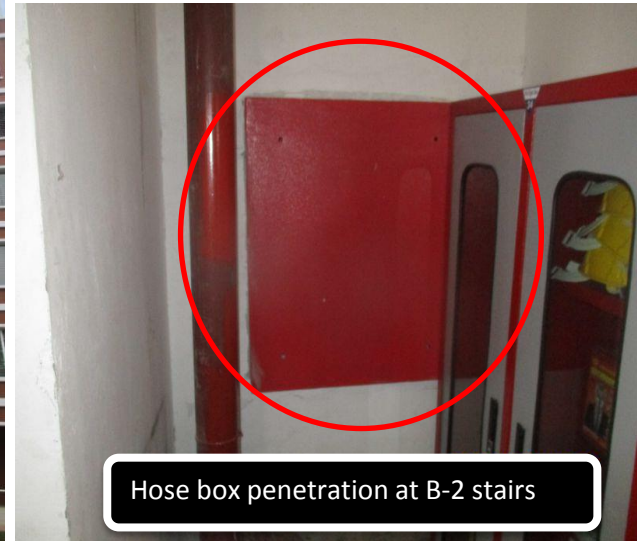
4	Fire Separation	Unsealed penetrations and openings are located in the exit stair enclosures. Location: Building-1, Stair-2 & 5, unseal penetrations within 10 ft., Building-2: hose box penetrations at both the stairs.	Seal all penetrations and openings in exit stair enclosure walls to maintain the fire separations. [Reference Accord building standard 6.14.7]	Within 3 months
---	-----------------	--	--	-----------------

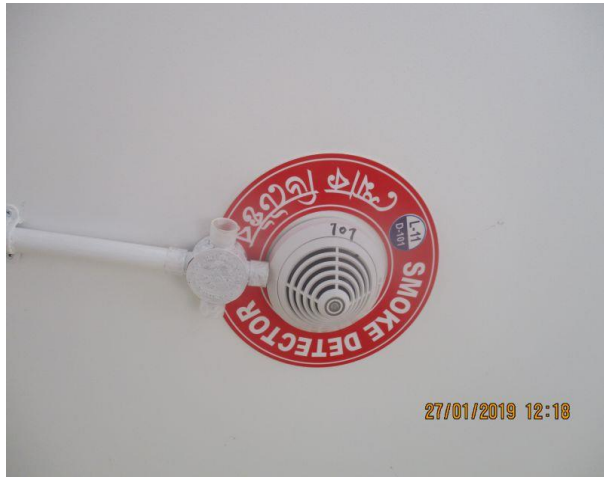
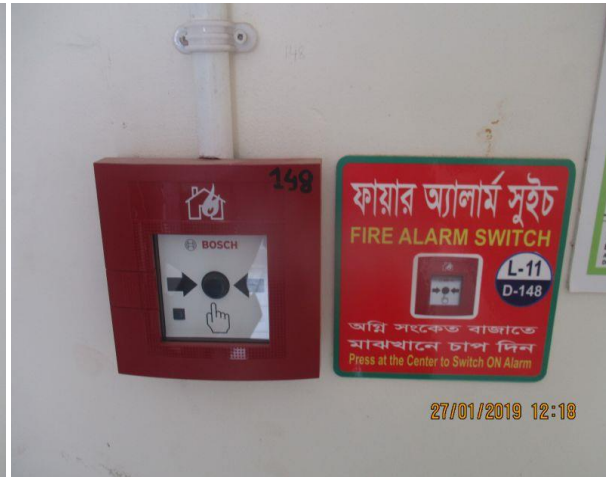
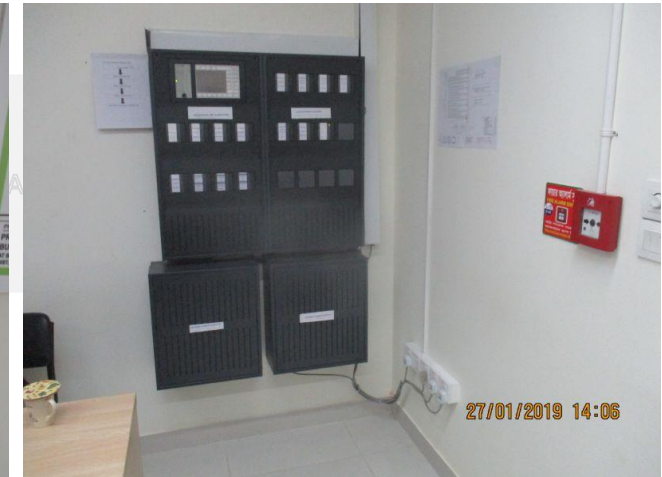
5	As Built Fire Detection System	Fire detection system installation requires detailed review to confirm compliance with NFPA 72 and ACCORD standards for Building-1,2,3,4	Submit as-built drawings, testing records, equipment certification and other relevant documentation to the ACCORD for review and approval	Design within 1 month Installation within 6 months
---	--------------------------------	--	---	---

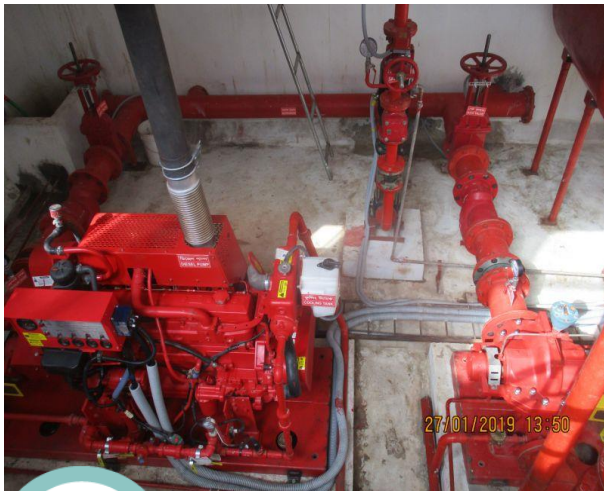
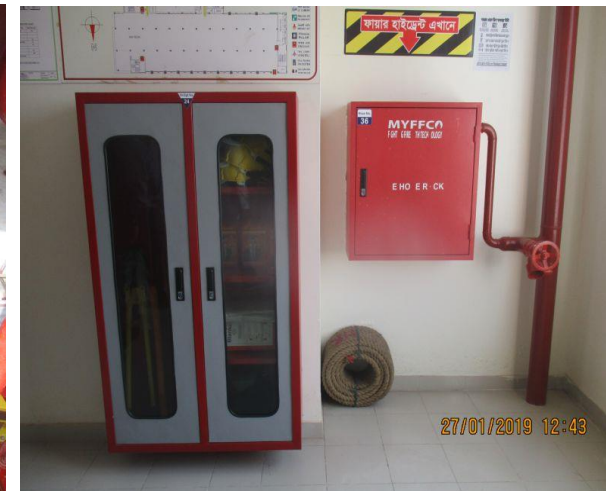
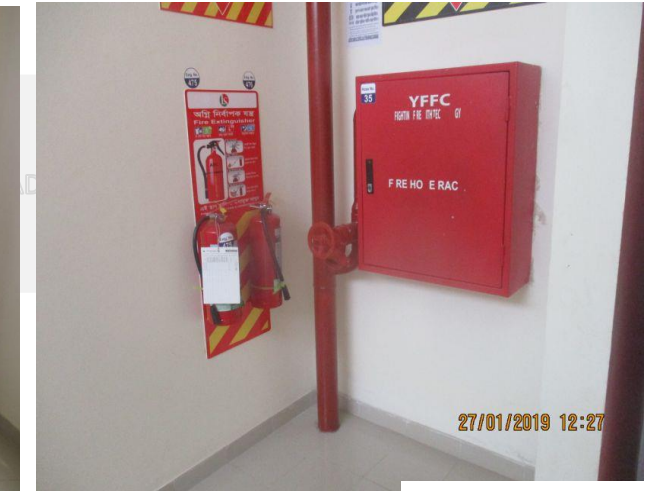
6	As Built Standpipe System	Standpipe system installation requires detailed review to confirm compliance with NFPA 14 and ACCORD standards for building-1 & 2	Submit as-built drawings, testing records, equipment certification and other relevant documentation to the ACCORD for review and approval	Design within 1 month Installation within 6 months
---	---------------------------	---	---	---

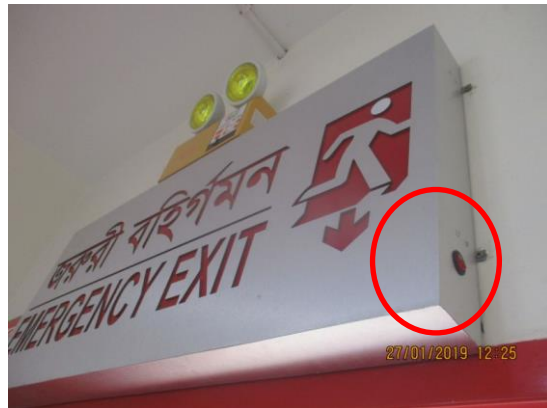
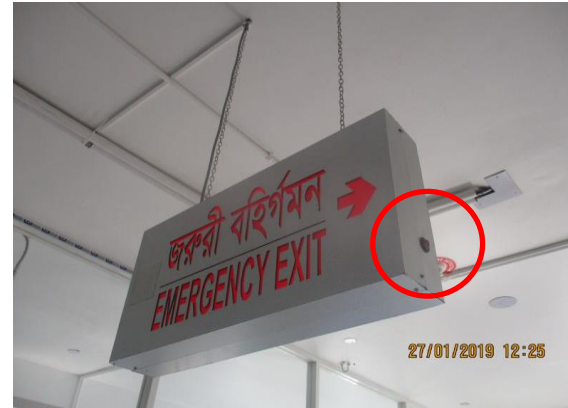
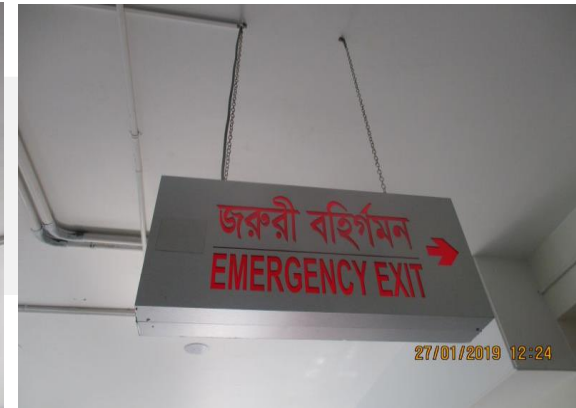
7	On/Off Switch	Manual on-off switch is provided for [emergency lighting / exit signage] units.	Remove manual on/off switches from [emergency lighting / exit signage] units to prevent them from being switched off	Within 1 month
---	---------------	---	--	----------------

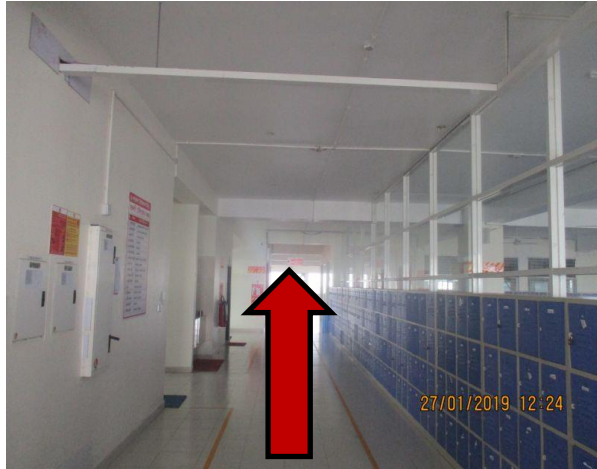
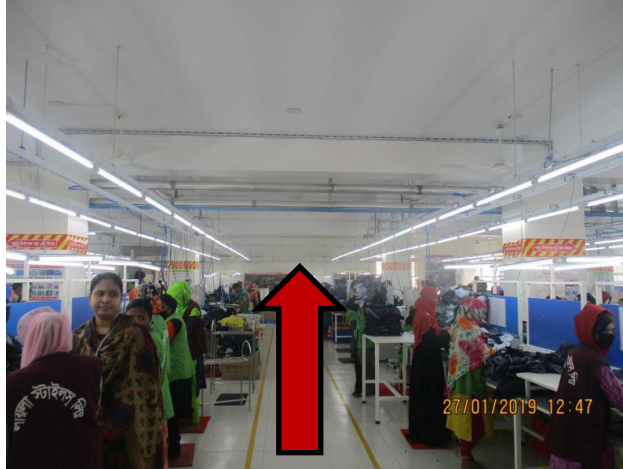
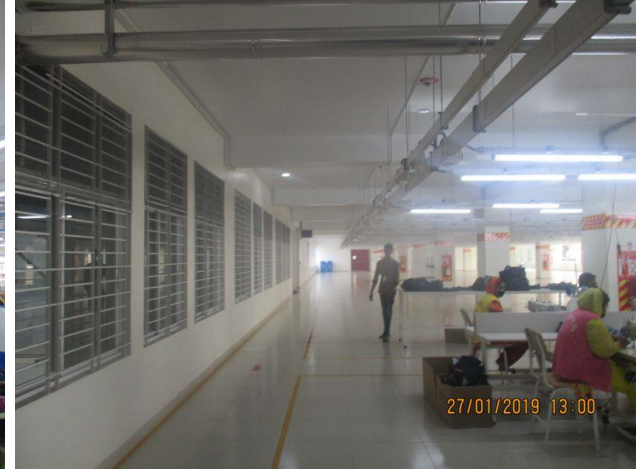
8	Inadequate Lighting	Based on the number and location of emergency lights observed, adequate illumination levels are not anticipated along egress routes.	Test the emergency lighting system on each floor and provide additional emergency fixtures to provide adequate illumination along the means of egress. Provide a minimum illumination of 10 lux at the floor level within exit stairs and exit discharge paths and minimum 2.5 lux along exit access aisles.	Within 3 months
---	---------------------	--	--	-----------------

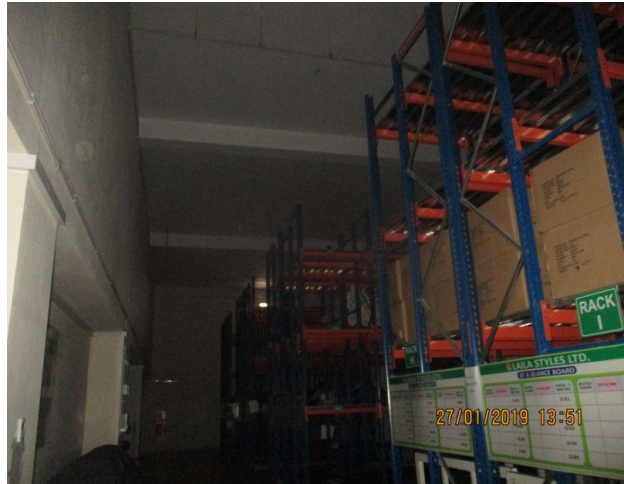
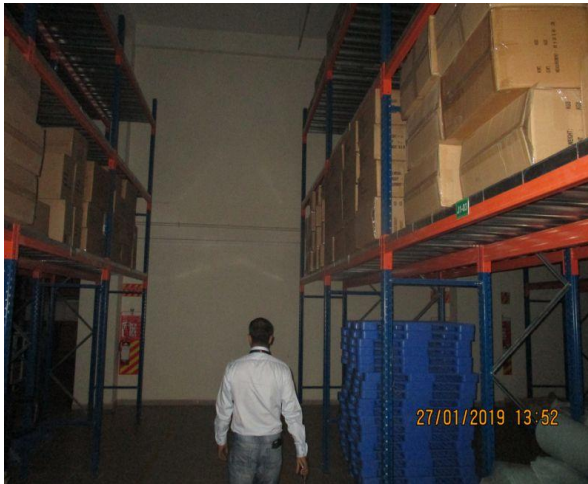
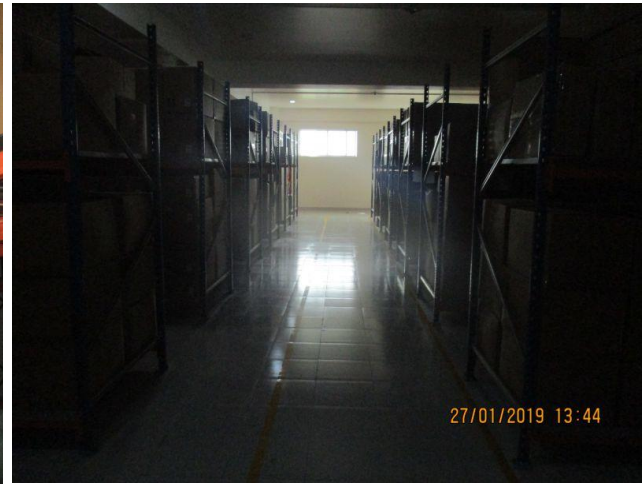
9	Directional Sign	Directional signs are not provided where direction of the path of travel to an exit has changed. Location: Building-2,	Illuminated directional signs shall be provided where there is a change in the direction for the path of travel and the direction to an exit is not obvious.	Within 1 month
---	------------------	--	--	----------------

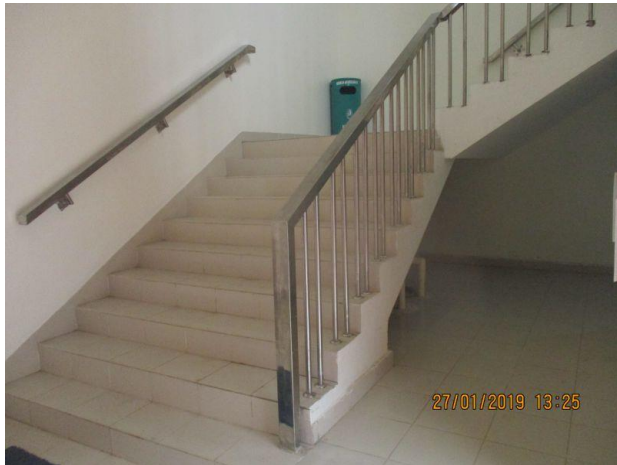
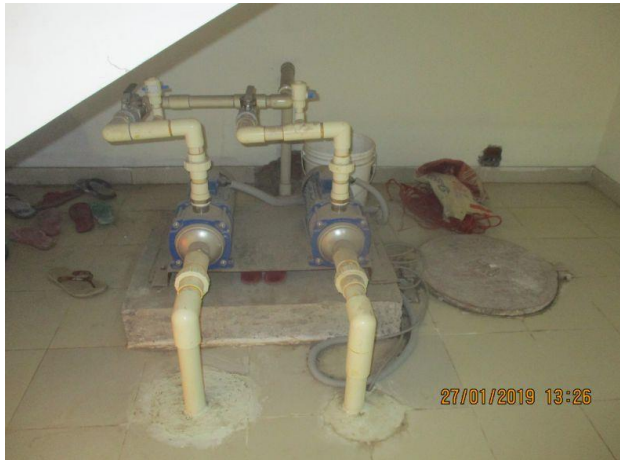
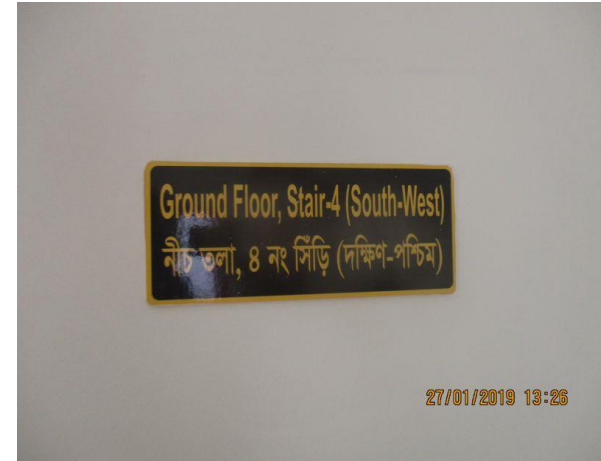
10	Storage in Exit Stair	Storage was located under the exit stair. Location: Pump under stair-4, Building-1	Remove storage from the exit stairs and egress path Or provide 2 hr. fire rated separation for the pump.	Within 1 month
----	-----------------------	---	---	----------------
