# FIRE SAFETY INSPECTION REPORT

**FACTORY: COTTON CLOTHING LTD- NEW Extension unit**

**ACCORD ID: 23419**

**Date: 13/01/2019**

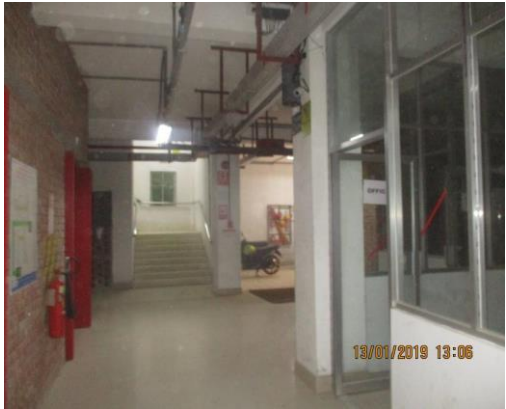
| Sl No. | Category | Findings | Required Action | Remediation Time Frame | Pictorial Evidence |
|---|---|---|---|---|---|
| 1 | Fire Rated Construction | The exit stairs enclosures are not separated from work areas and other spaces on each floor by fire-rated construction(Non rated doors, unsealed penetrations and openings etc.). | <p>Provide minimum 1.5-hr fire rated doors and seal all unprotected openings to separate the exit stairs from work areas and other building spaces on all floor levels.</p> <p>Ensure that the fire doors are self-closing and positive latching and that they are provided with fire exit (panic) hardware where serving production floors.</p> <p>If fire doors are required to be held open for functional reasons, provide automatic closing devices tied to the fire alarm system.</p> | Within 3 months | |

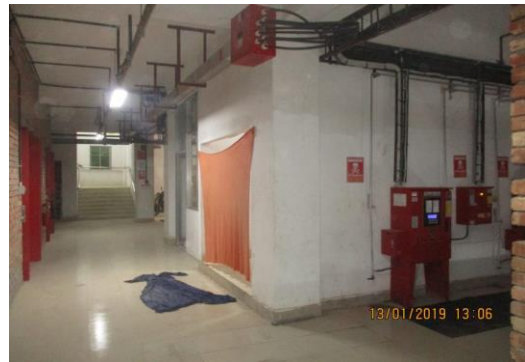
| Sl No. | Category | Findings | Required Action | Remediation Time Frame | Pictorial Evidence |
|---|---|---|---|---|---|
| 2 | Fire Rated Construction | The interior west exit stair discharges inside the building in the ground floor area. | <p>Provide 2-hr fire-rated exit passageway leading directly outside.</p> <ul style="list-style-type: none"> <li>- Modify stair to discharge directly outside.</li> <li>- Provide 2-hr fire-rated exit passageway leading directly outside (vestibules to separate any storage areas).</li> <li>- Provide sprinkler protection for discharge floor in accordance with NFPA 13.</li> </ul> | Within 3 months | |

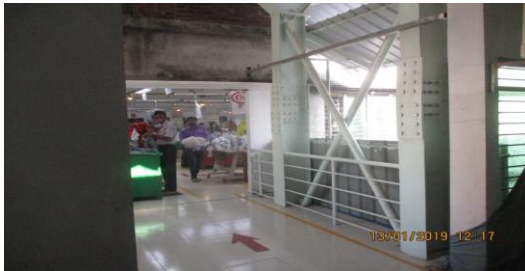
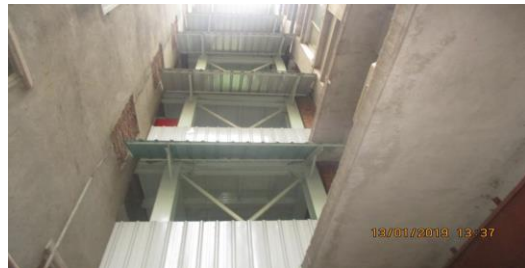
| Sl No. | Category | Findings | Required Action | Remediation Time Frame | Pictorial Evidence |
|---|---|---|---|---|---|
| 3 | Fire Rated Construction | The raised walkway is not separated from building 1 on the 1st, 2nd, 3rd & 5th floors by fire-rated construction. | <p>Provide minimum 1.5-hr fire rated doors and seal all unprotected openings to separate the exit stairs from work areas and other building spaces on all floor levels. Ensure that the fire doors are self-closing and positive latching and that they are provided with fire exit (panic) hardware where serving production floors. If fire doors are required to be held open for functional reasons, provide automatic closing devices tied to the fire alarm system.</p> | Within 3 months | |

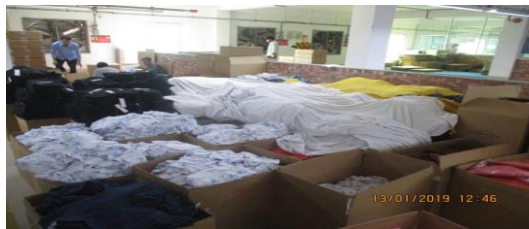
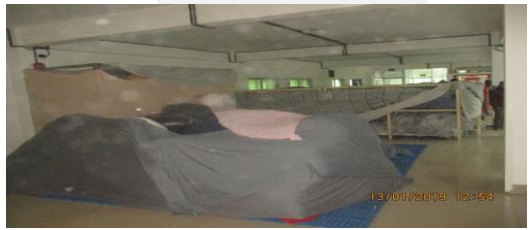
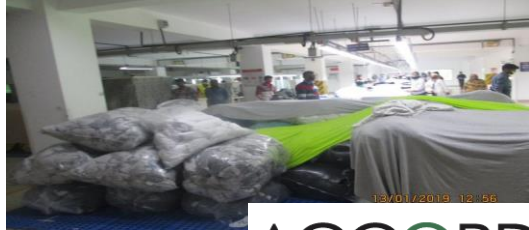
| Sl No. | Category | Findings | Required Action | Remediation Time Frame | Pictorial Evidence |
|---|---|---|---|---|---|
| 5 | Fire Rated Construction | Areas used for combustible storage are not separated by fire-rated.<br>Locations: 2nd & 3rd floors. | <p>Provide dedicated storage rooms separated by minimum 1-hr fire-rated construction.</p> <p>Where separate storage rooms are not feasible, provide defined storage areas and limit the storage arrangement as follows:</p> <ul style="list-style-type: none"> <li>- Maximum height of 2.4m and maximum area of 23m<sup>2</sup></li> <li>- If sprinkler protected: maximum height of 3.66m and maximum area of 93m<sup>2</sup></li> </ul> <p>Separate areas of unenclosed combustible storage by a minimum clear distance of 3m</p> | Within 3 Months | |

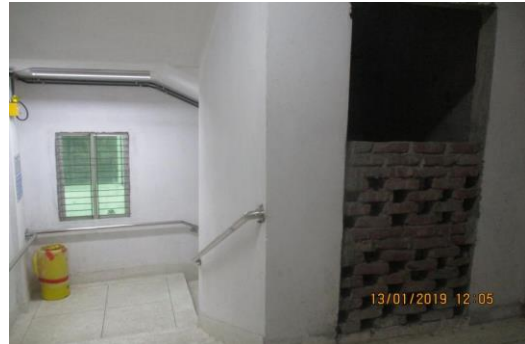
| Sl No. | Category | Findings | Required Action | Remediation Time Frame | Pictorial Evidence |
|---|---|---|---|---|---|
| 6 | Fire Rated Construction | Unsealed penetrations and openings are located in the west exit stair enclosures | Seal all penetrations and openings in exit stair enclosure walls to maintain the fire separations. | Within 3 Months | |

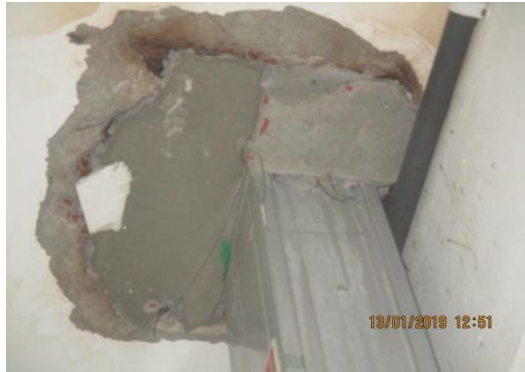
| Sl No. | Category | Findings | Required Action | Remediation Time Frame | Pictorial Evidence |
|---|---|---|---|---|---|
| 7 | Fire Rated Construction | Unsealed penetrations and openings are located in the fire rated floor/ceiling assemblies. | Seal all penetrations and openings in floor/ceiling (full thickness of the floor/ceiling) assemblies by fire rated materials to maintain the fire resistance rating.<br><br>Or<br>Provide a minimum 2-hr fire rated shaft to separate the utility risers from each floor if required. | Within 3 Months | |

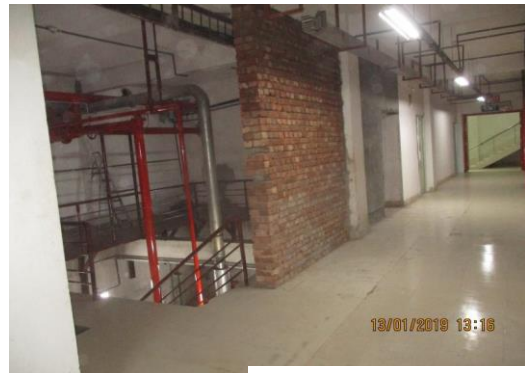
| Sl No. | Category | Findings | Required Action | Remediation Time Frame | Pictorial Evidence |
|---|---|---|---|---|---|
| 8 | Fire Rated Construction | The fire pump room is not provided with adequate fire separation. Location: Ground floor (East side). | Provide fire pump room with 2 hr. rated fire separation when not sprinkle red and 1 hr. rated fire separation when provided with automatic sprinklers in accordance with NFPA 20 Or, Physically separate the pump room from the protected building by a minimum of 50 ft. (15.3 m) in accordance with NFPA 20 | Within 3 Months | |

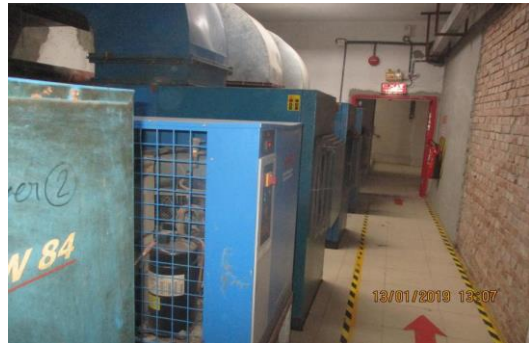
| Sl No. | Category | Findings | Required Action | Remediation Time Frame | Pictorial Evidence |
|---|---|---|---|---|---|
| 9 | Fire Rated Construction | The air compressor room is not separated by fire rated construction (openings, penetrations)<br>Location: Ground floor | Separate the air compressor room by minimum 2-hr fire rated construction. Seal and/or protected all fire separations. | Within 3 Months | |

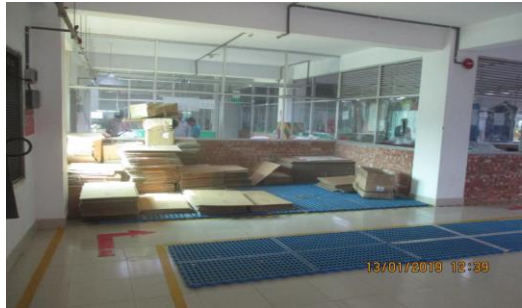
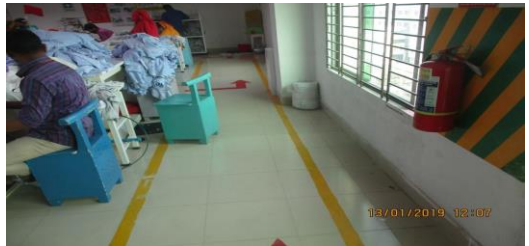
| Sl No. | Category | Findings | Required Action | Remediation Time Frame | Pictorial Evidence |
|---|---|---|---|---|---|
| 10 | Storage in Egress Path.<br>Locations: Various floors. | Storage was located in the egress paths. | Keep egress path and stair clear of storage. | Immediate | |

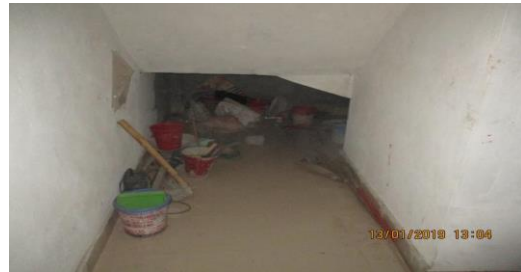
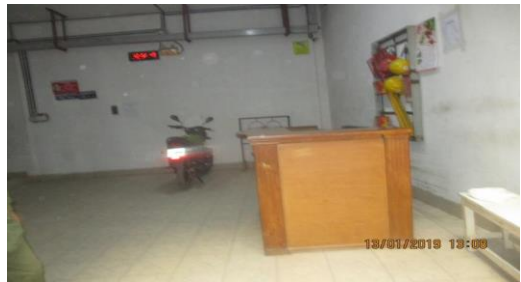
| Sl No. | Category | Findings | Required Action | Remediation Time Frame | Pictorial Evidence |
|---|---|---|---|---|---|
| 11 | Storage in Exit Stair | Storage was located in exit stairs. | Remove storage from the exit stairs and egress path | Immediate | |

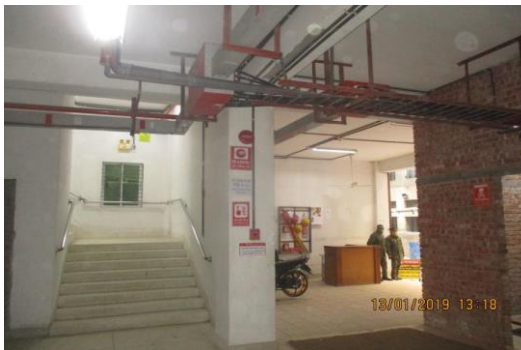
| Sl No. | Category | Findings | Required Action | Remediation Time Frame | Pictorial Evidence |
|---|---|---|---|---|---|
| 12 | Storage in Exit Stair | Electrical appliances were located in the west exit stair enclosures. | Remove and re-locate all electrical panels from exit stair enclosures. | Within 3 Months | |

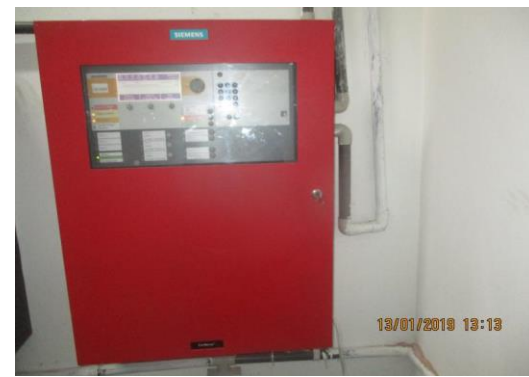
| Sl No. | Category | Findings | Required Action | Remediation Time Frame | Pictorial Evidence |
|---|---|---|---|---|---|
| 14 | Fire Detection & Alarm System | Fire detection & alarm system installation requires detailed review to confirm compliance with NFPA 72 and ACCORD standards | Submit as-built drawings, testing records, listing information and other relevant documentation to the ACCORD for review and approval, modification shall have to be done as per the reviewed design (if required) Upon approval & installation/modification the owner shall contact the Accord prior to conducting the final acceptance testing of the fire detection & alarm system installation. Also inspect, test and maintain the fire detection & alarm system and keep written records on-site, in accordance with NFPA 72 and ACCORD standards. | Within 2 months (Design submission) & 6 months (Installation) | |

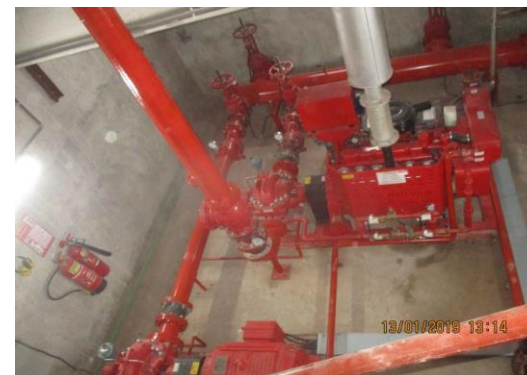
| Sl No. | Category | Findings | Required Action | Remediation Time Frame | Pictorial Evidence |
|---|---|---|---|---|---|
| 16 | Water Based Fire Protection System | The standpipe system installation is going on without approval from AHJ. | Submit As-Built drawing to AHJ for approval and replace or modify the standpipe system in accordance with NFPA 14. | Within 2 months (Design submission) & 6 months (Installation) | |

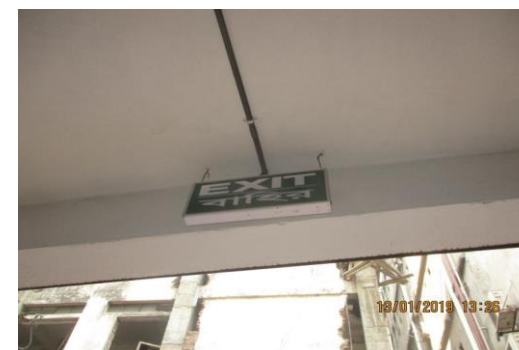
| SI No. | Category | Findings | Required Action | Remediation Time Frame | Pictorial Evidence |
|---|---|---|---|---|---|
| 20 | Non-Working Exit Signs | Exit signage not illuminated (burned out, broken, etc.). | Regularly inspect all exit signage and replace/install lights as needed to illuminate signs | Within 1 month | |
