# **FIRE SAFETY INSPECTION REPORT**

**Factory Name: Romo Fashion Today Ltd. (Extension 2)**

**ACCORD ID: 23550**

**Date: 30 January, 2019**

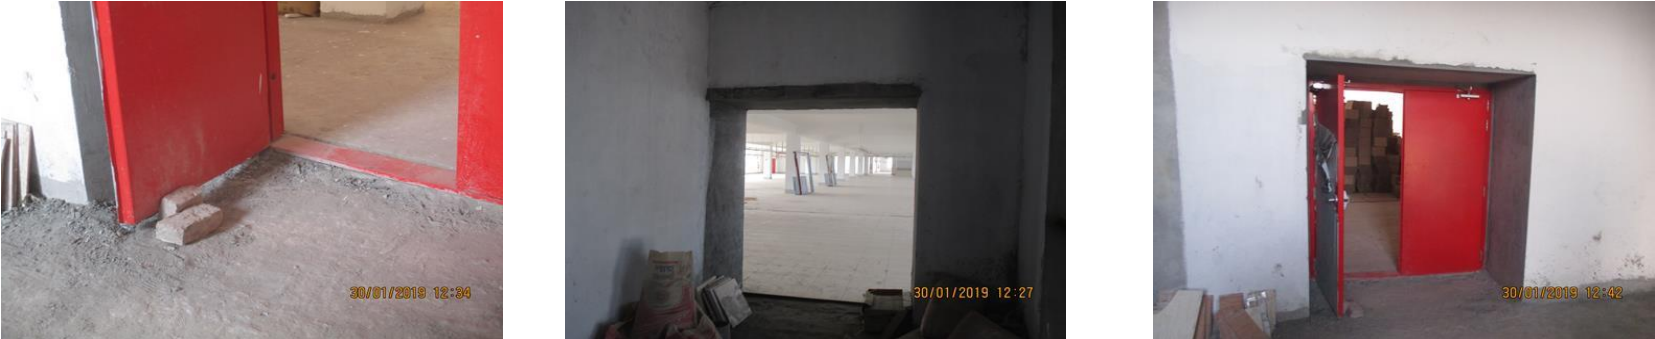
| Sl No. | Category | Findings | Required Action | |
|---|---|---|---|---|
| 1 | Fire Rated Construction | The exit stairs are not separated from [work areas, other spaces] on each floor by fire-rated construction. | <p>Provide minimum 1.5-hr fire rated doors and seal all unprotected openings to separate the exit stairs from work areas and other building spaces on all floor levels. Ensure that the fire doors are self-closing and positive latching and that they are provided with fire exit (panic) hardware where serving production floors.</p> <p>If fire doors are required to be held open for functional reasons, provide automatic-closing devices tied to the fire alarm system. Openings from exit enclosure to storage spaces shall be provided with a vestibule with fire rated construction and openings. Provide a 1.5-hr. fire rated door on the exit stair side and a 1-hr. fire rated door on the storage room side. Ensure that the fire rating of the vestibule construction matches that of the exit stair enclosure.</p> | Within 3 months |

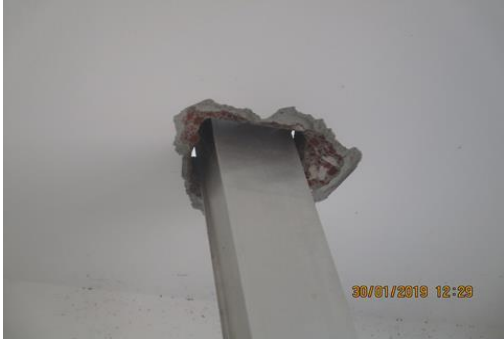
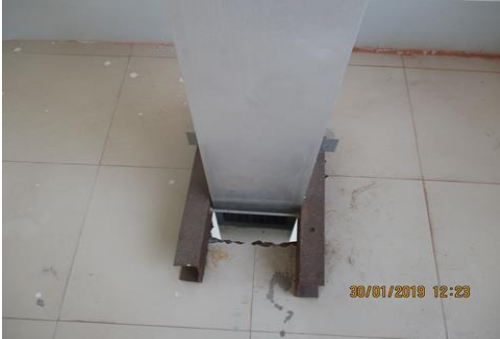
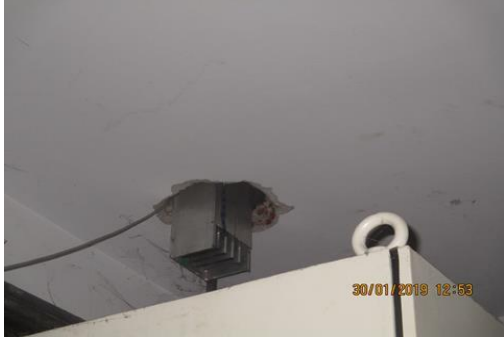
| 3 | Fire Rated Construction | Unsealed [ electrical riser ] shafts are located in the fire-rated floor/ceiling assemblies | Provide a minimum 2-hr fire rated shaft to separate the utility risers from each floor level and seal all penetrations in floor/ceiling assemblies to maintain the fire separation. | Within 3 months |

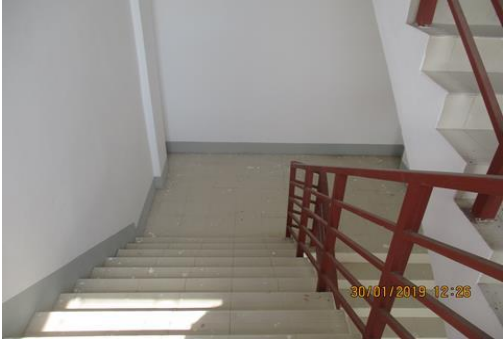
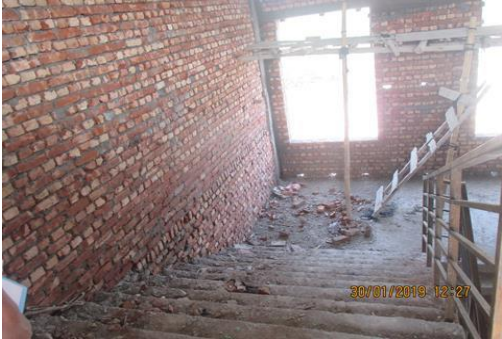
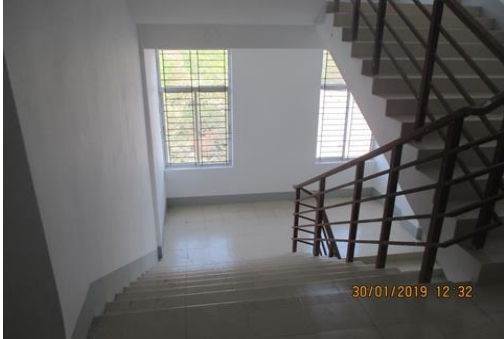
| 4 | Egress | Handrails are not provided on both sides of each exit stairs on all floors. | Handrails shall be provided on both sides of each stairway. Intermediate handrails shall be provided when the stair width exceeds 2.2m (87 in.). | Within 3 months |

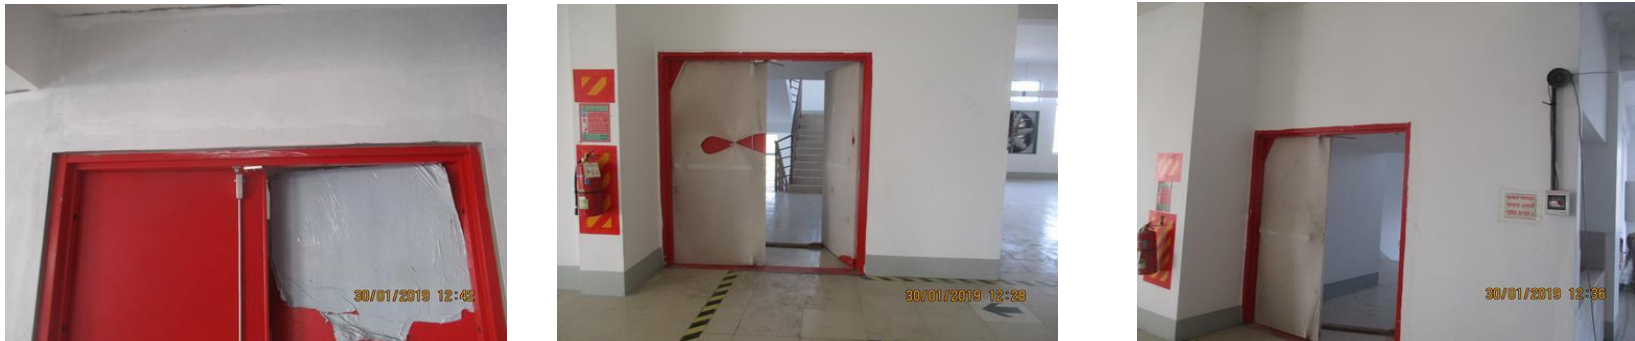
| 8 | Egress lighting | Exit sign not provided at all exit. | Lighted exit signs shall be placed at entrance to an exit. Additional exit signs shall be placed throughout the facility anywhere the continuation of the egress is not obvious. | Within 1 month |

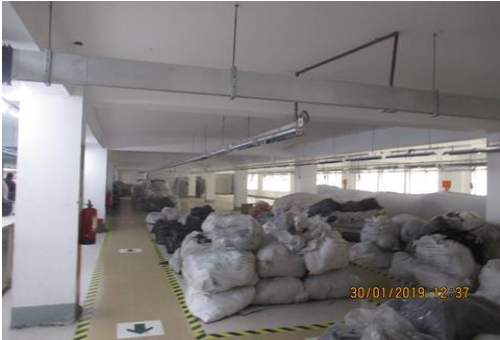
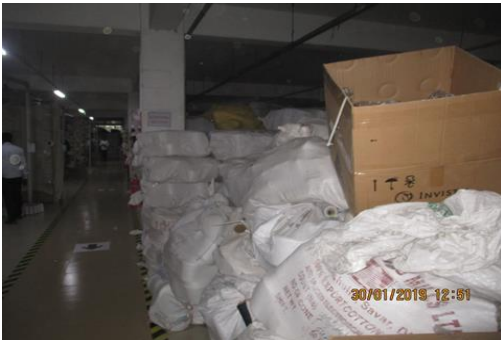
| 9 | Egress lighting | Directional signs are not provided where direction of the path of travel to an exit has changed.<br>Location: 1st floor | Directional signs shall be provided where there is a change in the direction for the path of travel and the direction to an exit is not obvious. | Within 1 month |

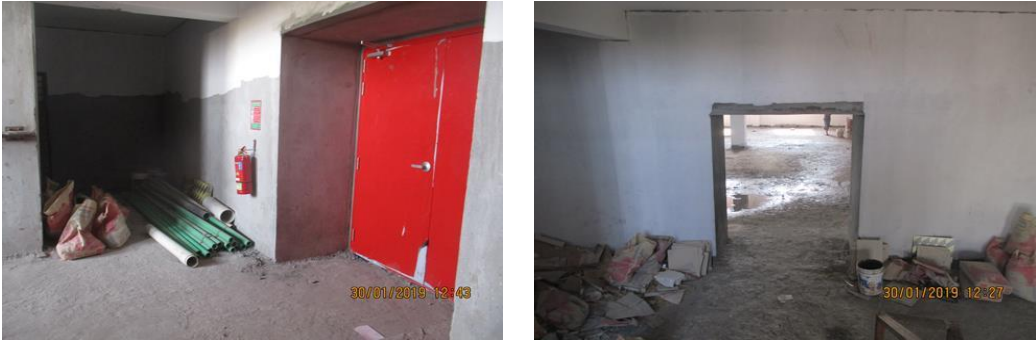
| 11 | Egress | Storage was located in the exit stair enclosure. | Factory shall Keep exit stair, exit stair enclosure and all egress paths clear of storage | Immediate |

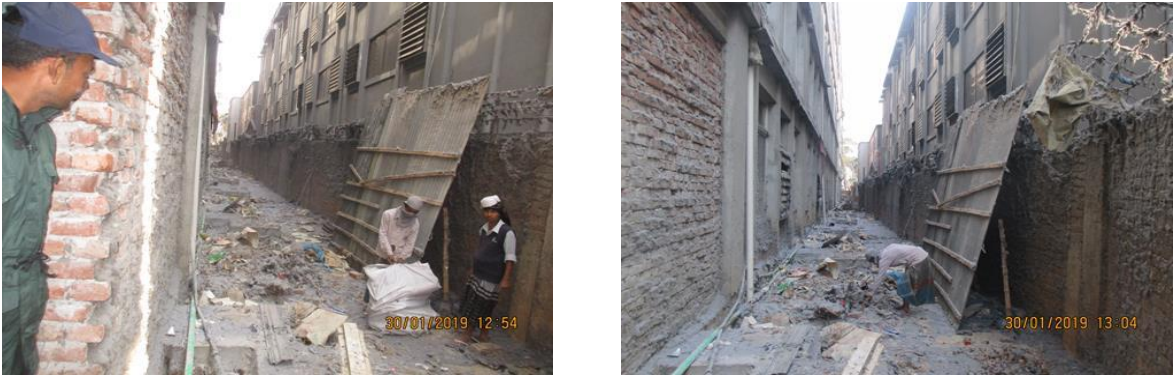
| 12 | Egress | Uneven path of travel and obstructions was observed in the exit discharge. | Remove the obstructions and level the exit path to the public way. | Within 1 month |

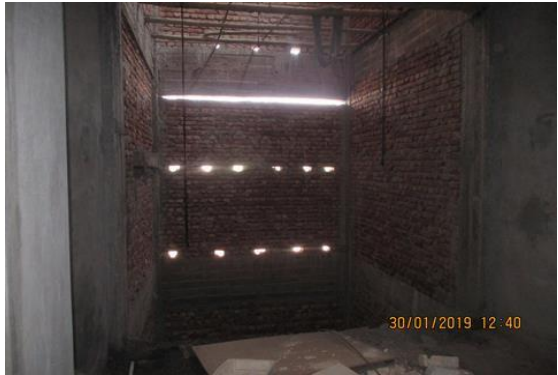
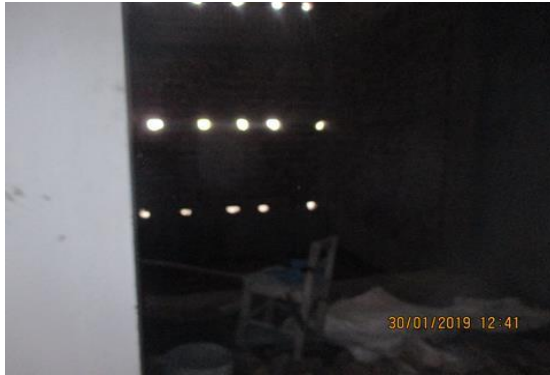
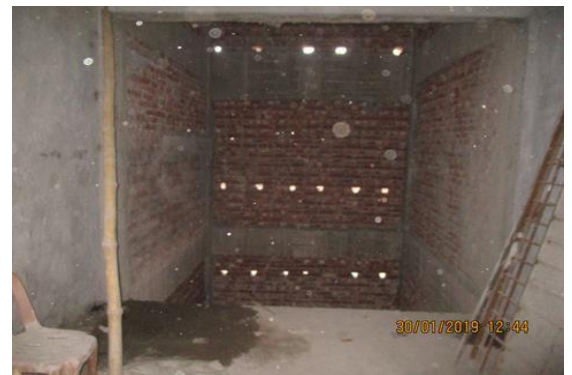
| 13 | Egress | Falling Hazard was observed on elevator shaft. | Guards shall be provided with minimum height of 1067 mm (42 in.). | Within 1 month |

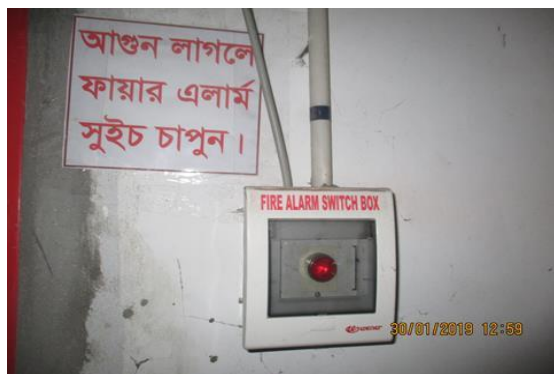
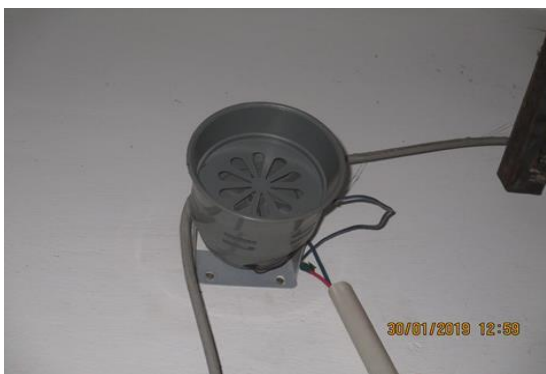
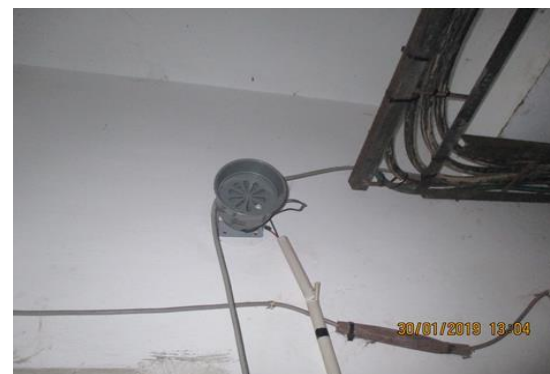
| 14 | Fire Detection & Protection | <p>The building is equipped with single-station smoke alarms. Smoke alarm activation sounds only a local alarm and does not provide automatic fire alarm notification of occupants.</p> <p>Factory reviewed the detection system drawing addressing another ACCORD listed factory "Romo Fashion Today Limited (ID: 12432)" only for <b>Main Production building</b>.</p> | <p>Remove single-station smoke alarms</p> <p>&amp;</p> <p>Provide automatic smoke detection throughout the building, tied into the fire alarm system, in accordance with NFPA 72.</p> | Install within 9 months |

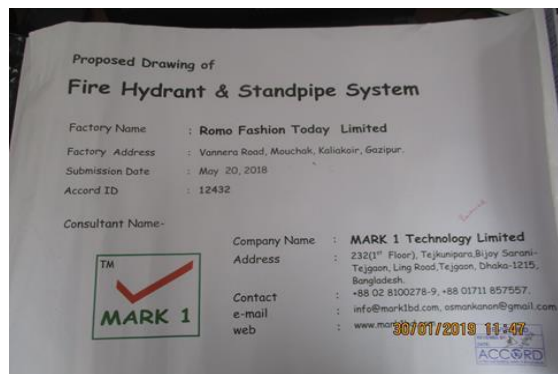
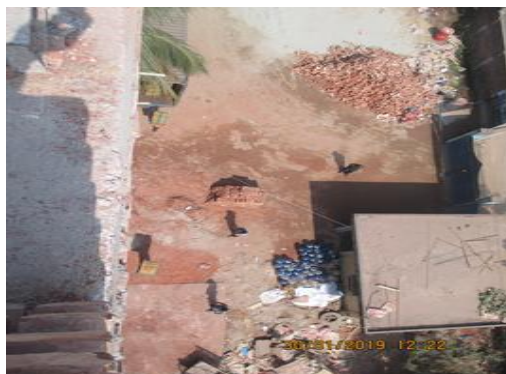
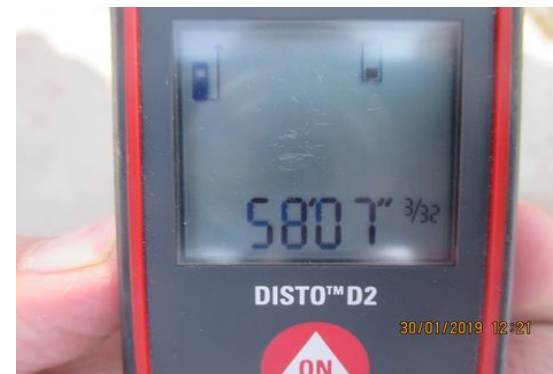
| 16 | Fire Detection & Protection | <p>The existing main production building with an occupiable floor greater than 10 m (33 ft) above the finished grade is not protected with an approved standpipe system.</p> <p>Factory has already reviewed the drawing by addressing another ACCORD listed factory "Romo Fashion Today Limited (ID: 12432)" only for <b>Main Production building</b>.</p> | Provide a standpipe system throughout the building in accordance with Accord standard and NFPA 14. | Install within 6 months |
