FIRE SAFETY INSPECTION REPORT

**BEQ KNIT LTD.
ZIRABO, ASHULIA, SAVAR, DHAKA**

ACC   **RD**
on Fire and Building Safety in Bangladesh

April 22, 2014

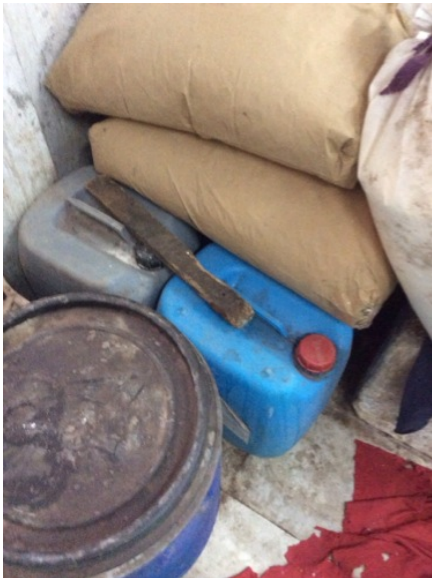
No.	Category	Finding	Recommendation	Remediation Timeframe
F-1	Fire Rated Construction	<p>Flammable liquid storage area is not separated by fire-rated construction (openings, non-rated doors, penetrations).</p> <p>The chemical store in the Washing plant (ground floor) is exposed to the working areas.</p>	<p>Separate the hazardous materials / flammable liquid storage room by a minimum 2-hr fire-rated construction. Seal and/or protected all openings to maintain the required fire separations.</p>	<p>Within 3 months</p>

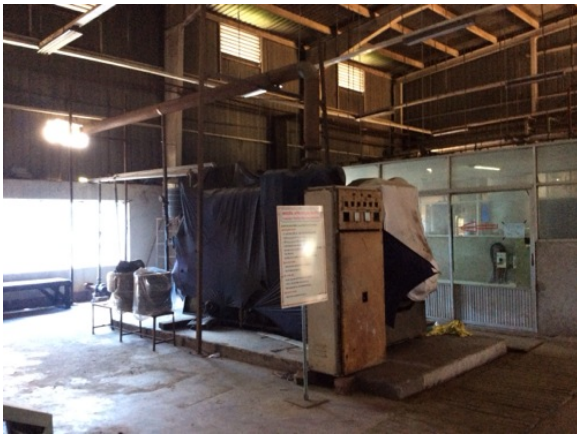
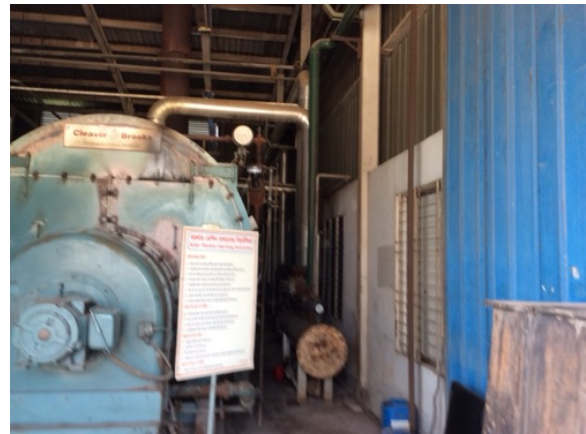
F-2	Fire Rated Construction	The boiler, generator and EMR room is not separated from the working areas of Beq Fabrics (adjacent building) by means of fire-rated construction (openings, non-rated doors, penetrations).	Separate the boiler, generator and EMR room from the adjacent working areas by a minimum 2-hr fire-rated construction. Seal and/or protected all openings to maintain the required fire separations.	Within 3 months
-----	-------------------------	--	--	-----------------

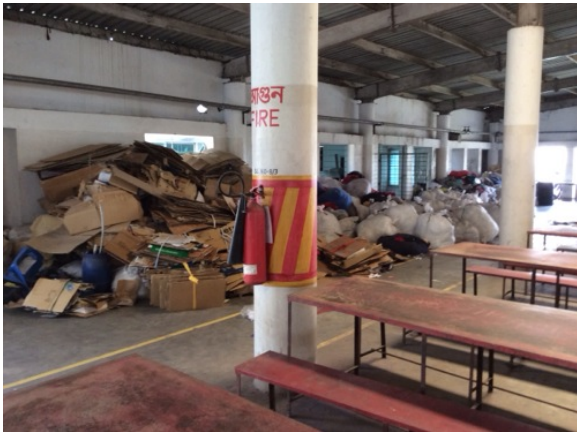
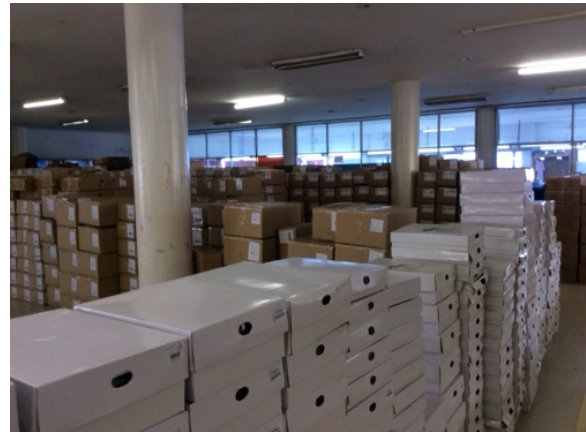
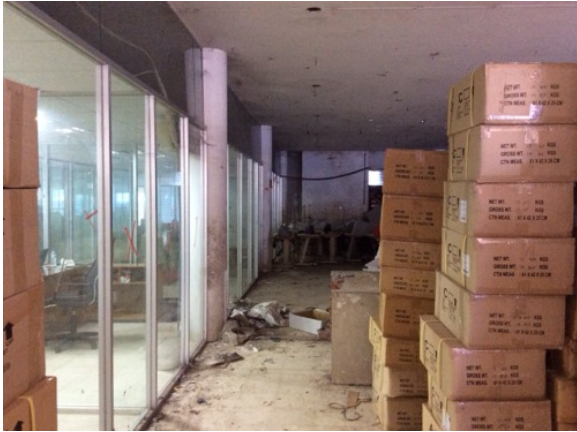
F-3	Fire Rated Construction	<p>The Fabrics store on the 7th floor was not separated from the dining areas (openings and unrated doors). The Finished goods store (4th floor) exceeded the permitted limits and was open to the working areas. Other storage areas like the Bonded wear house (3rd floor), Fabrics store (2nd floor) and Accessories store (1st floor) also had issues related to separation.</p>	<p>Provide dedicated storage rooms separated by minimum 1-hr fire-rated construction.</p> <p>Where separate storage rooms are not feasible, provide defined storage areas and limit the storage arrangement as follows:</p> <ul style="list-style-type: none"> - Maximum height of 2.4m and maximum area of 23m² - If sprinkler protected: maximum height of 3.66m and maximum area of 93m² <p>Separate areas of unenclosed combustible storage by a minimum clear distance of 3m.</p>	Within 3 months
-----	-------------------------	--	--	-----------------

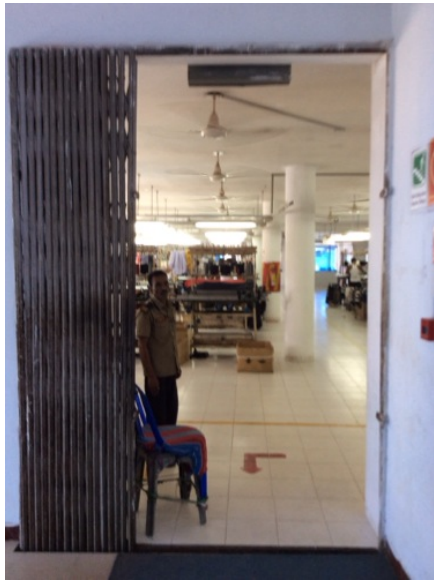
F-4	Fire Rated Construction	The exit stairs are not separated from work areas on each floor by fire-rated construction.	<p>Provide minimum 1.5-hr fire rated doors and seal all unprotected openings to separate the exit stairs from work areas and other building spaces on all floor levels. Ensure that the fire doors are self-closing and positive latching and that they are provided with fire exit (panic) hardware where serving production floors.</p> <p>If fire doors are required to be held open for functional reasons, provide automatic-closing devices tied to the fire alarm system.</p>	Within 3 months
-----	-------------------------	---	--	-----------------

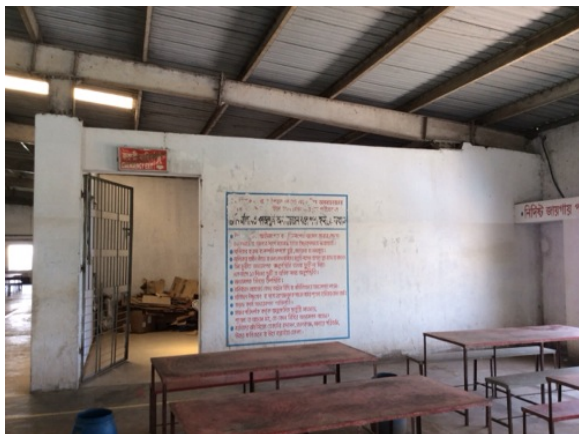
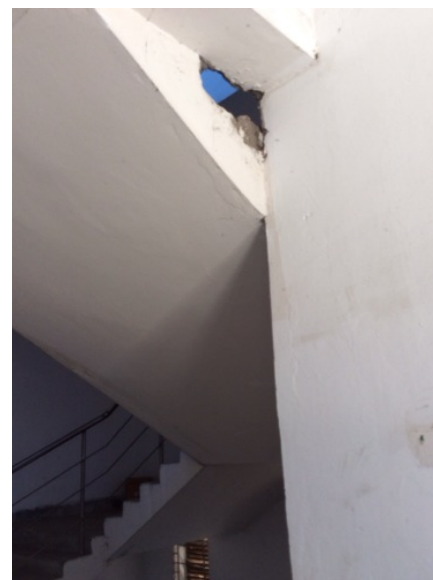
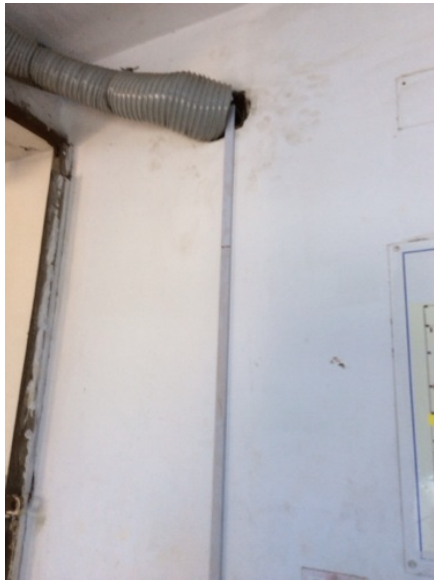
F-5	Fire Rated Construction	Unsealed penetrations and openings are located in exit stair enclosures.	Seal all penetrations and openings in exit stair enclosure walls to maintain the fire separation.	Within 3 months
		Penetrations were observed in multiple locations such as the Western stair enclosure (7th floor), Northern stair enclosure (7th floor), Western stair enclosure (4th floor) etc.

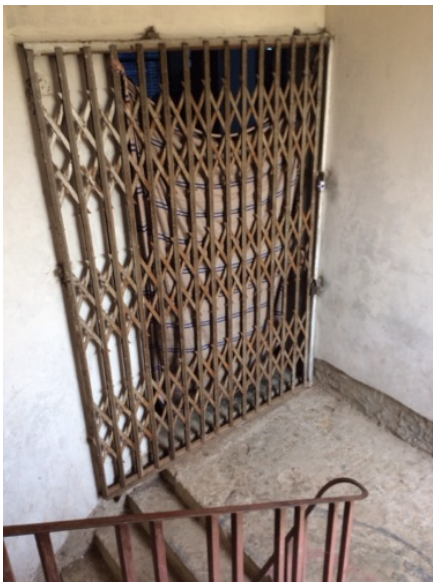
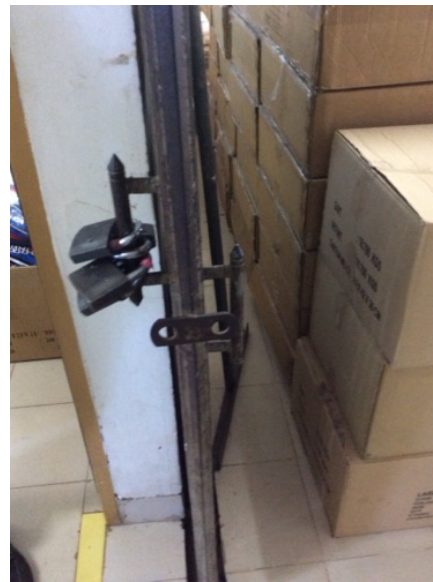
F-7	Egress	<p>Egress doors / gates with locking features are provided at building exits, exit stairs, along egress routes, exit discharge.</p> <p>Locking features were found in numerous locations through out the building. Apart from the exit gates for the Southern stair enclosure (on the 7th and 1st floor) all gates/doors were found to be open and unlocked during the inspection.</p>	<p>Remove locking features from all egress doors / gates.</p> <p>If locks are required for security reasons, utilize special door locking features complying with NFPA 101.</p>	Immediate
-----	--------	--	---	-----------

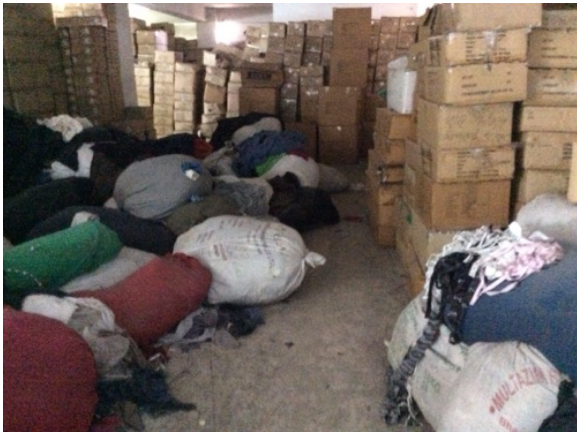
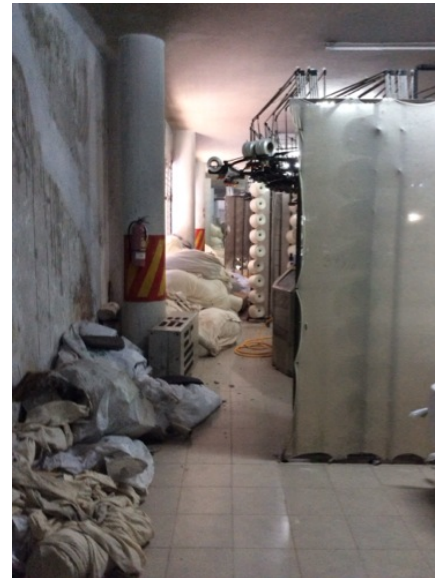
F-8	Egress	<p>Storage in the path of egress was found in various locations through out the building eg : Fabrics store (7th floor), Spinning section (ground floor).</p>	<p>Keep egress paths and stairs clear of storage.</p>	Immediate
-----	--------	---	---	-----------

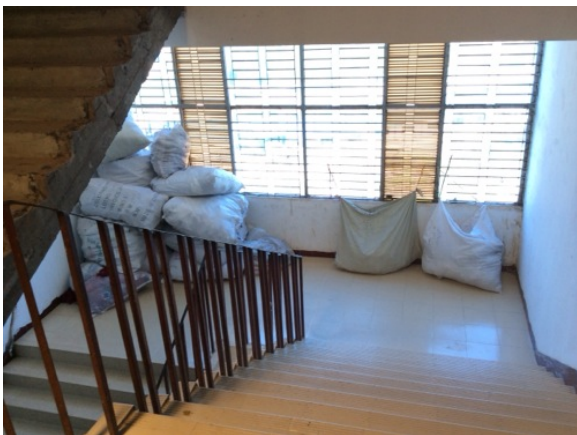
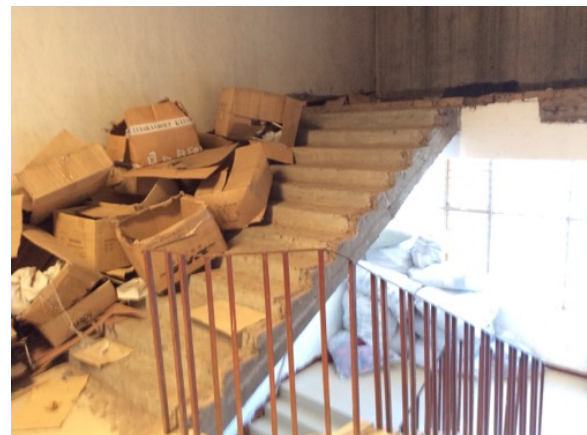
F-9 Egress

General storage was located in all the three stair enclosures.

Remove all storage from exit stairs and egress paths.

Immediate

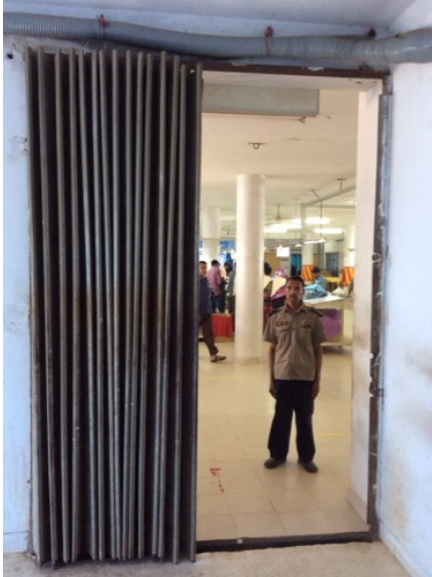
F-10 Egress

Concertina type retractable doors were predominantly used in all the exits. Rolling steel doors with locking features were also found along the path of egress.

Replace all gates / sliding doors along the means of egress with side-hinged, swinging egress doors.

Within 1 month

If locks are required for security reasons, utilize special door locking features complying with NFPA 101.

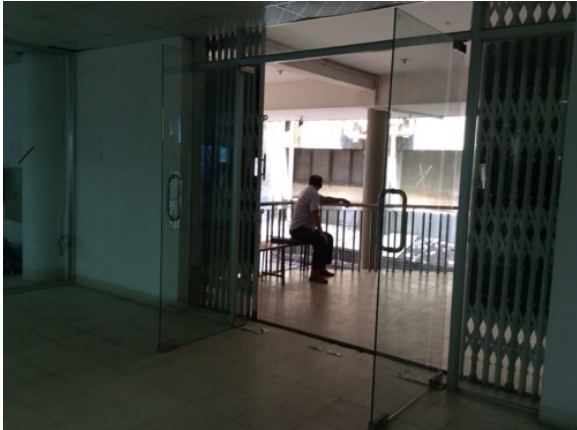
F-11	Egress	No Emergency Evacuation Plans were posted within/next to exit stairs on the 1st, 2nd and Ground floor.	Provide readily visible/identifiable emergency evacuation plans within/next to all exit stairs.	Within 1 month
F-12	Egress	Exit capacity (471) is not adequate for the occupant load (500) for the dining area on the 7th floor.	<p>Immediately reduce occupant load to less than the available exit capacity.</p> <p>Or</p> <p>Unlock the Southern stair exit and provide a means of egress that does not require passage through the hazardous area.</p>	Within 3 months
F-13	Egress	The main egress door serving the Office area on the 1st floor does not swing in the direction of egress travel.	Modify the egress door to swing in the direction of egress travel.	Within 3 months

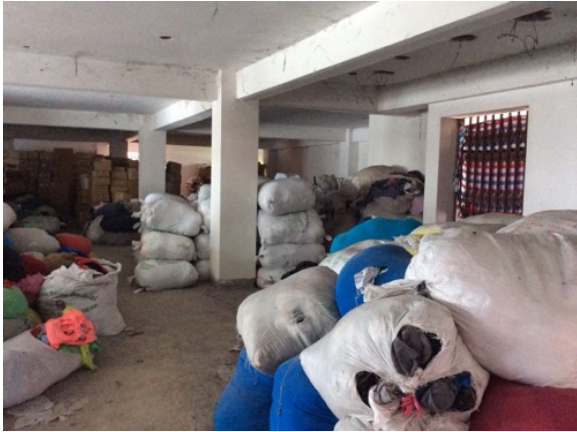
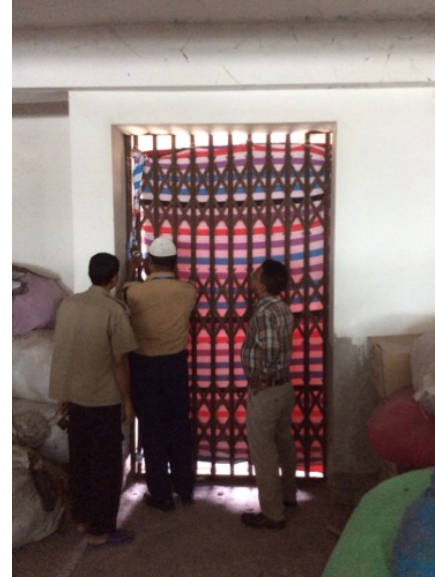
F-14	Egress	<p>The exits are not remotely located from each other such that a single fire event could compromise both exits.</p> <p>The Southern exit stair was found to be locked on the 1st and 7th floors. On these floors the Northern and Western, being the only functional stairs on the floors, were found to be non-remote.</p>	<p>Modify exit arrangement and insure that the Southern stair is usable on the mentioned floors.</p> <p>Provide sprinkler protection in accordance with NFPA 13.</p>	Within 3 months
F-15	Egress	<p>The egress path to the southern exit stair (7th floor) has to go through an area of increased hazard (combustible storage).</p>	<p>Provide 1-hr fire rated passageway that provides safe access to the Exit stair.</p>	Within 3 months

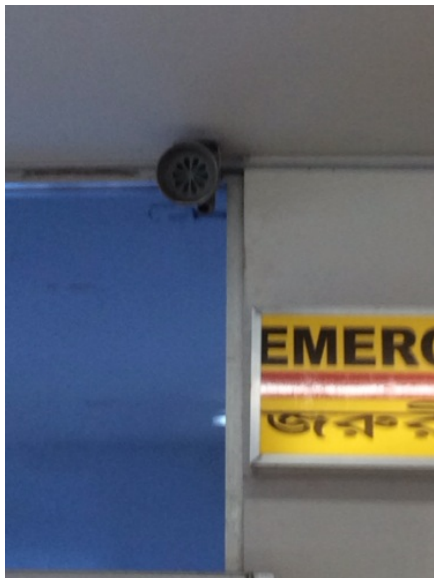
F-16	Fire Protection	The fire alarm system is antiquated, not a listed system, and does not provide alarm and notification features consistent with acceptable standards.	Replace the fire alarm system with a new, listed addressable fire alarm system in accordance with NFPA 72.	Design within 4 months, install within 9 months
------	-----------------	--	--	---

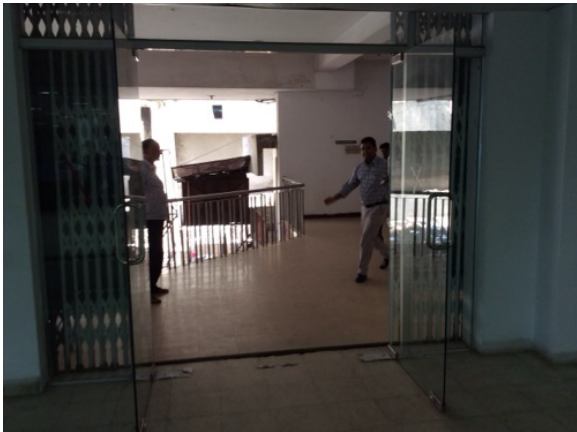
F-20	Egress Lighting	<p>Based on the number and location of emergency lights observed, adequate illumination levels are not anticipated along egress routes.</p> <p>The emergency lights were found to be inadequate in most of the stair enclosures.</p>	<p>Test the emergency lighting system on each floor and provide additional emergency fixtures to provide adequate illumination along the means of egress. Provide a minimum illumination of 10 lux at the floor level within exit stairs and exit discharge paths and minimum 2.5 lux along exit access aisles.</p>	Within 3 months
F-21	Egress Lighting	<p>Exit signs were found to be missing in many areas such as the Dining area (7th floor), the Southern and Western exit stairs, the Office area (1st floor), Washing areas (ground floor) etc.</p>	<p>Provide exit signs above all exits to the exterior and all doors to the exit stairs.</p>	Within 3 months

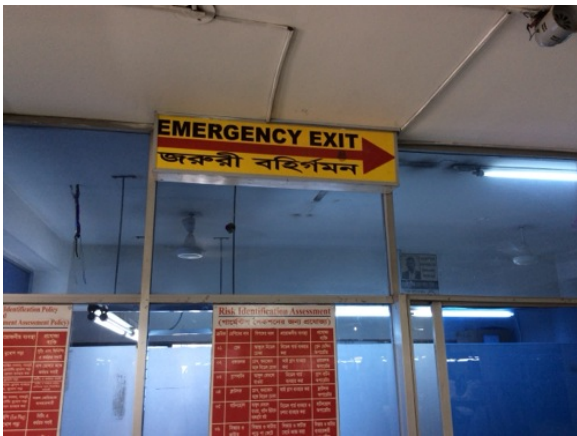
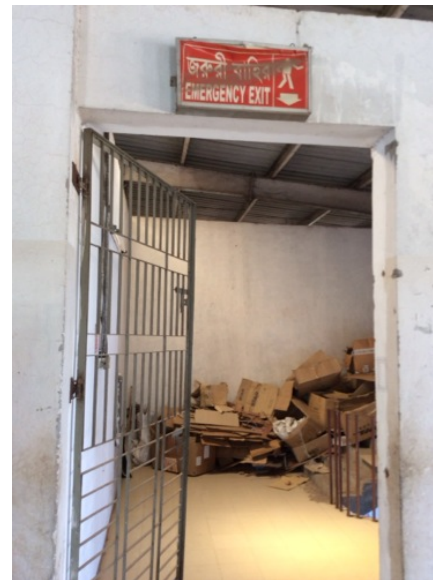
F-22	Egress Lighting	Broken and burned out exit signs were found on the 7th and 4th floor.	Regularly inspect all exit signage and replace/install lights as needed to illuminate signs.	Within 3 months
------	-----------------	---	--	-----------------

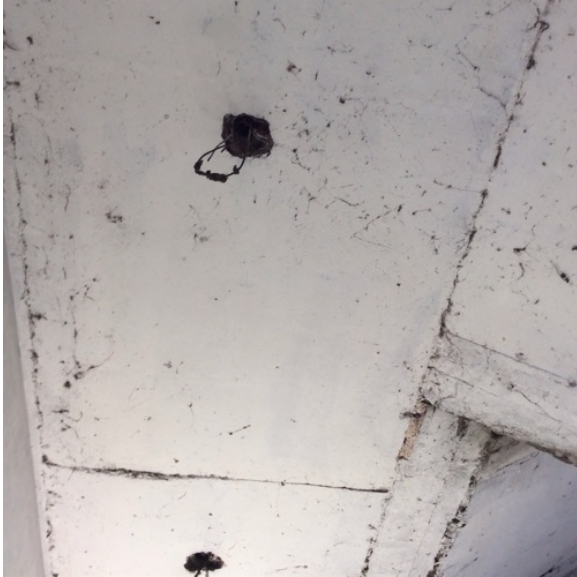
F-23	Egress Lighting	Emergency lights were found to be missing on several floors eg: Northern stair enclosure (ground floor) etc.	Regularly test the emergency lighting system on each floor and replace/repair lights as needed.	Within 3 months
------	-----------------	--	---	-----------------
