# INITIAL STRUCTURAL INTEGRITY ASSESSMENT REPORT (SIAR)

Factory Name: **AB Mart Fashionwear Ltd.**

Assessor: **Bureau Veritas**

Date: **22 Apr 2015**

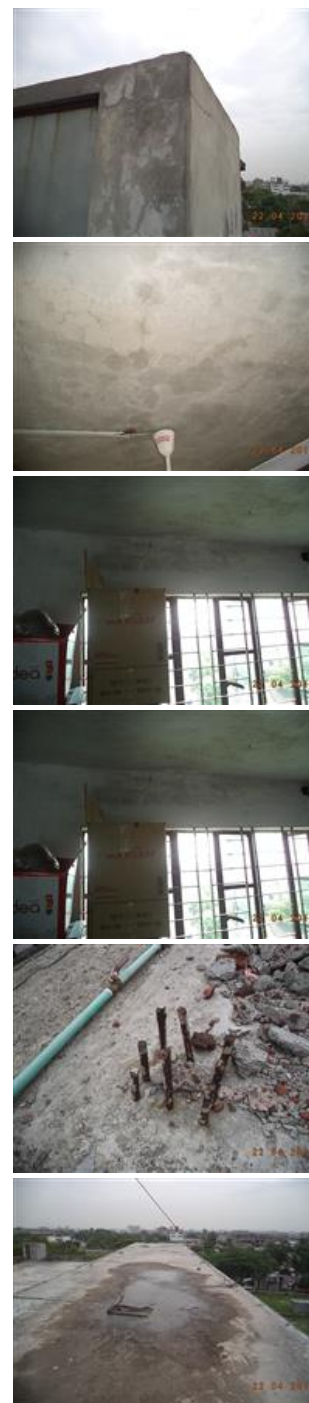
| Description: | Slabs were constructed with MCAC and roof slab is exposed to rainfall. No |

| | protective sealing was available on roof. | |

| Suggested Plan of Action: | Provide a protective coating at the structural elements constructed with MCAC exposed to rainfall or other sources of water. Have protective coating approved by the Alliance or a qualified structural engineer. | |
