# Apparel Gallery Ltd.

147-148, Norshingpur, Asulia, Savar, Dhaka  
(23.929985N,90.304914E)

23 March 2014

## Structural Inspection Report

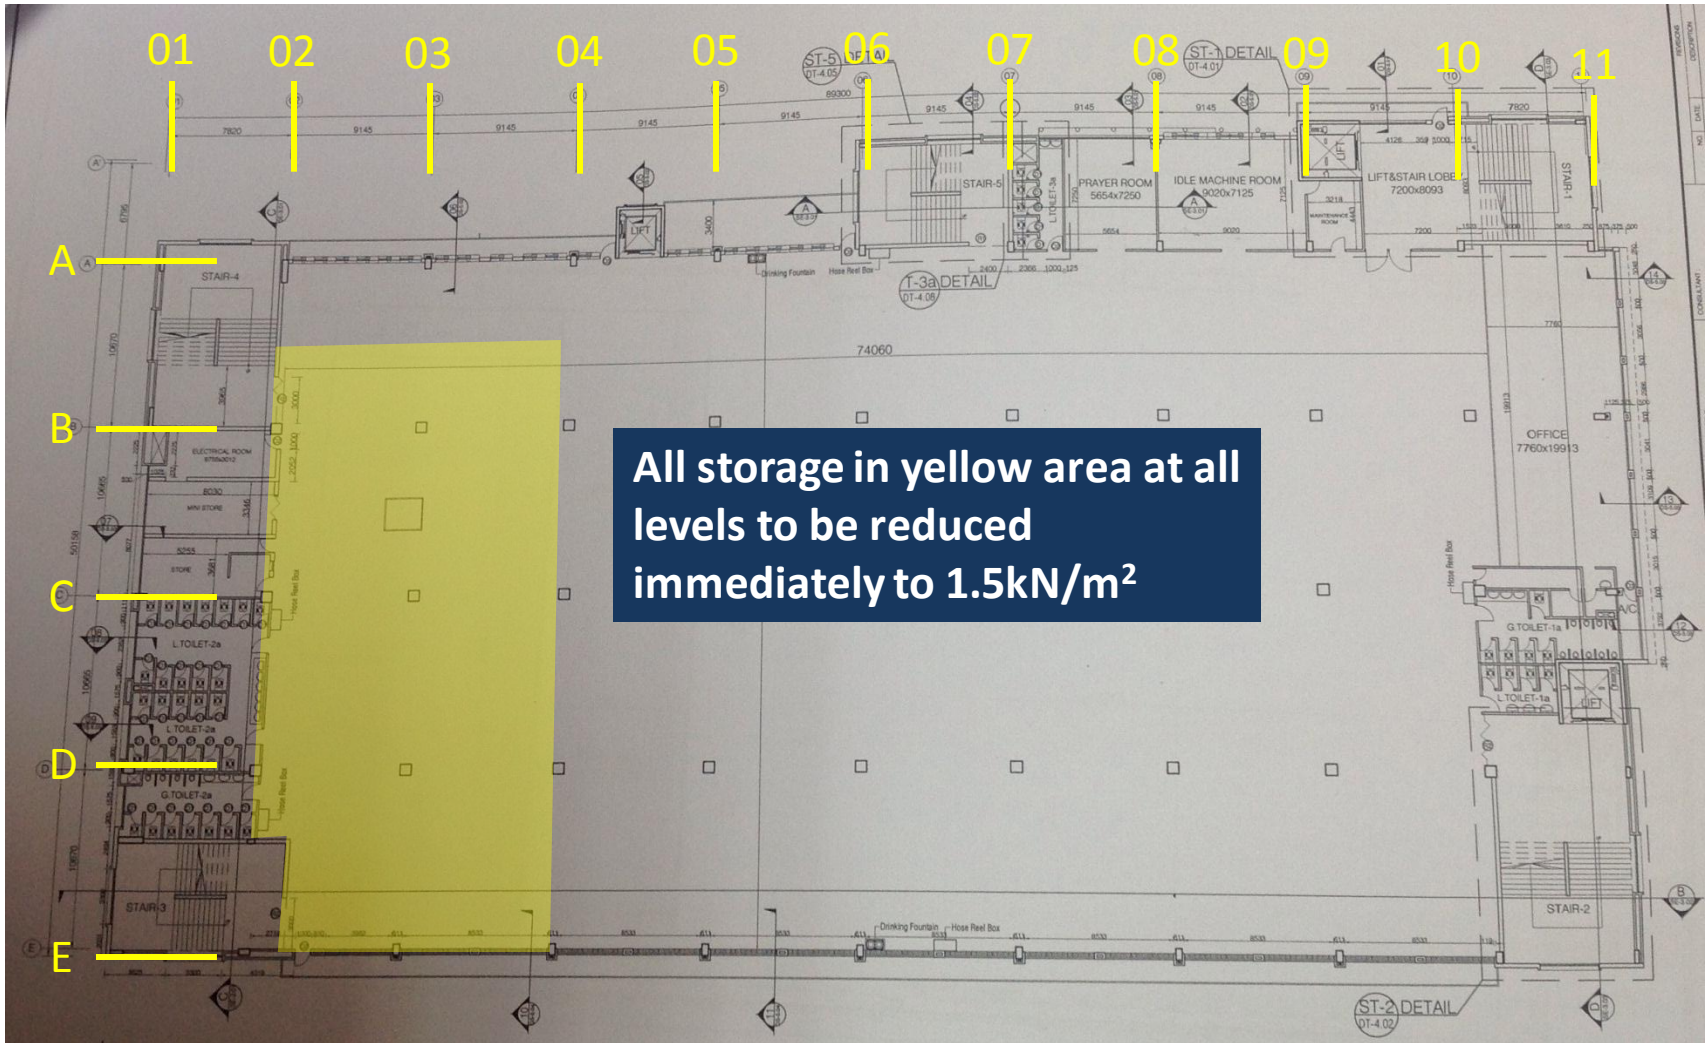
## Building 1 – Load Reductions Required

The principal reasons for our concern is that columns at ground floor appear to be stressed to levels that require **immediate** review.

- A full **Detailed Engineering Assessment** is to be commenced for columns in the area of the raised platform at ground floor (Grid B2 to E7 noting the further build up between B2 and E4).
- Until DEA is complete reduce load at all levels to less than 1.5kN/m<sup>2</sup> and especially from stacked garments from area highlighted on page 5
- At ground floor (grid B2-D4) remove the second lift of raised platform and investigate the construction of the lower platform. If found to be solid or filled with sand, remove material or evacuate areas above until structure and foundations proven.
- Conduct concrete tests to prove concrete strength.
- DEA to prove adequacy of foundations in the area B2 to E7 noting the cracking to basement slab at column D3. DEA to confirm if movement is still live as it was noted that the soffit of the ground floor slab had been freshly painted.

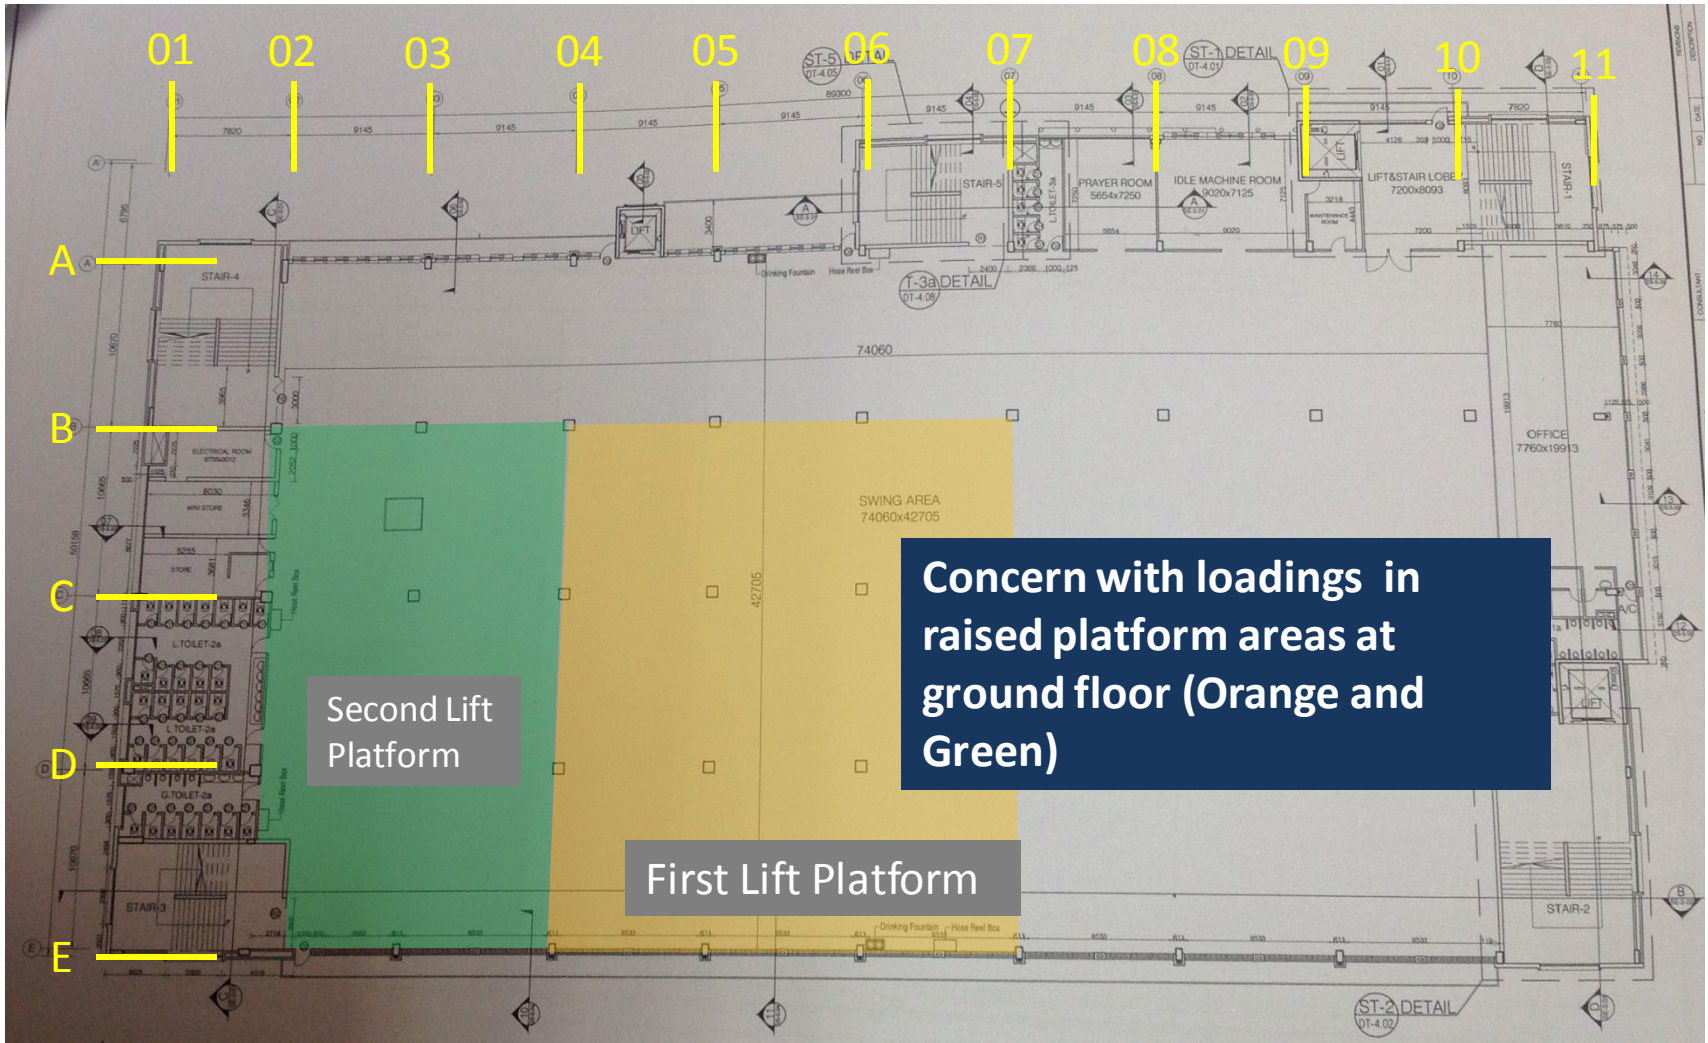
## Building 1 – Investigation and possible removal of raised platforms at ground Level

Factory Engineer to open up sections of raised platforms at ground floor level to investigate build-ups, if infill areas are solid we would expect immediate platform removal or local evacuation in these areas until structure and foundation capacity is proven.

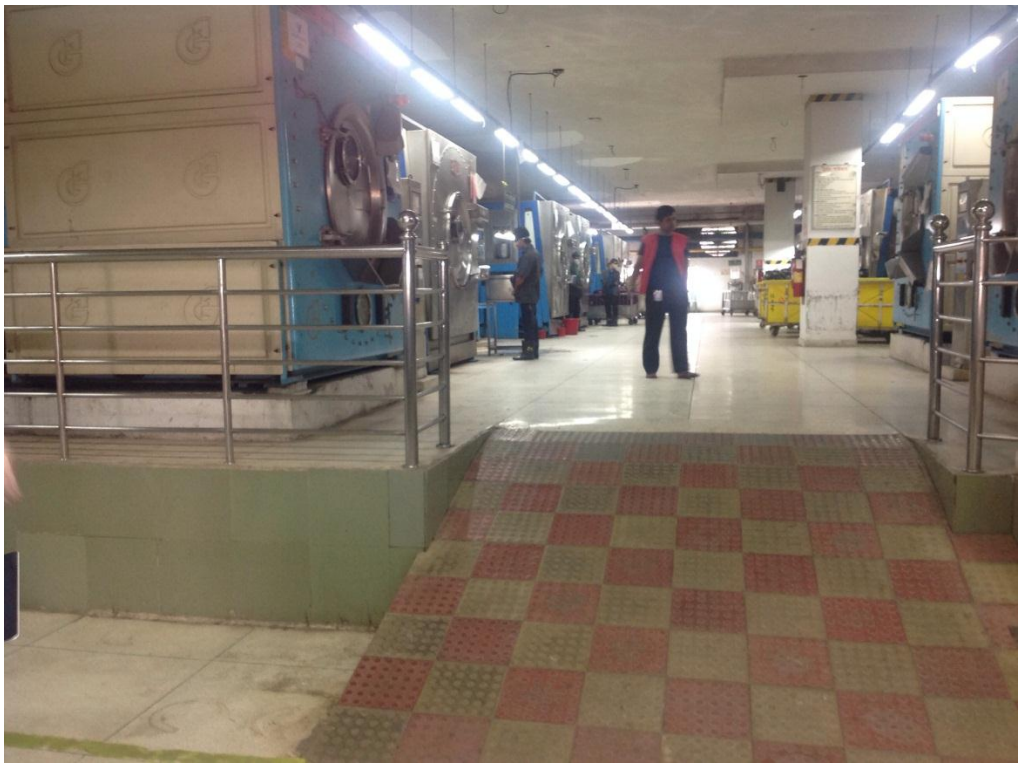
**Heavy loading due to raised floor area on  
Ground Floor**

Raised floor area,  
build up unknown.

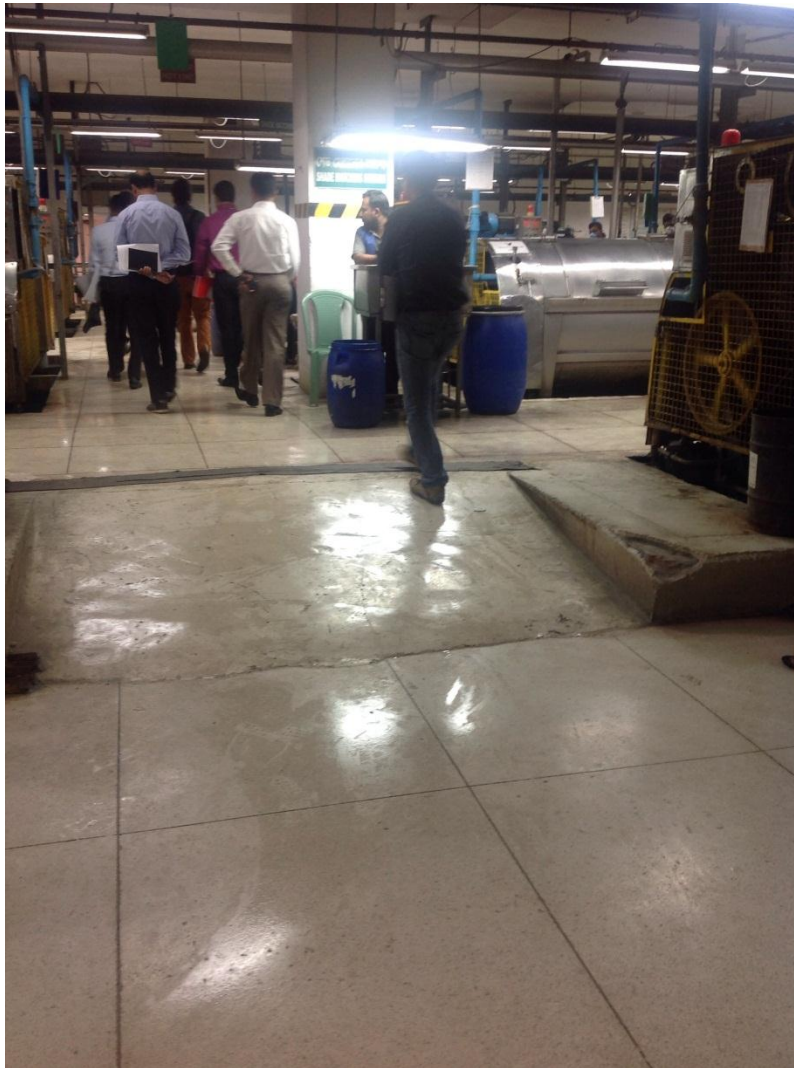
Raised floor area on top of raise area, not identified on drawings. Build up unknown.

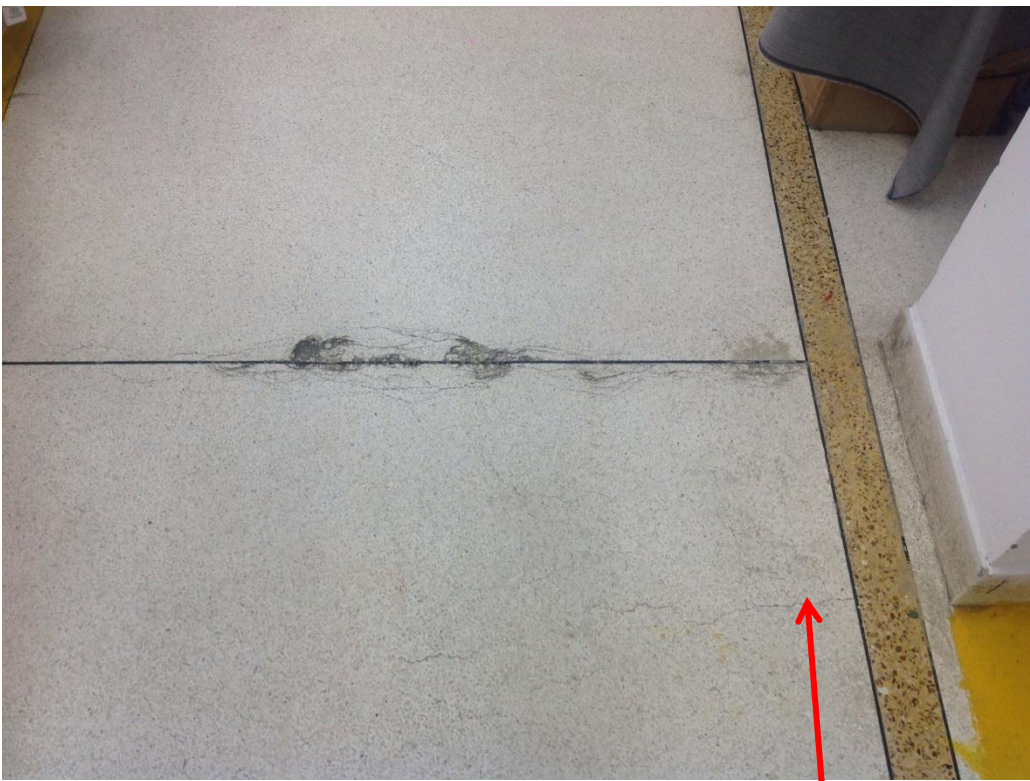
Multiple cracking  
in floor finish.

A check on slab design is required due to consistent cracking observed across all floors.

- **Create controlled loading plans for all floors**, designating where storage can be placed and can not be placed.
- **Provide calculations showing the structural adequacy of all slabs/beams**, taking into account the loading plans and all built structure including additions beyond the original design. Provide concrete strength tests.

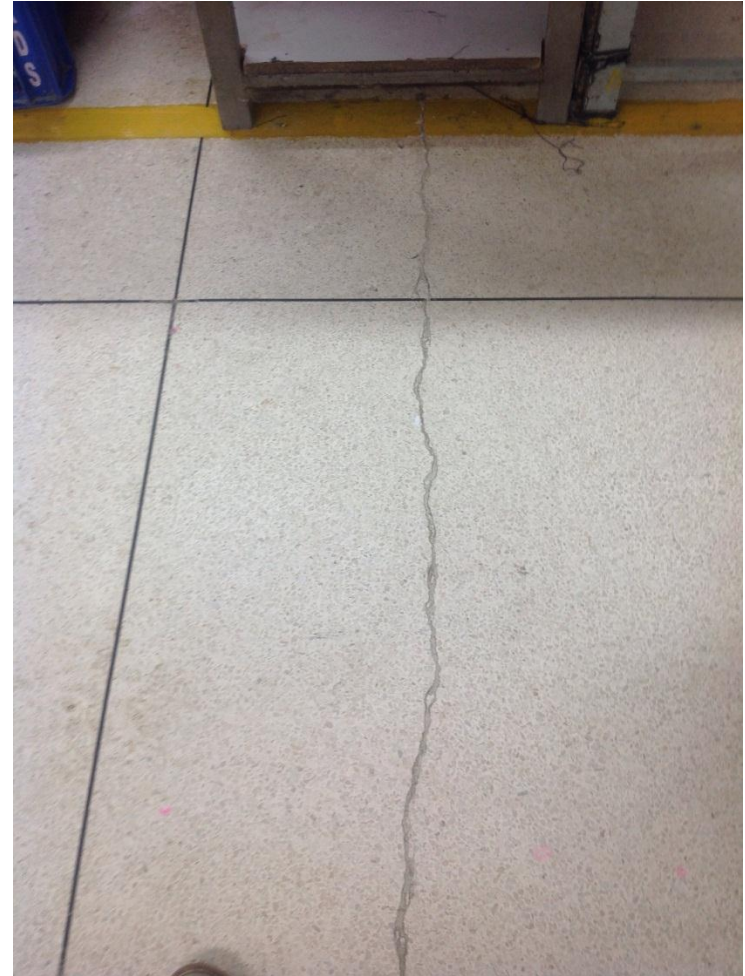
Floor cracking

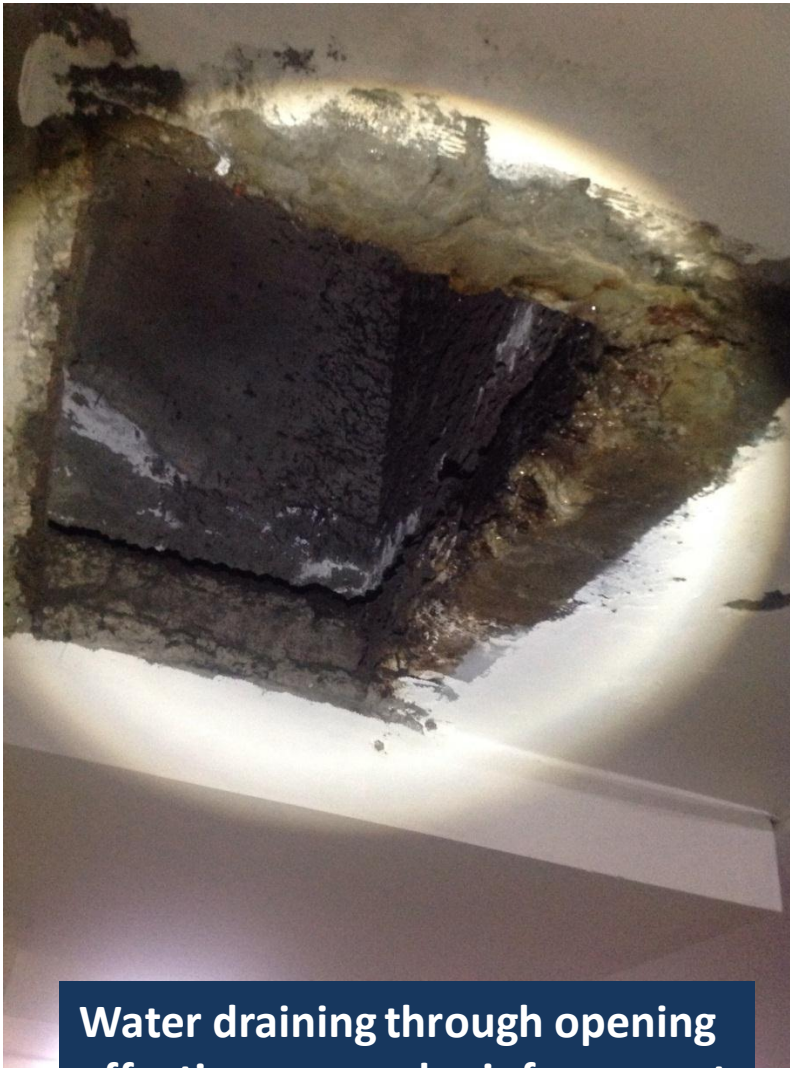
Opening in slab,  
exposed  
reinforcement.

Water draining through opening  
affecting exposed reinforcement.

- Remove source of water to avoid further corrosion to reinforcement. Clean all affected reinforcement back to bare steel. Repair concrete using suitable structural mortar.

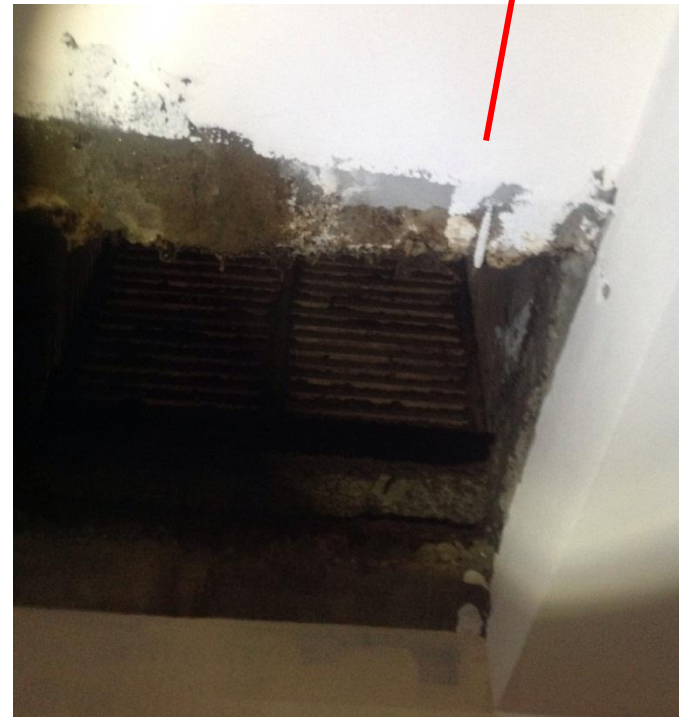
Opening in floor with exposed  
reinforcement and water ingress.

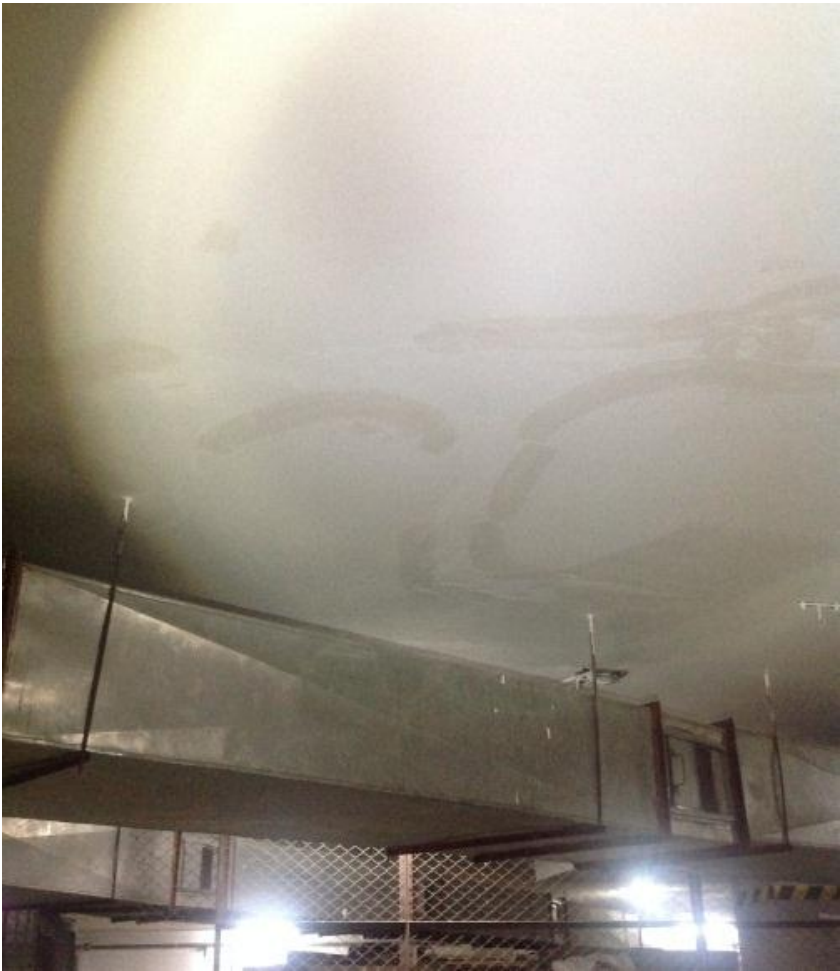
Recently repaired  
cracking in Soffit of  
ground floor slab  
adjacent to column  
with Basement  
slab cracking.

Evidence of repairs to cracks in soffit of ground floor under raised floor area's under area of raised platforms at ground floor. Water observed in areas below raised platform, thus risk of water ingress to cracks leading to corrosion,

- Evidence of repairs to cracks in soffit of ground floor under raised floor area's, repair should be removed by Building Engineer and reinforcement behind check for possible signs of corrosion.

- Repairs as detailed by the Building Engineer to be completed should investigations above reveal corrosion of reinforcement.

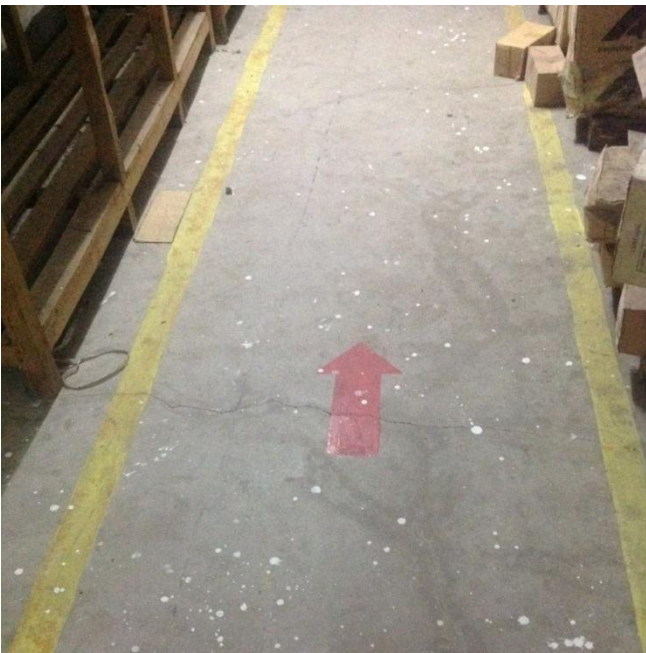
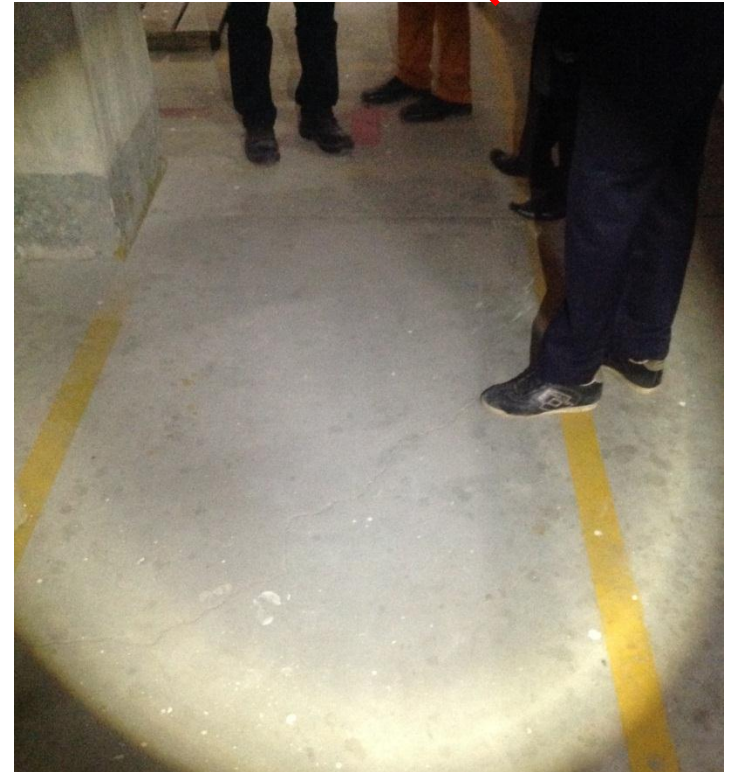
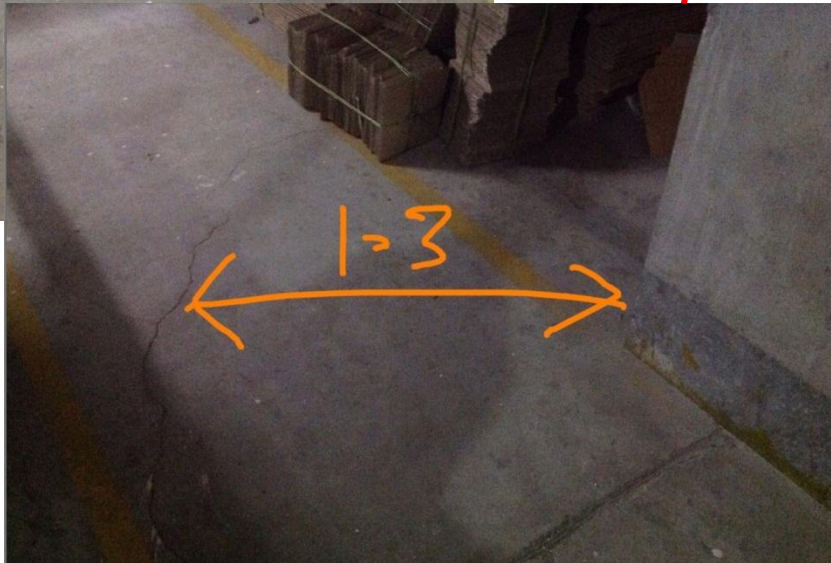
Cracking in Basement slab around column perimeter.

Cracking in basement slab

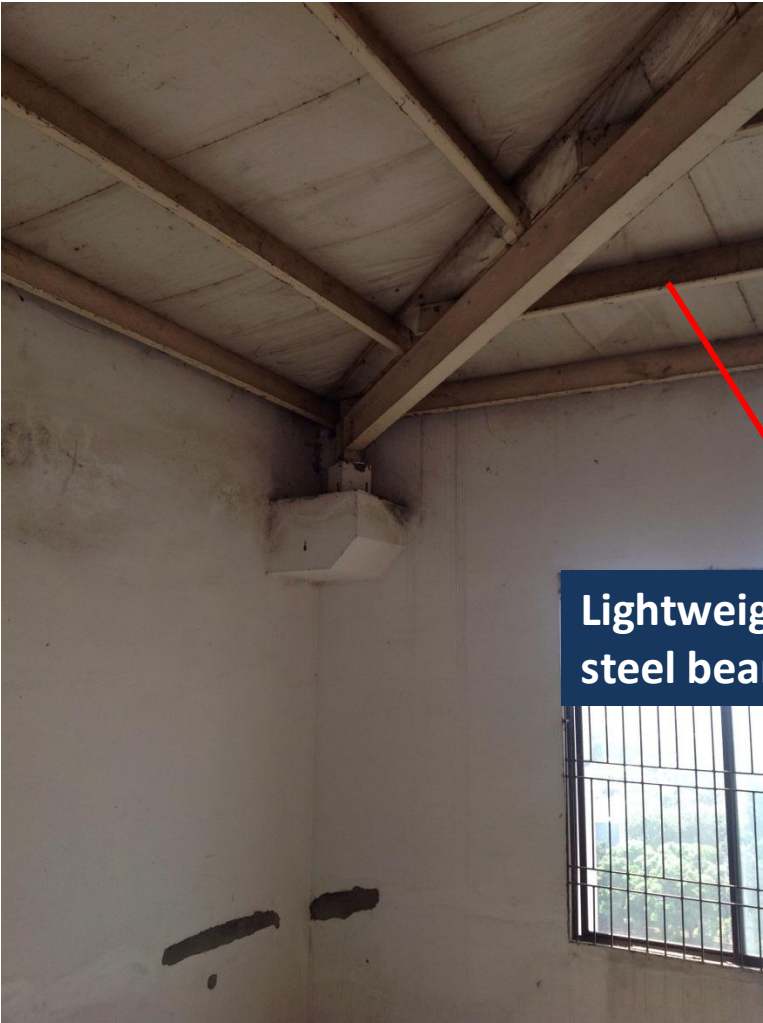
Lightweight timber roof on steel beam cut at one end

- Building Engineer to inspect section of roof that remains and verify its adequacy against uplift giving consideration to open door on roof.

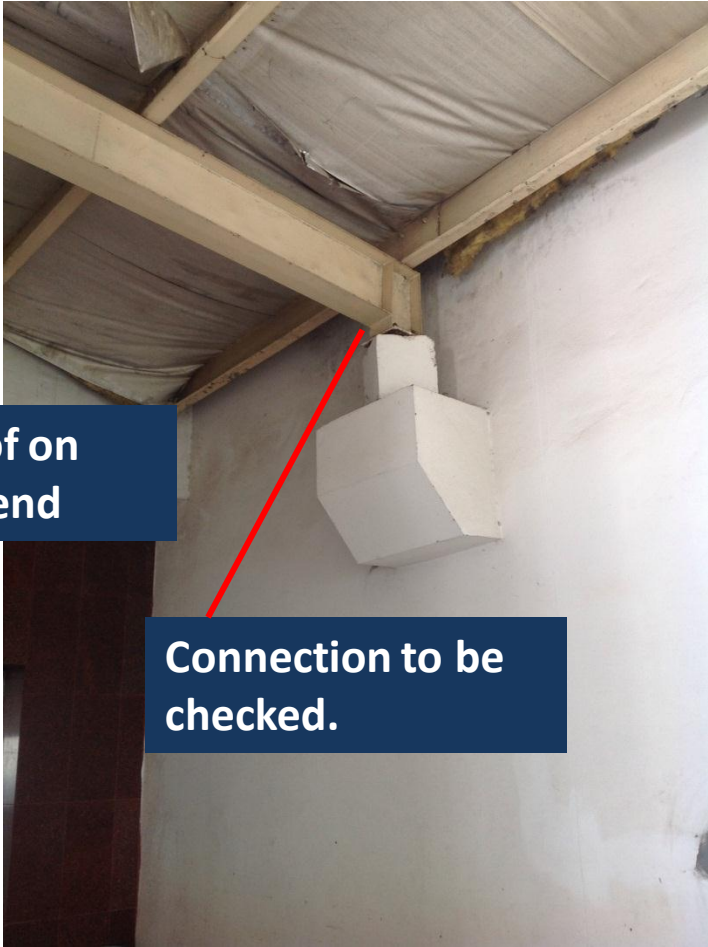
Connection to be checked.

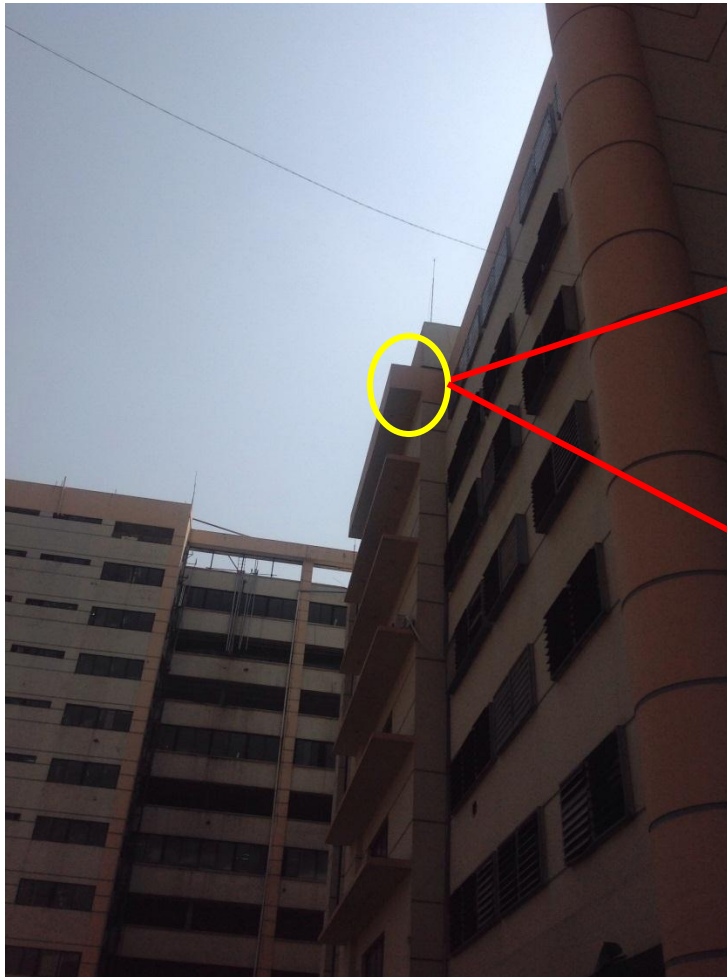
Vertical Crack between cantilever and main structure.

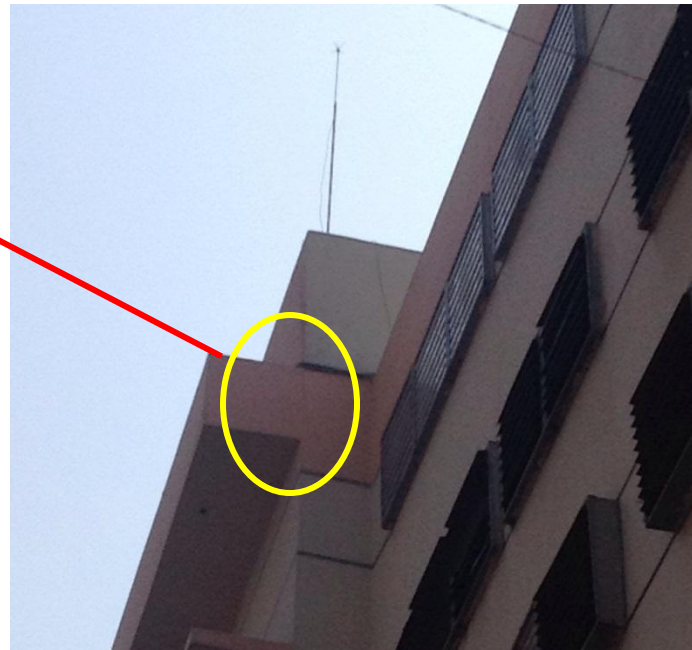
Check if crack is structural or cosmetic.

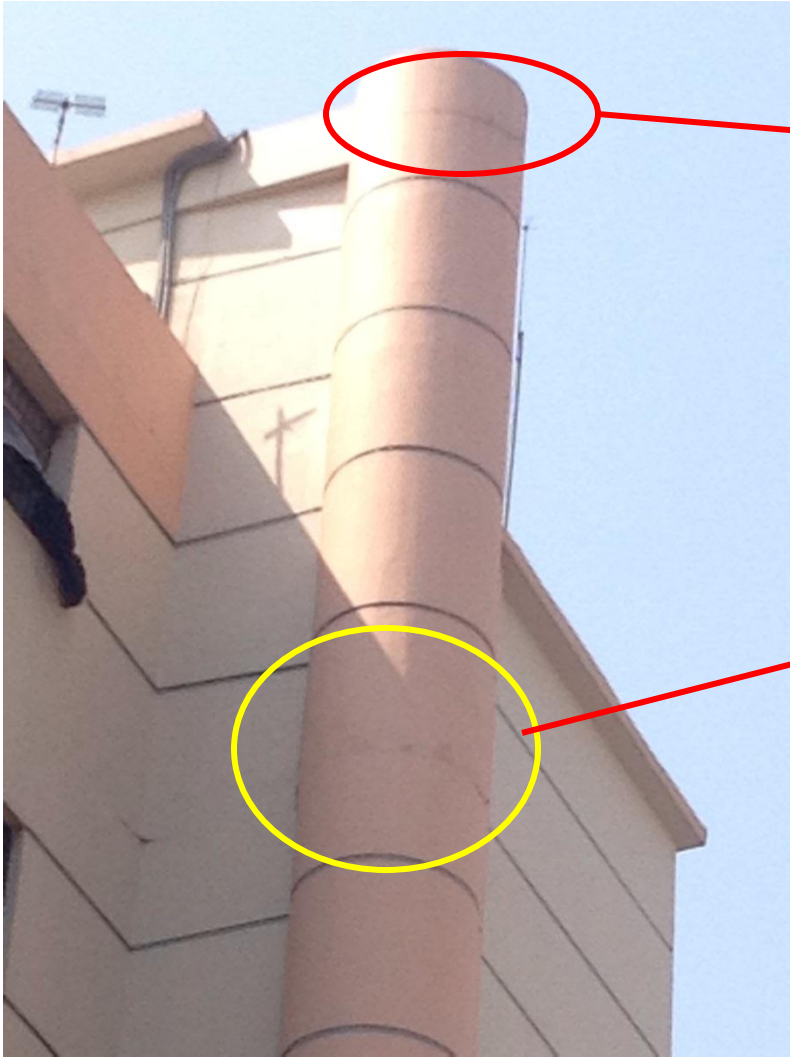
Horizontal Crack.

**Check if cracks are structural or cosmetic.**

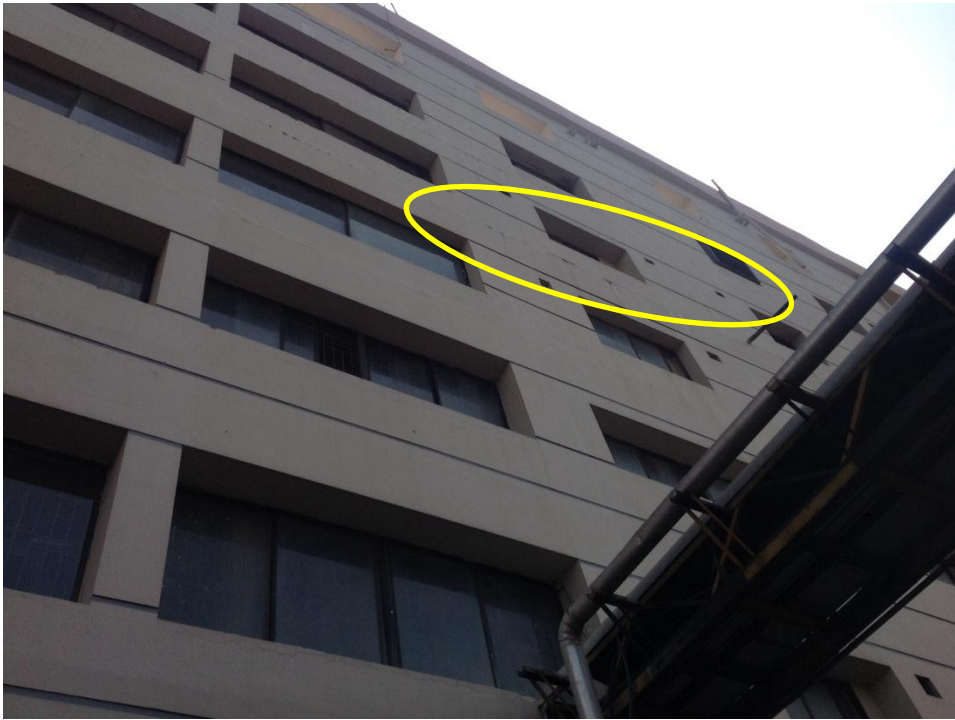
Spalling/Cracking, possibly due to corrosion of reinforcement.

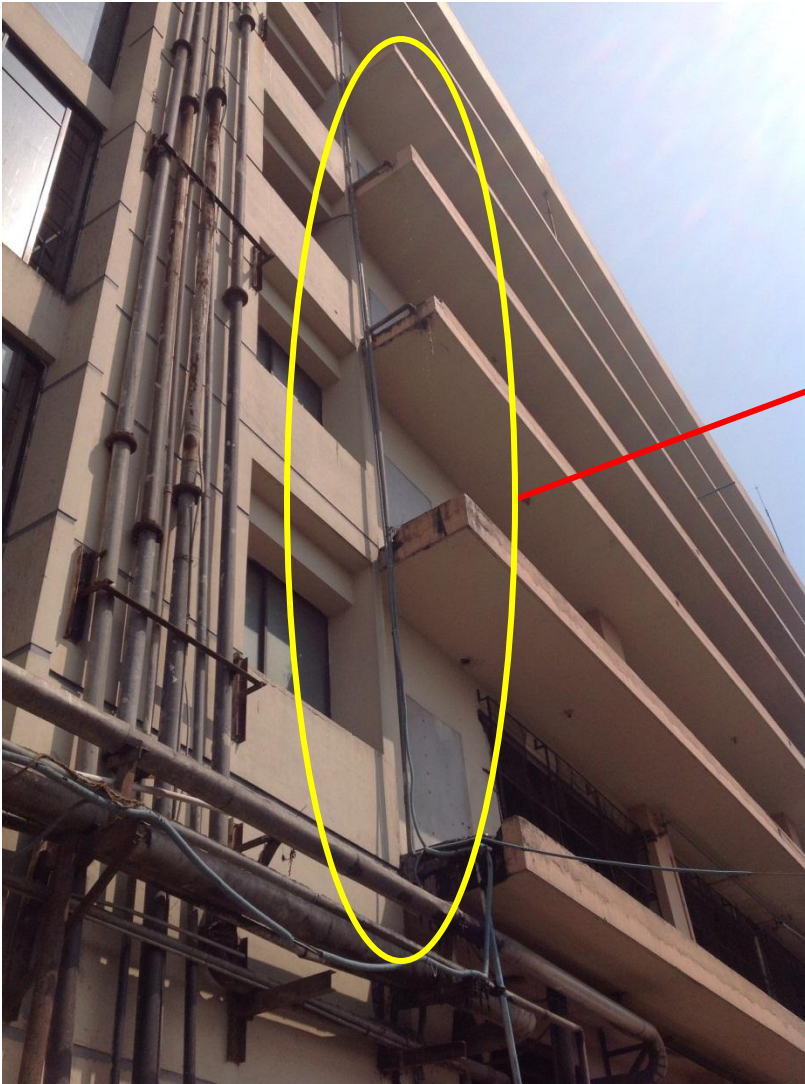
Water falling onto edges of all slabs, possible corrosion of reinforcement.

Evidence of water draining down façade of building causing possible reinforcement corrosion, remove source of water/divert and check slab edges for spalling/corrosion

**Check for corrosion of reinforcement**

- Engineer to inspect water leakage and damaged structure including the exterior and propose a suitable repair.

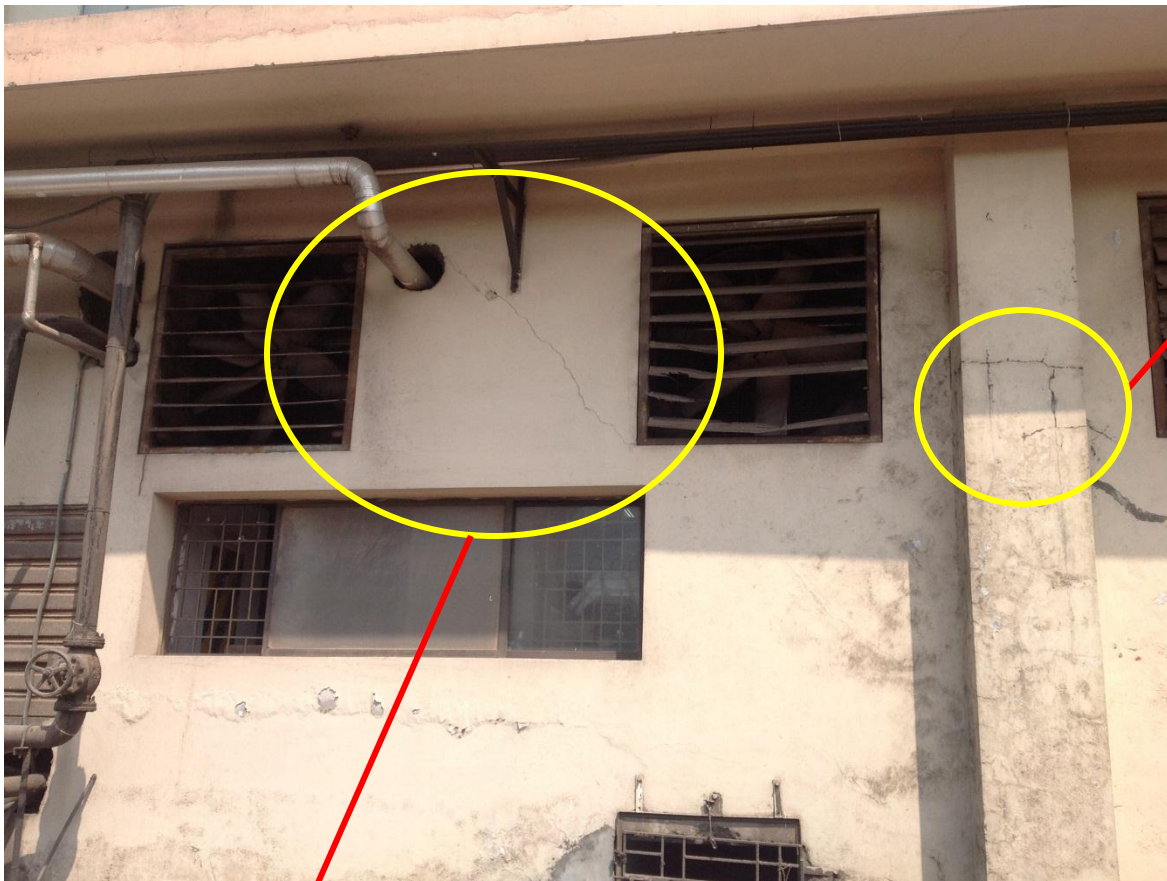
Cracking in column face.  
Remove render to check.

Diagonal Crack.  
Remove render to check.

Check if crack is structural  
or cosmetic.

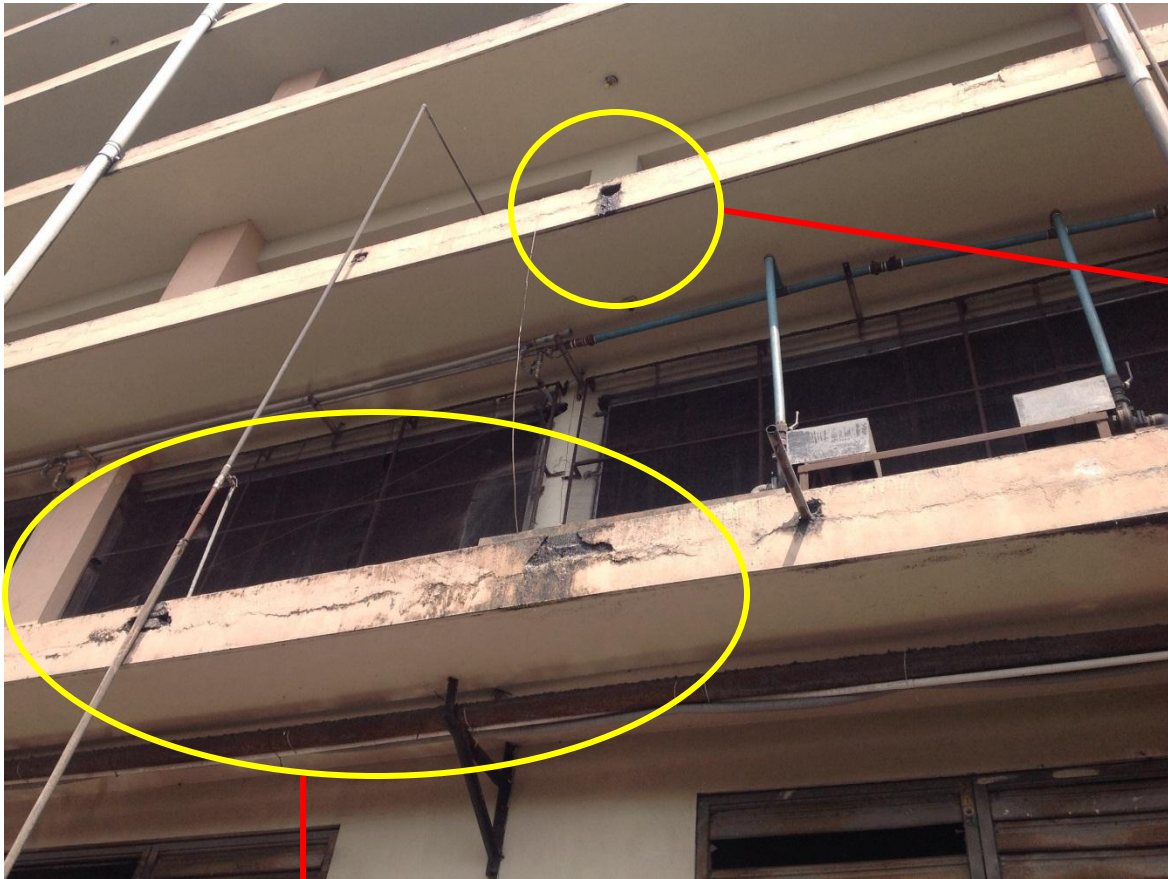
Drainage outlet falling onto cantilever edge below.

Cracking/Spalling.  
Confirm if reinforcement is  
corroded.

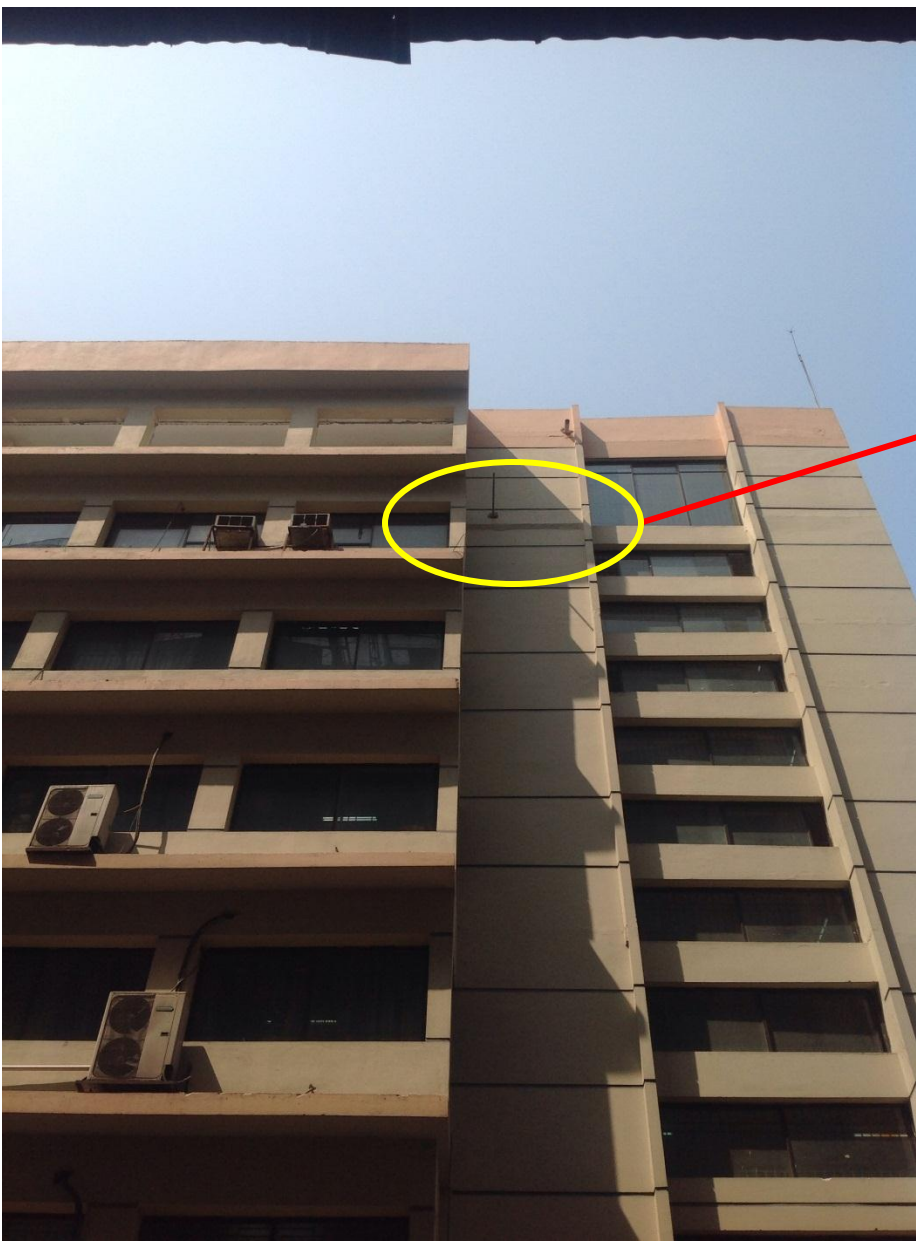
Façade steps out at 6<sup>th</sup> floor level possibly due to construction tolerances.

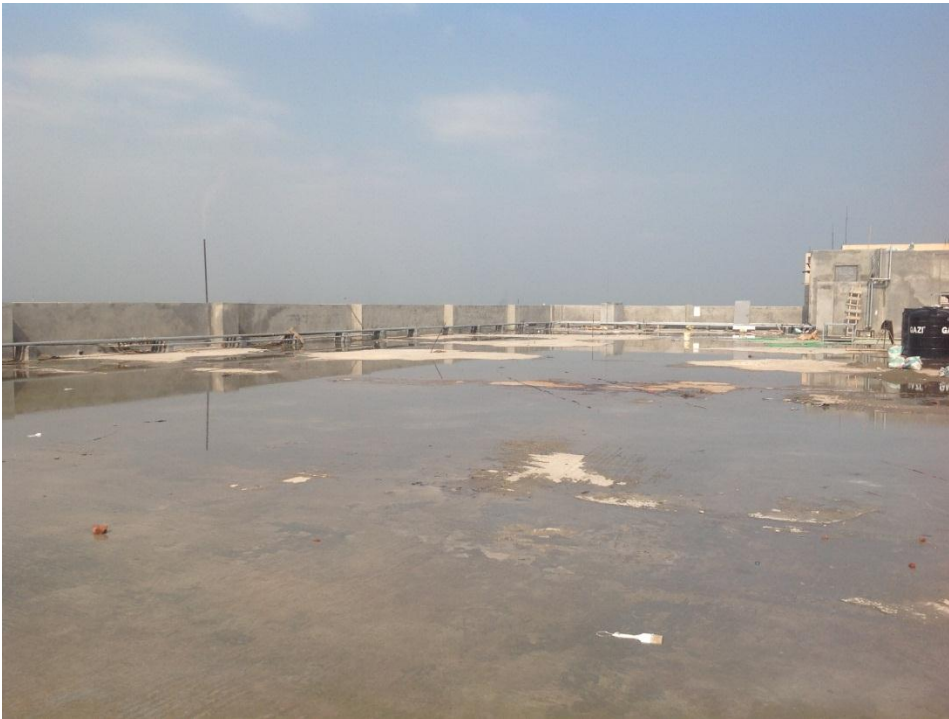
Water ponding on  
unprotected  
concrete slab (roof  
structure removed)

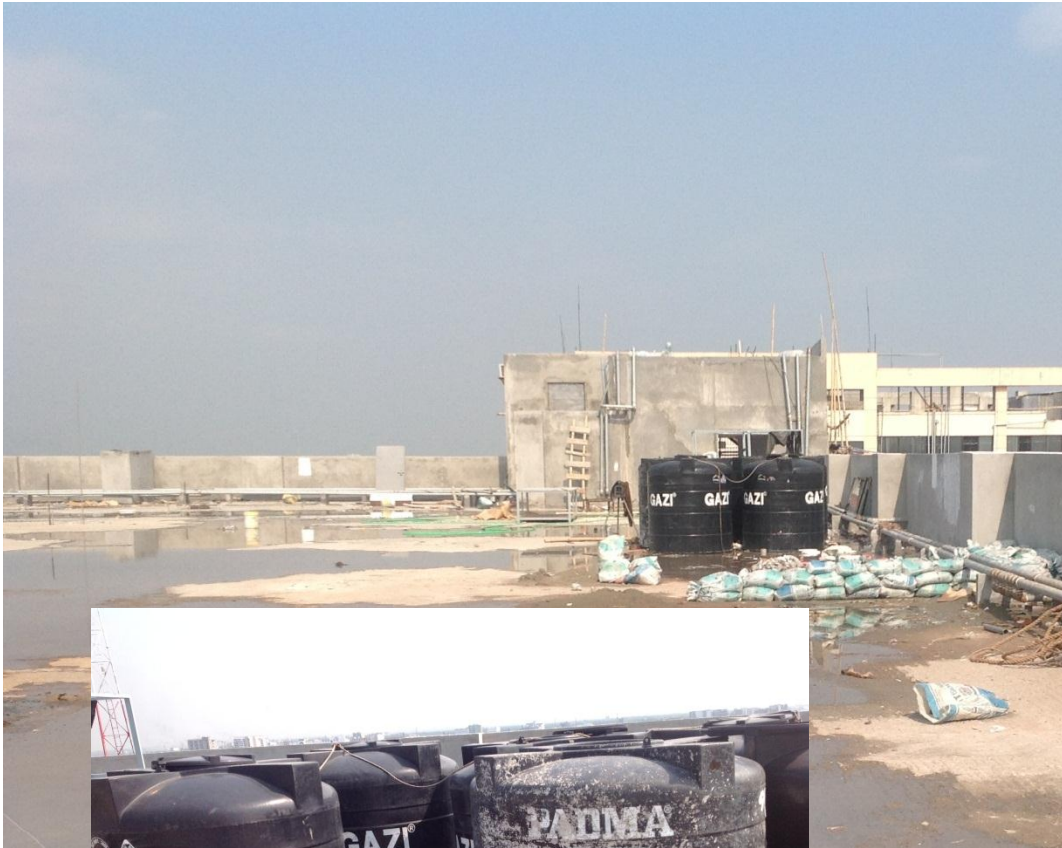
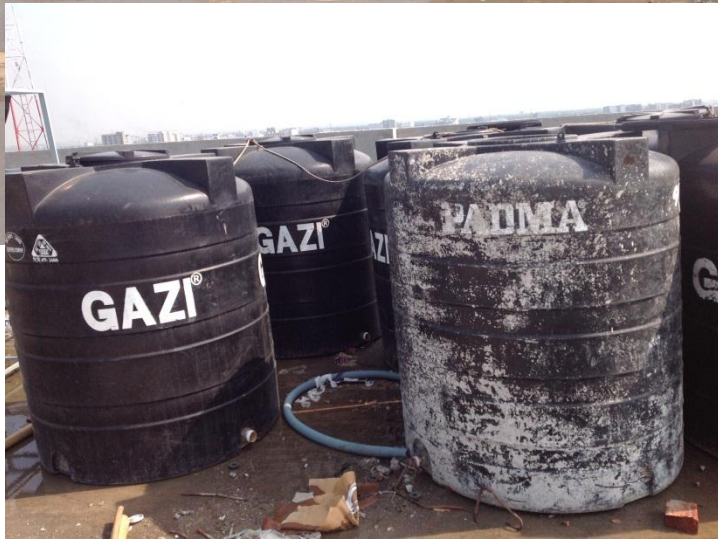
6 No. 2500L water tanks. (Currently not connected or filled)

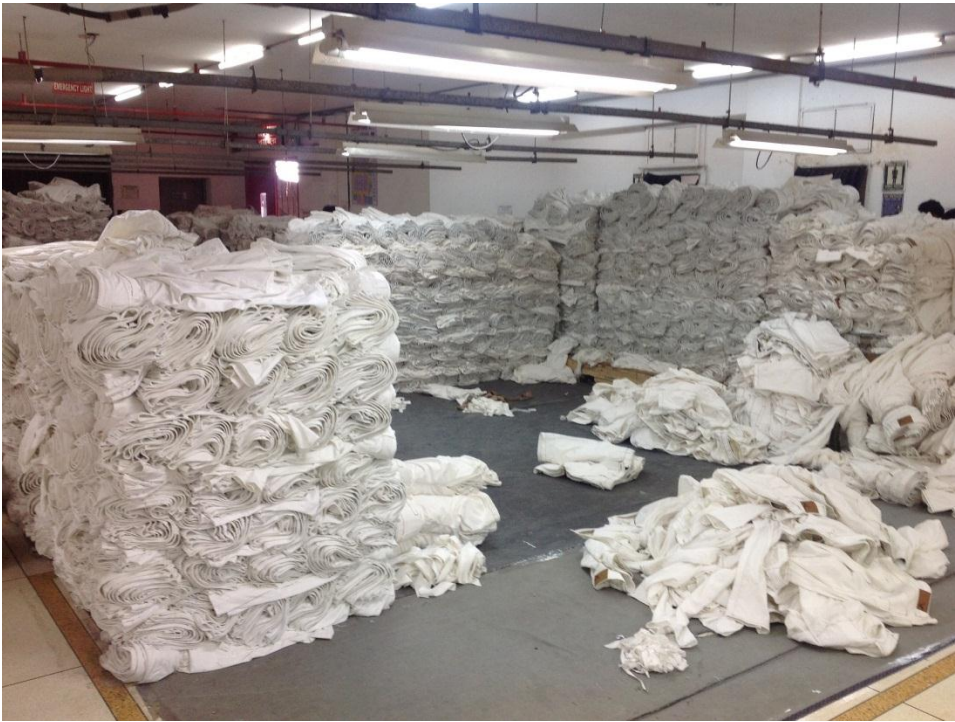
High storage loads

Verify concrete strengths in columns in locations supporting bonded warehouse areas due to high observed loads.

- Factory Engineer to review design, loads and columns stresses in area identified above.
- Verify insitu concrete stresses either by cores or existing cylinder strength data for columns. We note that cylinders have been provided for slabs and foundations but also note that these elements were specified with a different concrete mix and target strength.
