# Apparel Gallery Ltd.

147-148, Norshingpur, Asulia, Savar, Dhaka  
(23.929985N,90.304914E)

23 March 2014

## Structural Inspection Report

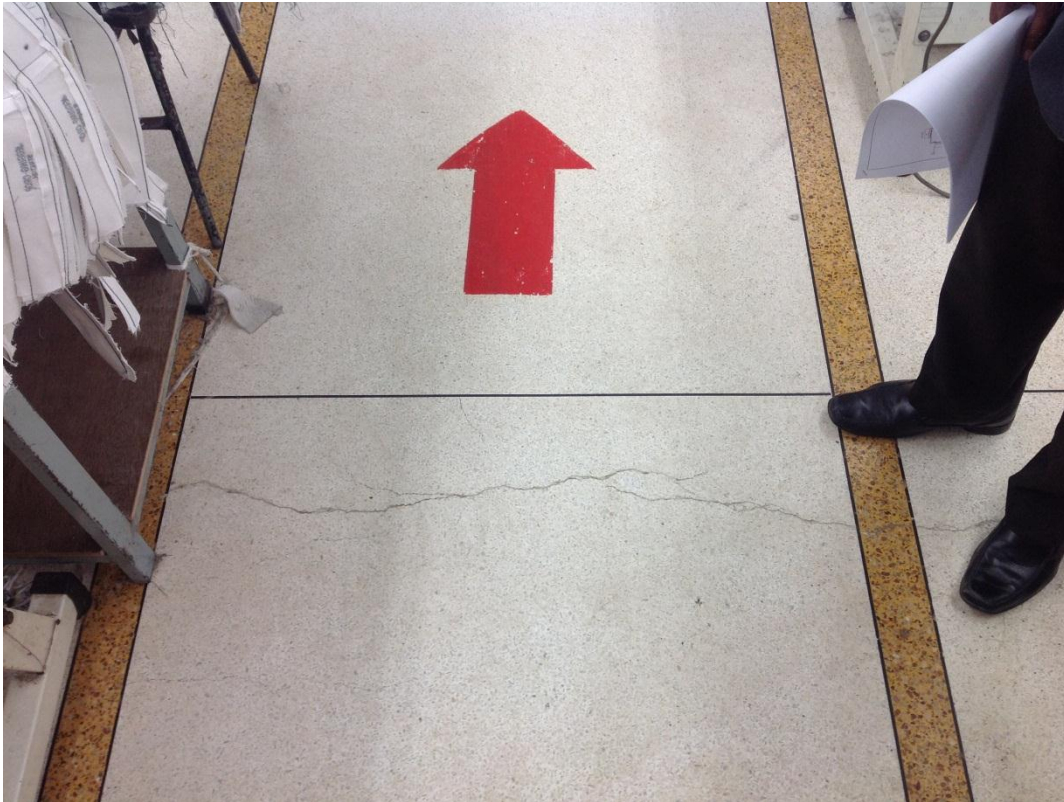
Cracking on  
column line.

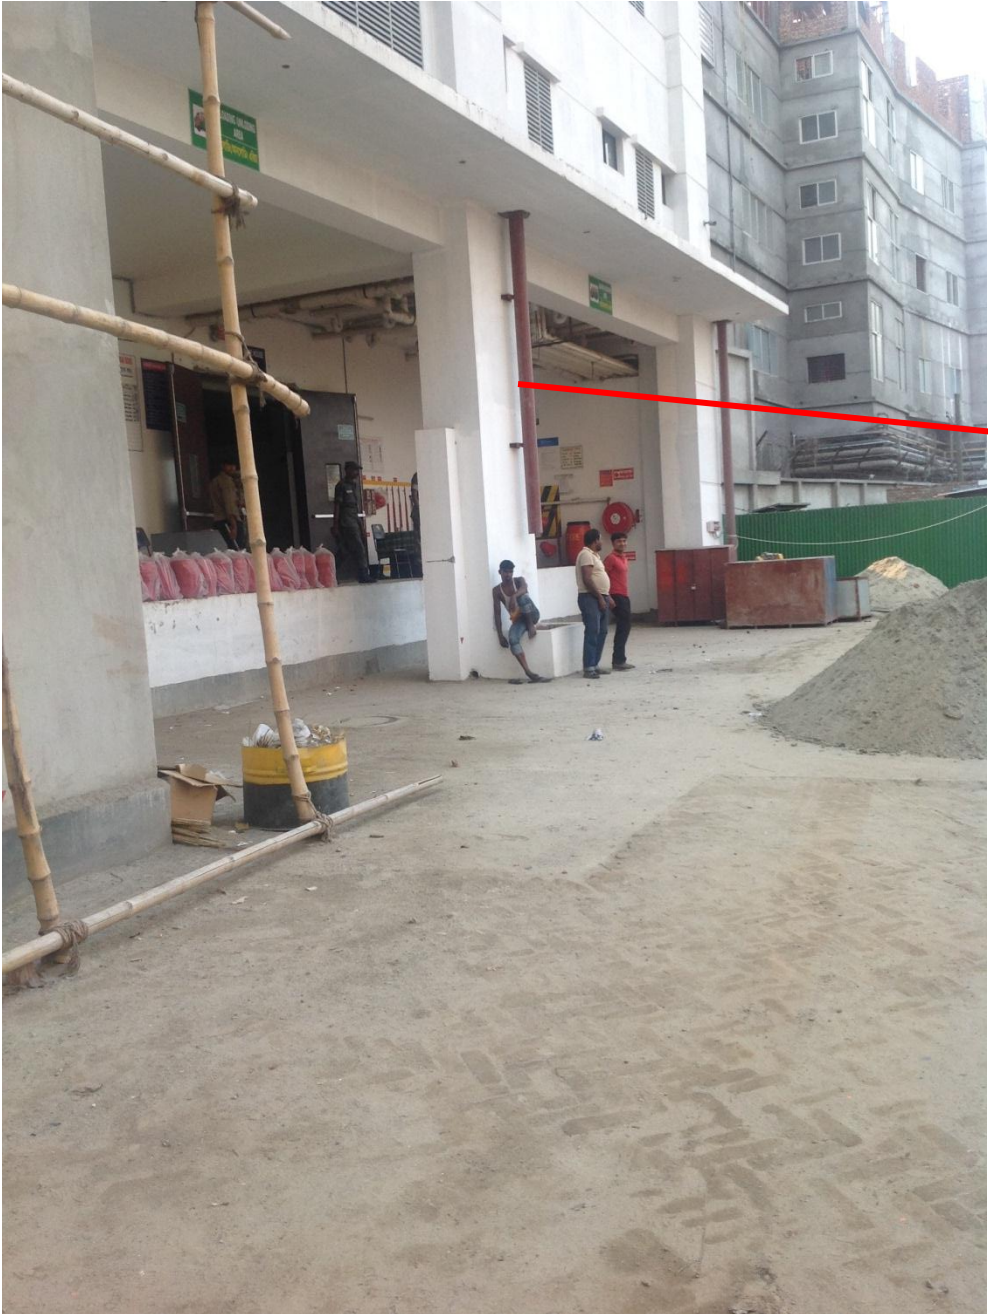
Column in loading bay vulnerable to vehicle impact.

Impact protection should be provided.

- Impact protection should be provided.
