# **FIRE SAFETY INSPECTION REPORT**

## **MIDLINE SWEATER LTD. FACTORY**

**ACCORD ID: 23393**

**Date: 20 February, 2019**

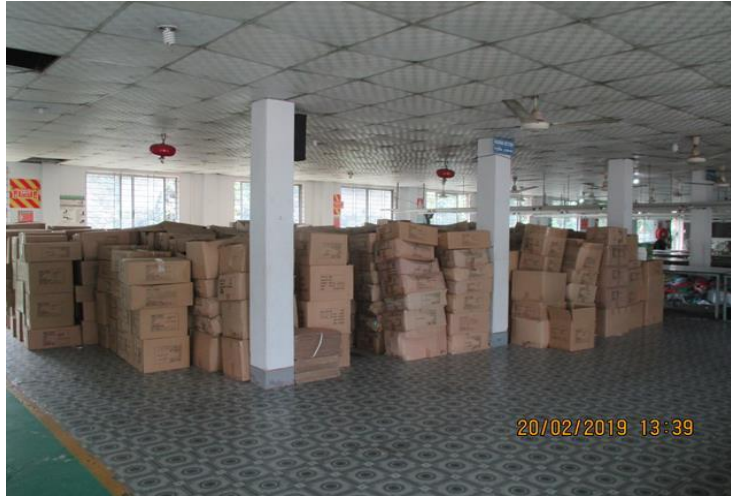
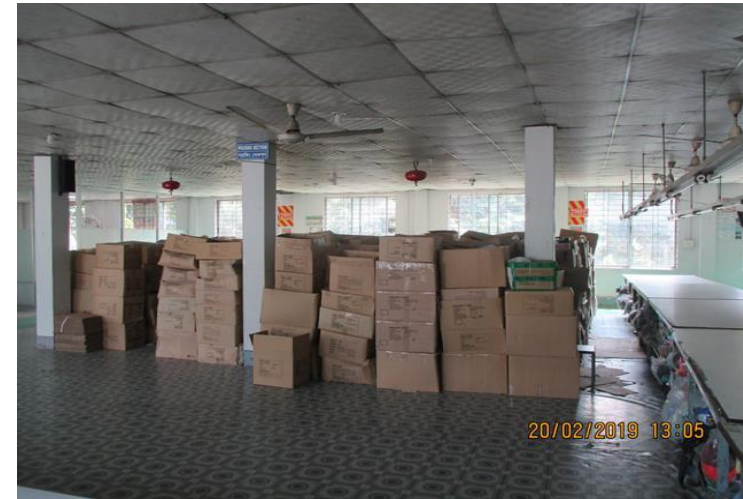
| SI No. | Category | Findings | Required Action | Remediation Time Frame |
|---|---|---|---|---|
| F-1 | Fire Rated Construction | Areas used for in-process storage of combustible materials are open to the surrounding occupancy (Location: 1st floor-cutting section, 7th floor) | <p>Provide defined storage areas and limit the storage arrangement as follows:-</p> <ol style="list-style-type: none"> <li>1. General Condition: Maximum height of 2.4m and maximum area of 23m<sup>2</sup>. Separate areas of unenclosed combustible storage by a minimum clear distance of 3m.</li> <li>2. If sprinkler protected: maximum height of 3.66m and maximum area of 93m<sup>2</sup>. Separate areas of unenclosed combustible storage by a minimum clear distance of 3m.</li> </ol> <p>or</p> <ol style="list-style-type: none"> <li>3. Enclose the storage area from the surrounding occupancy with a minimum 1 hour construction.</li> </ol> | Within 3 months |

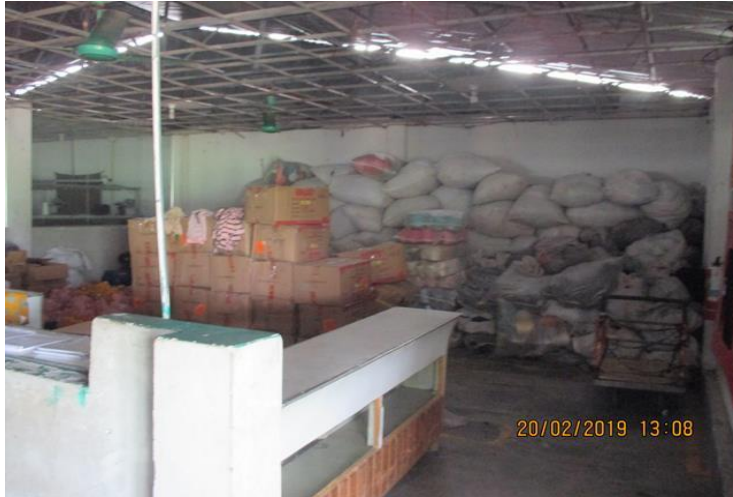
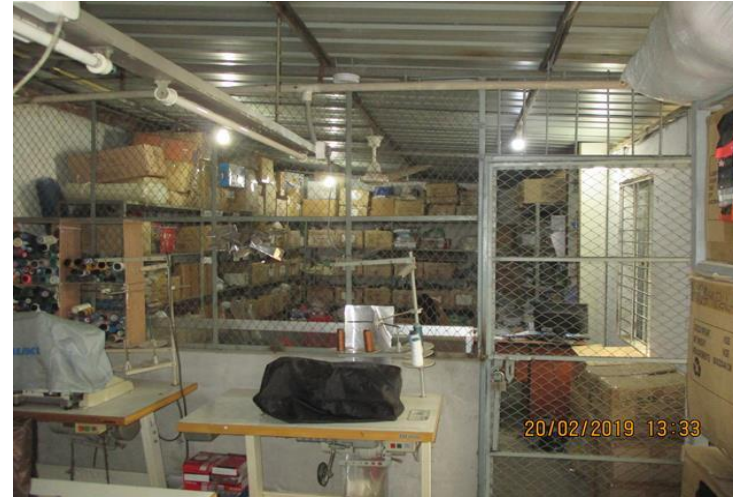
| F-2 | Fire Rated Construction | Rooms used for storage of combustible materials are not separated from the surrounding occupancy/areas (Location: Ground Floor, 7th Floor) | Rooms used for storage of combustible materials shall be separated from the surrounding occupancy with a minimum 1 hour construction. | Within 3 months |

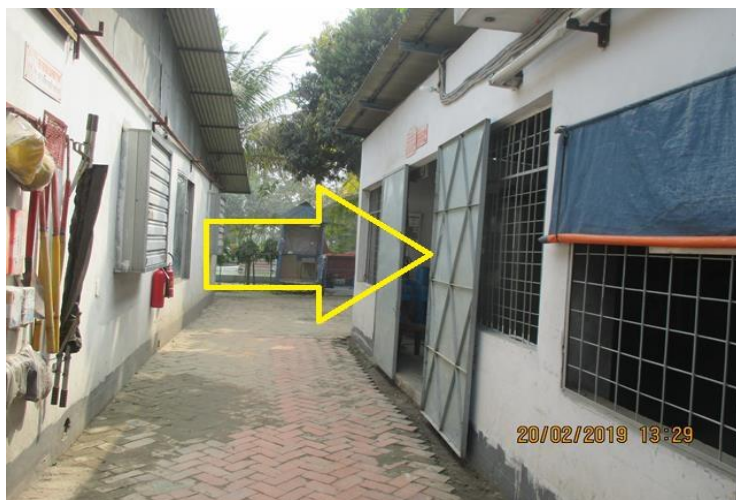
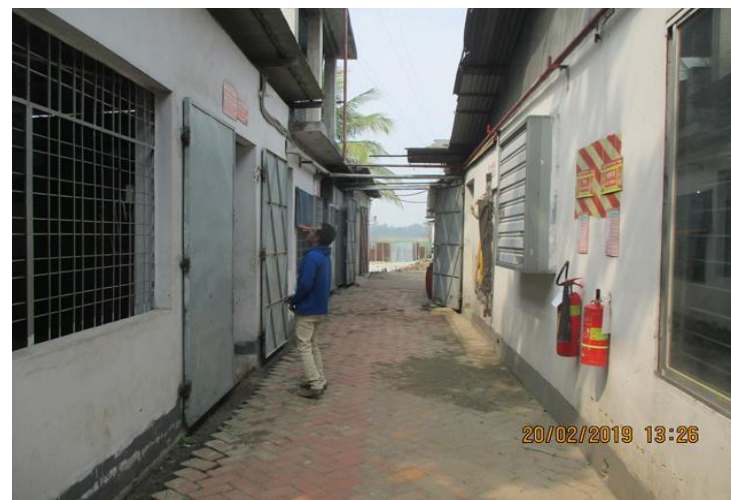
| F-3 | Egress | <p>The exit discharge path [serving west exit] is less than 10 ft wide beside utility building and is not separated from the building interior &amp; utility building.</p> | <p>Seal all penetrations and openings to the interior of the building along the discharge path, up to a height of 10 ft., to provide a minimum 1-hr fire separation.</p> <p>Alternatively, provide a second remote discharge path to the public way (only include this if feasible).</p> | Within 3 months |

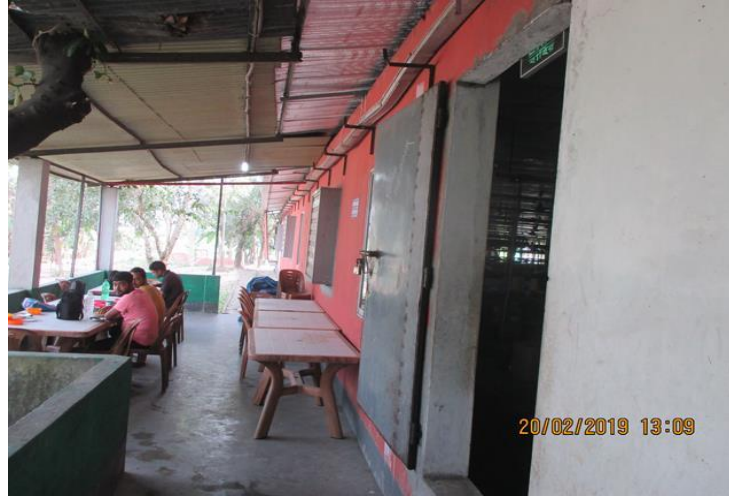
| F-4 | Egress | North exit of main production shed discharge through dinning area. | Remove the dinning area from exit discharge path<br>Or<br>Provide a 1 hr fire rated exit passage way for safe evacuation. | Within 3 months |

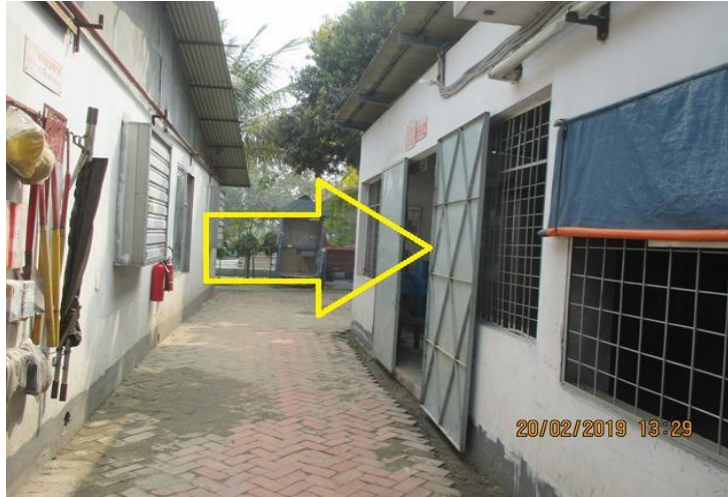
| F-5 | Fire Rated Construction | Boiler, Generator, Substation, room is not properly fire separated. | Separate the generator, boiler, substation, rooms by a minimum 2-hr fire-rated construction from each other. Seal and/or protect all openings to maintain the required fire separations. Provide proper ventilation and consult a qualified engineer. | Within 3 months |

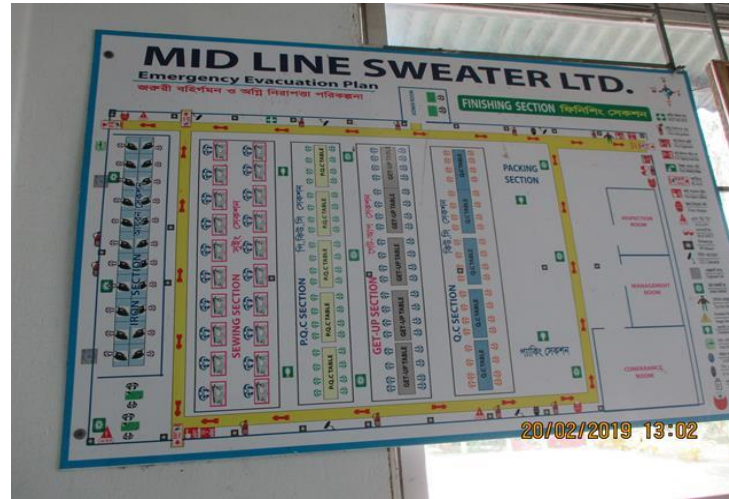
| F-7 | Egress | Updated emergency evacuation maps is not posted at the entrance of all exit. | Fire evacuation maps shall be posted at the entrance to each exit as per updated layout & floor area. | Within 2 month. |

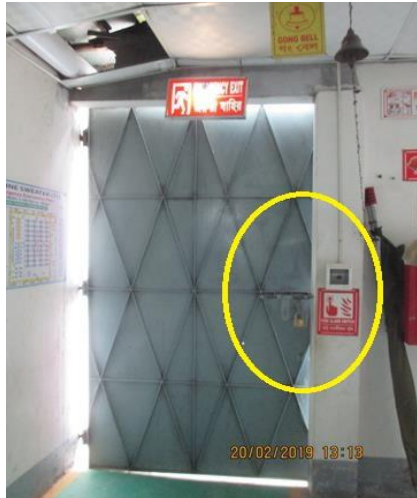
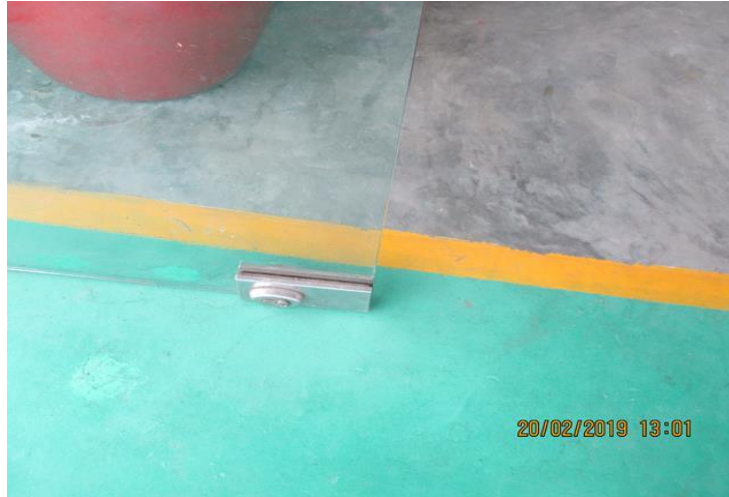
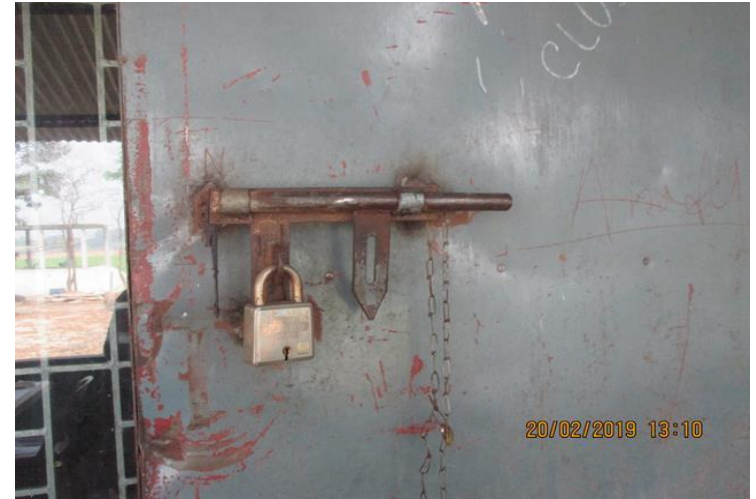
| F-8 | Egress | Egress doors/gates with locking features not complying with NFPA 101 are provided at [building exits, exit stairs, along egress routes, exit discharge] | Remove locking features from all egress doors/gates. If locks are required for security reasons, utilize specialized door locking features complying with NFPA 101. | Immediate |

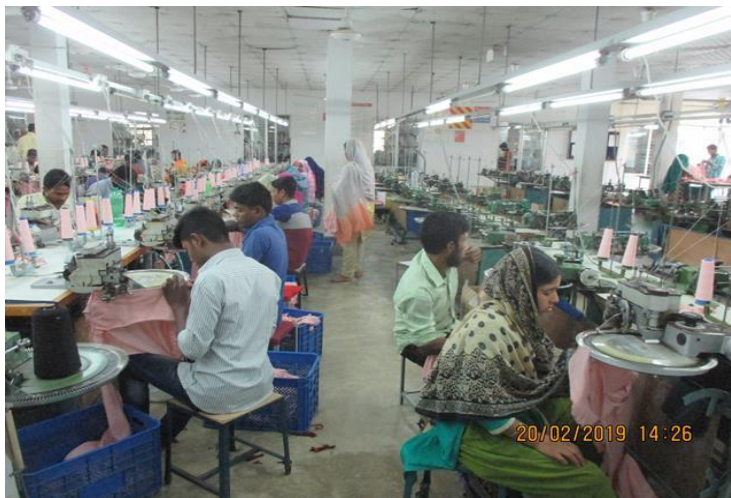
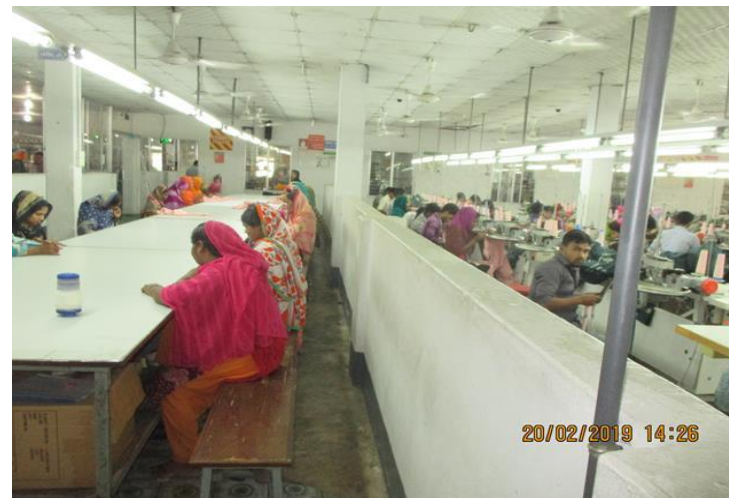
| F-11 | Egress | The width of egress aisles is less than 36-inch.<br>Location: East and west side of the building in every floor. | Provide minimum aisle widths of 36-inch. | Within 3 months |

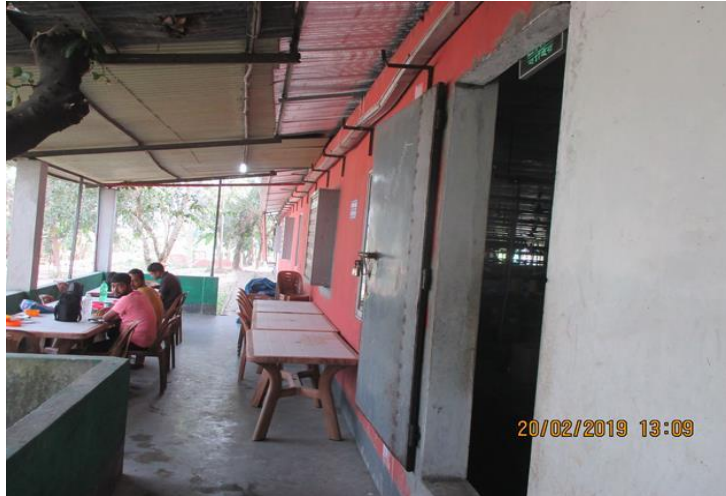
| F-12 | Fire Rated Construction | Dining area is not separated from the production area with fire rated assemblies | Remove the dining area from the production floor & relocate it in a safe location<br>or<br>If this is not possible provide 2-hr fire-rated construction & 2-hr fire rated exit passageway leading directly to the staircases | Within 3 Months |

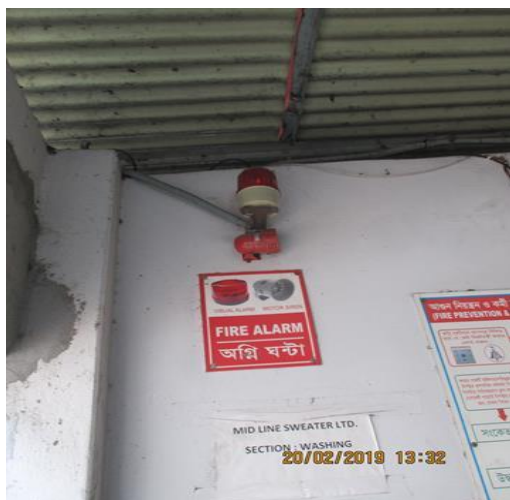
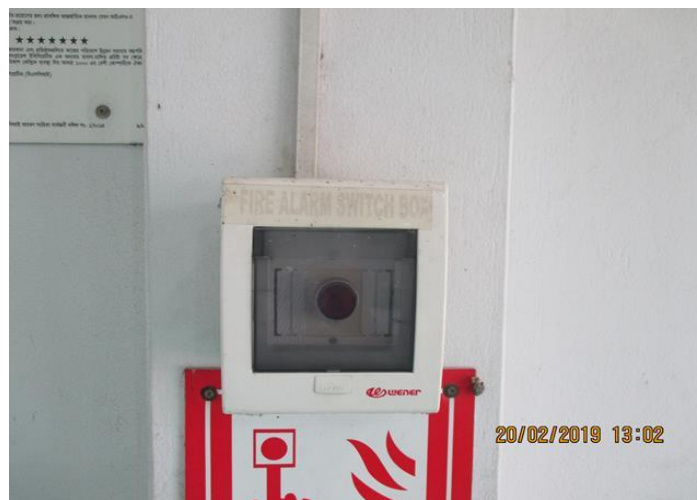
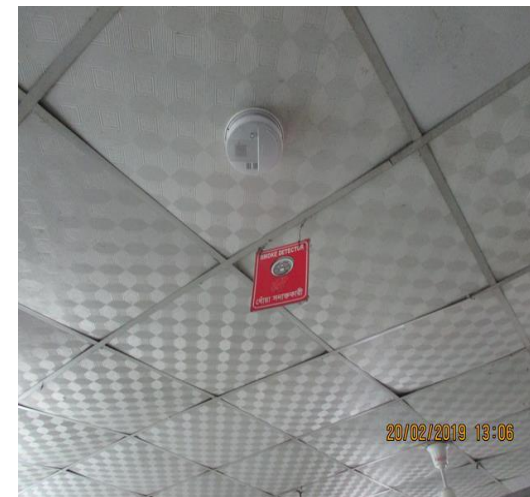
F-13

The fire detection system is antiquated, not a listed system, and does not provide alarm and notification features consistent with acceptable standards.

Replace the fire detection system with a new, listed addressable fire detection system in accordance with NFPA 72.

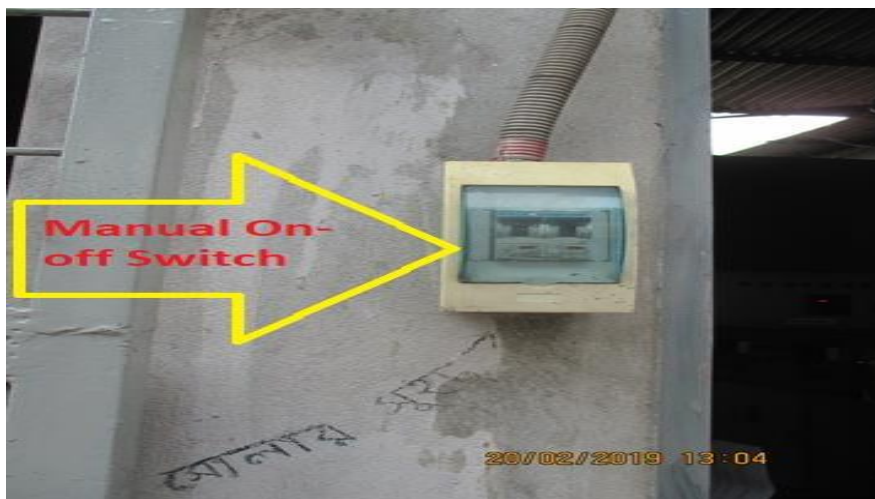
| F-15 | Egress Lighting | Manual on-off switch facility available for emergency lights | Remove manual on/off switches from emergency lighting units to prevent them from being switched off. | Within 1 month |

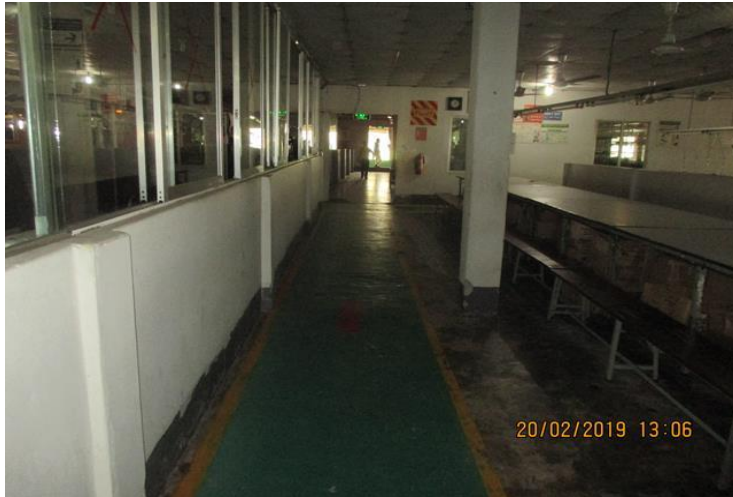
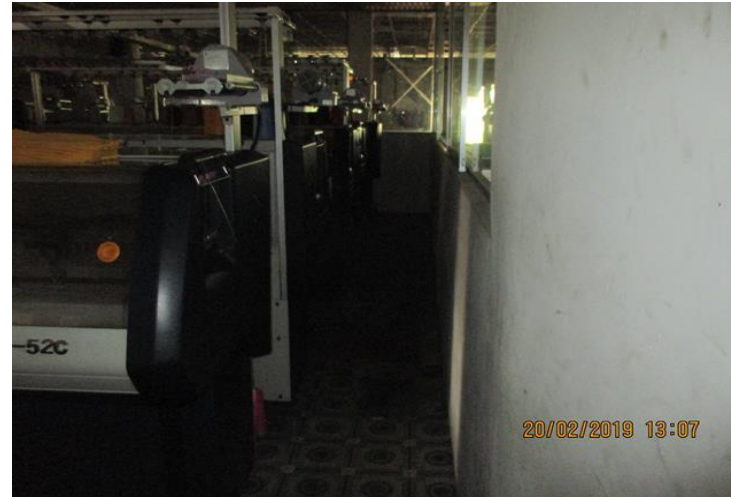
| F-16 | Egress Lighting | Based on the number and location of emergency lights observed, adequate illumination levels are not anticipated along egress routes. | Test the emergency lighting system on each floor and provide additional emergency fixtures to provide adequate illumination along the means of egress. Provide a minimum illumination of 10 lux at the floor level within exit stairs and exit discharge paths and minimum 2.5 lux along exit access aisles. | Within 3 months |
