# **FIRE SAFETY INSPECTION REPORT**

**NRG Knit Composite (Unit-1)**

**ACCORD ID: 23565**

**Date: 29 January, 2019**

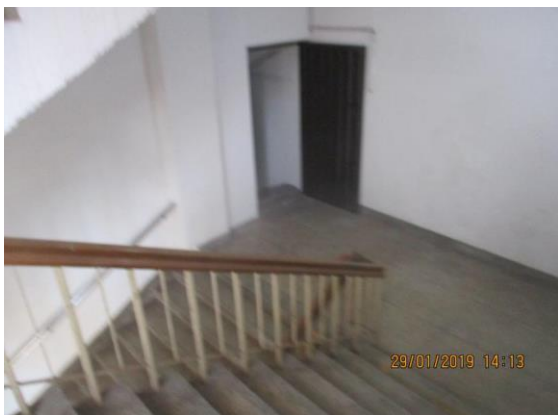
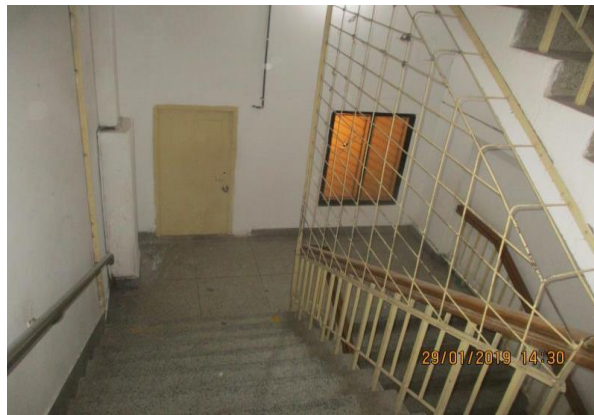
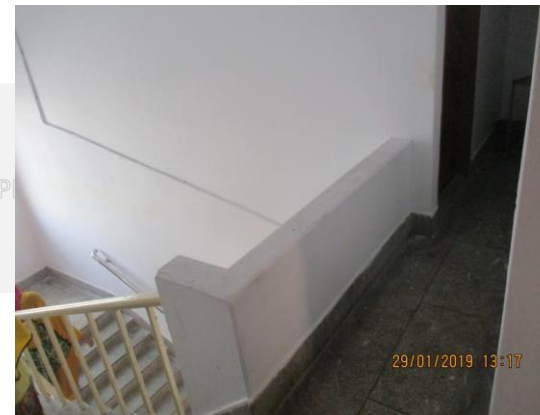
| SI No. | Category | Findings | Required Action | Remediation Time Frame |
|---|---|---|---|---|
| 1 | Fire Rated Construction | Exit stairs are not separated from work areas & other spaces on each floor by fire-rated construction due to unprotected openings and penetrations.<br>Location: Building-1 (Sweater Building), Building-2 (Dining & Wearhouse) | Separate the exit stairs from work areas and other building spaces on all floor levels by minimum 2- hr fire-rated construction. Provide minimum 1.5- hr fire rated doors and seal all unprotected openings and penetrations to maintain the fire separation. Ensure that all fire doors are self-closing and positive latching, and are provided with fire exit (panic) hardware where serving production floors or assembly occupancies. If fire doors are required to be held open for functional reasons, provide automatic-closing devices tied to the fire alarm system. Once fire doors are installed, every door in a stair enclosure serving more than 5 stories shall be provided with re-entry unless it meets ACCORD standard 6.8.3.1. | Within 3 months |

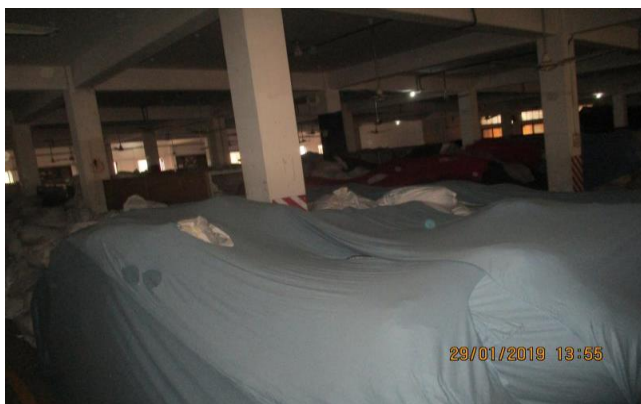
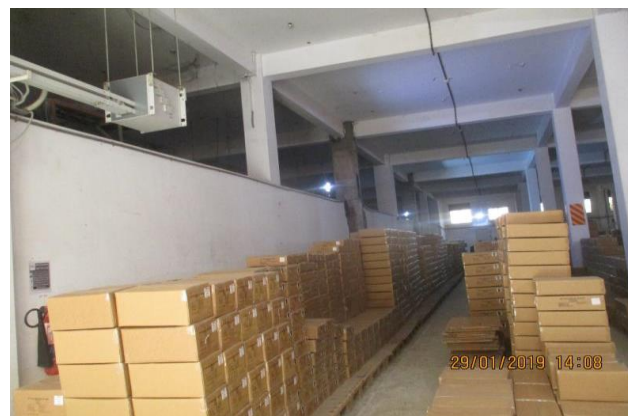
| 2 | Fire Rated Construction | Rooms used for combustible storage are not separated by fire rated construction properly.<br>Location: Ground, 2nd, 3rd & 4th floors | Provide dedicated storage room separated by minimum 1-hr fire-rated construction. | Within 3 months |

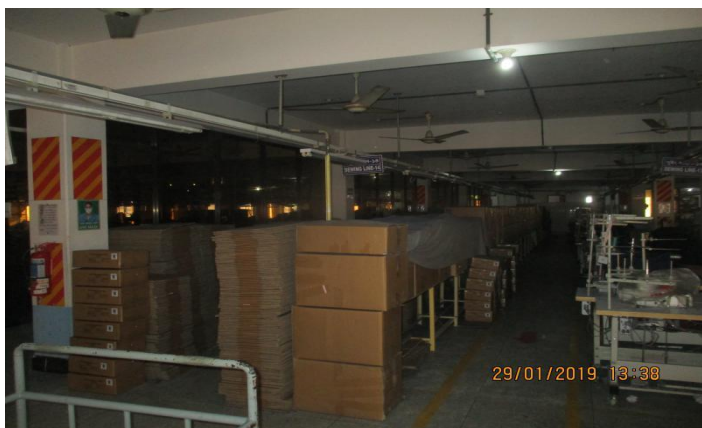
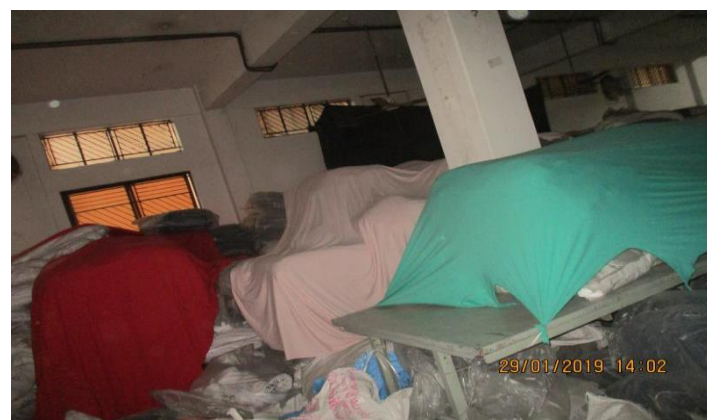
| 3 | Fire Rated Construction | <p>Areas used for combustible storage are not separated by fire rated construction.</p> <p>Location: 1st, 2nd &amp; 3rd floors</p> | <p>Provide dedicated storage rooms separated by minimum 1-hr fire-rated construction.</p> <p>Where separate storage rooms are not feasible, provide defined storage areas and limit the storage arrangement as follows:</p> <ul style="list-style-type: none"> <li>- Maximum height of 2.4m and maximum area of 23m<sup>2</sup></li> <li>- If sprinkler protected: maximum height of 3.66m and maximum area of 93m<sup>2</sup></li> </ul> <p>Separate areas of unenclosed combustible storage by a minimum clear distance of 3m.</p> | Within 3 months |

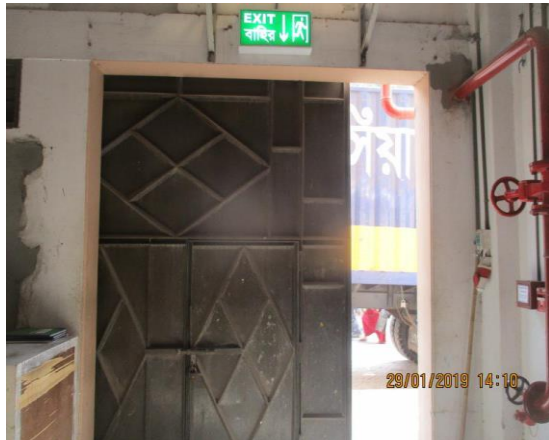
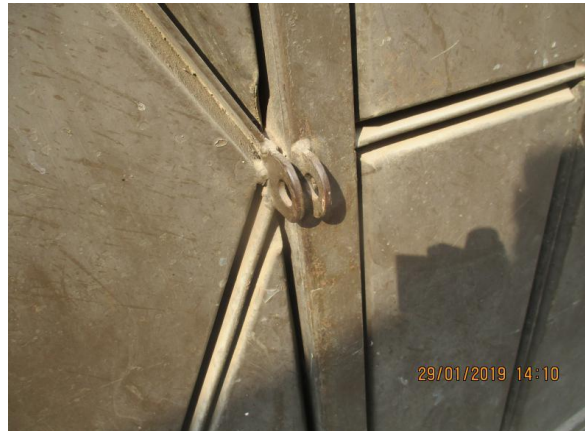
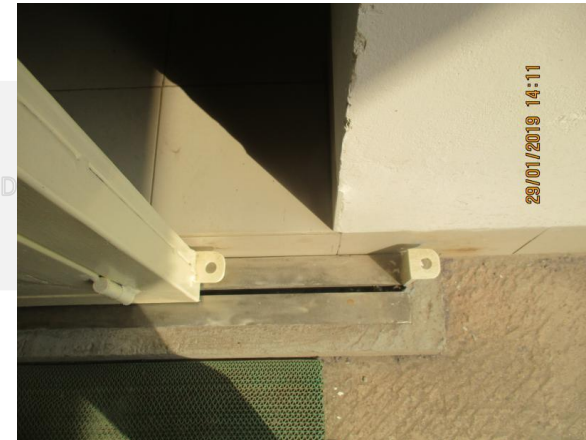
| 4 | Egress | Egress doors/gates with locking features not complying with NFPA101 are provided at [ building exits, exit stairs, along egress routes, exit discharge] | <p>Remove locking features from all egress doors/gates. If locks are required for security reasons, utilize specialized door locking features complying with NFPA101.</p> <p>OR</p> <ol style="list-style-type: none"> <li>1. Remove all non compliant locking features from egress doors.</li> <li>2. If locks are required for security reasons, utilize special door locking features complying with NFPA 101.</li> <li>3. Doors may be locked where the latch and lock are disengaged with one motion where the occupant load does not exceed 49 persons.</li> <li>4. Doors may be provided with locking hardware from the ingress side provided that a panic bar is installed on any door with an occupant load exceeding 49 persons.</li> </ol> | Immediate |

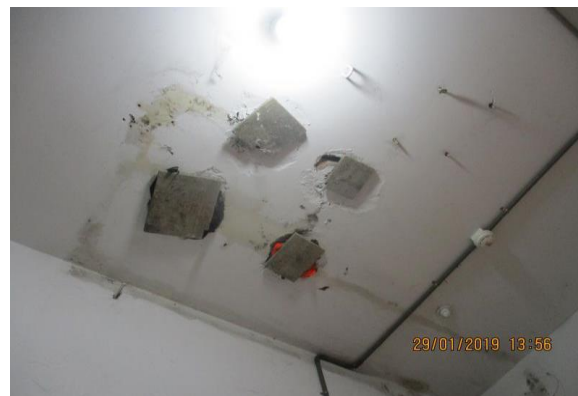
| 5 | Fire Rated Construction | Unsealed penetrations and openings are located in the fire rated floor/ceiling assemblies.<br>Location: 1st floor finishing room (sw corner) | Seal all penetrations and openings in floors/ceiling assemblies to maintain the fire separation. | Within 3 months |

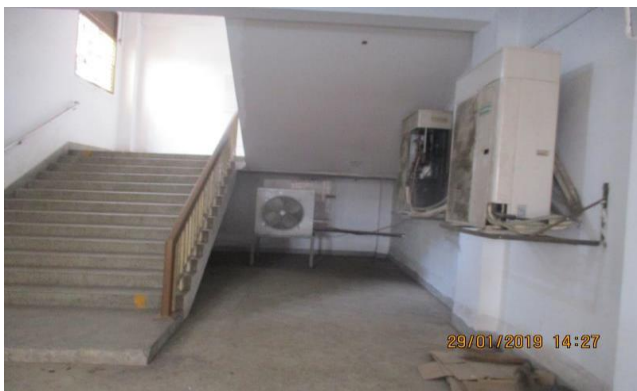
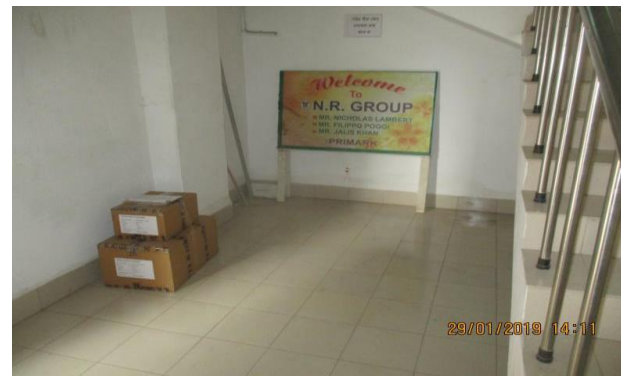
| 7 | Egress | Storage was located in exit stairs. | Remove storage from the exit stairs and egress path | Immediate |

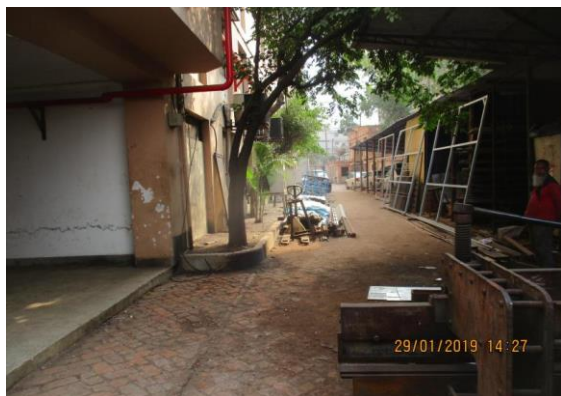
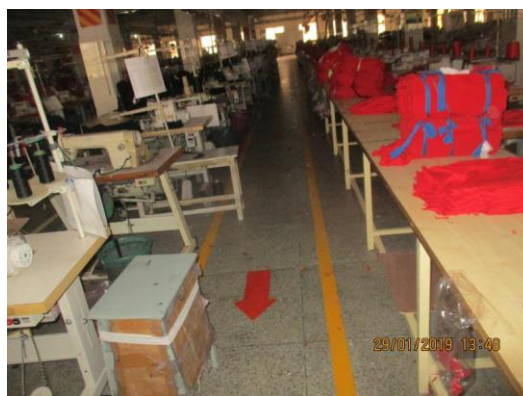
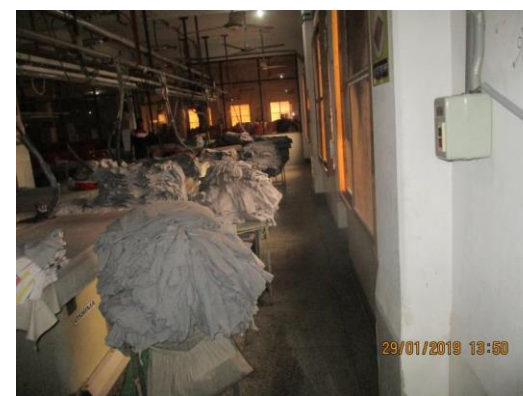
| 8 | Egress | Storage was located in the egress path.<br>Location: Ground, 2nd & 3rd floors. | Keep egress path and stair clear of storage. | Immediate |

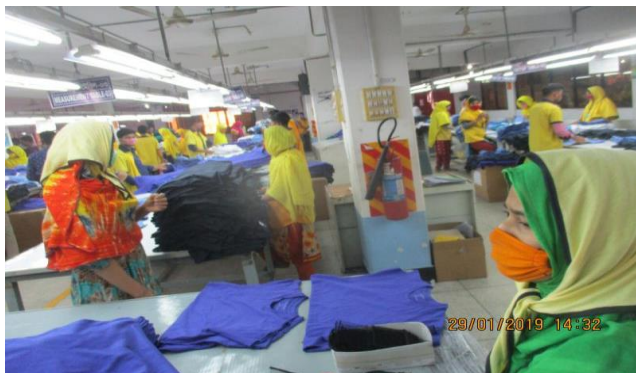
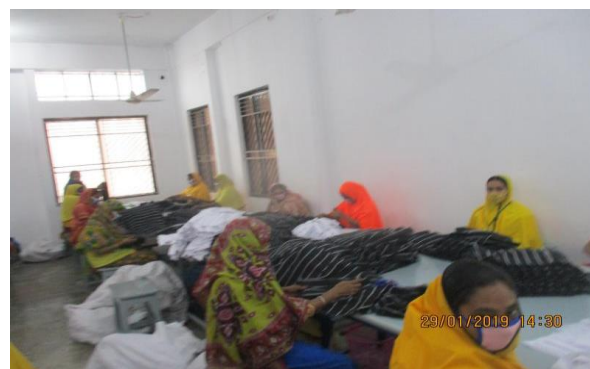
| 10 | Egress | The width of egress aisles is less than 36-in.<br>Locations: Ground, 1st, 2nd & 3rd floors. | Provide minimum aisle widths of 36-in. | Within 3 months |

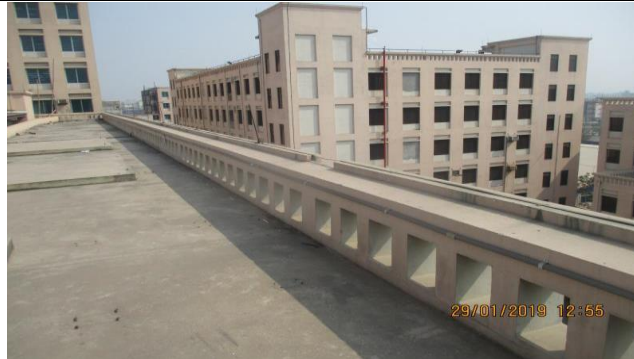
| 12 | Parapets or Guards | Parapets or guards are provided in occupied roof which is less than 1067mm (42 inch.). | Provide parapets or guards with a minimum height of 1067mm (42 inch.). | Within 3 months |
