# **FIRE SAFETY INSPECTION REPORT**

## **GLOBAL FASHION GARMENTS LTD.**

**89 BERULIA ROAD, TATI, SAVAR, DHAKA,  
BANGLADESH-1340**

March 3, 2014

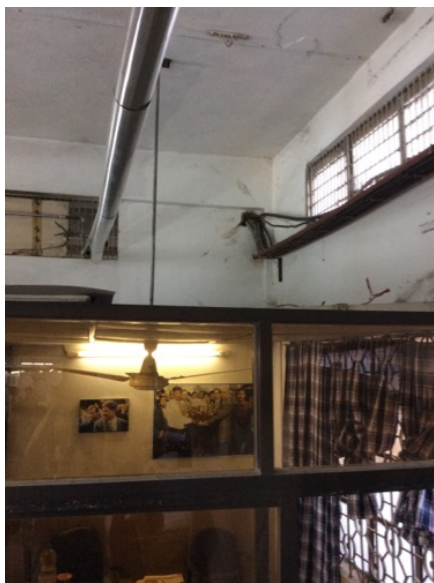
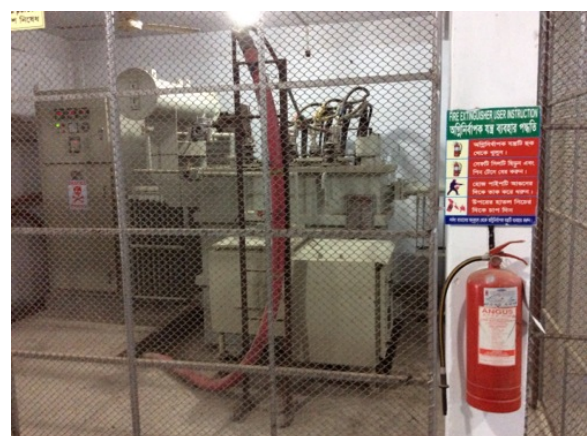
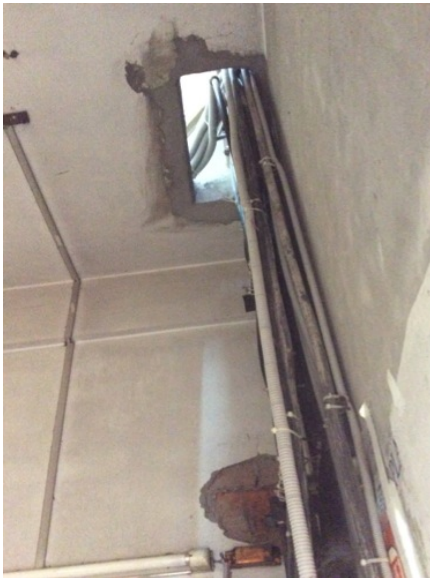
| No. | Category | Finding | Recommendation | Remediation Timeframe |
|---|---|---|---|---|
| F-1 | Fire Rated Construction | <p>The boiler / generator and transformer room is not separated by fire-rated construction and is open to each other in the one service room openings, non-rated doors and penetrations all present located on the ground floor.</p> <p>The services room is open to the factory floor due to no adequate fire rated construction i.e. penetrations and door openings.</p> | Separate the boiler / generator and transformer room by a minimum 2-hr fire-rated construction. Seal and/or protected all openings to maintain the required fire separations | Within 3 months |

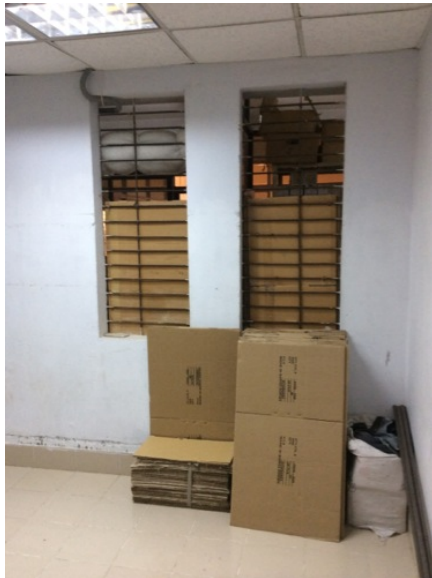
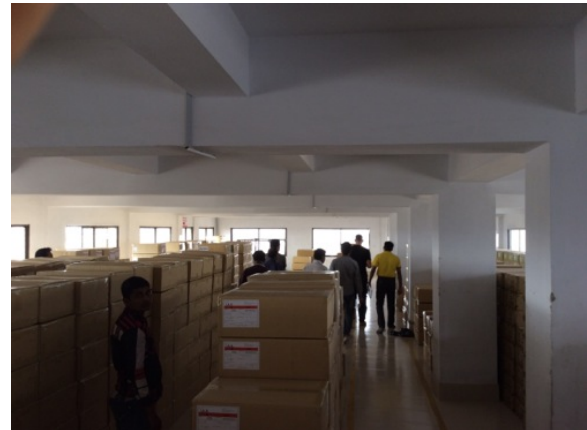
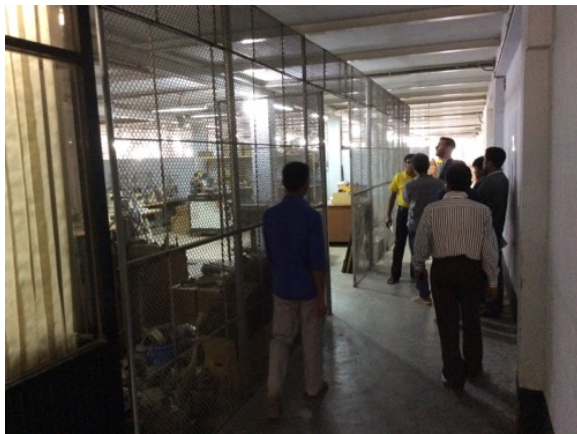
| F-2 | Fire Rated Construction | <p>Areas used for combustible storage are not separated by fire-rated construction on the main store located on the ground floor and minor storage spaces throughout the factory. No adequate fire rated doors and penetrations present.</p> | <p>Provide dedicated storage rooms separated by minimum 1-hr fire-rated construction.</p> <p>Where separate storage rooms are not feasible, provide defined storage areas and limit the storage arrangement as follows:</p> <ul style="list-style-type: none"> <li>- Maximum height of 2.4m and maximum area of 23m<sup>2</sup></li> <li>- If sprinkler protected: maximum height of 3.66m and maximum area of 93m<sup>2</sup></li> </ul> <p>Separate areas of unenclosed combustible storage by a minimum clear distance of 3m.</p> | Within 3 months |

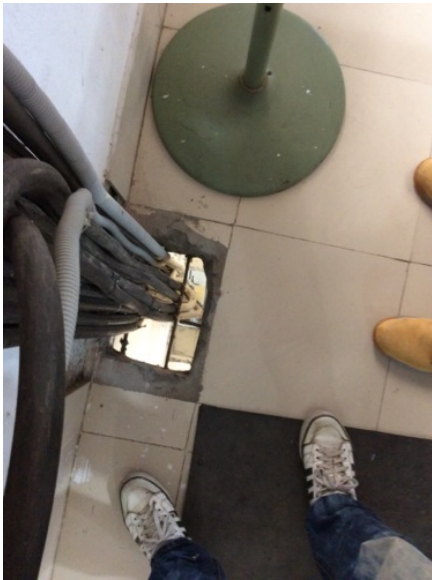
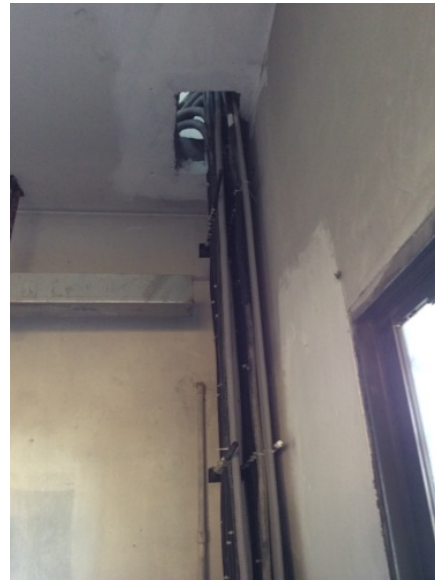
| F-3 | Fire Rated Construction | Unsealed penetrations and openings are located in the fire-rated floor/ceiling assemblies to each floor located at all service shaft zones, daylight can be seen through each level allowing smoke to rise up each floor in the event of a fire. | Provide a minimum 2-hr fire-rated shaft to separate the utility risers from each floor level.<br><br>Seal all penetrations and openings in floor/ceiling assemblies to maintain the fire separation. | Within 3 months |

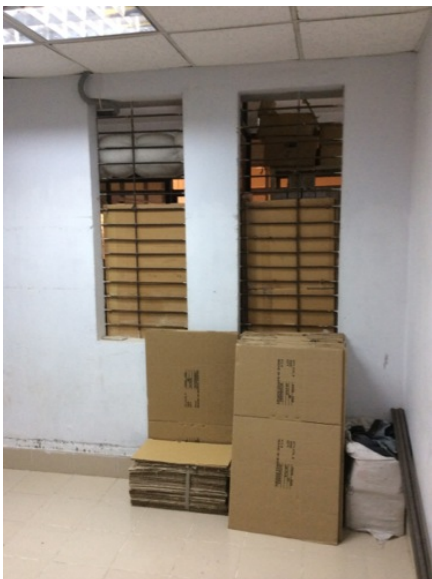
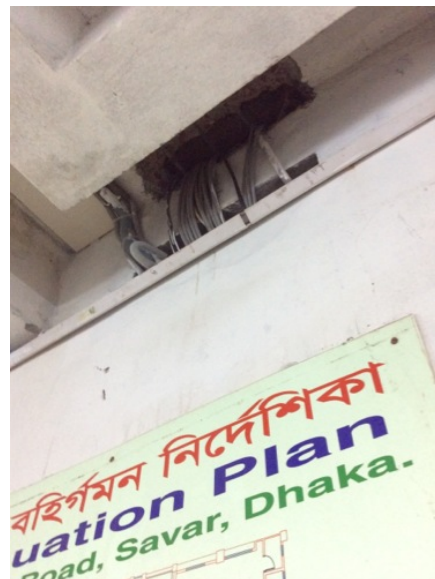
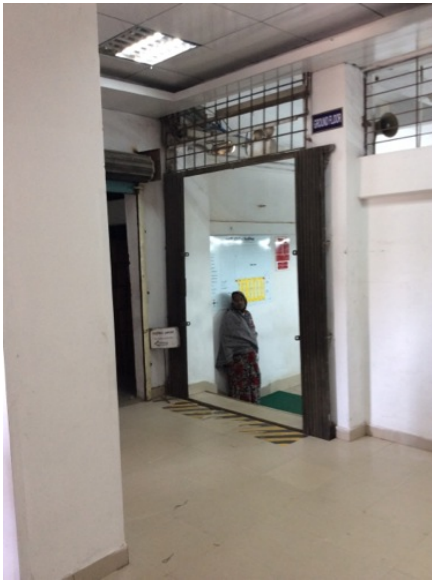
| F-4 | Fire Rated Construction | Unsealed penetrations and openings are located in all exit stair enclosures i.e electrical cabling service shafts open, open walling above doors and walls with no windows allowing smoke to rise up stairwell shaft. | Seal all penetrations and openings in exit stair enclosure walls to maintain the fire separation. | Within 3 months |

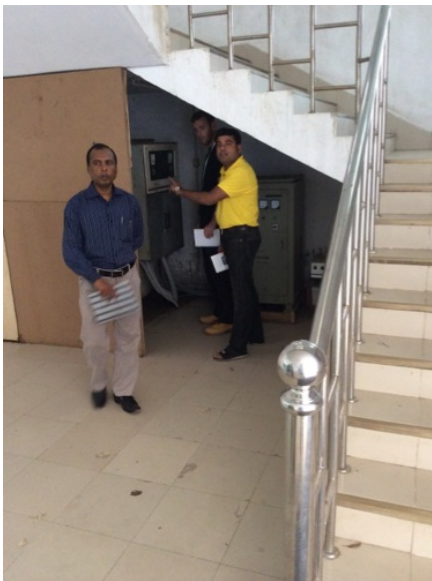
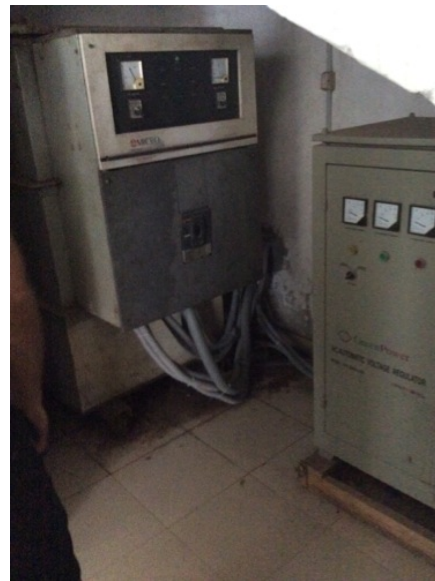
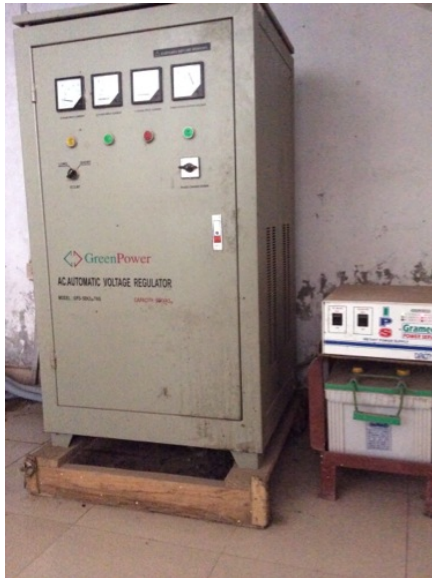
| F-5 | Fire Rated Construction | Voltage stabilizer and IPS system located beneath stairwells, area is not separated by fire-rated construction (openings, non-rated doors, penetrations). | Separate the electrical supply area by a minimum 2-hr fire-rated construction. Seal and/or protected all openings to maintain the required fire separations. | Within 3 months |

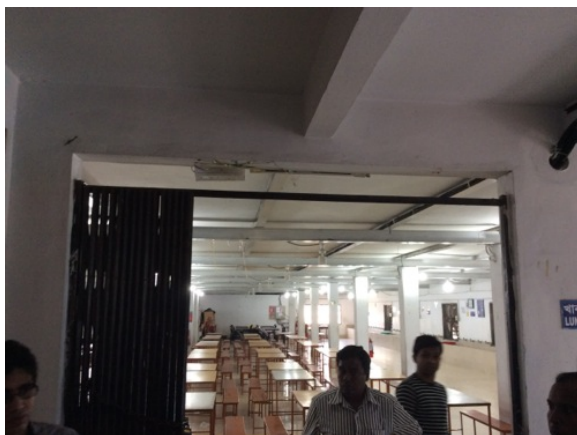
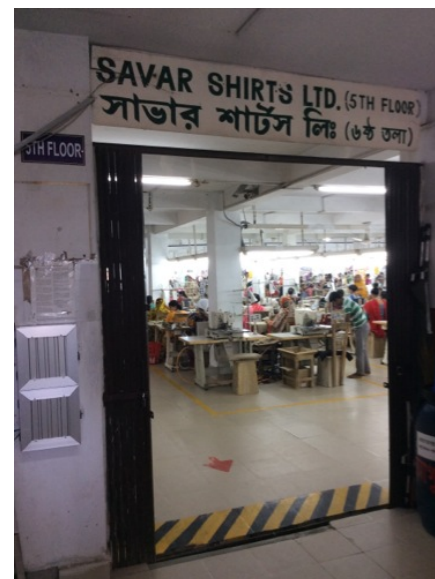
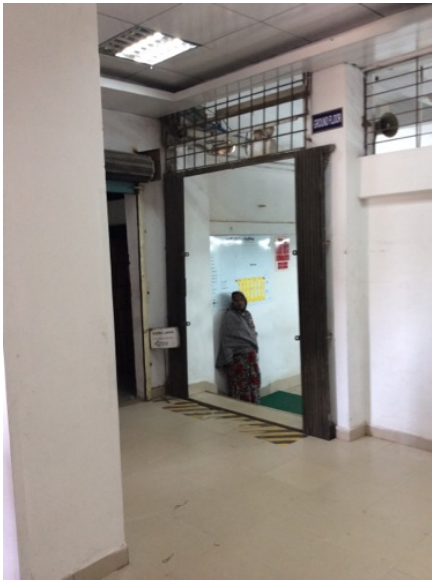
| F-6 | Egress | All egress steel sliding gates have locking features located at all exits on floor plates, storage areas and main egress routes to assembly points. All doors were open and unlocked during the inspection. | Remove locking features from all egress doors / gates.<br><br>If locks are required for security reasons, utilize special door locking features complying with NFPA 101. | Immediate |

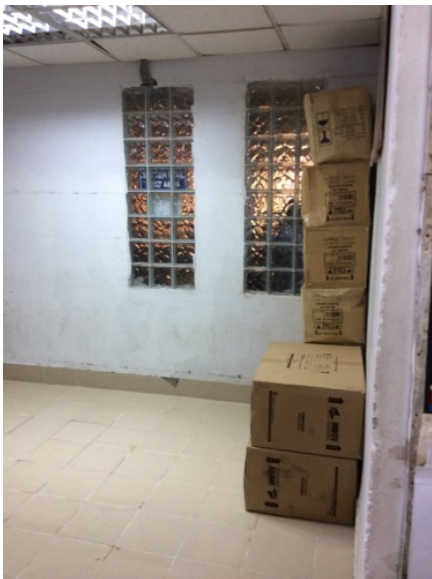
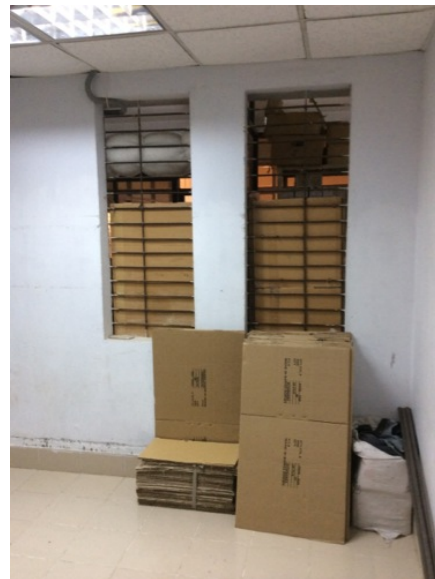
| F-7 | Egress | Combustable storage was located in the East most facing exit stair. | Remove all storage from exit stairs and egress paths. | Immediate |

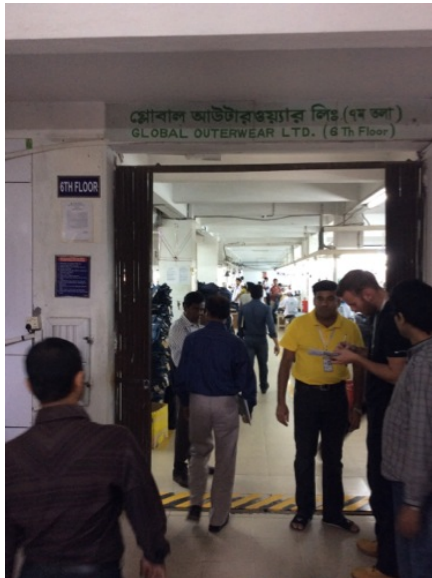
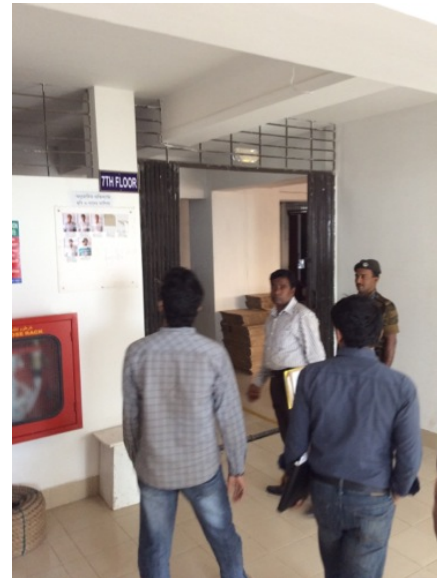
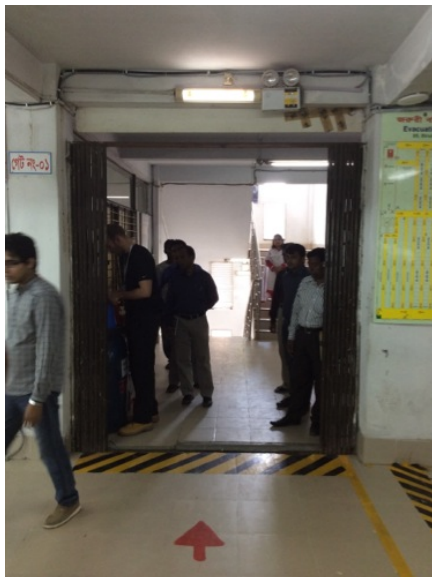
| F-8 | Egress | Collapsible gates are provided at all building exits, exit stairs, along egress routes and main exit discharge. | Replace all gates / sliding doors along the means of egress with side-hinged, swinging egress doors.<br><br>If locks are required for security reasons, utilize special door locking features complying with NFPA 101. | Within 1 month |

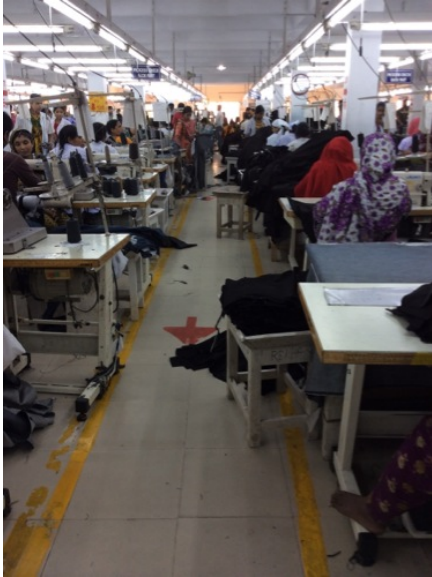
| F-9 | Egress | The width of egress aisles is less than 36-in, due to employees desks and work type storage of completed garments is being placed in a basket on the egress path, this path must be kept clear to a minimum of 36 inch. | Provide minimum aisle widths of 36-in. | Within 3 months |

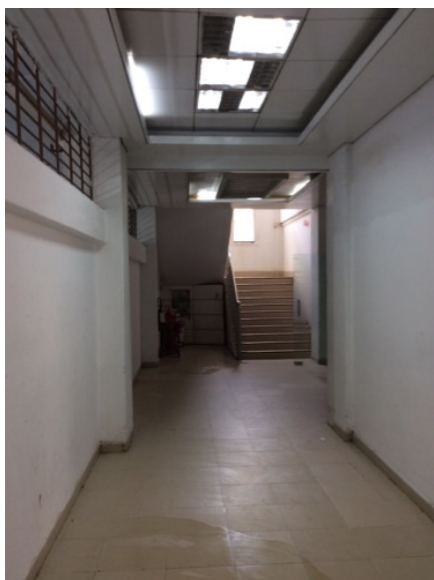
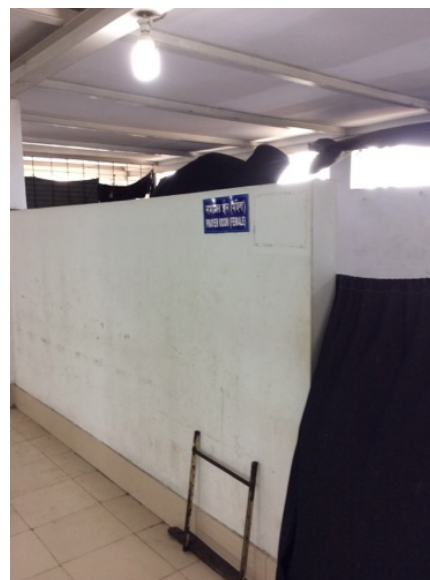
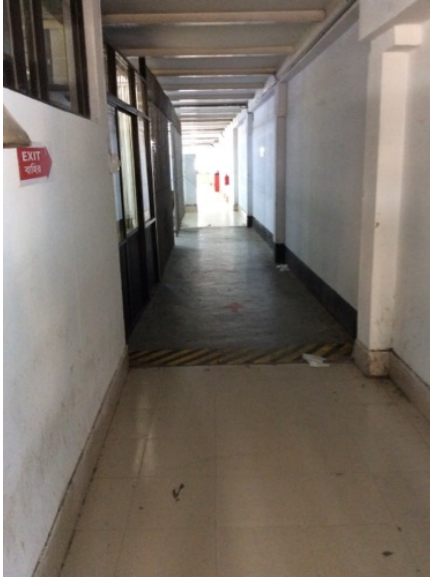
| F-10 | Egress | <p>Two (2) Exit stairs discharge inside the building.</p> <p>The East stairwell discharges to ground floor, the closest main exit is shared with the South stair and is 65ft away with no adequate 2 hour fire protection in place.</p> <p>The North most stair gives egress from the 10th and 9th floor to the 8th floor however this opens to the factory floor and the next main egress is 20 ft away with no adequate fire construction/protection. See attached floor plan for better understanding of layout.</p> | <p>Specify appropriate upgrade based on conditions:</p> <ul style="list-style-type: none"><li>- Provide 2-hr fire-rated exit passageway leading directly outside (vestibules to separate any storage areas).</li></ul> | Within 6 months |

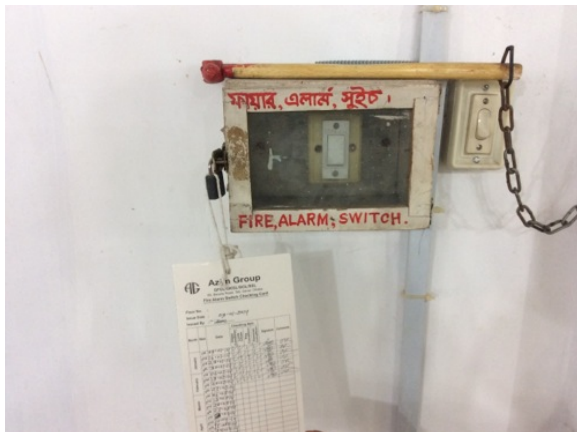
| F-11 | Fire Protection | The fire alarm system is antiquated, not a listed system, and does not provide alarm and notification features consistent with acceptable standards. | Replace the fire alarm system with a new, listed addressable fire alarm system in accordance with NFPA 72. | Design within 4 months, install within 9 months |

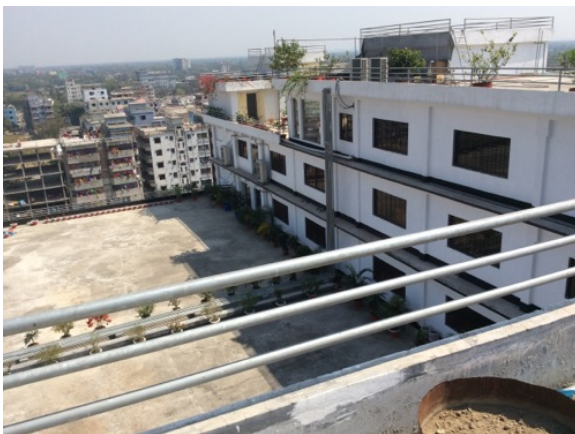
| F-12 | Fire Protection | It was observed that the high-rise building has an occupied floor greater than 23m (75 ft) and is not provided with automatic sprinkler protection. The large occupant loads, heavy fuel loading, and anticipated extended egress times warrant sprinkler protection. | Provide automatic sprinkler protection throughout the building in accordance with NFPA 13. | Design within 6 months, install within 12 months |

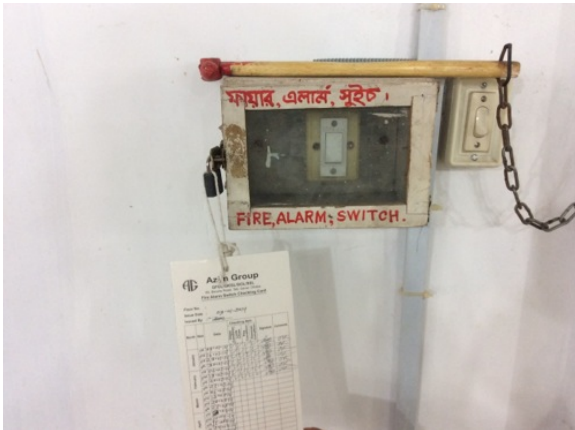
| F-13 | Fire Protection | Inspection, testing, and maintenance records for the fire alarm system were not available. | Inspect, test and maintain the fire alarm system, and keep written records on-site, in accordance with NFPA 72. | Within 3 months |

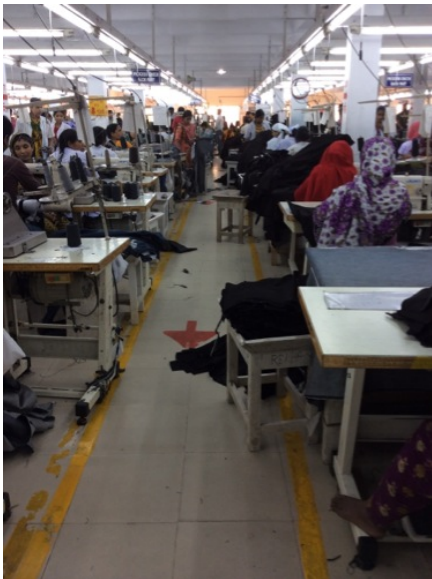
| F-14 | Fire Protection | The fire alarm system does not appear to provide adequate audible notification coverage. | Provide additional notification appliances such that the fire alarm system is audible throughout the building in accordance with NFPA 72. | Within 6 months |

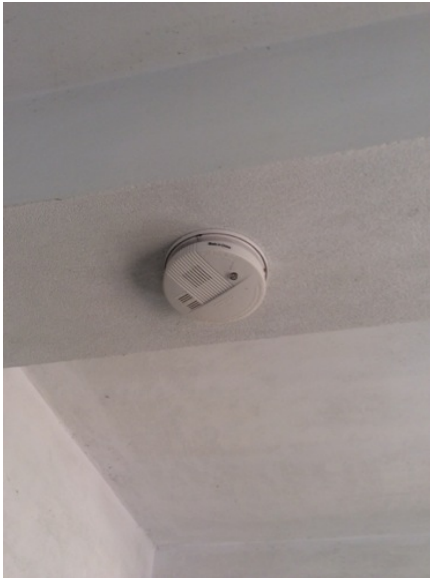
| F-15 | Fire Protection | The building is equipped with single-station smoke alarms. Smoke alarm activation sounds only a local alarm and does not provide automatic fire alarm notification of occupants. | Replace the single-station smoke alarms with automatic smoke detectors tied into the fire alarm system. Configure the fire alarm system to initiate occupant notification upon activation of any two smoke detectors in addition to the manual fire alarm stations. | Within 6 months |

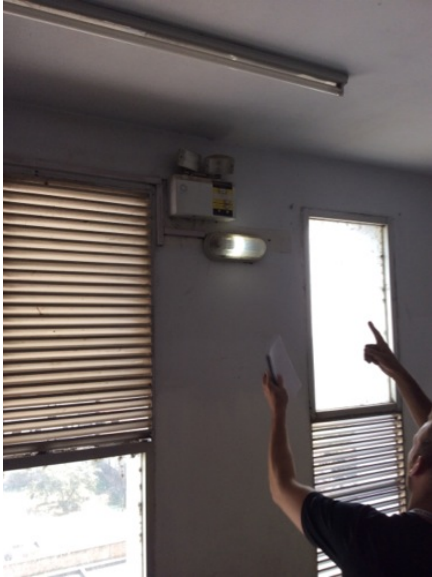
| F-16 | Egress Lighting | Emergency lighting did not function in test mode throughout all stairwells suggesting maintenance plans not being carried out as stated.(burned out, broken, etc. | Regularly test the emergency lighting system on each floor and replace/repair lights as needed. | Within 1 month |

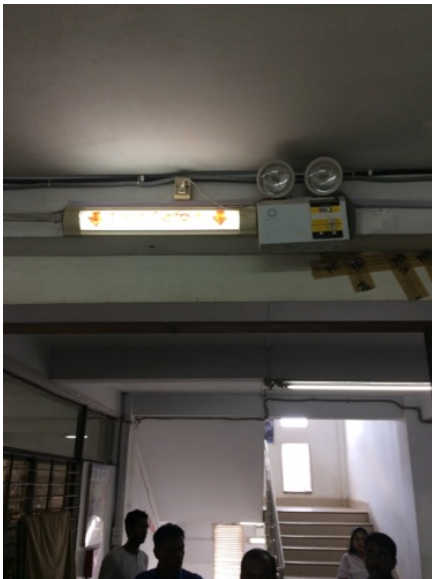
| F-17 | Egress Lighting | Manual on-off switch is provided for battery backup emergency lighting/exit signage units. | Remove manual on/off switches from emergency lighting/exit signage units to prevent them from being switched off. | Within 1 month |
