# Risingtex Fashion Ltd.

Auchpara, Ashulia  
(23.887955N, 90.297218E)  
8th January 2019

# Observations

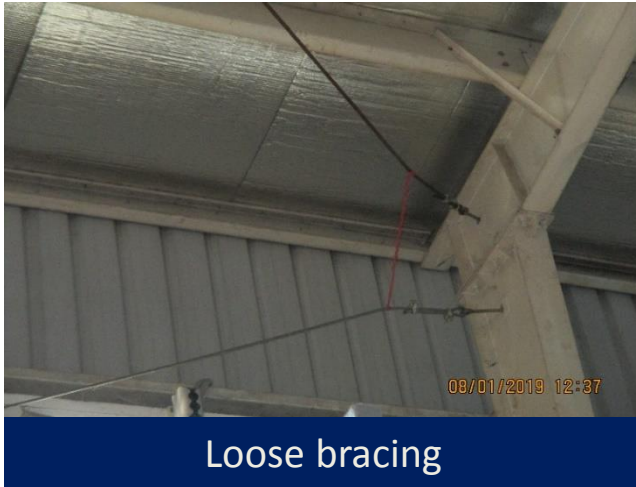
Vertical bracings were designed as stability system against lateral loading. But no compression strut was observed in long direction. Moreover, vertical bracings were found missing and existing bracings were loose in several locations. Also, connection details were not provided in structural drawing.

Loose bracing

| Item No. | Observation | Recommended Action Plan | Recommended Timeline |
|---|---|---|---|
| 2 | Lateral stability of Main Production Shed | Install bracings as per provided drawing and tighten the loose bracings. | 6-weeks |

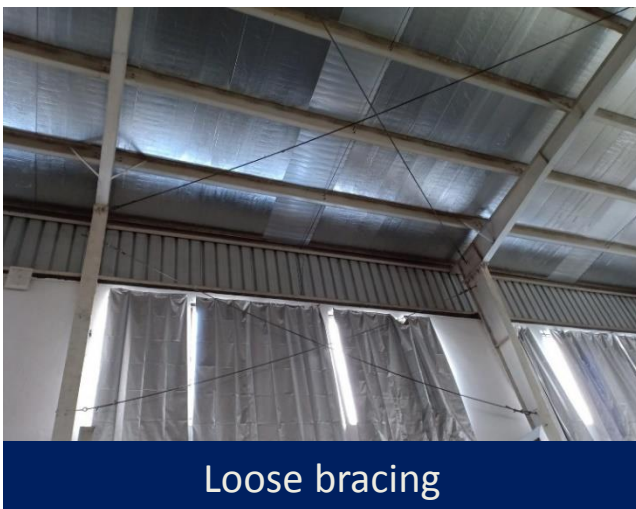
Loose bracing

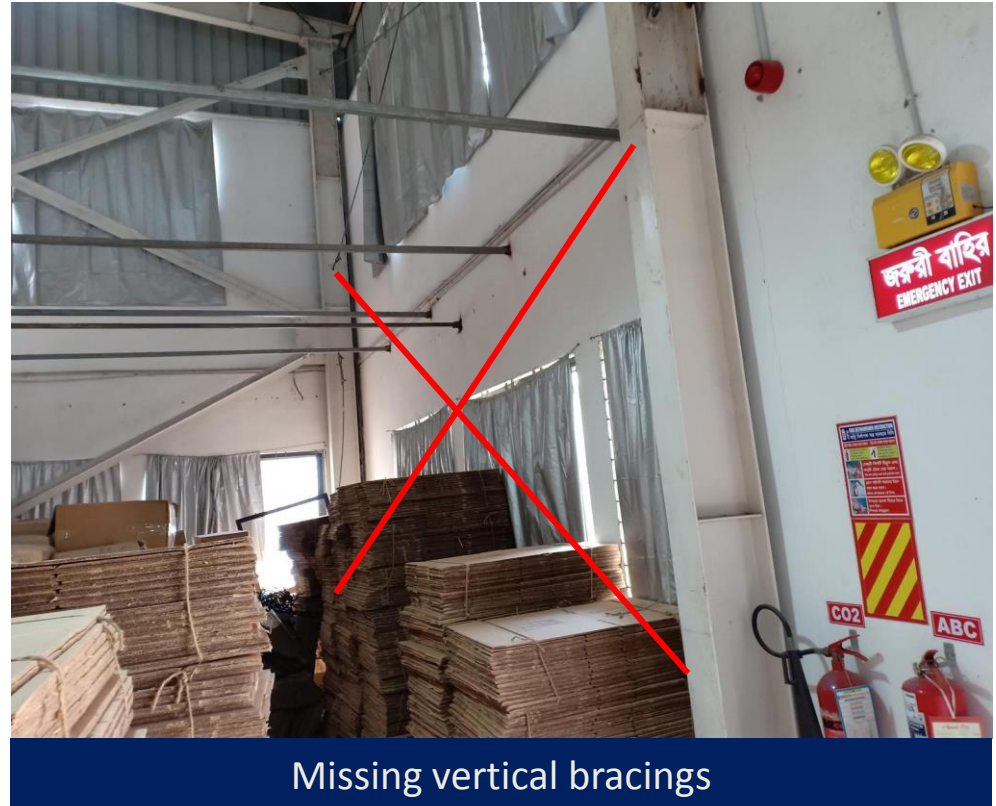
Missing vertical bracings

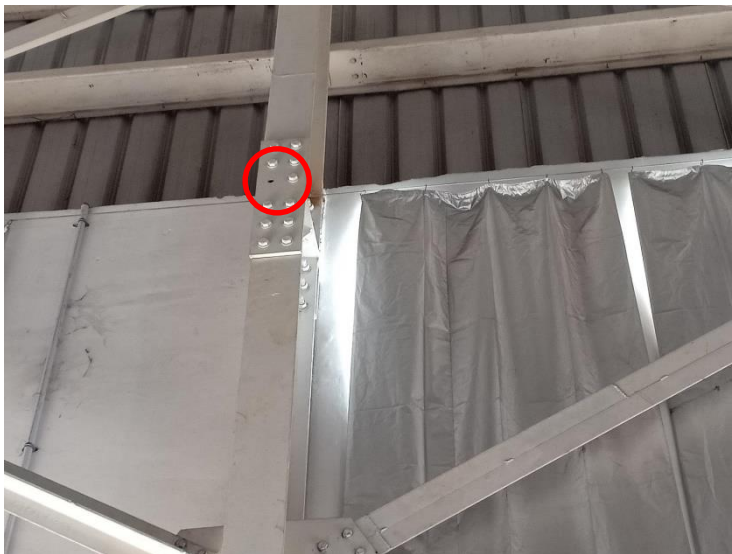
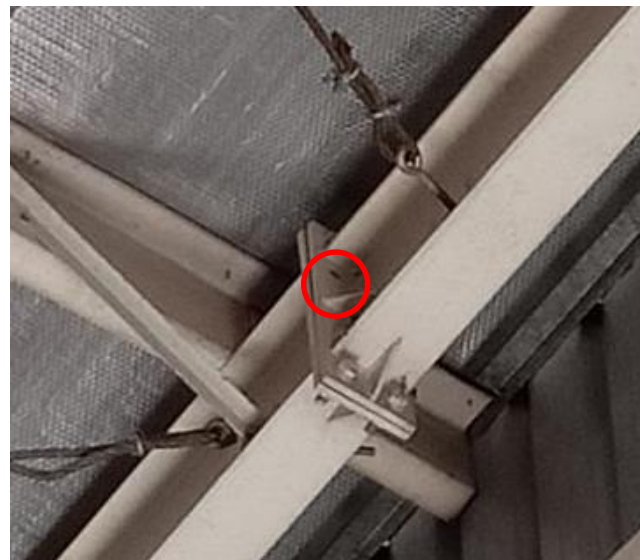
Bolts missing in several location

Significant gaps and bolts missing were observed at several connections. Building engineer is required to carry out suitable remedial works.

| Item No. | Observation | Recommended Action Plan | Recommended Timeline |
|---|---|---|---|
| 4 | Significant gaps and missing bolts at several connections | Identify all the locations of missing bolts & gaps and carry out suitable repair works where necessary. | 6-weeks |

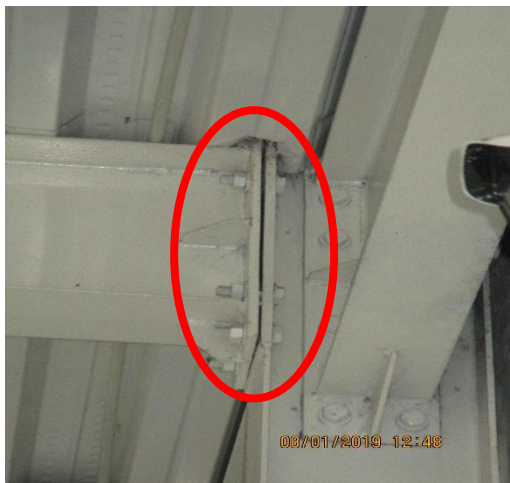
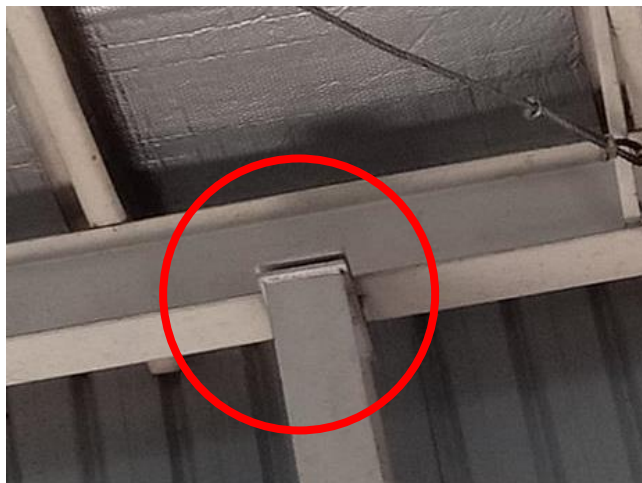
Existence of significant gap at connections

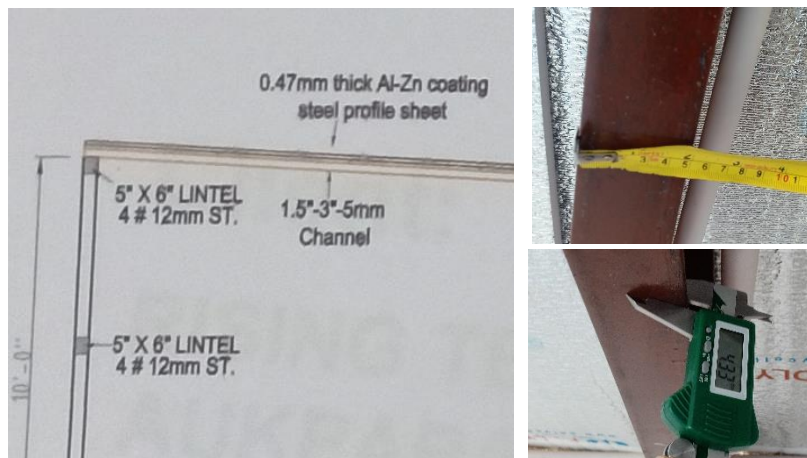
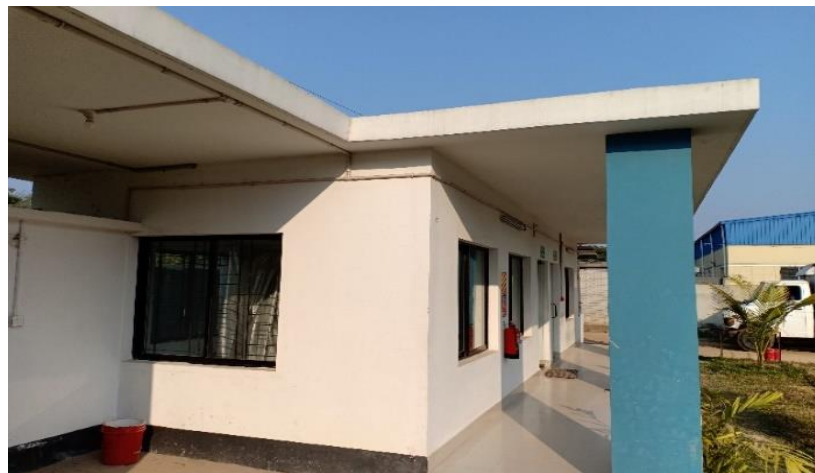
Canteen Shed

Channel sizes of rafter of canteen shed was found (100 x 50 x 4) mm instead of (75x37x5) mm.

| Item No. | Observation | Recommended Action Plan | Recommended Timeline |
|---|---|---|---|
| 5 | Lack of information and mismatch in provided drawings | Building Engineer to survey the ancillary structures and prepare accurate as-built drawing documents with connection details. | 6-weeks |

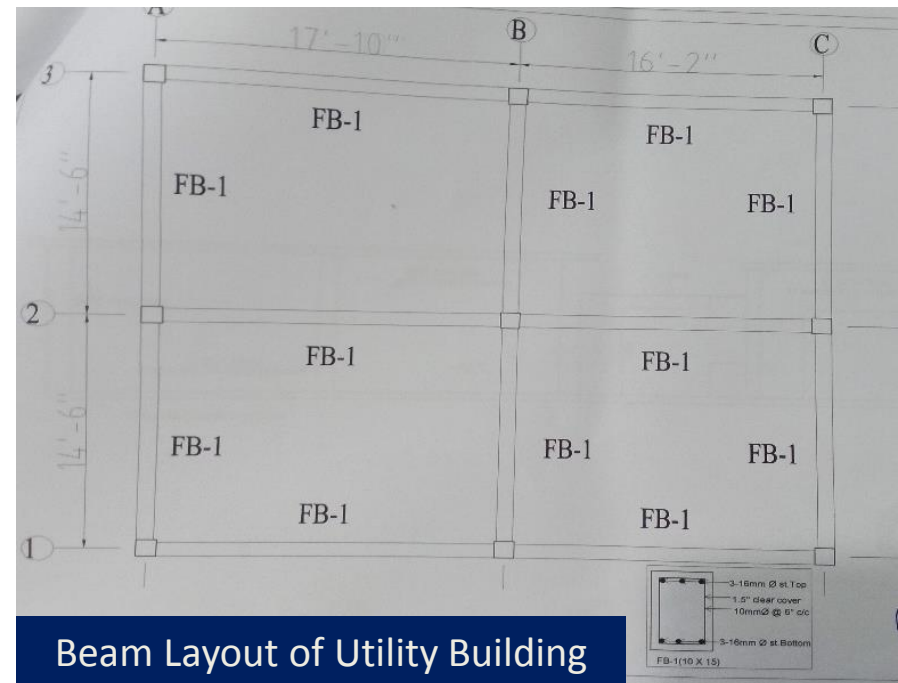
Beam Layout of Utility Building

Beam sizes did not match with drawings of Utility Building. Depth of beam was found 250 mm (10 inches) instead of 375 mm (15 inches).
