INITIAL STRUCTURAL INTEGRITY ASSESSMENT REPORT (SIAR)

Factory Name: **LALMAI FOOTWEAR LTD**
Address: **DHANPUR, CHAPAPUR, KOTWALI, COMILLA
3500,Area 2,46500 COMILLA Chittagong Bangladesh**
Assessor: **Sumerra**
Date: **16 Apr 2014**

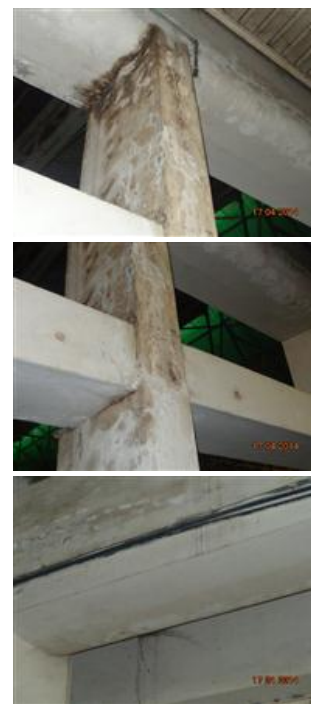
Question:	Have all areas of needed maintenance, including areas with efflorescence, dampness, standing water on rooftops, and corrosion been addressed.
Priority Level:	Medium
Non-Compliance Level:	1
Description:	Building #2: On the Ground floor North side near steel roof beam that is connected to shed # 1 there is water drain which is leaking and causing dampness on surrounding structural materials. Shed #1: Columns on the south side are damp due to water leakage.
Source of Findings:	Photograph: Areas of dampness
Suggested Plan of Action:	Under guidance from a qualified structural engineer, address all areas of needed maintenance by correcting the identified issues.
Suggested Deadline Date:	30 Nov 2014
Standard:	Alliance Standard Part 8 Section 8.26 Durability and Maintenance
