# Rose Intimates Ltd.

Baroipara, Ashulia, Savar, Dhaka, Bangladesh  
(24.021676N, 90.243656E)

8<sup>th</sup> and 21<sup>st</sup> January 2019

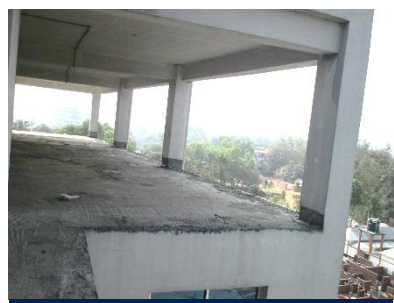
No barrier found on 5<sup>th</sup> floor

| Item No. | Observation | Recommended Action Plan | Recommended Timeline |
|---|---|---|---|
| 10 | Falling Hazard. (Main Factory Building) | Factory is required to provide railing/barrier for the under construction zone to protect any falling hazard. | Immediate - Now |

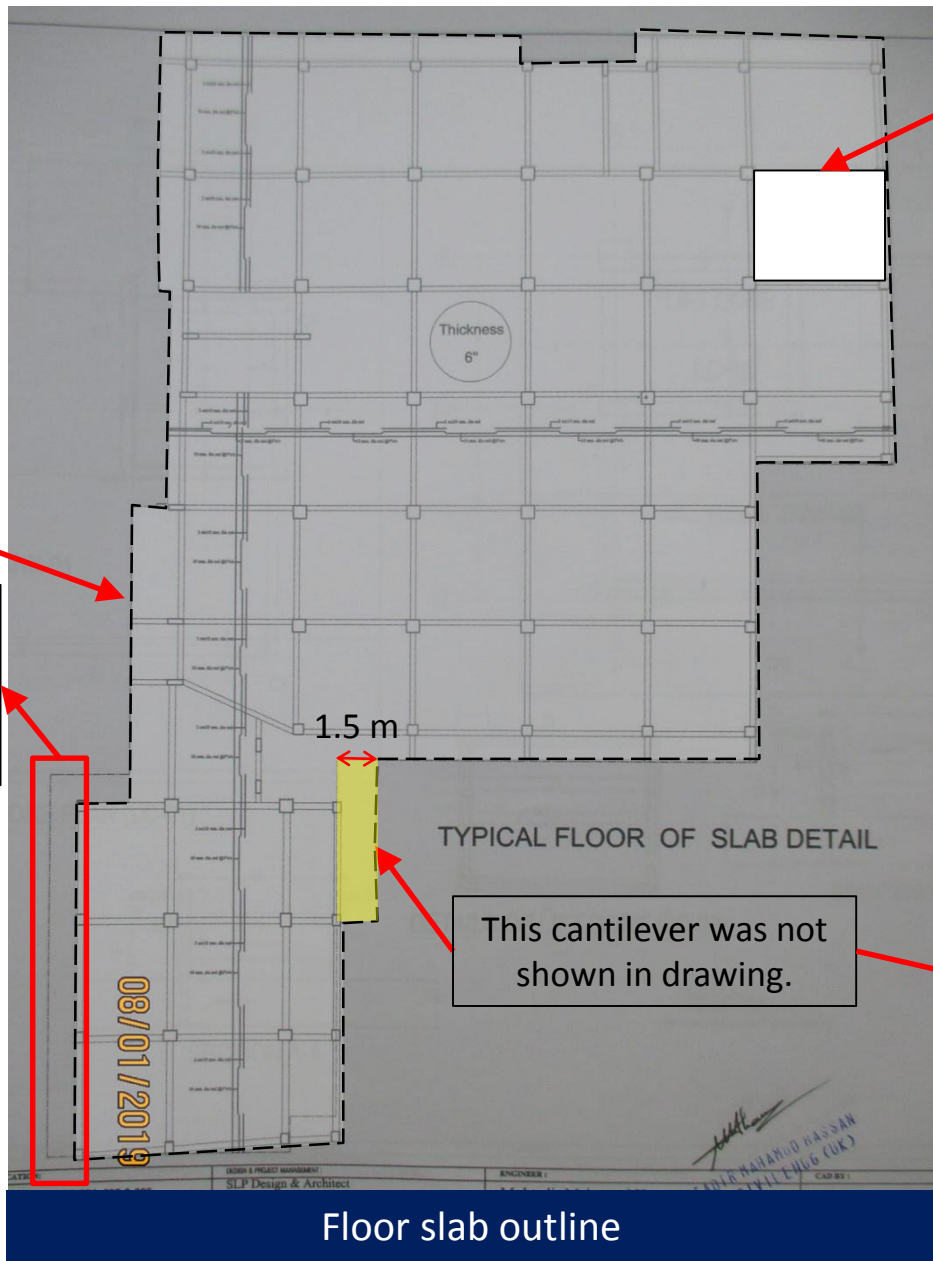
Floor slab outline

The slab layout (cantilever) of this building was not matched with provided drawings.

There was no cantilever in the marked portion but shown in layout drawing.

There was a void at 1st floor level (over loading/unloading zone) but shown in slab layout.

| Item No. | Observation | Recommended Action Plan | Recommended Timeline |
|---|---|---|---|
| 1 | Discrepancies in as-built drawings. (Main Factory Building) | Factory Engineer to survey the structure and prepare a full set of “as-built” drawings which reflect the as-constructed status. | 6-weeks |

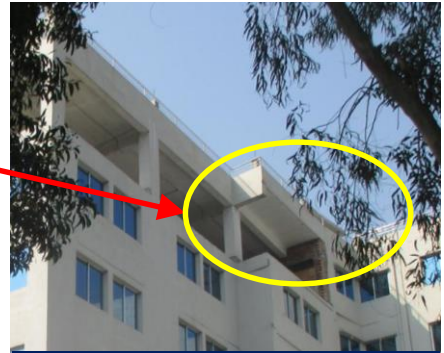
Cantilever on roof

This cantilever was not shown in drawing.

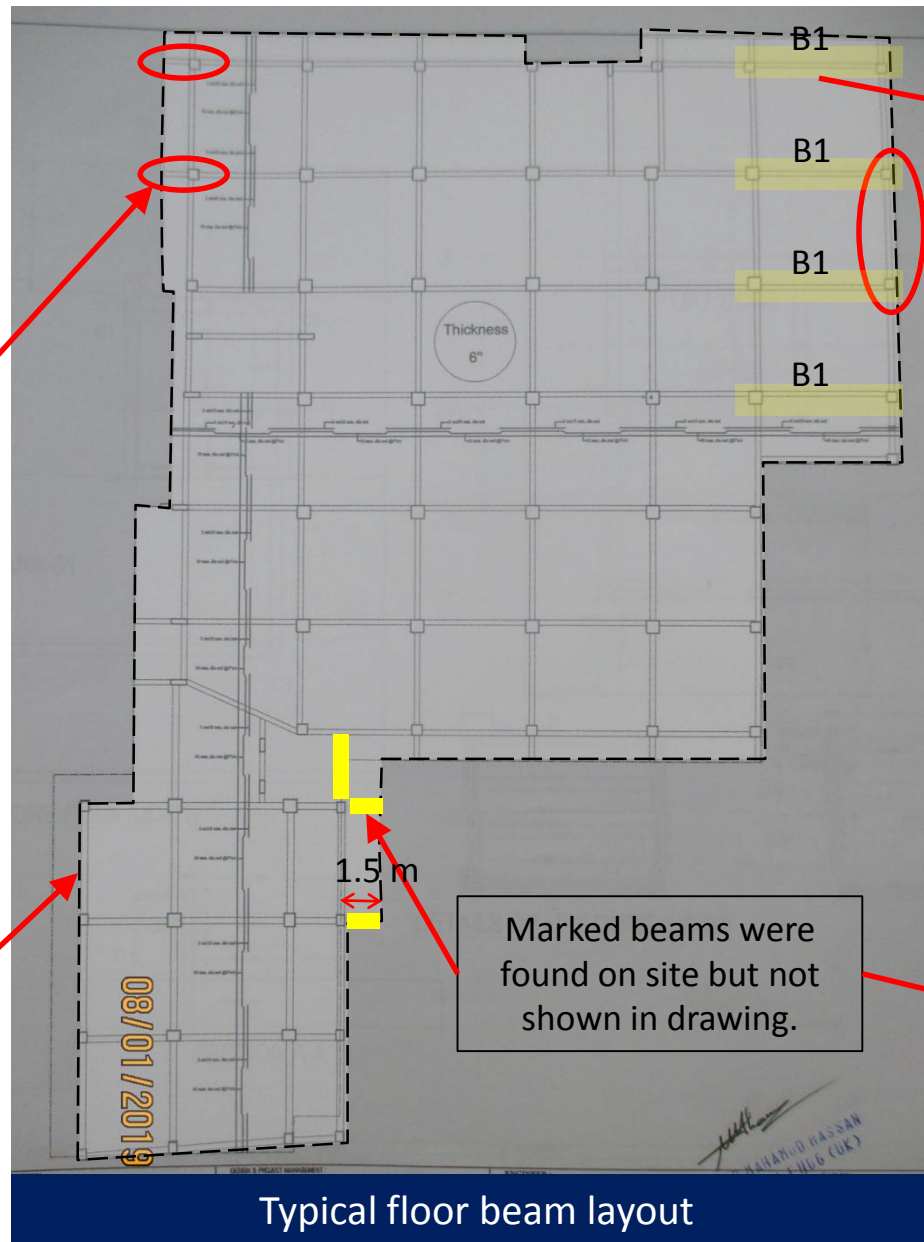
Slab outline

The floor beam layout of this building was not matched with provided drawings.

There was no cantilever beam on site but shown in drawing.

Beam B1 (300x600mm) was found instead of B2 (300x750mm) in the marked locations.

There was no beam in the marked portion at 1<sup>st</sup> floor level but shown in drawing.

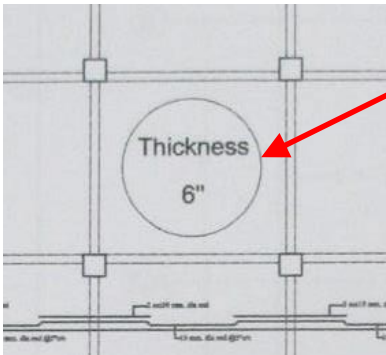
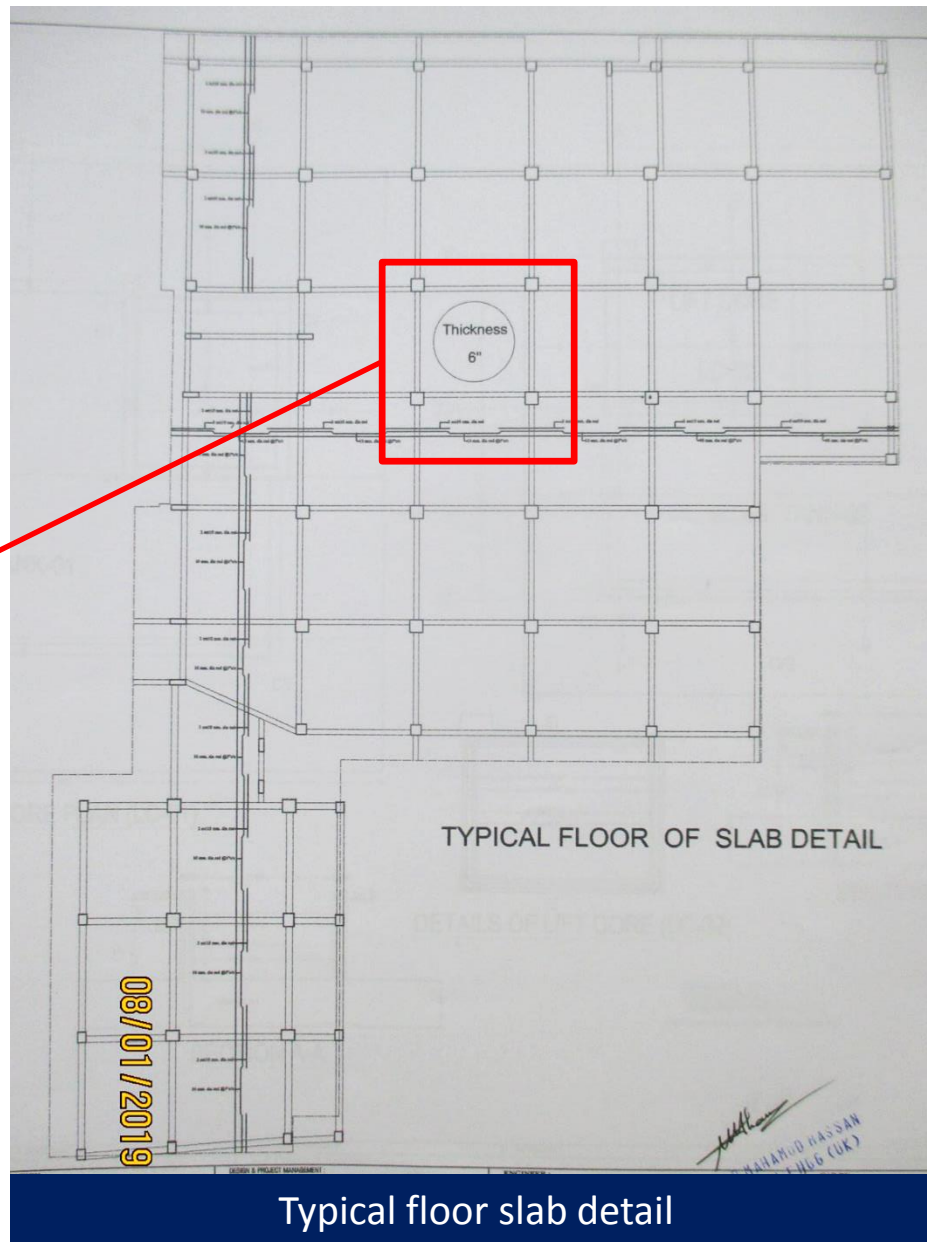
The floor slab thickness was not matched with provided drawings.

150mm (6") slab thickness was shown in drawings. But it varies floor to floor from 150mm to 200mm.

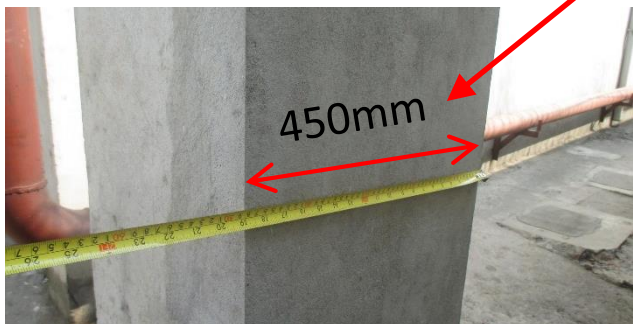
The size of C7 column was measured 300mmx 450mm instead of 300mm x 300mm. Also, 10 number rebar was found instead of 12.

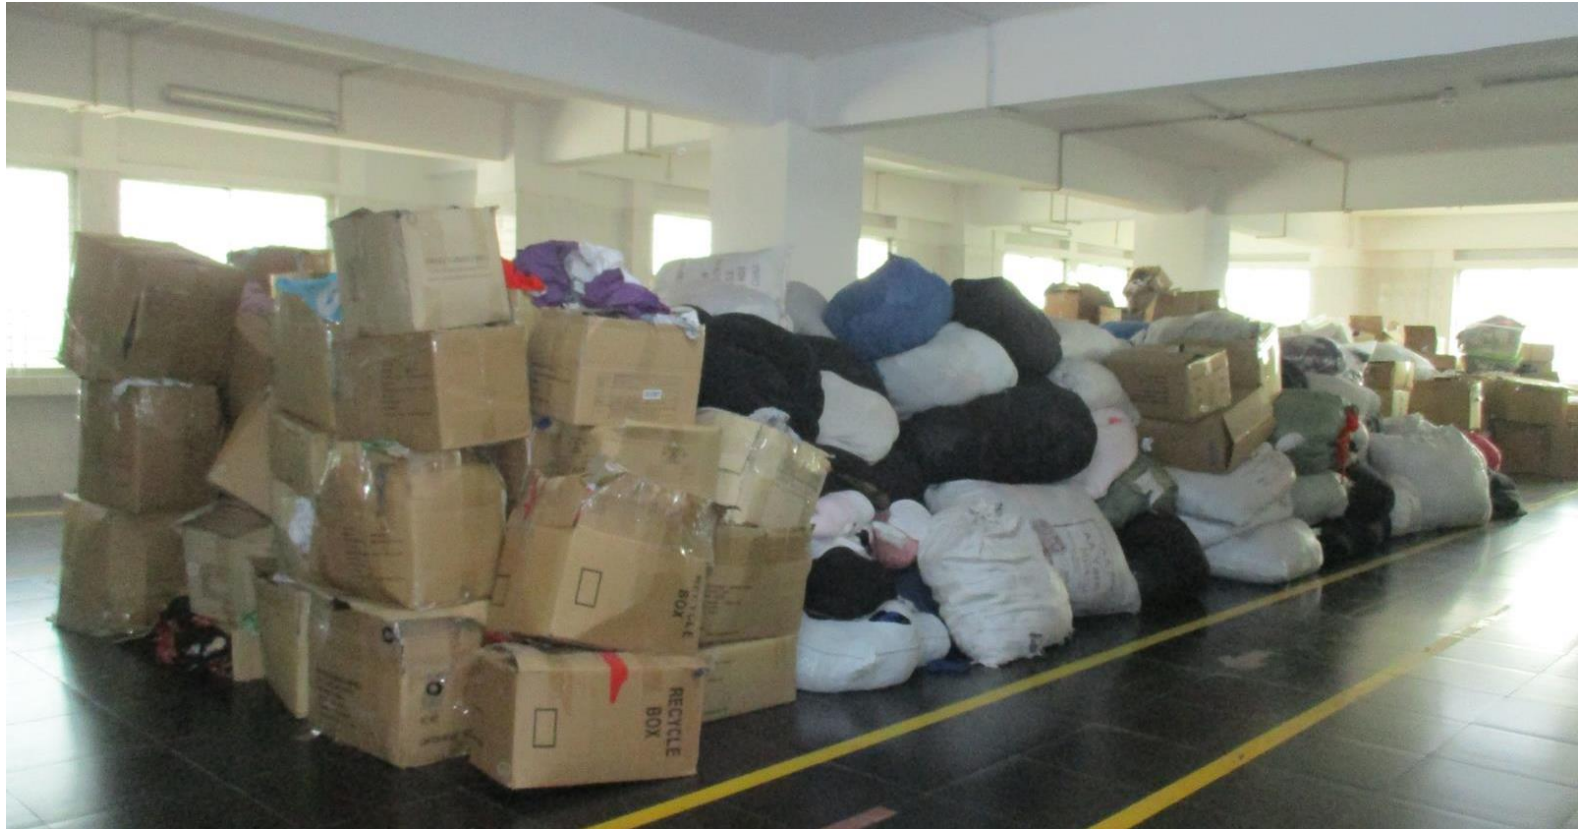
Neither visible load plan nor load restriction height marking was observed in any floor to maintain the design live load. The factory is required to implement floor load management program.

| Item No. | Observation | Recommended Action Plan | Recommended Timeline |
|---|---|---|---|
| 5 | Lack of floor load management program. (Main Factory Building) | Provide proper signage and load restriction height marking in each floor level and maintain floor live loading according to floor load plan. | 6-weeks |
| 6 | Lack of floor load management program. (Main Factory Building) | Implement the allowable floor loading plan. | 6-months |

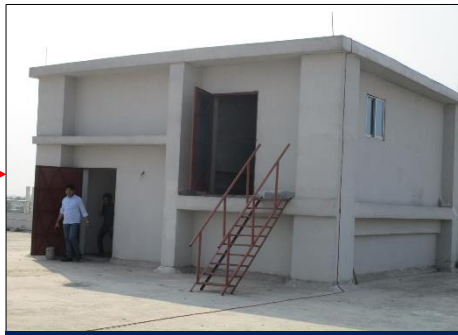
O.H.W.T with lift core

On the roof level, there three RC over head water tanks were shown whereas only one RCC water tank was found on the marked location. In addition, no roof top detail was found in as-built architectural drawing.

| Item No. | Observation | Recommended Action Plan | Recommended Timeline |
|---|---|---|---|
| 7 | Lack of detail for roof floor and adjacent steel stair. (Main Factory Building) | Factory engineer to prepare the floor layout for roof level. | 6-weeks |

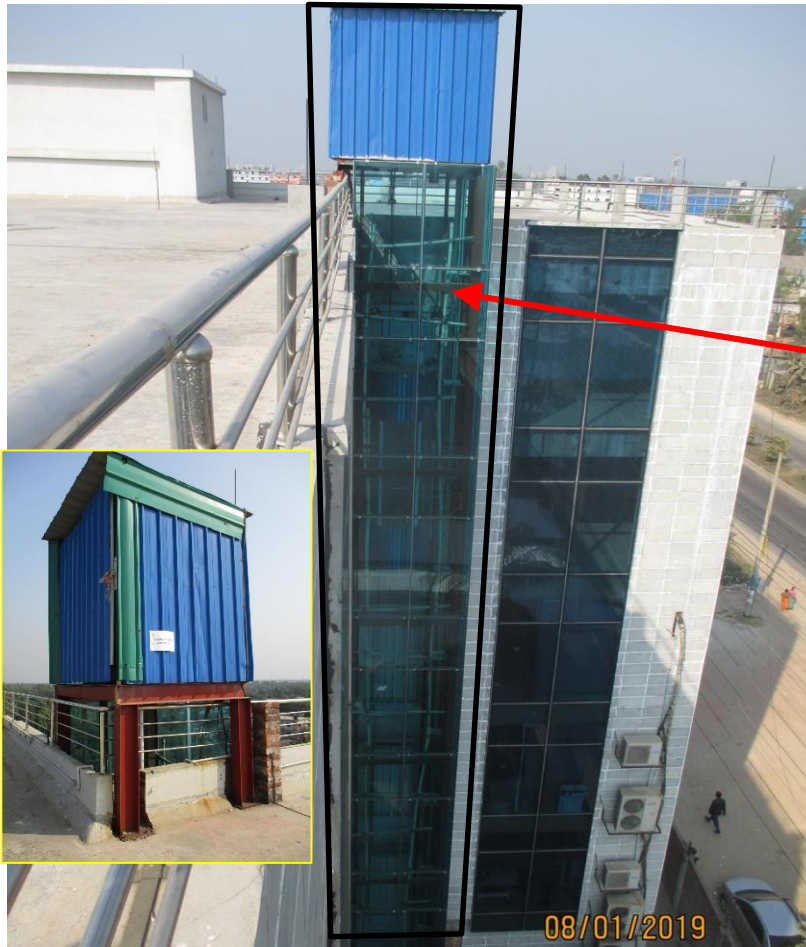
The steel lift core adjacent to main building.

A steel stair adjacent to main factory building have no architectural and structural details.  
The connection between main building and steel stair seems to be non-engineered.  
Structural redundancy of vertical member not to be verified.

| Item No. | Observation | Recommended Action Plan | Recommended Timeline |
|---|---|---|---|
| 8 | Lack of detail for roof floor and adjacent steel stair. (Main Factory Building) | Factory engineer to prepare the detail drawing and check the effect of steel stair to the main building and incorporate the analysis/calculation in the design report. | 6-weeks |

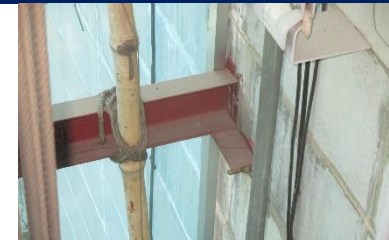
Connection (bolted) between steel frame to building

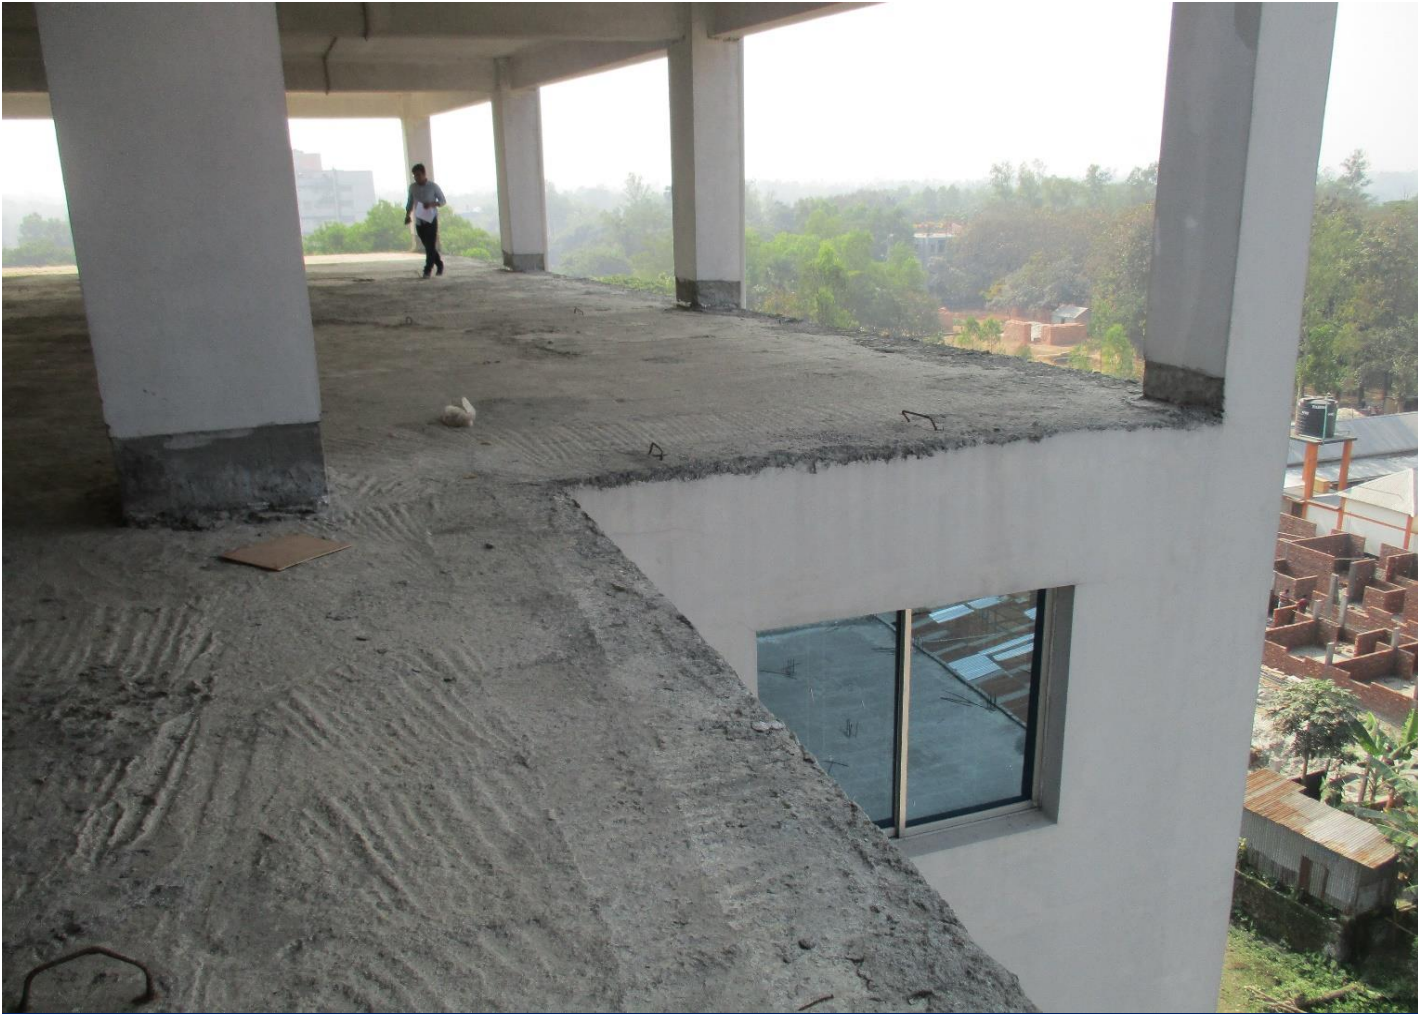
No peripheral railing/barrier was observed at 5<sup>th</sup> floor level which may causes any falling hazard. The factory is required to provide barrier around the floor.

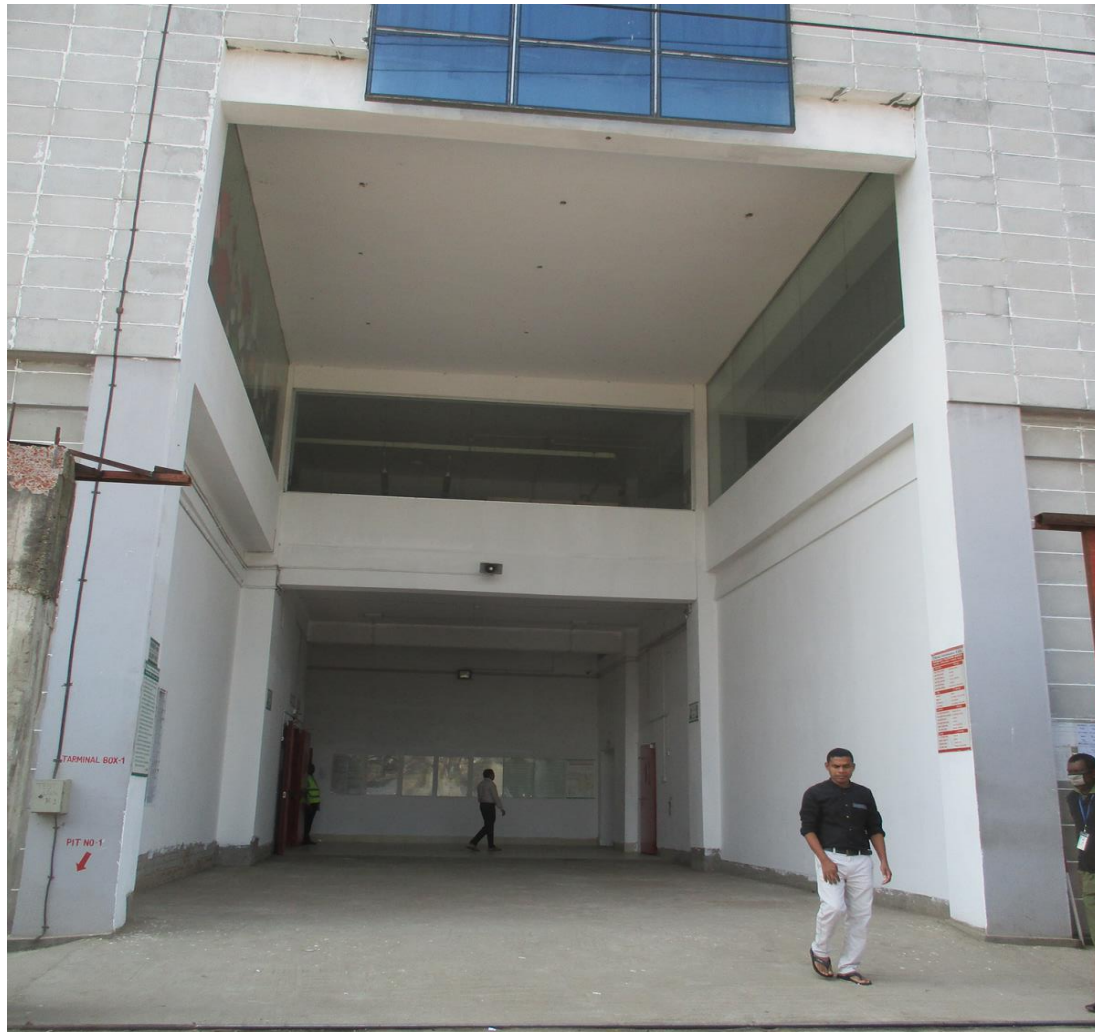
No barrier and signage was observed to protect the columns in loading-unloading zone which are susceptible to vehicle impact.

| Item No. | Observation | Recommended Action Plan | Recommended Timeline |
|---|---|---|---|
| 11 | Column is susceptible to vehicle impact. (Main Factory Building) | Factory is required to provide barrier for the columns susceptible to vehicle impact in loading unloading zone. | 6-weeks |

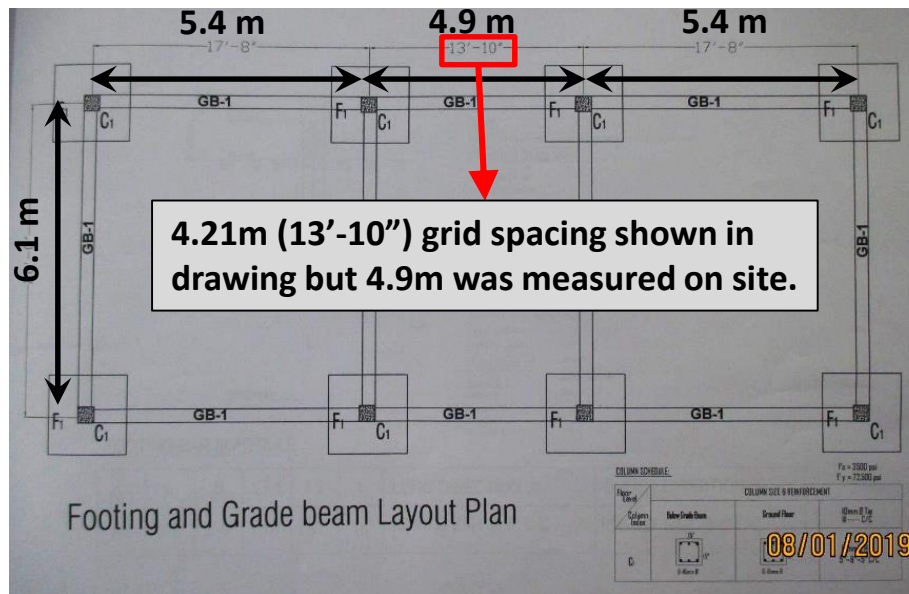
The grid spacing of Doctor's and Child-care building was not similar with provided drawings.

| Item No. | Observation | Recommended Action Plan | Recommended Timeline |
|---|---|---|---|
| 12 | Lack of as-built drawings. (Utility Buildings) | Factory Engineer to survey the structure and prepare a full set of "as-built" drawings which reflect the as-constructed status. | 6-weeks |

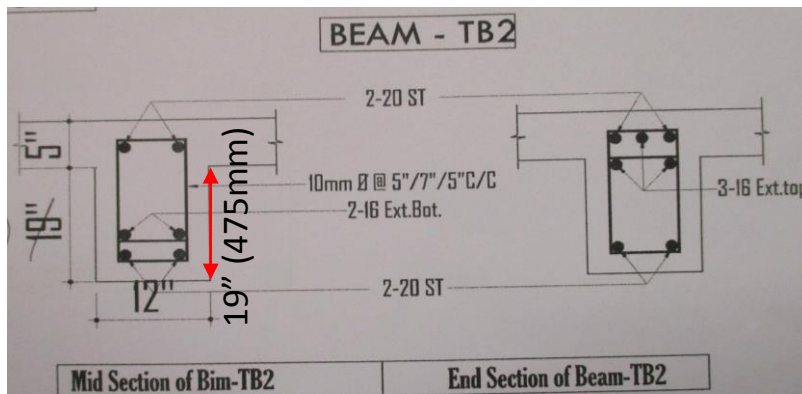
On site, down stand of TB-2 was measured 425mm (17") instead of 475mm (19").

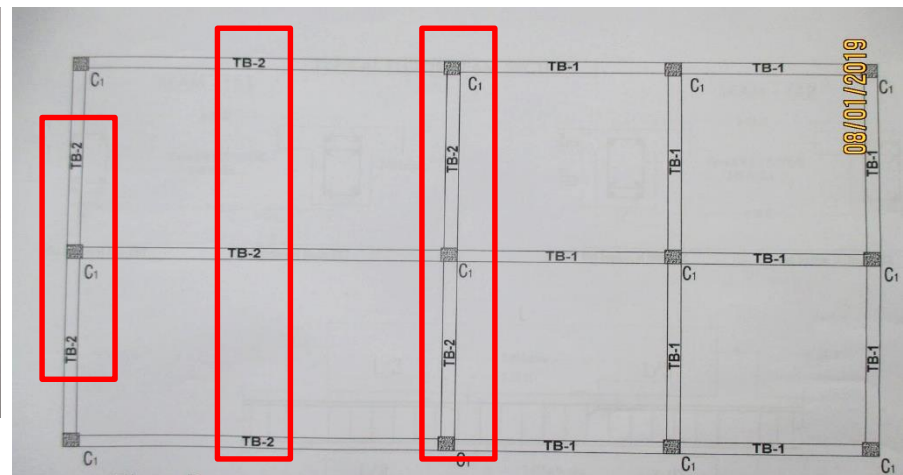
Column & beam layout

Also, column schedule and grid spacing of generator building was not available in the drawings.

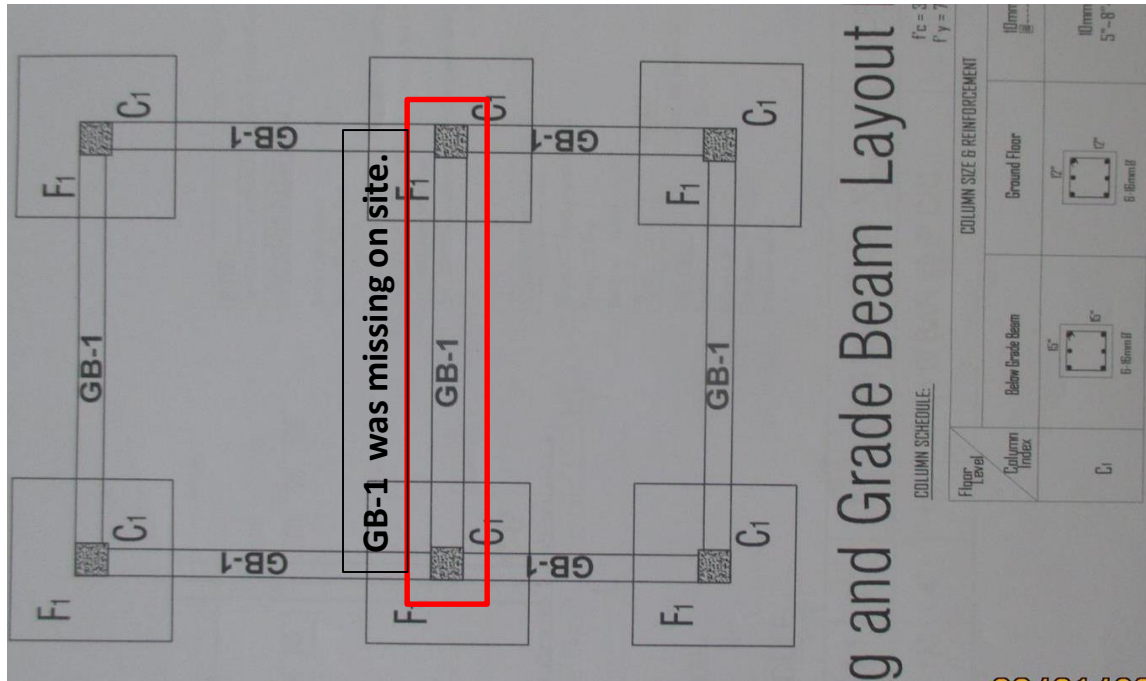
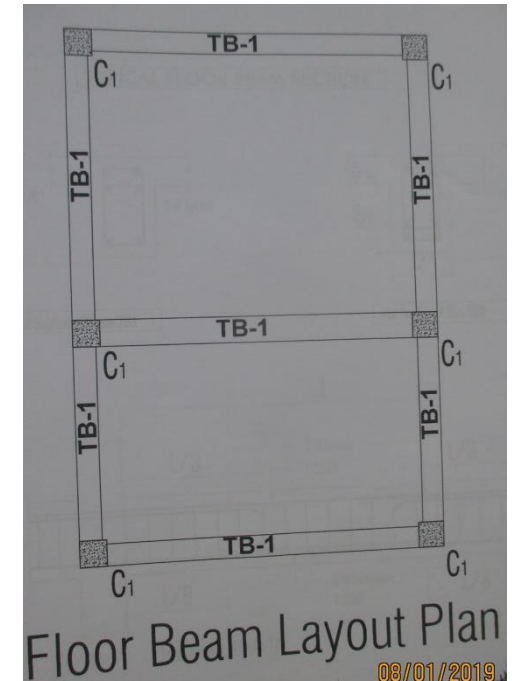
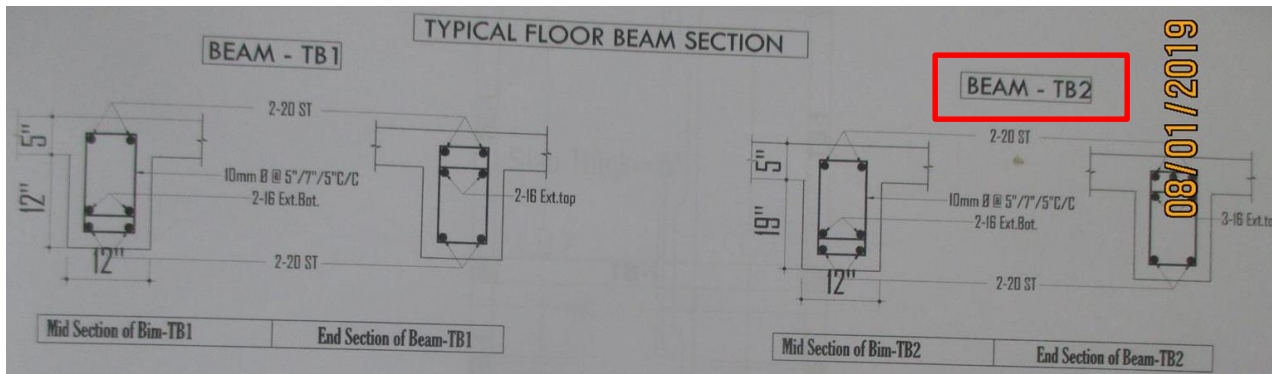
**TB-2 beam was not found in beam layout as well as on site**

The column grid spacing of Fire pump building was not shown in provided drawings. Also, internal grade beam was not found on site. There is no TB2 beam but shown in drawing.
