# United Costume Limited R.N. Knit Tex Ltd.

Malancha Nagar, I/A, R # 02, West Isdair, Fatullah, Narayanganj  
(23.633561N, 90.481962E)

7<sup>th</sup> January 2019

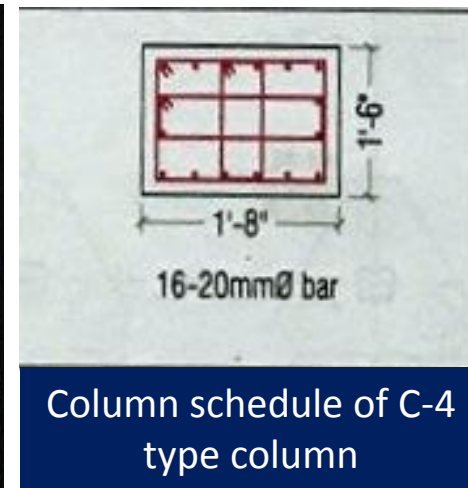
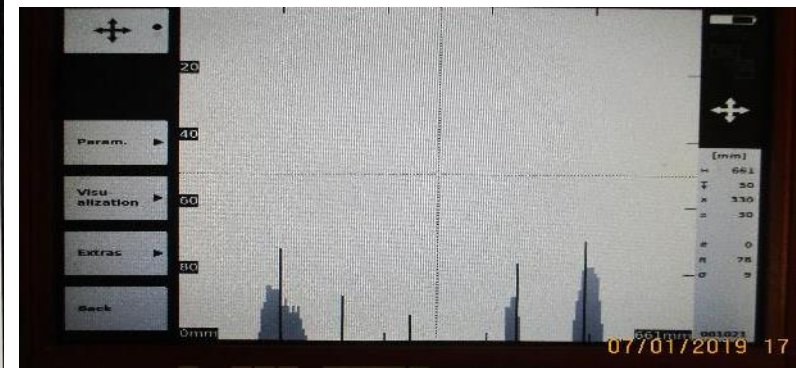
Column Layout

The number of rebar of C-4 column was found 5 number in 1'-8" face instead of 6 number as shown in the as-built drawing. The rebar number of the column is required to be confirmed in column schedule and layout.

| Item No. | Observation | Recommended Action Plan | Recommended Timeline |
|---|---|---|---|
| 1 | (Production Building)<br>Discrepancies between drawings and on-site observation | Factory engineer is required to survey all the structural elements properly and update as-built drawings. | 6-weeks |

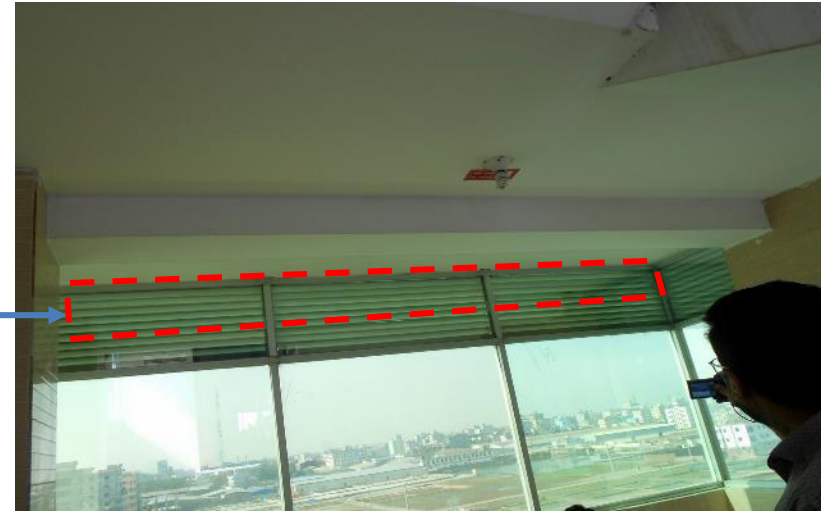
On the marked location in typical beam layout, no beam was found in any floor except ground floor whereas the beam was shown in as-built drawing.

Missing beam in all floor

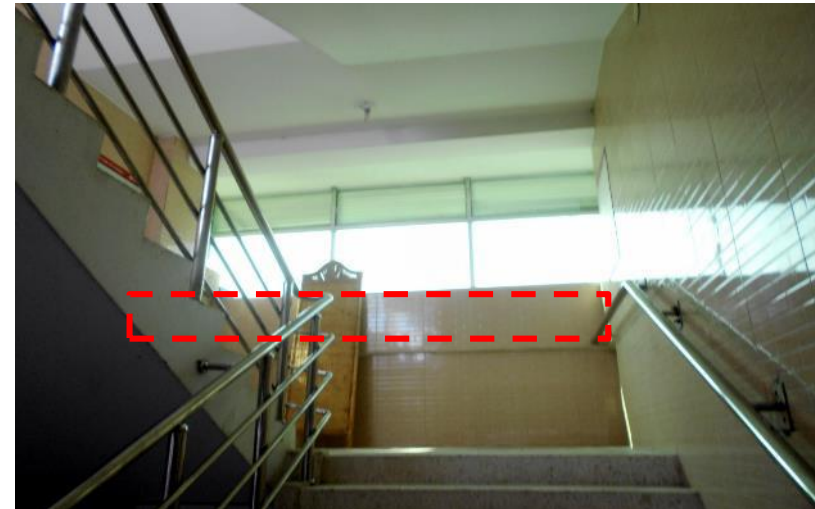
Beam is found on Ground floor only

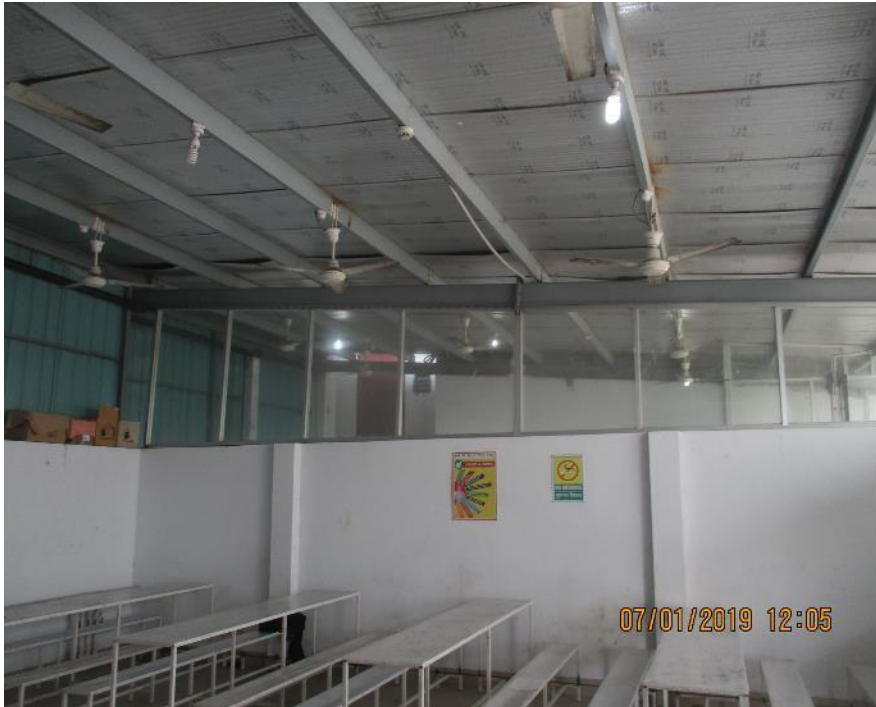
Steel frame (No vertical/Horizontal bracing)

No vertical bracing or compression strut was observed to provide lateral stability of the shed. Factory is required to check stability of roof Shed against lateral loads.

| Item No. | Observation | Recommended Action Plan | Recommended Timeline |
|---|---|---|---|
| 2 | (Production Building)<br>Lateral stability of roof top shed to be verified | Factory engineer to check the stability of lightweight steel shed against vertical and lateral loads. | 6-weeks |
| 3 | (Production Building)<br>Lateral stability of roof top shed to be verified | Carry out remedial works resulting from engineering assessment where necessary. | 6-months |

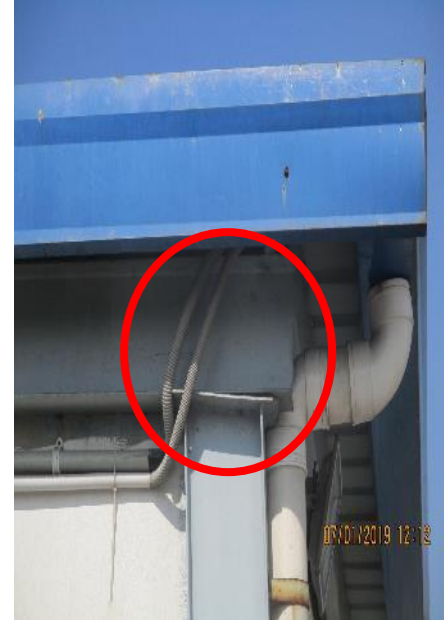
Improper welding connection between rafter and column

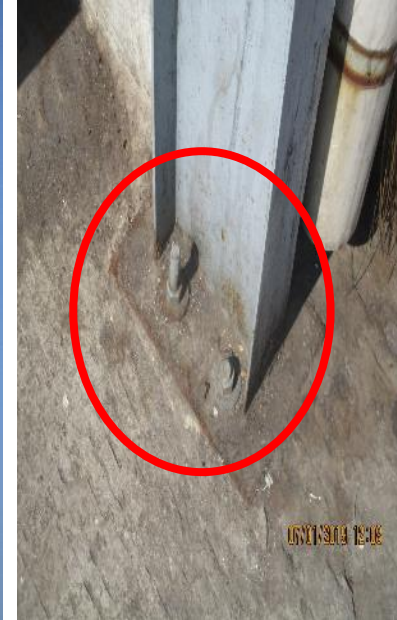
Steel columns were bolted on roof slab

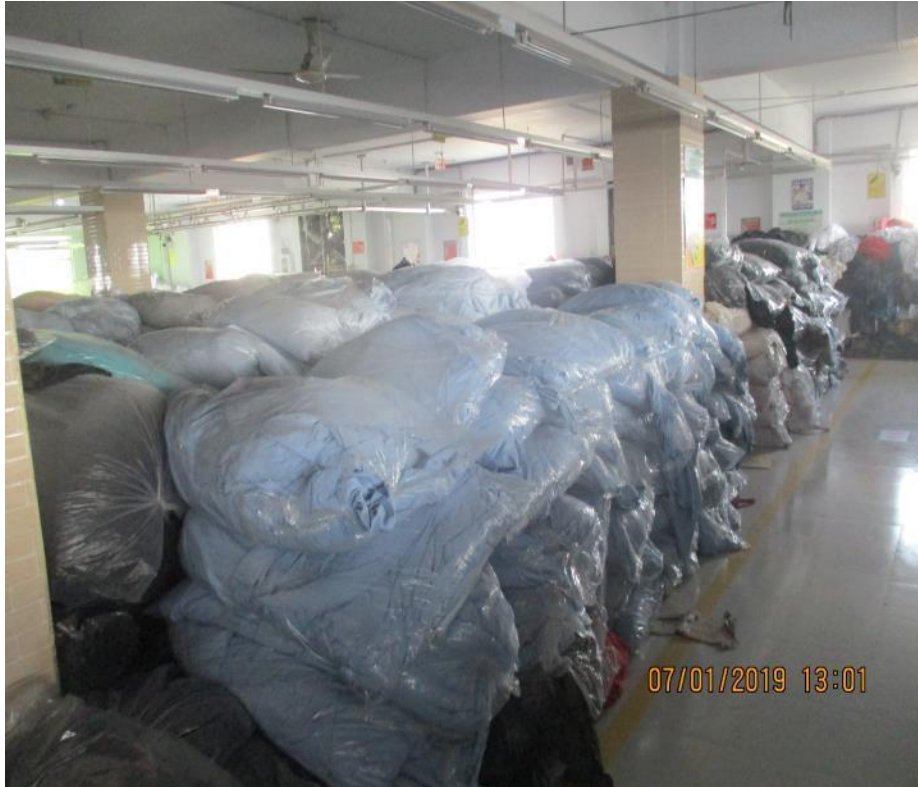
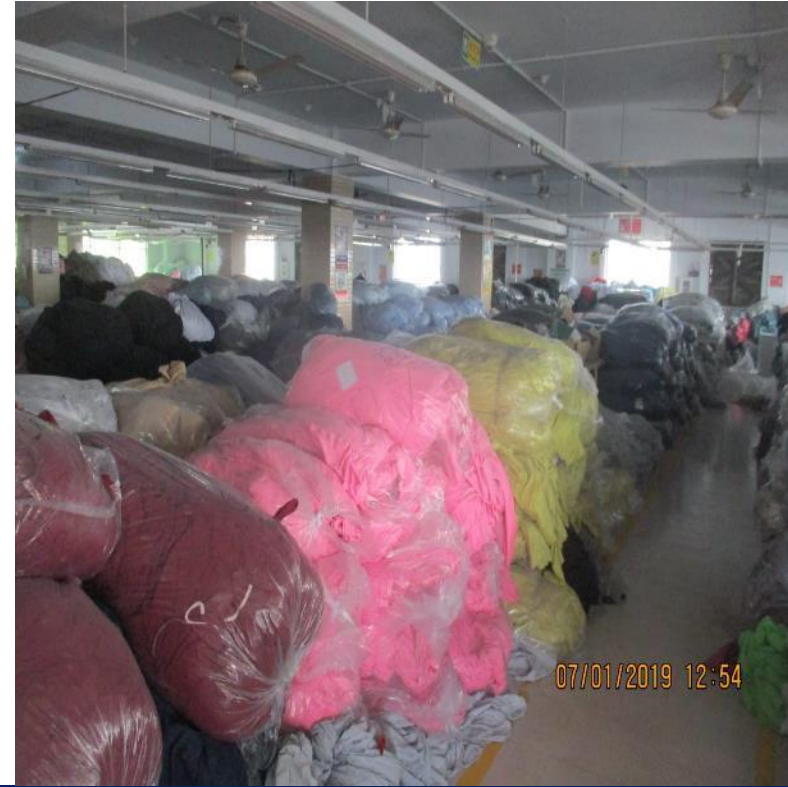
No load management programs were visible except posting load plan. Factory is required to implement load management program (with signage) as per its floor loading capacity. Follow the load plans for all floors and make sure that the workers understand the loading requirements.

| Item No. | Observation | Recommended Action Plan | Recommended Timeline |
|---|---|---|---|
| 4 | (Production Building)<br>Implement floor load management program | Factory is required to implement load management program (signage, load restriction height marking) as per its floor load plan. | 6-weeks |

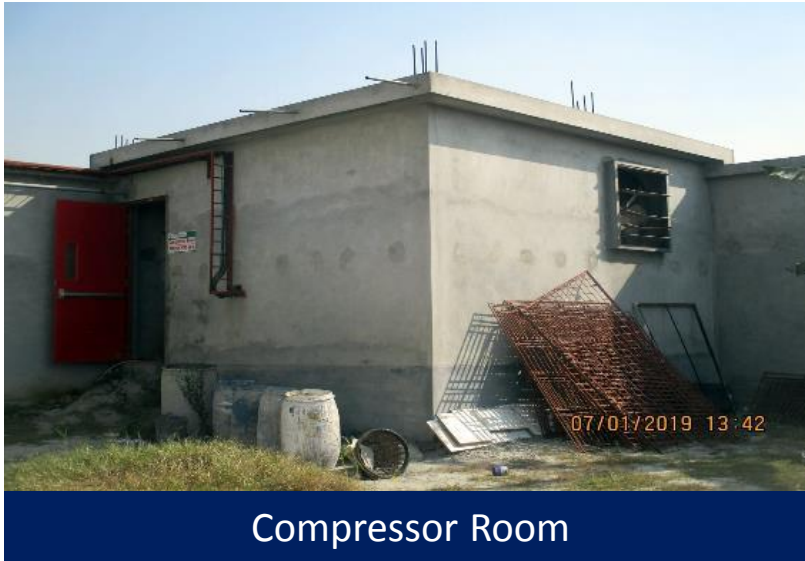
Compressor Room

No As-Built drawings were available on site for the Boiler & Generator Room and Compressor Room. Factory engineer is required to produce as-built drawings reflecting on-site condition.

| Item No. | Observation | Recommended Action Plan | Recommended Timeline |
|---|---|---|---|
| 5 | (Boiler & Generator Room & Compressor Room)<br>Lack of As-built Documents | Factory engineer is required to survey all the structural elements properly and produce correct as-built drawings. | 6-weeks |
