# Romo Fashion Today Ltd. (Extension 2)

Vannera Road, Mouchak, Kaliakoir, Gazipur

30<sup>th</sup> January 2019

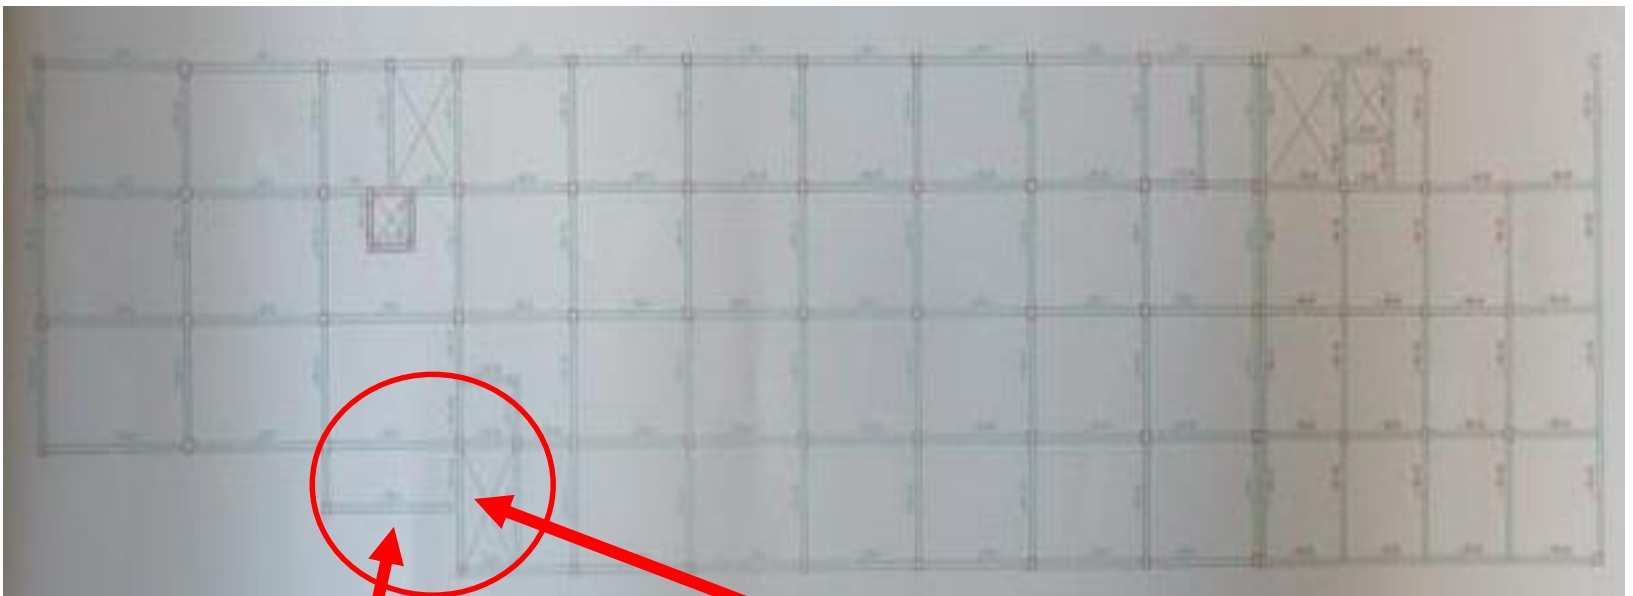
**Columns appeared to be stressed in excess  
of normal design limit**

Cursory calculation indicates that highlighted columns appear to be stressed above normal design limit.

| Item No. | Observation | Recommended Action Plan | Recommended Timeline |
|---|---|---|---|
| 1 | (Main Production Building)<br>Columns appeared to be stressed in excess of normal design limits | Factory Engineer to review design, loads and columns stresses of the building columns. | Immediate - Now |
| 2 | (Main Production Building)<br>Columns appeared to be stressed in excess of normal design limits | Verify insitu concrete strengths by taking 100mm diameter cores from minimum of 4 columns (lower tier). | Immediate - Now |
| 3 | (Main Production Building)<br>Columns appeared to be stressed in excess of normal design limits | An Engineering Assessment to be commenced. | Immediate - Now |
| 4 | (Main Production Building)<br>Columns appeared to be stressed in excess of normal design limits | Produce and actively manage a loading plan for all floor plates within the factory giving consideration to floor capacity and column capacity. | 6-weeks |
| 5 | (Main Production Building)<br>Columns appeared to be stressed in excess of normal design limits | Engineering Assessment to be completed. | 6-weeks |
| 6 | (Main Production Building)<br>Columns appeared to be stressed in excess of normal design limits | Make structural alterations as per the recommendation of engineering assessment. | 6-months |
| 7 | (Main Production Building)<br>Columns appeared to be stressed in excess of normal design limits | Continue to implement load plan. | 6-months |

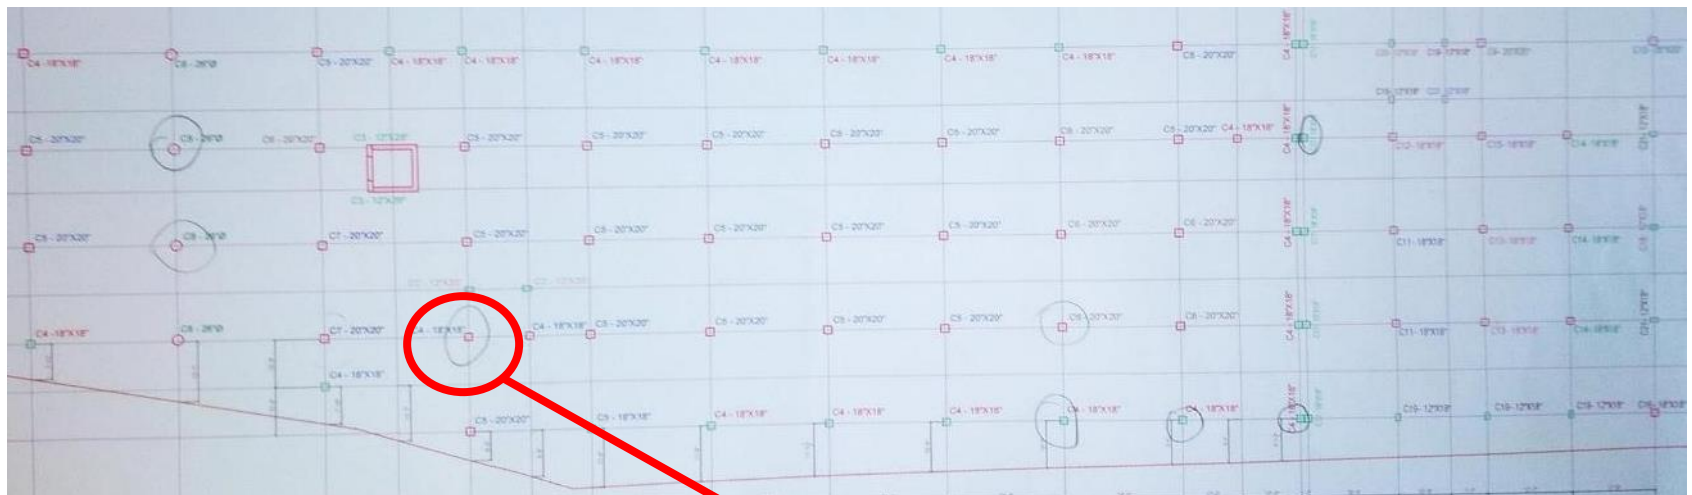
Column layout plan

C4 column dimension was measured to 18"x18" (450mm x 450mm) on site which was mentioned in column layout plan. But it was shown 21"x21" (525mm x 525mm) in column schedule.

| Item No. | Observation | Recommended Action Plan | Recommended Timeline |
|---|---|---|---|
| 8 | (Main Production Building)<br>Discrepancy in as-built drawing | Building engineer to survey the building and produce as-built documentation reflecting as constructed condition. | 6-weeks |

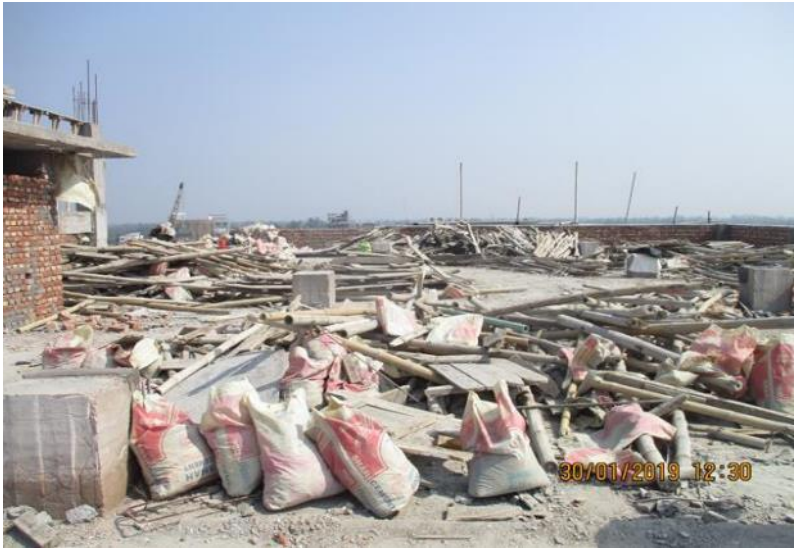
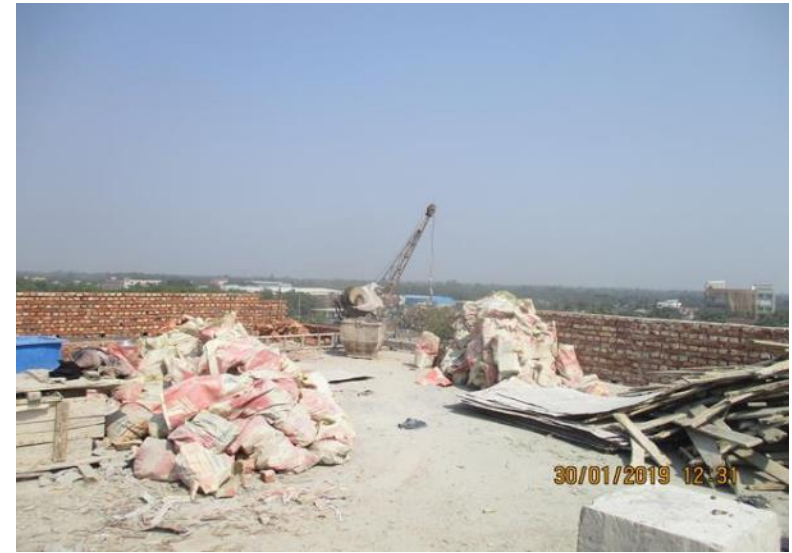
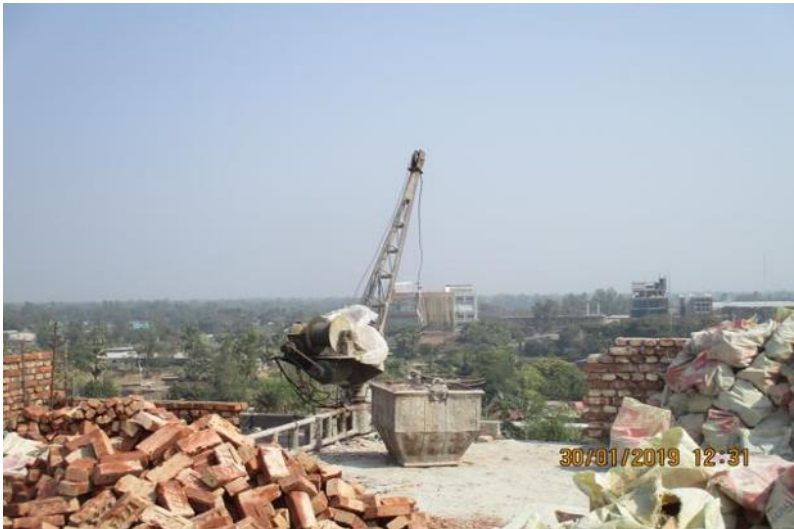
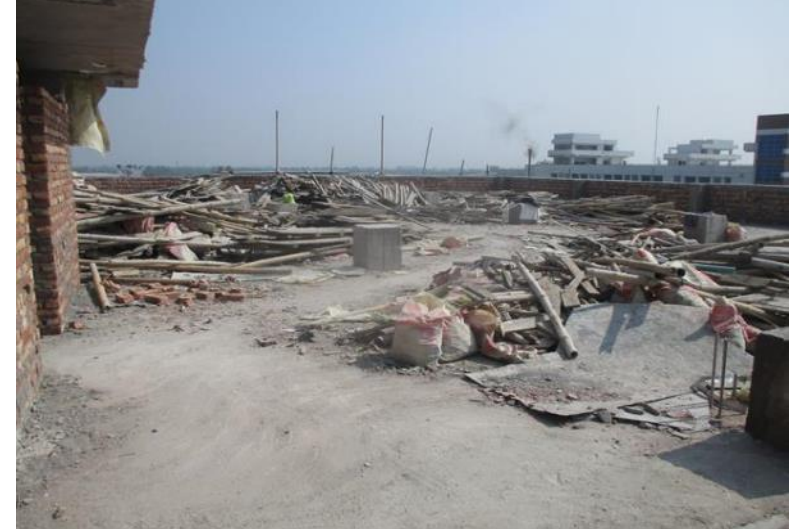
Construction material was found on roof floor

| Item No. | Observation | Recommended Action Plan | Recommended Timeline |
|---|---|---|---|
| 9 | (Main Production Building)<br>Construction material on the roof | Remove all storage from roof. | 6-weeks |

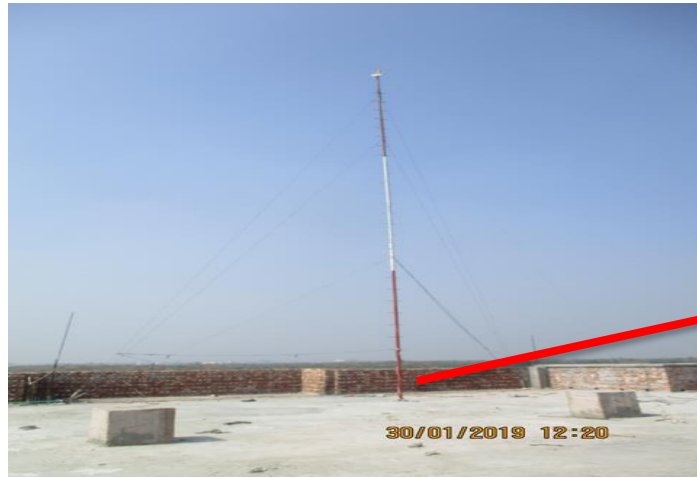
Undocumented telecommunication tower was observed on the roof.

| Item No. | Observation | Recommended Action Plan | Recommended Timeline |
|---|---|---|---|
| 10 | (Main Production Building)<br>Undocumented telecommunication tower on roof of Main Building | Building Engineer to assess the telecommunication tower regarding Engineering robustness and stability. | 6-weeks |
| 11 | (Main Production Building)<br>Undocumented telecommunication tower on roof of Main Building | Carry out remedial works arise from Engineering Assessment where necessary. | 6-months |

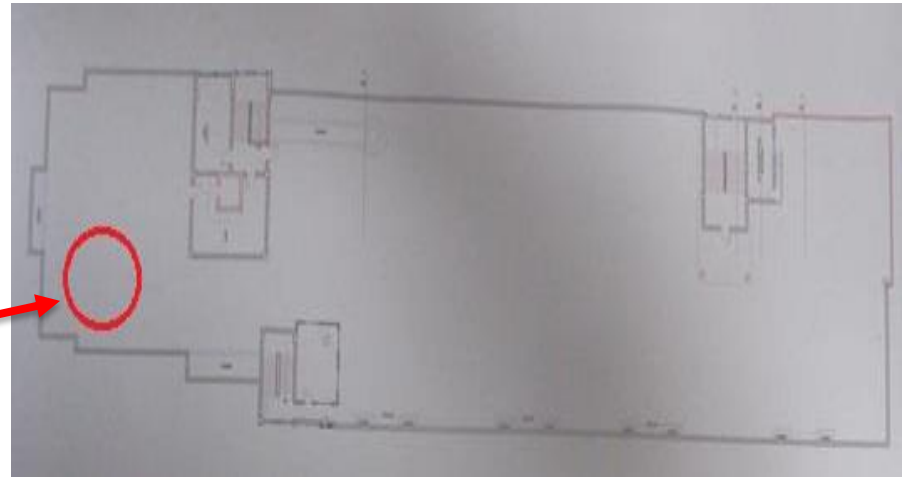
A telecommunication tower observed on the roof which was not shown in as built drawing

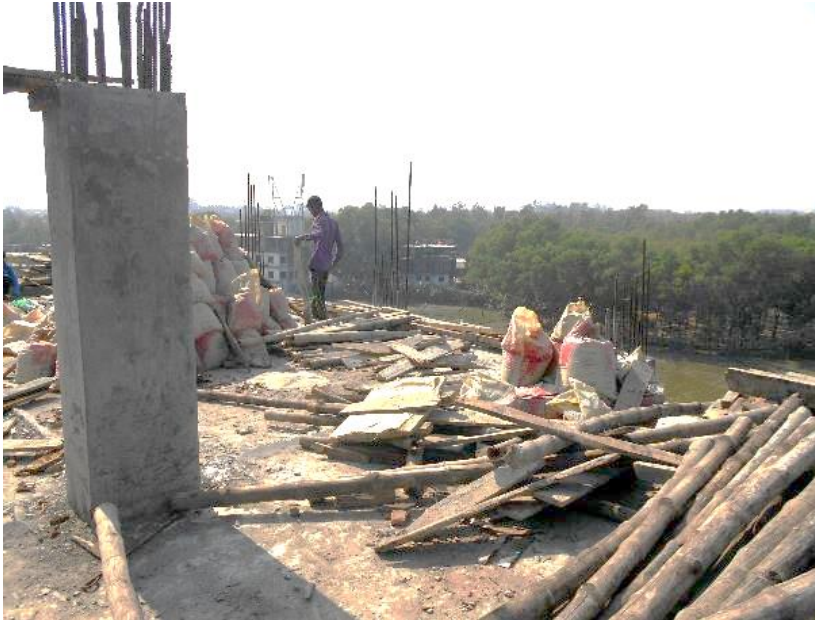
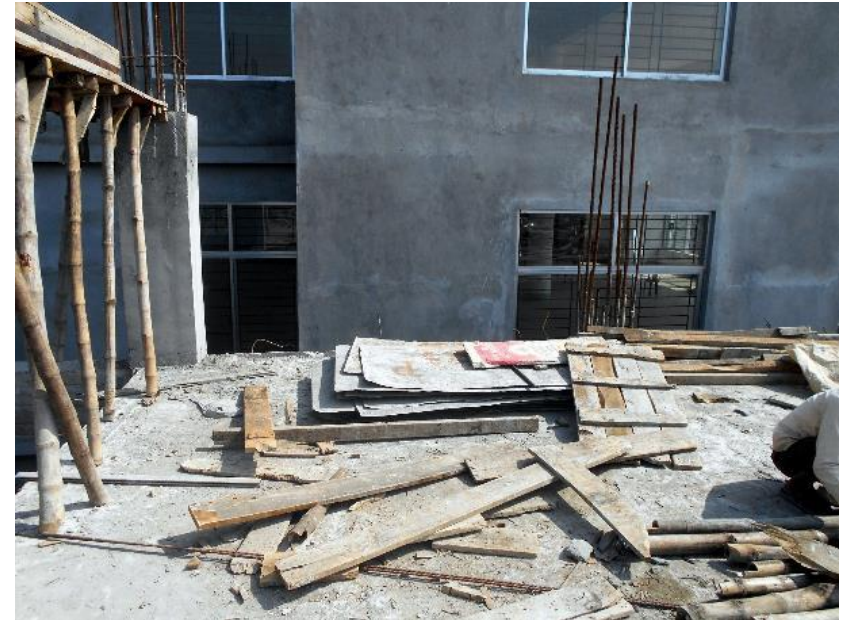
Construction material was found in the roof and 1<sup>st</sup> floor.

| Item No. | Observation | Recommended Action Plan | Recommended Timeline |
|---|---|---|---|
| 12 | (Boiler & Compressor Building)<br>Construction material on the roof | Remove all storage from roof. | 6-weeks |

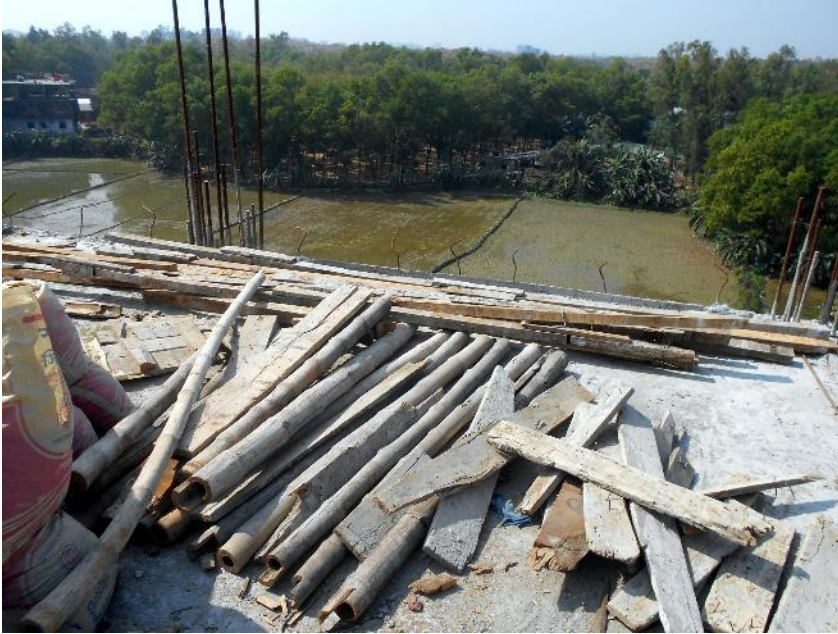
Roof level

No barrier found on roof level and 1<sup>st</sup> floor stair zone which is prone to falling hazard

| Item No. | Observation | Recommended Action Plan | Recommended Timeline |
|---|---|---|---|
| 13 | (Boiler & Compressor Building)<br>Falling hazard | Provide periphery railing/parapet wall to avoid possible falling hazard. | Immediate - Now |
