FIRE SAFETY INSPECTION REPORT

**MANAMI FASHION LTD.
KABIRPUR, ASHULIA, SAVAR**

ACCORD
on Fire and Building Safety in Bangladesh

April 16, 2014

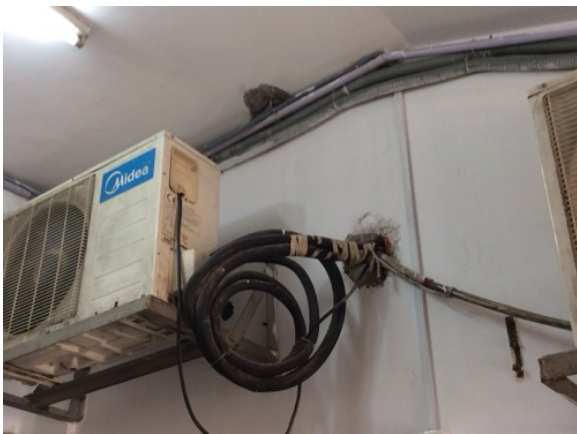
| No. | Category | Finding | Recommendation | Remediation Timeframe |
|---|---|--|---|---|
| F-1 | Fire Rated Construction | Unsealed penetrations and openings are located on the ground floor of the south western exit stair enclosures. | Seal all penetrations and openings in exit stair enclosure walls to maintain the fire separation. | Within 3 months |

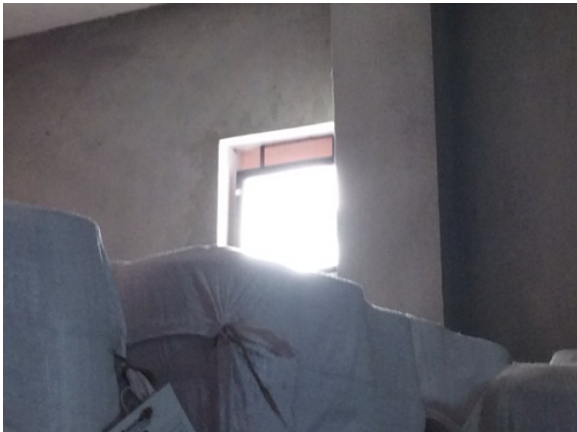
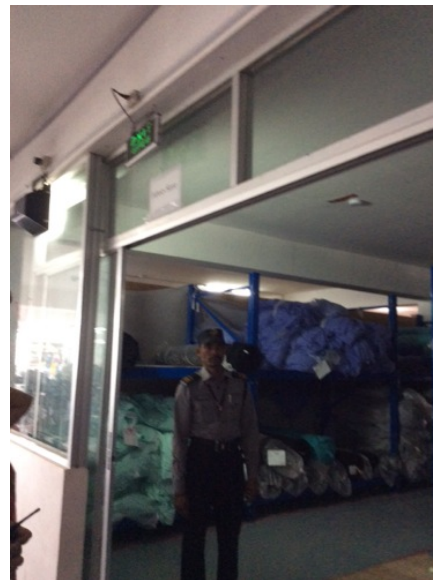
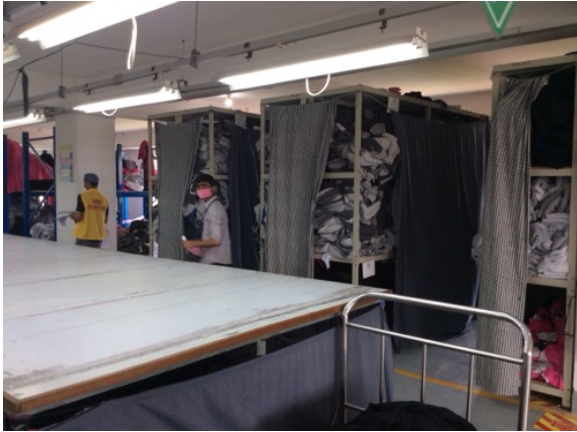
| F-2 | Fire Rated Construction | The bonded warehouse and other associated storage areas on the ground floor has unsealed penetrations and lacked fire rated doors. The fabric and accessory store on the second floor was not segregated from the production areas via fire rated construction. The makeshift fabric store of the cutting section on the second floor also exceeds the recommended limits. | Provide dedicated storage rooms separated by minimum 1-hr fire-rated construction. Where separate storage rooms are not feasible, provide defined storage areas and limit the storage arrangement as follows: - Maximum height of 2.4m and maximum area of 23m ² - If sprinkler protected: maximum height of 3.66m and maximum area of 93m ² Separate areas of unenclosed combustible storage by a minimum clear distance of 3m. | Within 3 months |

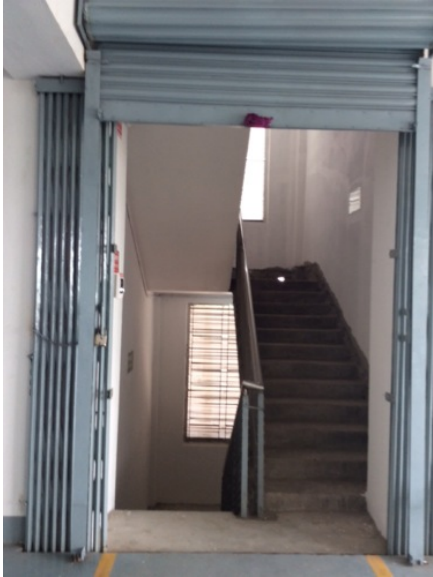
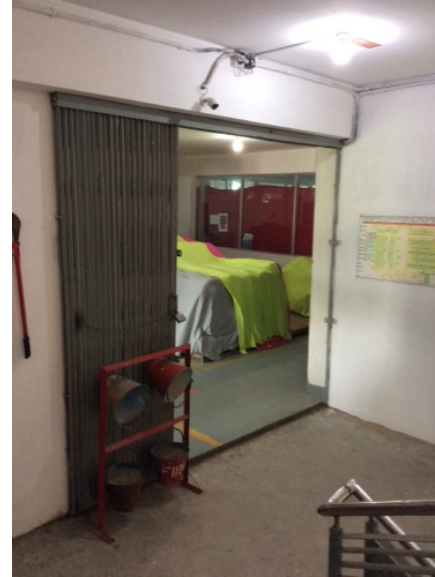
| F-3 | Fire Rated Construction | The exit stairs are not separated from work areas on each floor by fire-rated construction. | Provide minimum 1.5-hr fire rated doors and seal all unprotected openings to separate the exit stairs from work areas and other building spaces on all floor levels. Ensure that the fire doors are self-closing and positive latching and that they are provided with fire exit (panic) hardware where serving production floors. If fire doors are required to be held open for functional reasons, provide automatic-closing devices tied to the fire alarm system. | Within 3 months |

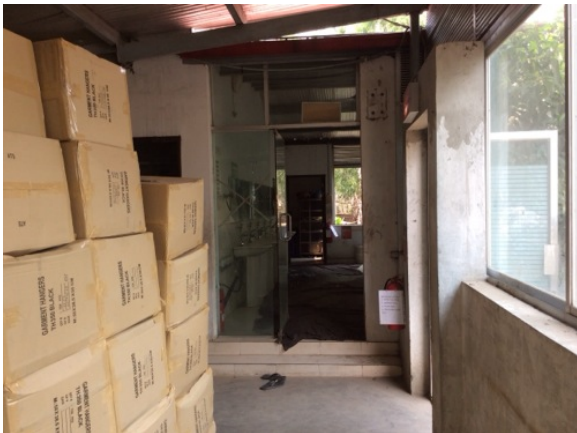
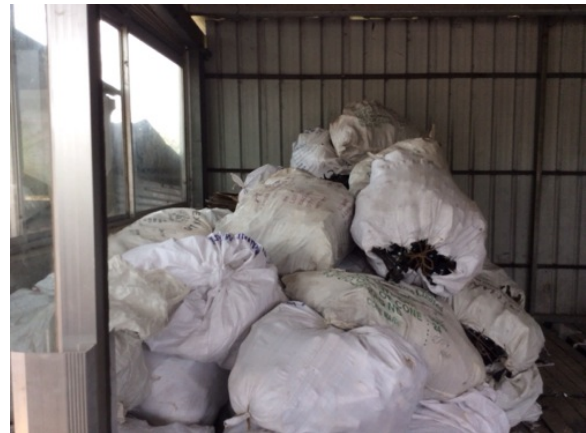
| F-4 | Fire Rated Construction | The storage area in the single storied shed are not segregated by fire rated construction and interferes with the egress paths of the dining and child care areas. | Provide dedicated storage rooms separated by minimum 1-hr fire-rated construction. | Within 3 months |

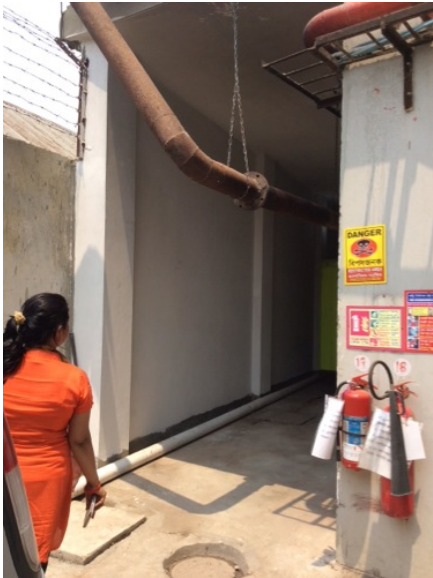
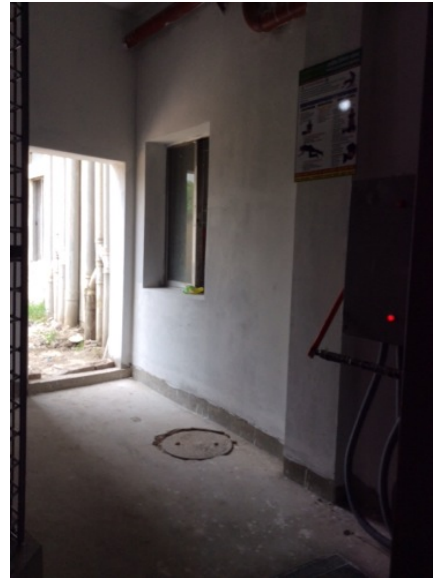
| F-5 | Fire Rated Construction | The generator and transformer room in the utility shed is not separated from the working areas by fire-rated construction (unprotected openings). | Separate the generator and transformer room by a minimum 2-hr fire-rated construction. Seal and/or protected all openings to maintain the required fire separation. | Within 3 months |

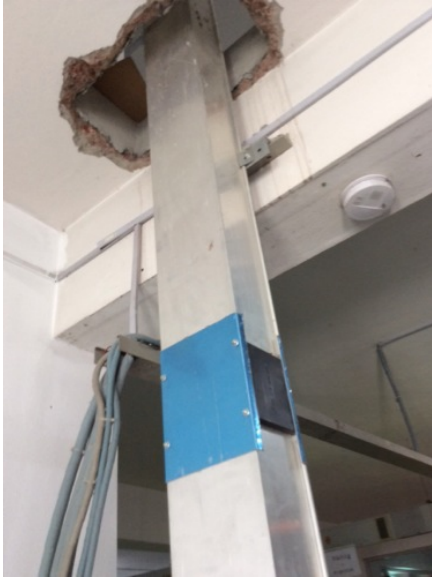
| F-6 | Fire Rated Construction | Unsealed penetrations and openings are located in the fire-rated floor/ceiling assemblies. Eg: Near the newly installed utility shaft on the second floor | Provide a minimum 2-hr fire-rated shaft to separate the utility risers from each floor level. | Within 3 months |

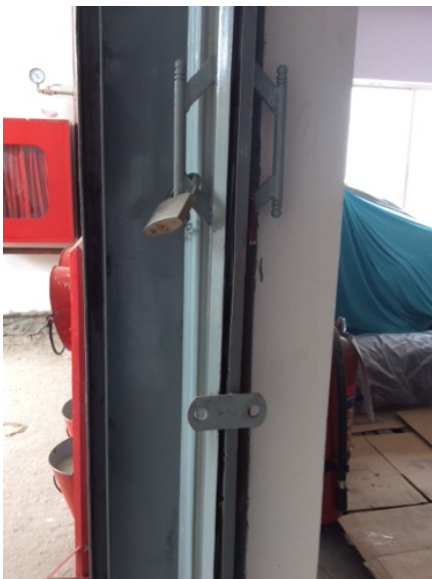
| F-7 | Egress | Egress doors / gates with locking features are provided at building exits, exit stairs, along egress routes and in exit discharge on all the floors. | Remove locking features from all egress doors / gates. If locks are required for security reasons, utilize special door locking features complying with NFPA 101. | Immediate |
| | | All the doors were found to be open during the inspection session. | | |

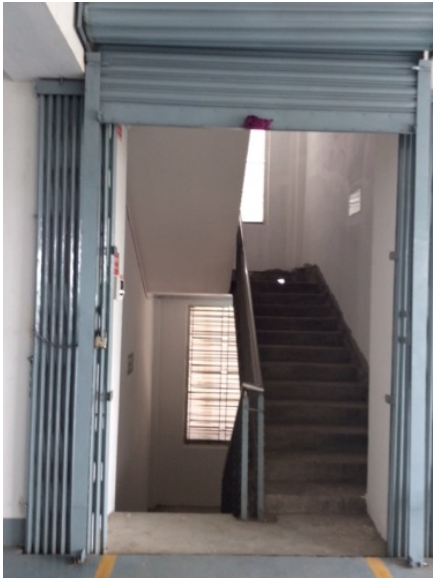
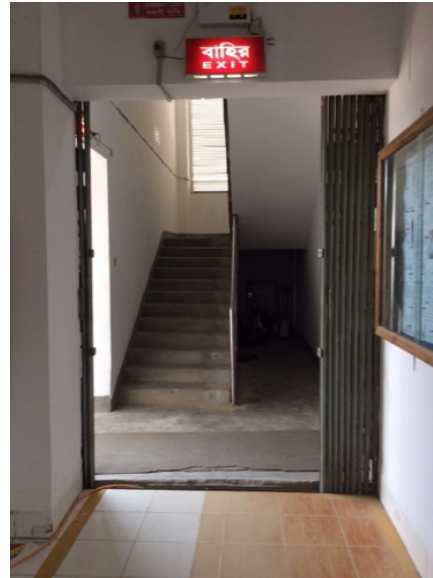
| F-8 | Egress | Collapsible gates / sliding doors are provided at all building exits, exit stairs, and in exit discharge points. | Replace all gates / sliding doors along the means of egress with side-hinged, swinging egress doors. If locks are required for security reasons, utilize special door locking features complying with NFPA 101. | Within 1 month |

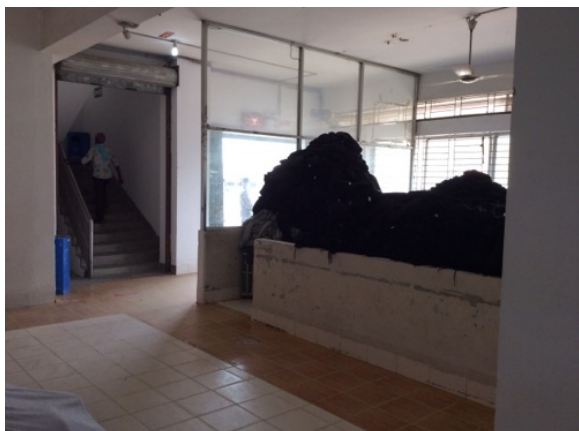
| F-9 | Egress | On the ground floor the northern exit stairs discharges into the production and transient storage areas. | Provide 2-hr fire-rated exit passageway leading directly outside (vestibules to separate any storage areas). Alternatively provide sprinkler protection for discharge floor in accordance with NFPA 13. | Within 3 months |

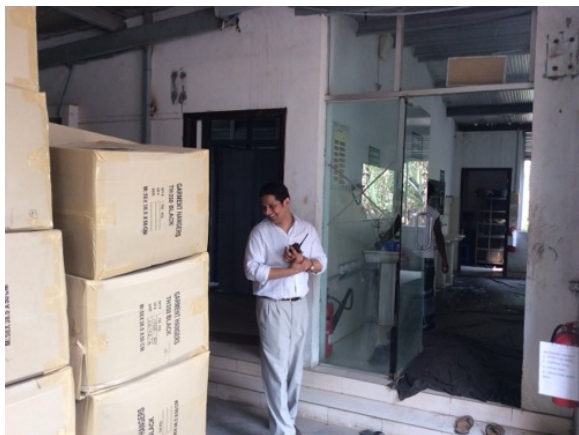
| F-10 | Egress | The day-care room does not have direct access to an exit. The discharge has to take place through the one storied storage area. | Provide a minimum 2-hr fire-rated exit corridor between the day-care room and exit gate. | Within 3 months |

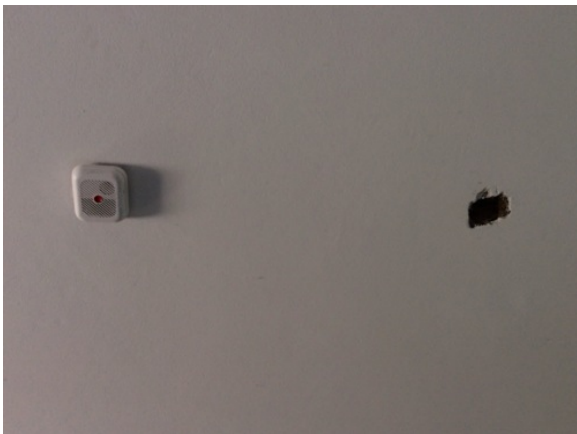
| F-13 | Fire Protection | The building is equipped with single-station smoke alarms. Smoke alarm activation sounds only a local alarm and does not provide automatic fire alarm notification of occupants. | Remove single-station smoke alarms. Provide automatic smoke detection throughout the building in accordance with NFPA-72 | Within 6 months |

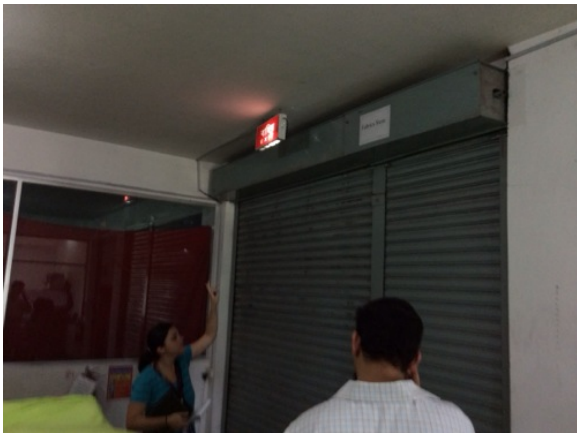
| F-14 | Egress Lighting | Some of the exit signs were in a position such that the most immediate exit access was not evident. Eg: On the second floor the exit signs pointed into the storage areas. | Replace all intermediate exit signs with directional signage such that the most immediate exit egress path is known. | Within 3 months |
