Revision: Issue 1
Date: 18th March 2015

NR Knitting Mills Ltd.

Enayetnagar, Bholail, Fatullah, Narayanganj.
(23.619090N, 90.478626E).
11th March 2015

Structural Inspection Report

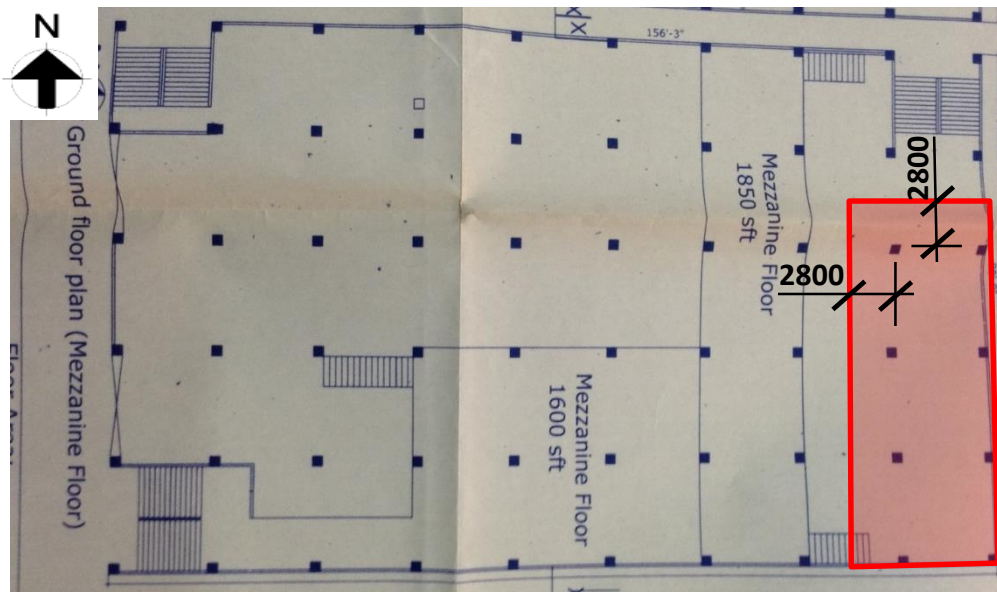
We have important and urgent concerns in relation to the column stresses in the building. Columns carrying the toilet areas at the east end of the building appear to be stressed to levels that require urgent review. The following **immediate** actions are required to be carried out:

Vacate and cordon off this area at all levels **immediately**, pending outcome of Detail Engineering Assessment

1. The area indicated below is to be vacated and cordoned off at all levels.
2. A Detail Engineering Assessment for the building is to be carried out, the extent of which is outlined towards the end of this report.

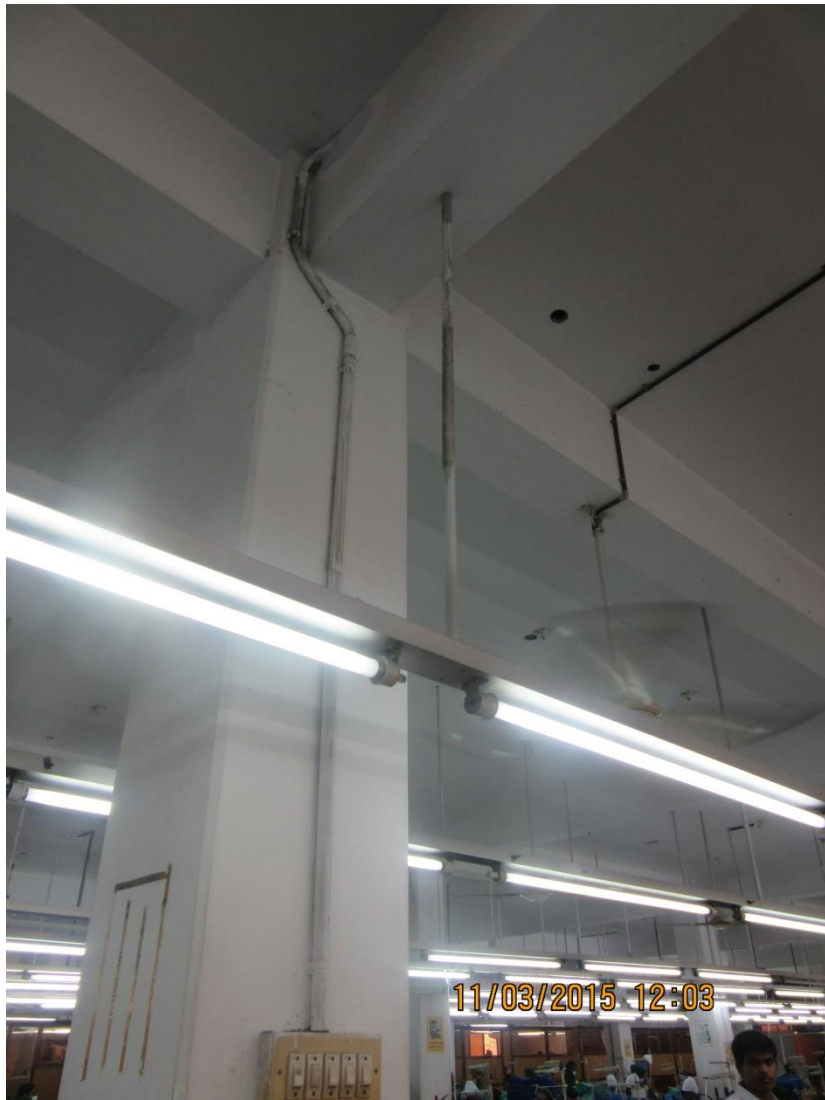
Beams and slab at ground and 1st floor

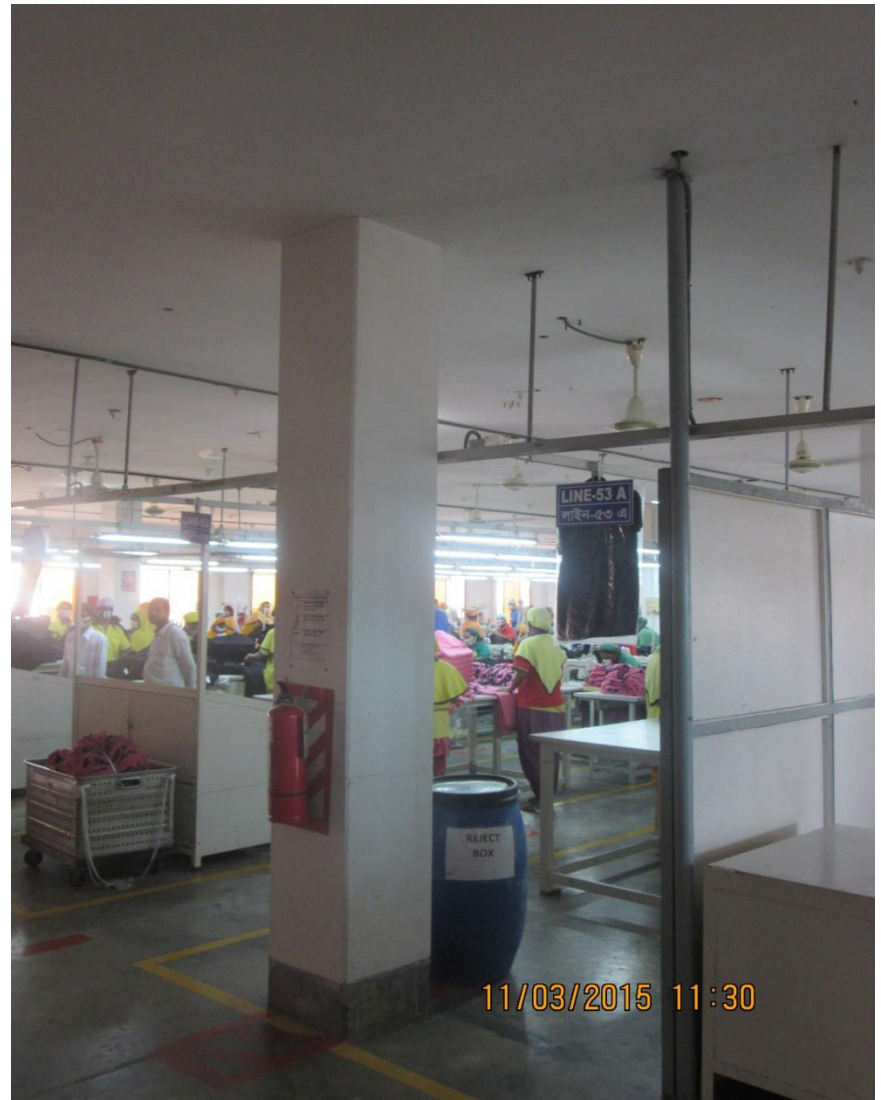
Flat slab from 2nd floor and above

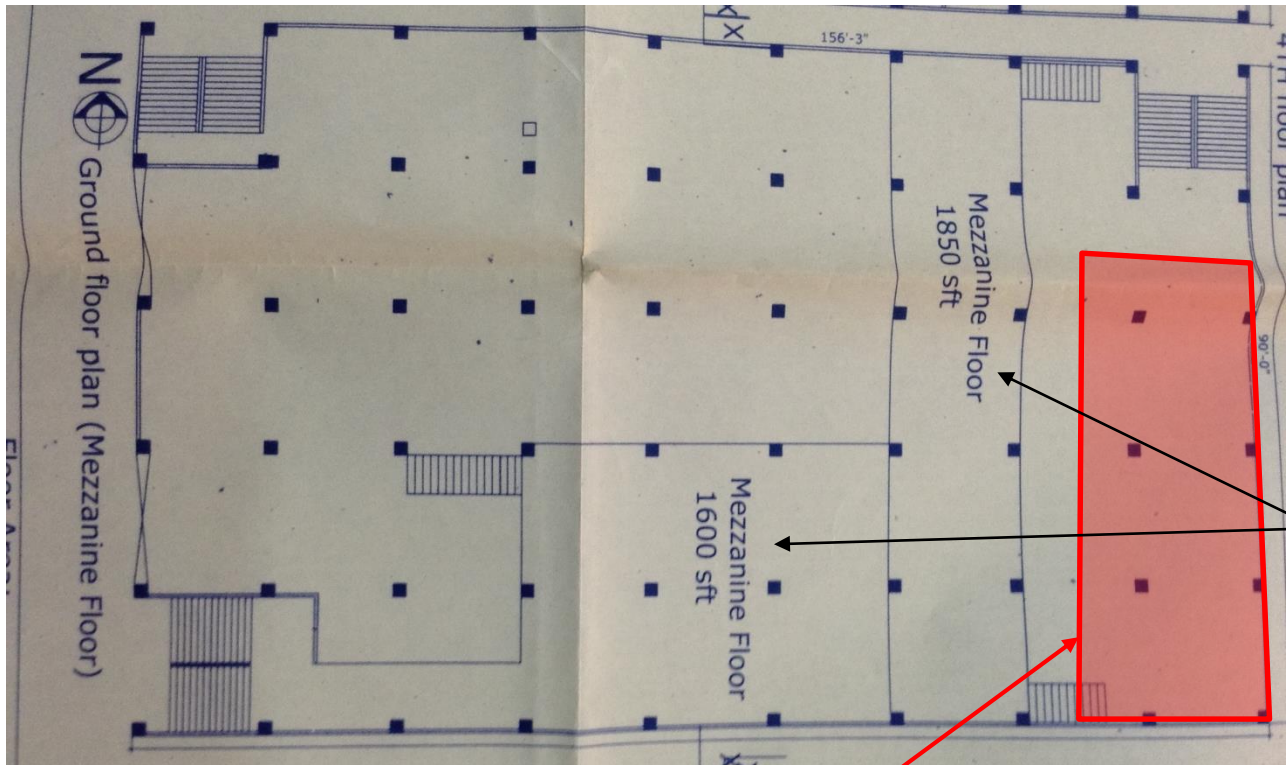
Highly-stressed columns

We were informed that this mezzanine was constructed with a timber floor which was removed due to Accord Requirements, apart from the light steel framework. We were informed that there was no intention to replace the floor and use the area again.

- Columns in this area are stressed to levels that require immediate review.
- Other columns appear to be stressed to levels in excess of normal design limits.

- Vacate and cordon off the area highlighted above at all levels **immediately**.
- Verify insitu concrete strength by 100mm dia. cores from min. 4 no. columns at ground floor level and min. 4 no. columns at 2nd floor level where aggregate changes to brick chips.
- A **Detail Engineering Assessment** of Factory to be commenced, see attached scope.

- Produce and actively manage a loading plan for all floor plates within the factory, giving consideration to floor capacity and column capacity.
- Detail Engineering Assessment to be completed.

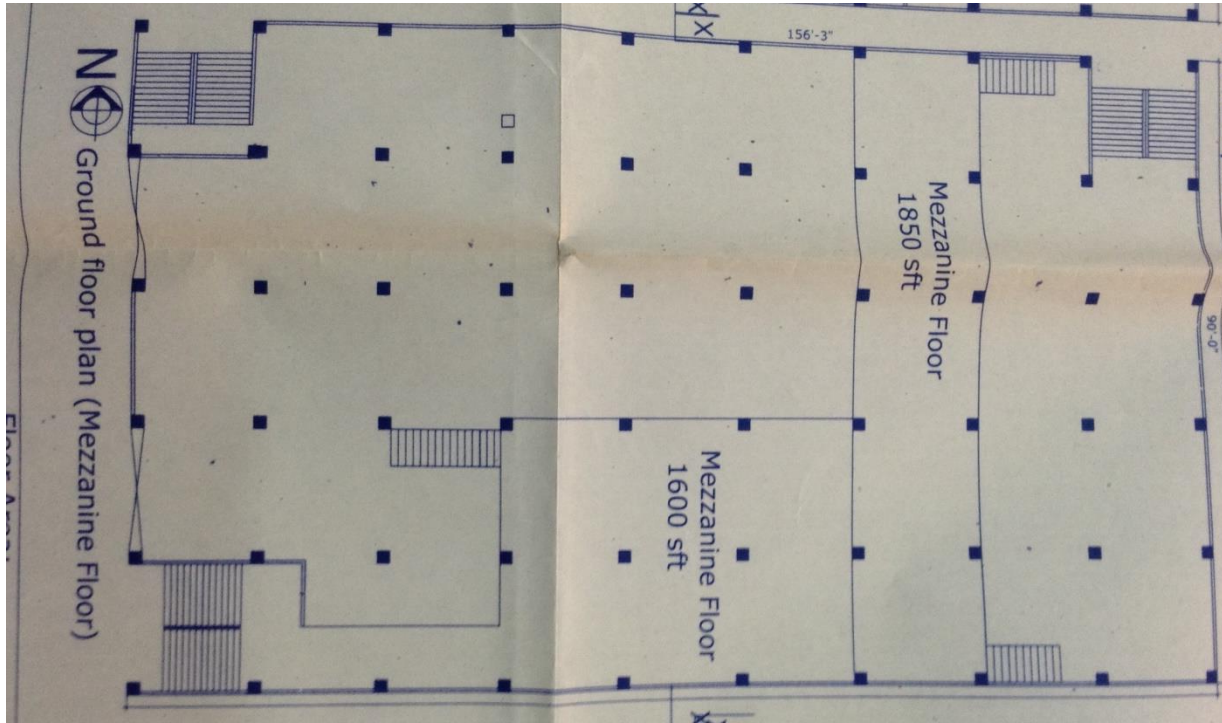
Punching shear stresses in flat slabs

Flat slab at 2nd floor level and above –
punching shear stresses appear to be in
excess of normal design limits

- As part of Detail Engineering Assessment (see Item 1), verify insitu concrete strength by 100mm dia. cores from flat slabs at min. 4 no. floor levels. Cores to be taken near mid-span.
- Input results into loading plan (see Item 1).

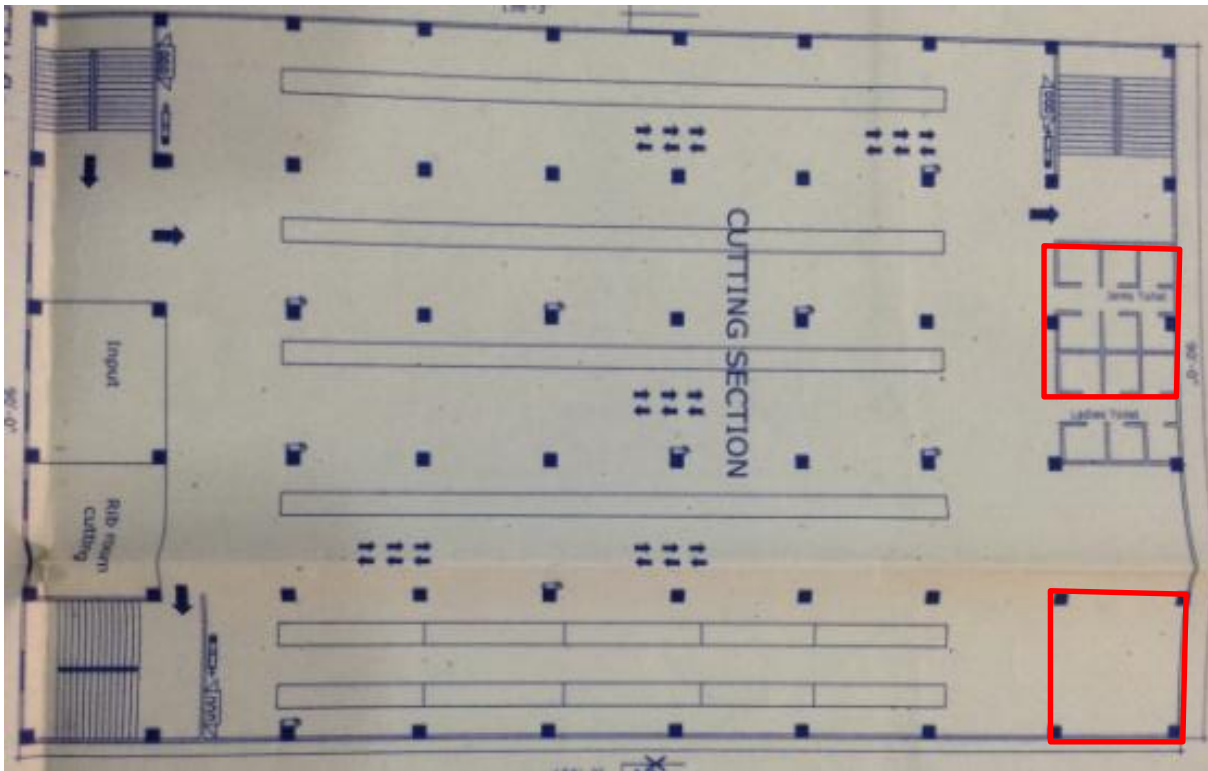
Discrepancies between drawings and on-site observations

Toilet blocks as observed

Arrangements and location of the toilet blocks on the architectural drawing does not match with on-site observations

- As part of Detail Engineering Assessment (see Item 1), Factory Engineer to carry out survey of as-constructed building.

- As part of Detail Engineering Assessment (see Item 1), Factory Engineer to produce accurate as-constructed drawings for the building.
