Orbitex Knitwear Ltd Debonair Ltd

Gorat, Sarker Market Road, Ashulia, Dhaka - 1341
(N23.943, 90.305E)

01 June 2014

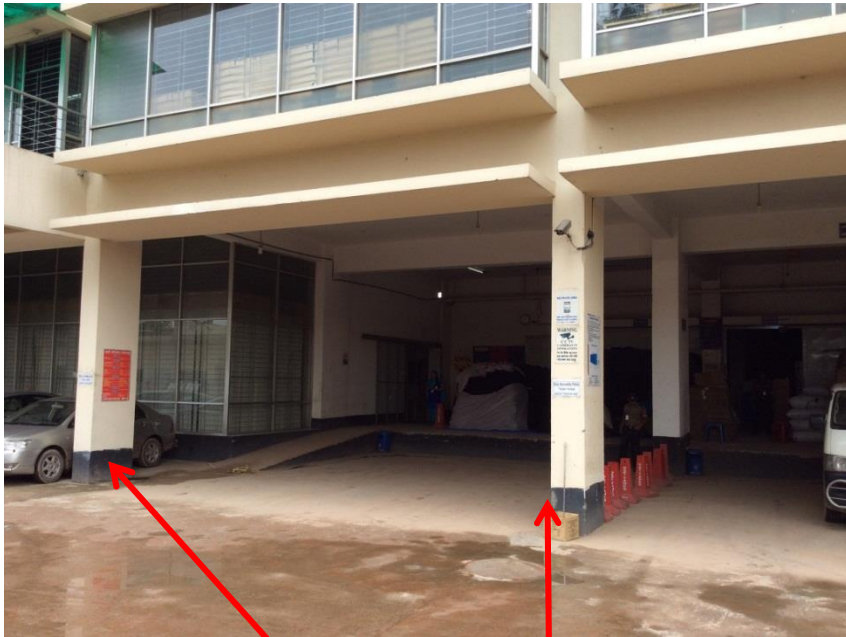
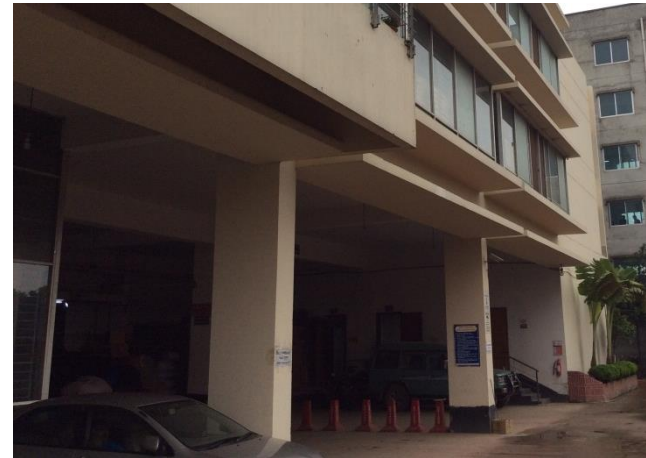
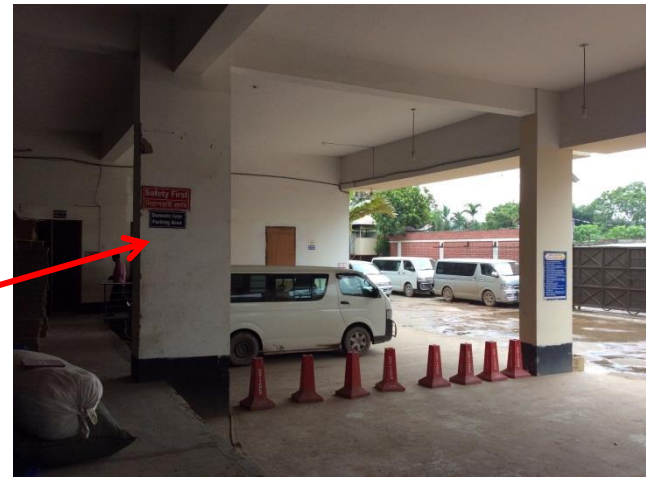
Risk of vehicle accidentally colliding with the columns to the delivery area.

At ground level, the delivery and parking area is located between columns, and no barrier was in place to protect the columns from vehicle collision.

Columns vulnerable to collision loading

Item No.	Observation	Recommended Action Plan	Recommended Timeline
1	Risk of vehicle accidentally colliding with the columns to the delivery area	Building Engineer to check that the columns have been adequately designed for impact loading	6-months
2	Risk of vehicle accidentally colliding with the columns to the delivery area	Suitable column protection barriers to be designed and constructed.	6-months
3	Design check for cantilever structures on north facade	The Building Engineer is to carry out a full design check of the cantilever structure and produce detailed drawings for the structural support as this is not presently shown in sufficient detail on the structural drawings.	6-months
4	Design check for slab loading in areas noted	The Building Engineer is to carry out a full design check on the slabs and beams in the areas noted to confirm their ability to transfer the loadings back to the columns.	6-months

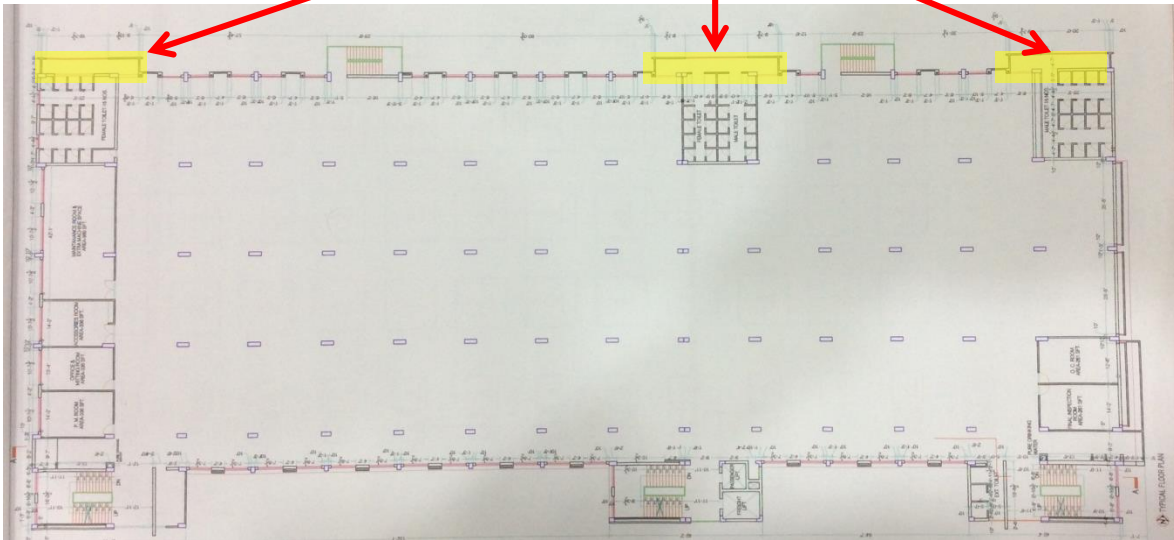
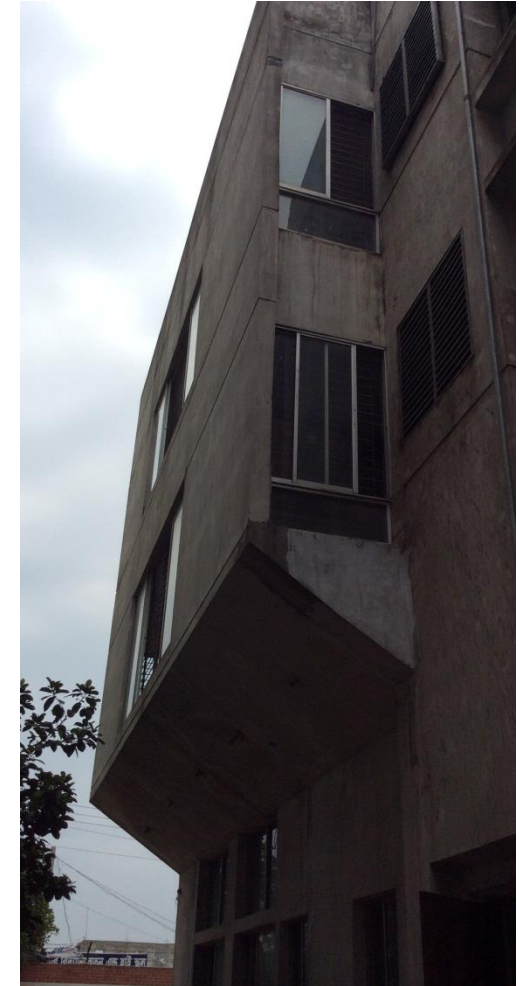
Locations of cantilever structures

Design check for cantilever structures on north facade.

The structural design of the cantilever extensions along the northern elevation of the main building could not be verified by observation alone. A more detailed investigation into the structure will be required to verify the structural adequacy.

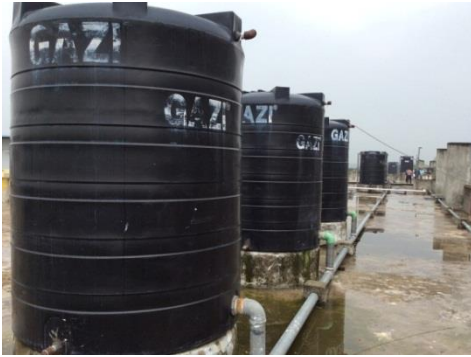
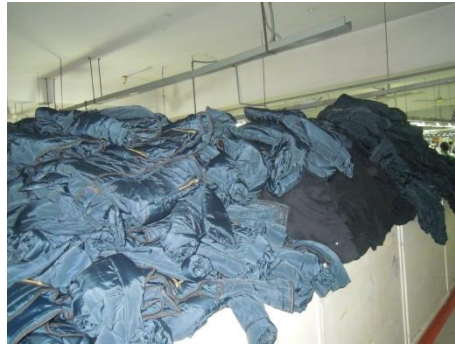
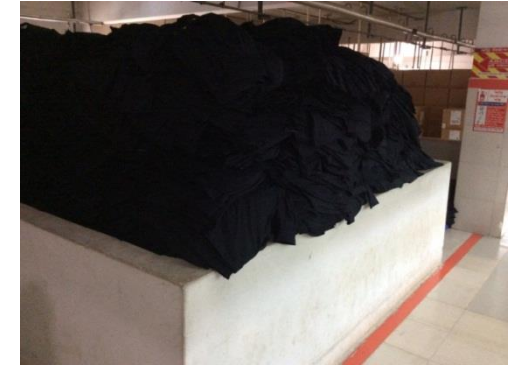
Approximate water tank locations (roof level)

Nine water tanks (5000lts each) were observed on roof level at various locations. Some were positioned directly above columns, whilst others were positioned within the bays between columns. The plinths that the tanks are positioned on varied significantly in height.

5	Design check for slab loading in areas noted	The Building Engineer is to produce and actively manage a loading plan for all floor plates within the factory giving consideration to floor capacity and column capacity.	6-months
6	It is noted that the building has permit approval for 3 additional storeys. Any proposed additions to the existing building structure should be reviewed by the Building Engineer	If any additions to the building structure are proposed, the Building Engineer shall provide calculations showing the structural adequacy of all columns taking into account any additions to the existing structure, the loading plans and as built structure, including in-situ concrete strength testing.	6-months

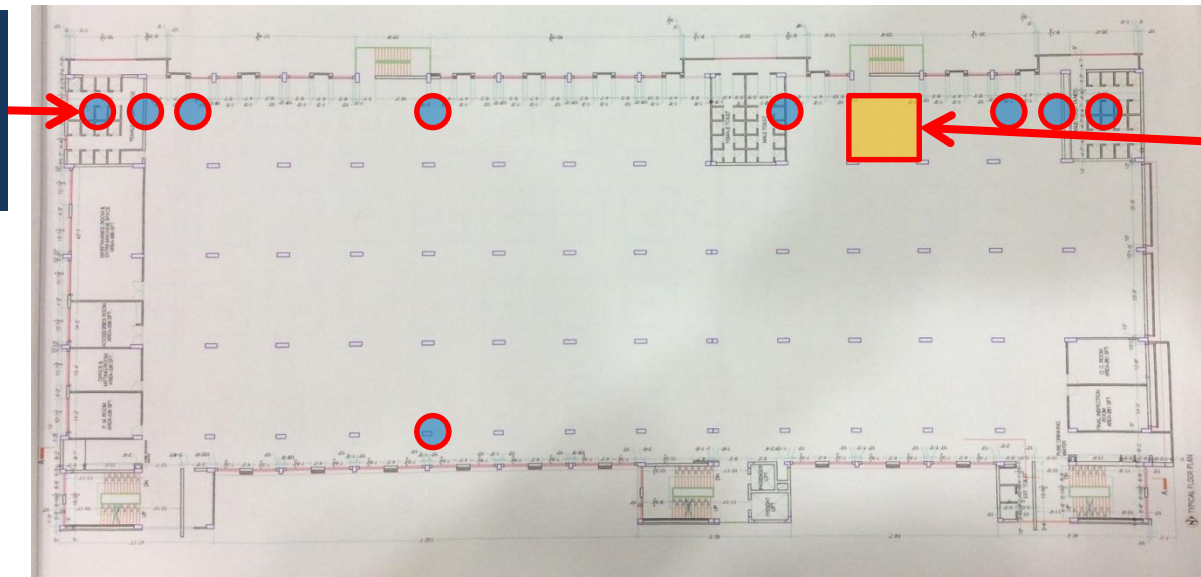
Location of most significant storage area (L2)

Several bays of storage were observed on level 2. Material was generally stacked to a high level.

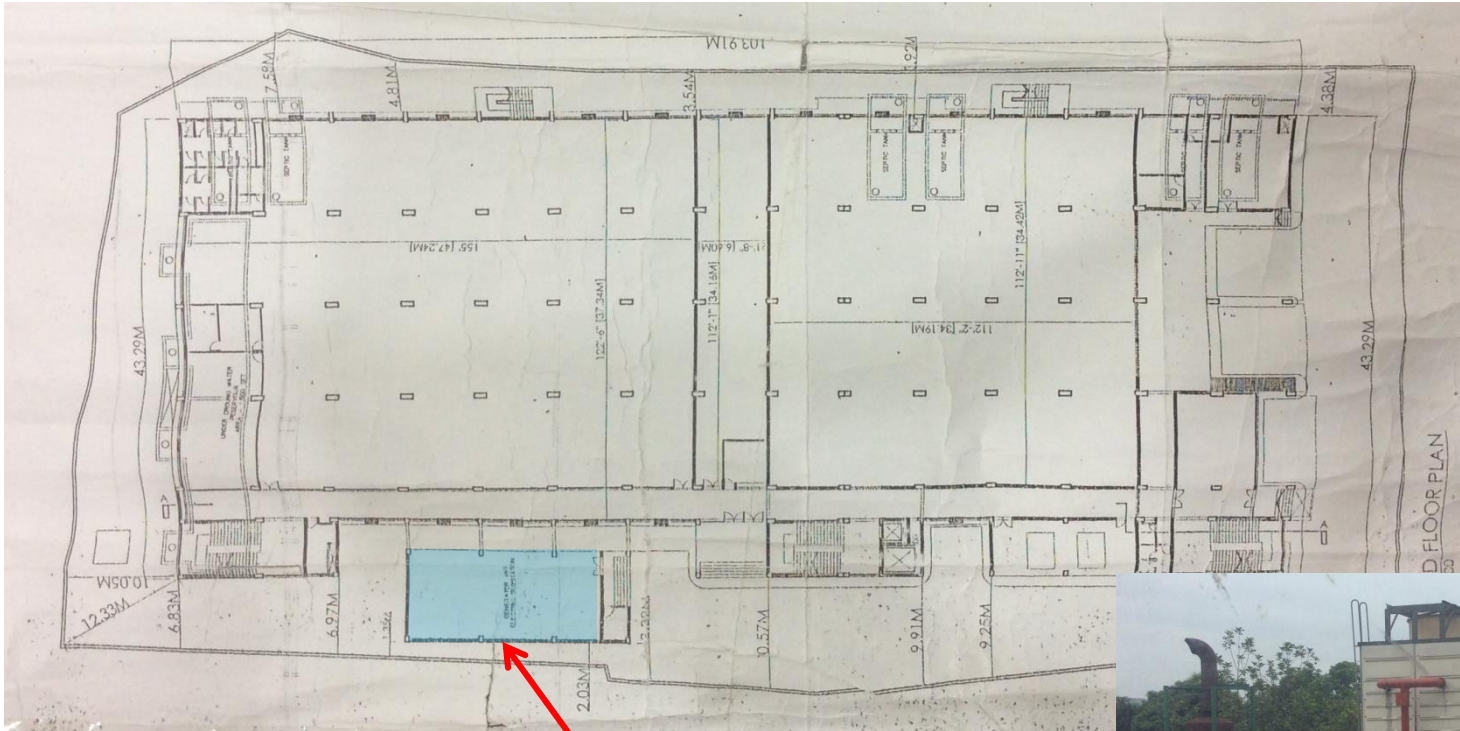
Location of generator building

Water tanks and a Chiller were located on the roof slab of the Generator Building

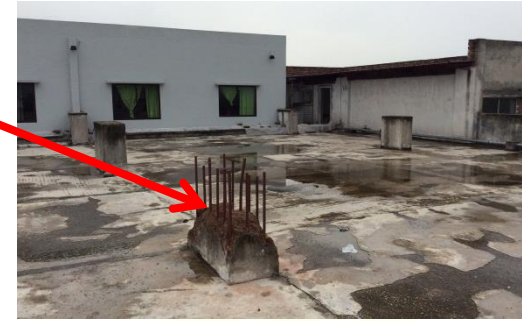
Rebar had been exposed at roof level, in anticipation of expansion upwards

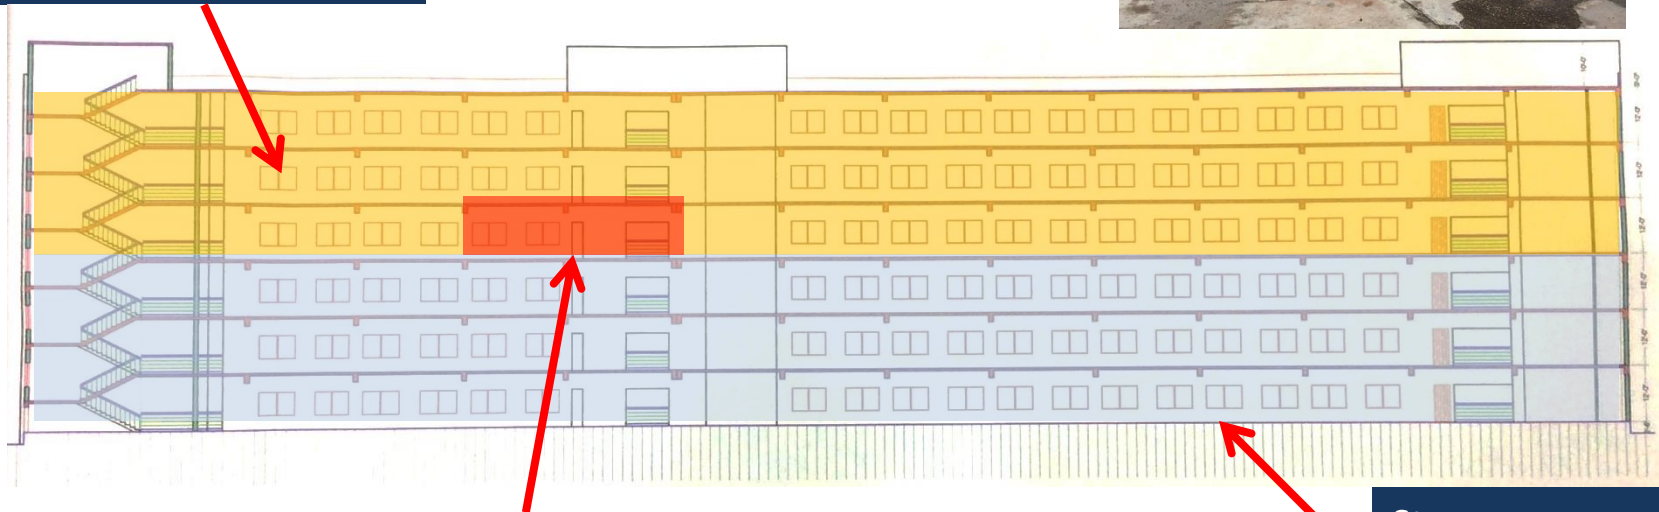
Storeys constructed on day of inspection

It is noted that the building has permit approval for 3 additional storeys. Any proposed additions to the existing building structure should be reviewed by the Building Engineer

The Building Permit drawings allow for 6 storeys. 3 Storeys plus a shed at roof level are presently constructed.

A steel shed (with masonry walls) is currently in place on level 3 of the building. This will be demolished to allow for construction of additional concrete slabs

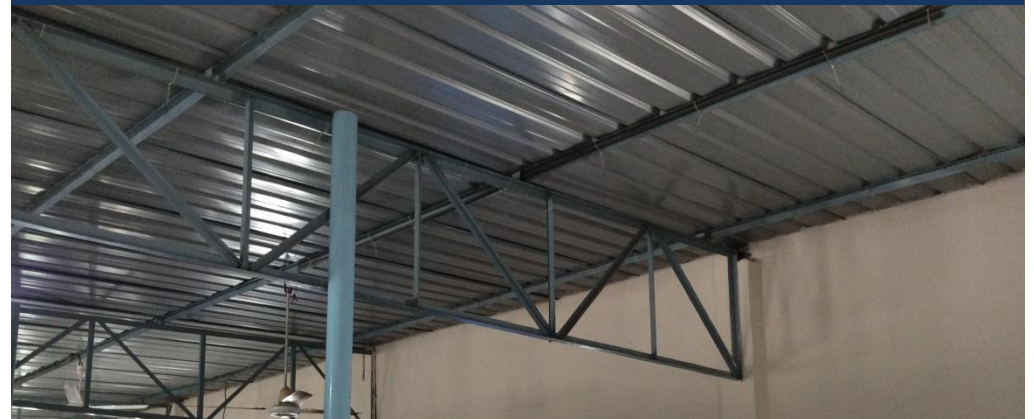
Dining/Prayer room – roof truss appeared to be hanging from box section columns

Item No.	Observation	Recommended Action Plan	Recommended Timeline
7	Design check for the light steel roofs to the Dining/ Prayer Room/ Storage Building.	The Building Engineer is to assess the structural adequacy of the light steel roof structures to resist lateral wind loading (pressure, suction and uplift).	6-months
8	Design check for the light steel roofs to the Dining/ Prayer Room/ Storage Building.	Any works deemed necessary following the above assessment to be implemented on site and overseen by the Building Engineer.	6-months
9	Edge protection to the stairs and roof drainage	The Building Engineer is to design an appropriate edge protection system and to oversee its construction on site.	6-months
10	Edge protection to the stairs and roof drainage	The Building Engineer is to design and oversee the construction of an appropriate rain water drainage system for the roofs to prevent water damage to the building.	6-months

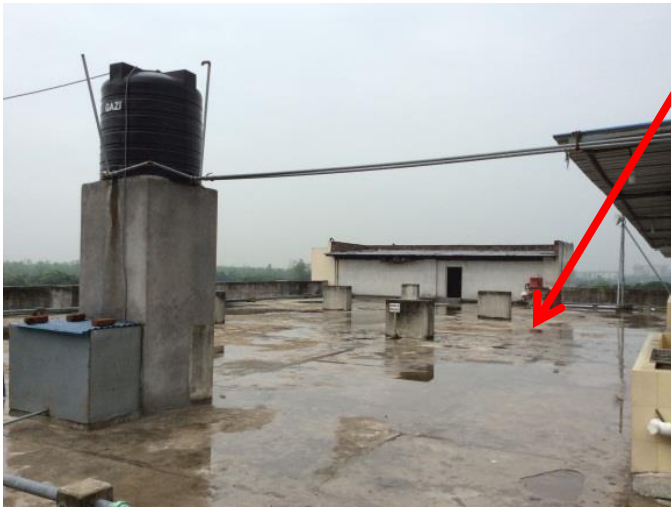
There was no apparent roof drainage system. This was the case for the Main Building as well as the Generator Building – both had concrete roofs supporting water tanks.

Roof of Main Building, with no clear drainage strategy

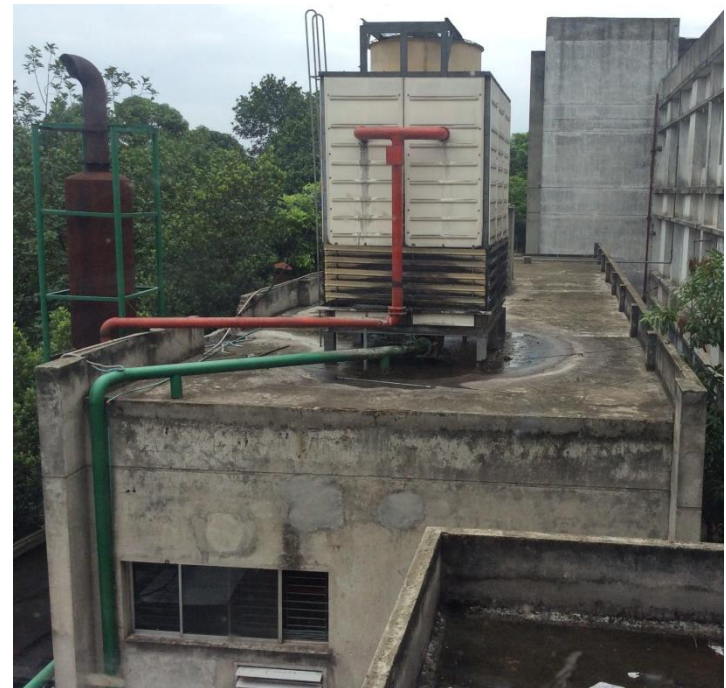
Edge protection was not in place on the stairs of the Main Building or on the roof of the Generator Building.

Roof of Generator Building, with no edge protection and water tanks positioned directly onto the slab

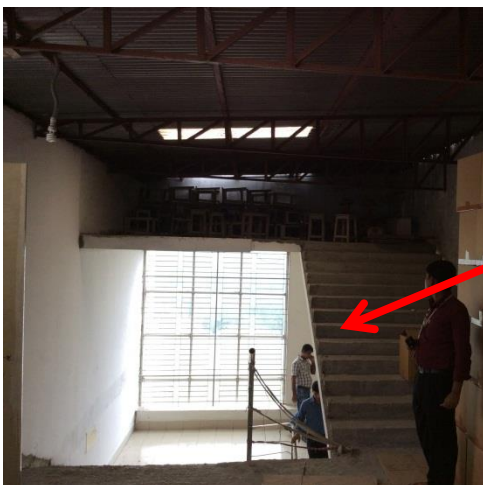
Lack of edge protection on stairs of main building
