Shinest Apparels Ltd

Azim Tower, Plot No. 217/1, Beribadh, Mohammadpur, Dhaka, Bangladesh
(23.768754N, 90.345978E)
24 May 2014

Observations

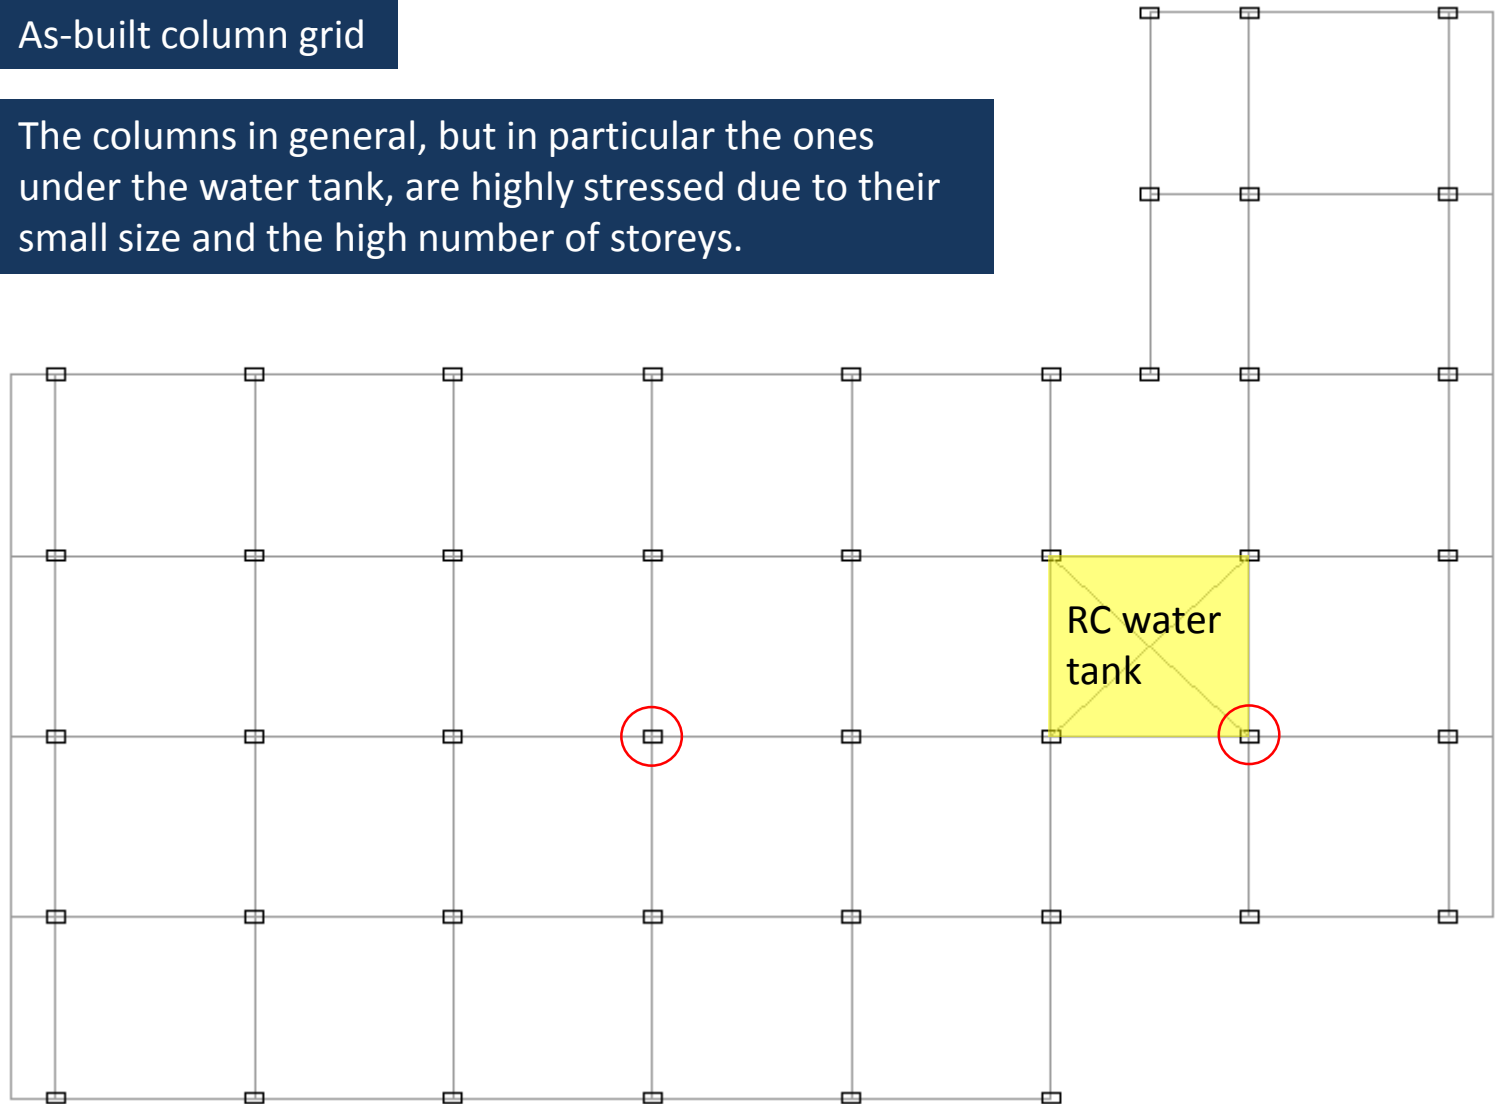
As-built column grid

Small column sizes leading to high column stresses

The columns in general, but in particular the ones under the water tank, are highly stressed due to their small size and the high number of storeys.

Item No.	Observation	Recommended Action Plan	Recommended Timeline
1	Small column sizes leading to high column stresses	Release all water from RC water tank on the roof and restrict loads to 1.0kN/m ² on the roof, to 1.5kN/m ² in 8th to 1st floor and to 2.0kN/m ² in ground floor, pending the outcome of the Detail Engineering Assessment.	Immediate - Now
2	Small column sizes leading to high column stresses	Building Engineer to review design, loads and columns stresses in all columns.	Immediate - Now
3	Small column sizes leading to high column stresses	Verify insitu concrete stresses either by 100mm diameter cores or existing cylinder strength data for a minimum of 4 columns.	Immediate - Now
4	Small column sizes leading to high column stresses	A Detail Engineering Assessment of the building to be carried out immediately, see attached scope.	Immediate - Now
5	Small column sizes leading to high column stresses	Produce and actively manage a loading plan for all floor plates within the building, giving consideration to floor capacity and column capacity.	6-weeks

6	Small column sizes leading to high column stresses	Detail Engineering Assessment to be completed.	6-weeks
7	Small column sizes leading to high column stresses	Continue to implement load plan.	6-months

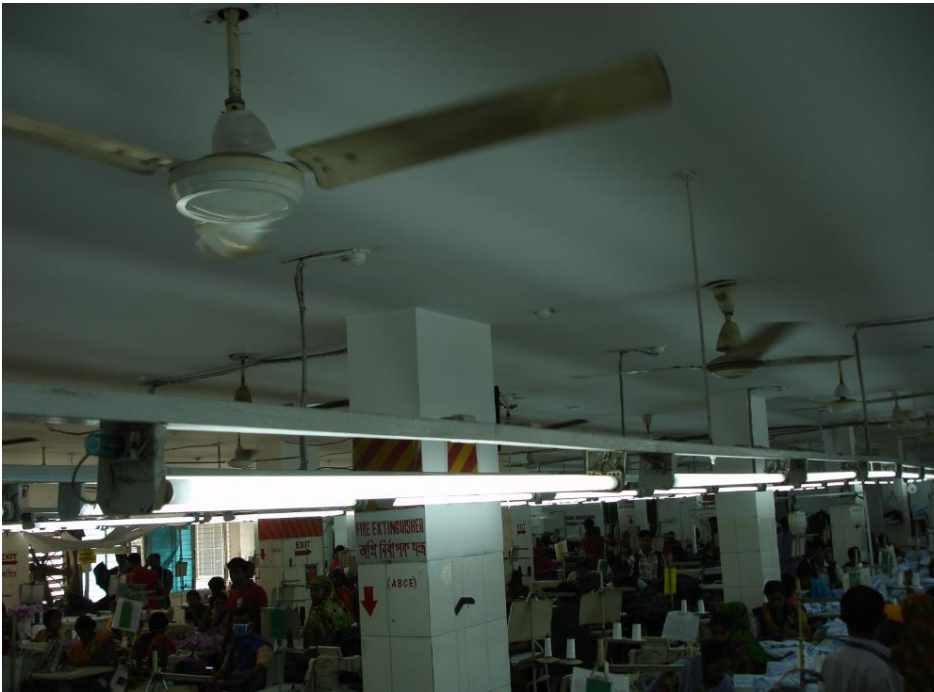
High punching shear stresses in some areas of the flat slabs

SLAB THICKNESS = 7"
A. 12 mm dia 5"o/c at alt ckd.
B. 12 mm dia 7"o/c at alt ckd.
Use 2- 10 mm dia Ext. Top betn ckd (shown in sketch)

SLAB THICKNESS = 5"
A. 10 mm dia 5"o/c at alt ckd.
B. 10 mm dia 7"o/c at alt ckd.
Use 2- 10 mm dia Ext. Top betn ckd (shown in sketch)

The reinforcement drawings are inconsistent regarding slab thickness and reinforcement quantities.

The punching shear stress is high for some columns, e.g. 1st internal combined with small column size based on a slab thickness of 7".
With a slab thickness of only 5", the punching shear stresses would be high for all columns.

The column sizes vary in the different storeys (e.g. 495 x 300mm on 7th floor, 650 x 320mm on 1st floor).

Item No.	Observation	Recommended Action Plan	Recommended Timeline
8	High punching shear stresses in some areas of the flat slabs	As part of the Detail Engineering Assessment (see Item 1), verify in-situ concrete strength of slabs either by 100mm diameter cores (remote from columns) or existing cylinder strength data.	Immediate - Now
9	High punching shear stresses in some areas of the flat slabs	Verify existing top reinforcement of slabs.	Immediate - Now
10	High punching shear stresses in some areas of the flat slabs	Review of design, loads and column stresses in flat slabs to be completed.	6-weeks
11	High punching shear stresses in some areas of the flat slabs	Output from review to be incorporated in load plan (see Item 1).	6-weeks
12	High punching shear stresses in some areas of the flat slabs	Continue to implement load plan.	6-months

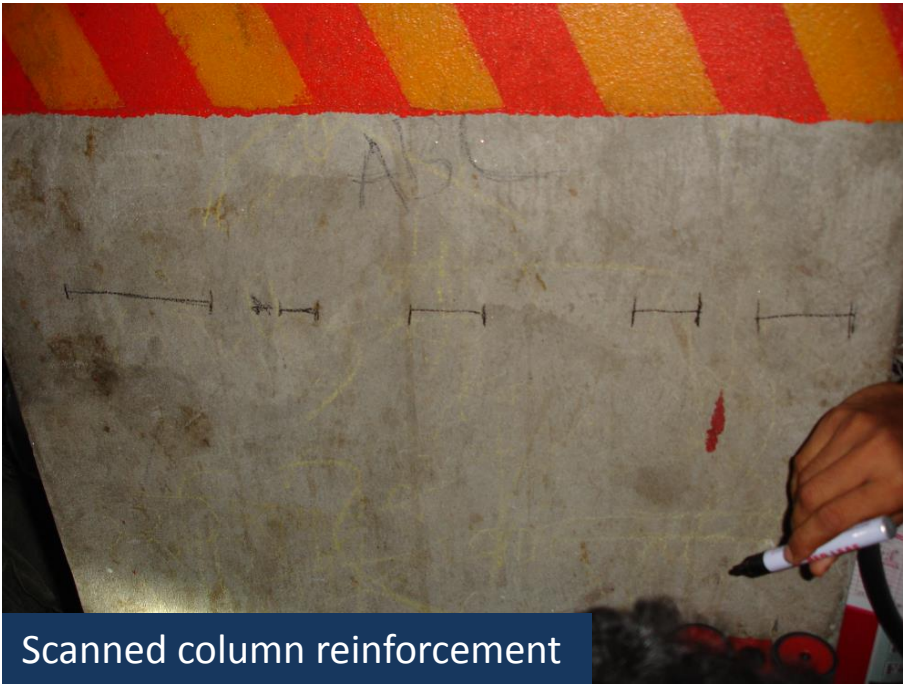
Discrepancies between observed and documented column reinforcement

There are discrepancies in the reinforcement drawings for the columns regarding size and reinforcement amount.

A typical column should have 3 bars on its short side and 7 bars on the long side. Several columns were checked and the number of bars on the long side seem to deviate from the drawings.

Item No.	Observation	Recommended Action Plan	Recommended Timeline
13	Discrepancies between observations and documentation	As part of Detail Engineering Assessment (see Item 1), Building engineer to verify the column and flat slab reinforcement as constructed.	Immediate - Now
14	Discrepancies between observations and documentation	Building Engineer to survey building.	Immediate - Now
15	Discrepancies between observations and documentation	Drawings and documentation to be updated as required to reflect as-constructed details.	6-weeks
16	High storage load in localised areas	Limit storage load as required in accordance with loading plan (see Item 1).	6-weeks
17	High storage load in localised areas	Continue to implement load plan.	6-months

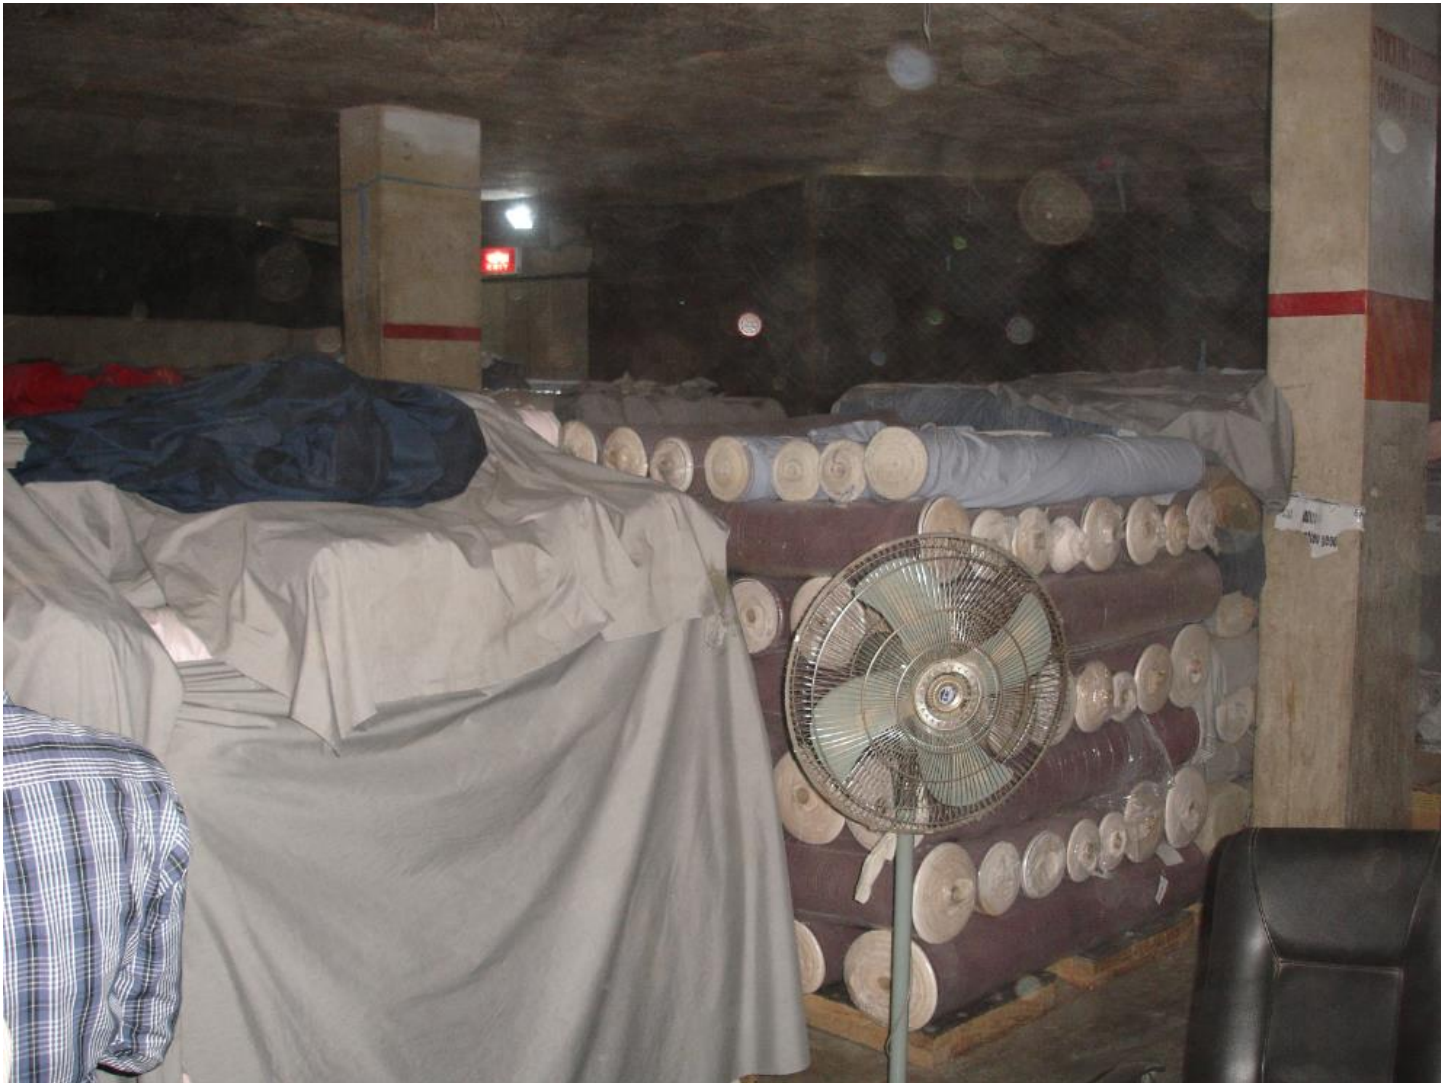
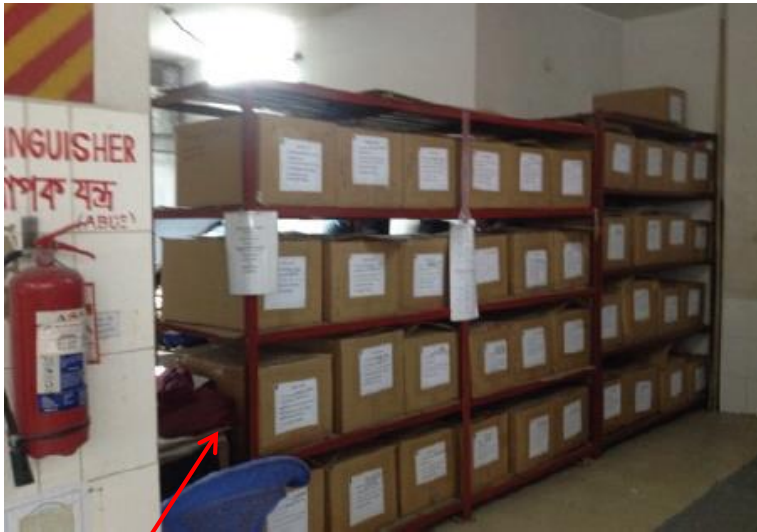
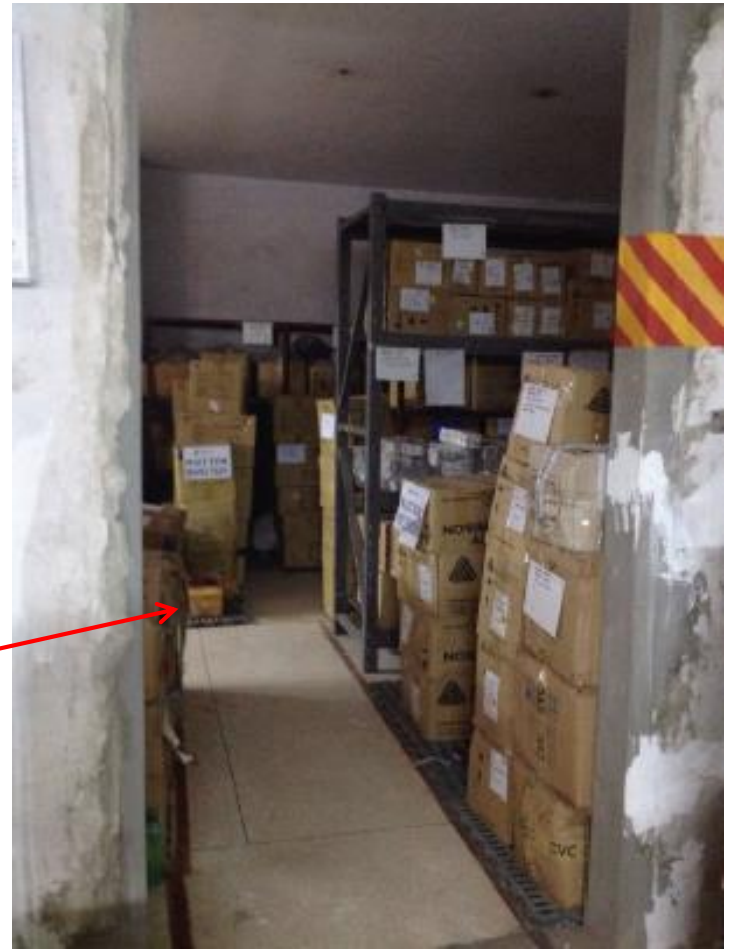
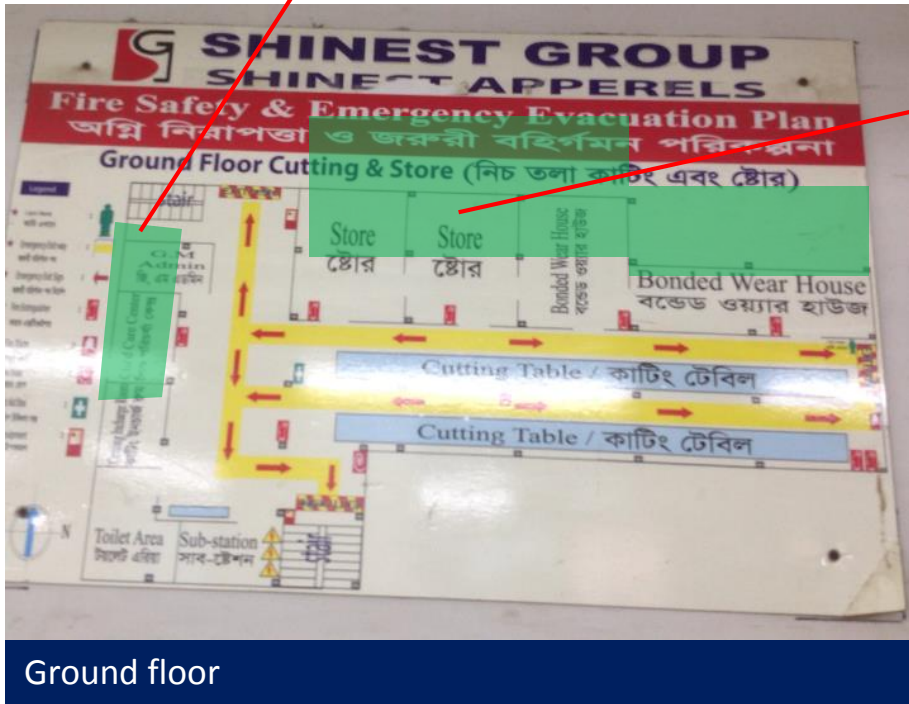
Basement

High storage load in localised areas

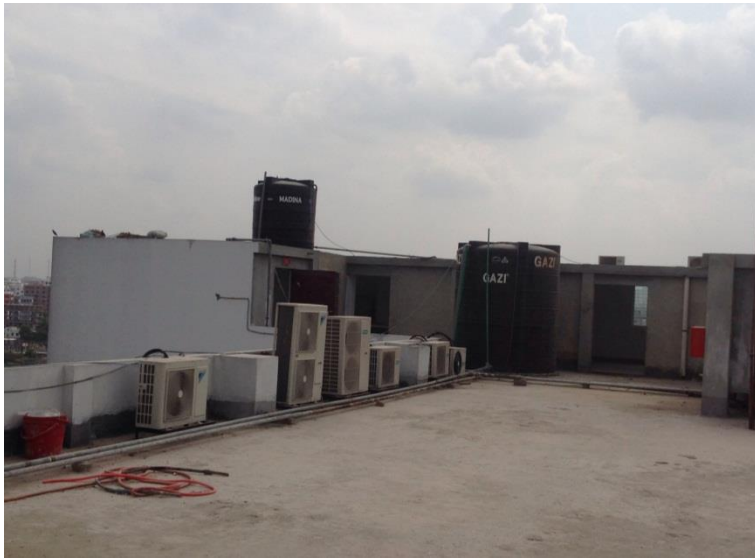
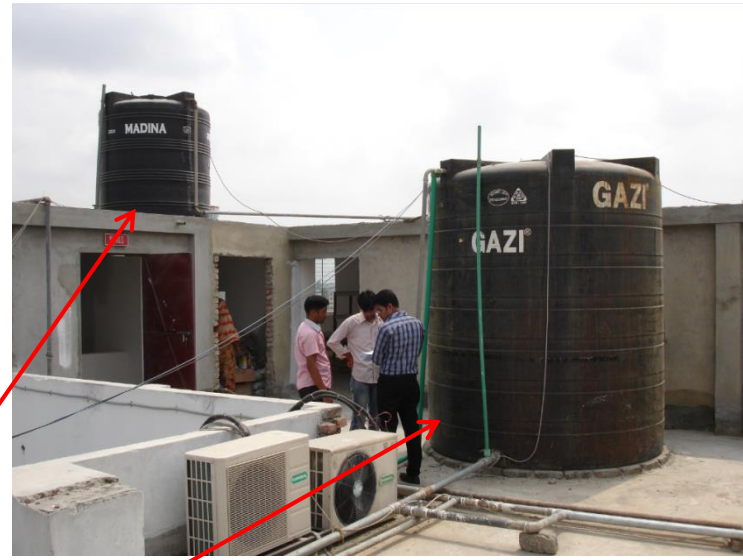
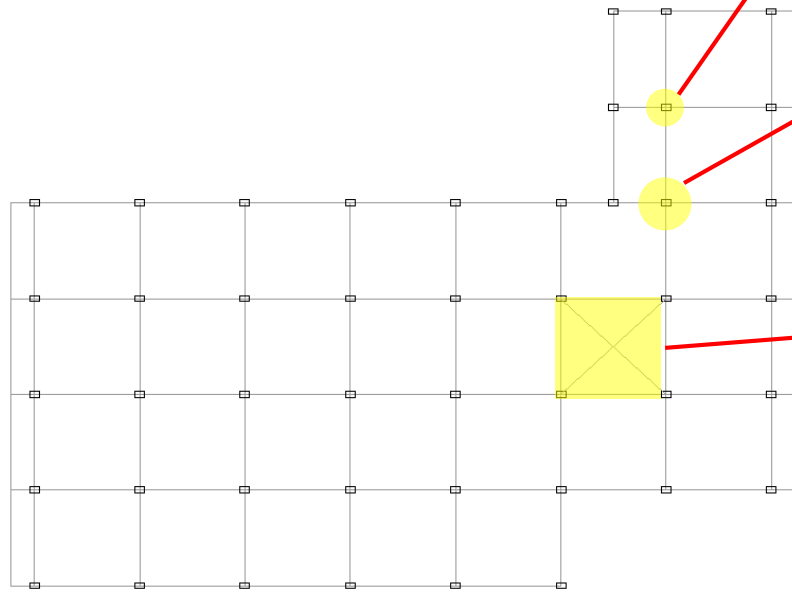
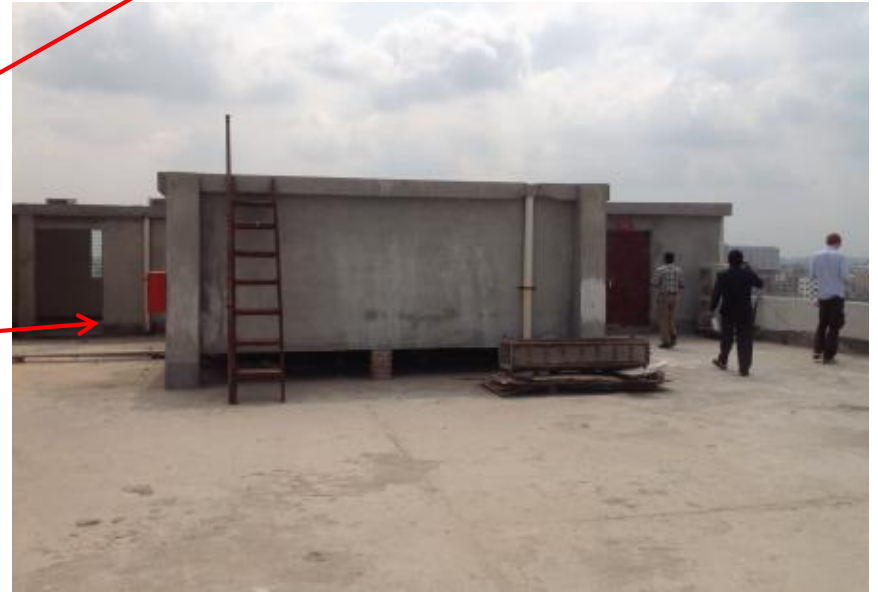
Roof

High storage load in localised areas

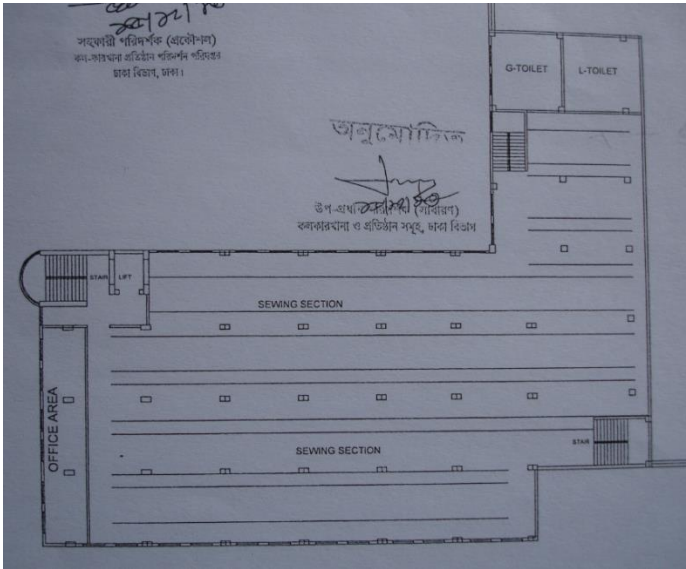
Permit drawing

The permit drawings are inconsistent with the structural drawings.

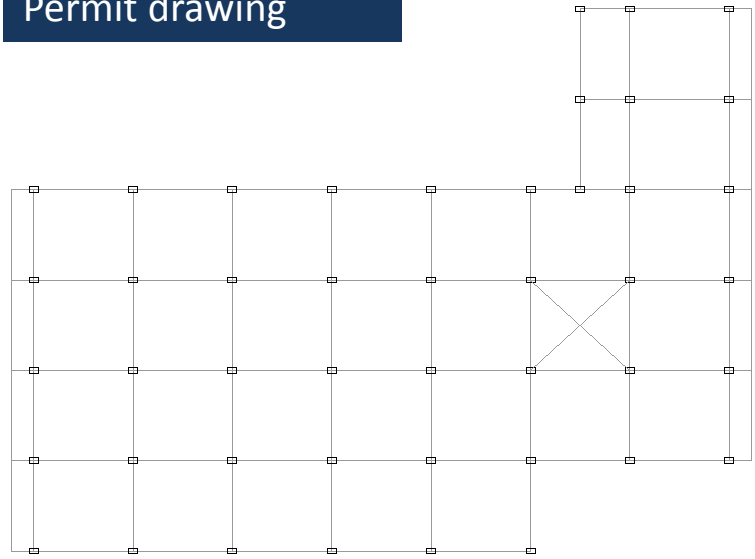
As-built layout

The as-built structure deviates from both in some areas.
