# Yester Jeans Ltd.

Plot # 111-114, Adamjee EPZ, Siddhirgonj, Narayangonj.  
(23.674005 N, 90.529693 E)

28 February 2015

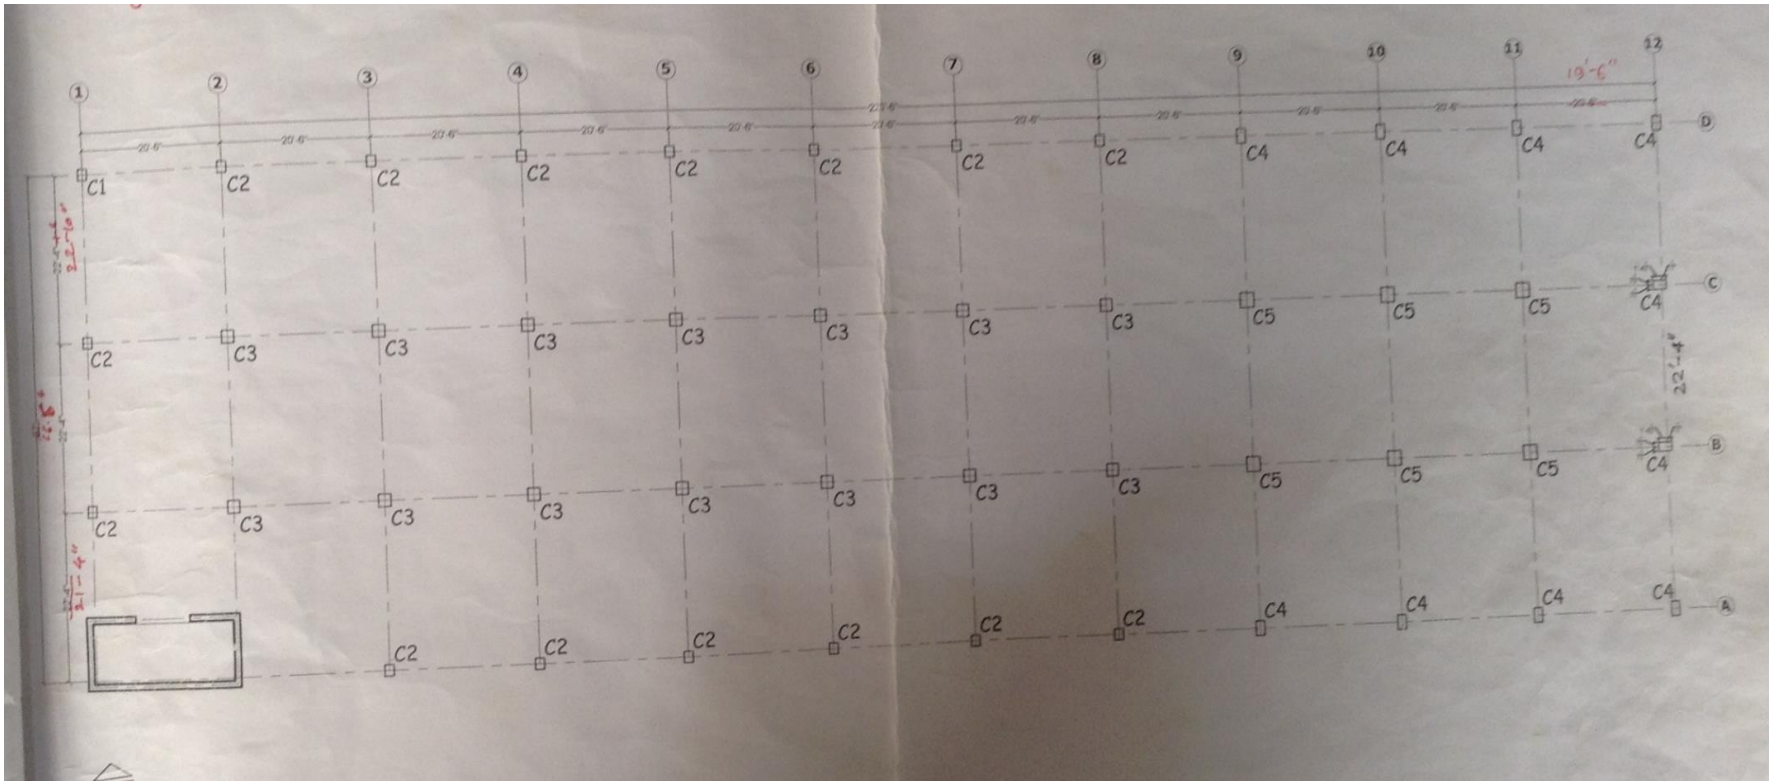
# Apparently high stress levels in columns

Cursory calculations indicate high column working stress levels.

| Item No. | Observation | Recommended Action Plan | Recommended Timeline |
|---|---|---|---|
| 1 | Apparently high stress levels in columns | Building Engineer to review design, loads and column stresses. | 6-weeks |
| 2 | Apparently high stress levels in columns | Verify in-situ concrete strength either by taking 100mm dia. cores from 4 columns or by using existing cylinder strength data. | 6-weeks |
| 3 | Apparently high stress levels in columns | Produce a loading plan and actively manage the floor loading for all floor plates within the Building giving consideration to floor capacity and column capacity | 6-weeks |
| 4 | Apparently high stress levels in columns | Continue to implement the Loading Plan. | 6-months |

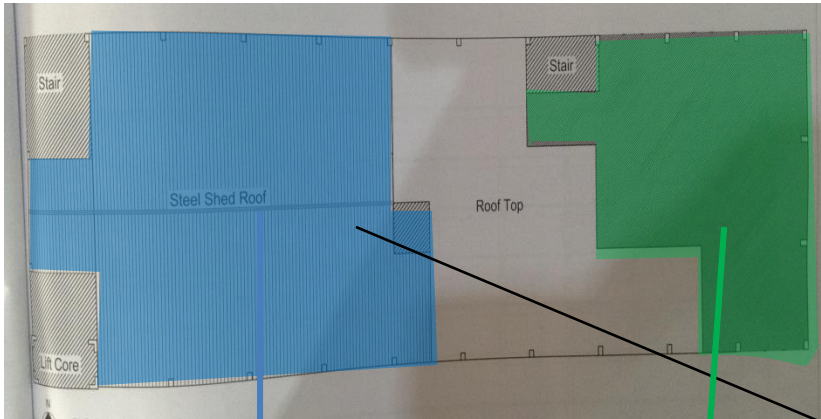
Steel shed structure as build

| Item No. | Observation | Recommended Action Plan | Recommended Timeline |
|---|---|---|---|
| 10 | Discrepancies between permit drawing, design drawings and as built structure | Building Engineer to commence an update of the drawings to reflect the as-built structure and loading levels at all floor levels, including as built floor finishes thickness. | 6-weeks |
| 11 | Discrepancies between permit drawing, design drawings and as built structure | The steel roof design drawings to be attached to the As-built drawings and the structure of the roof to be confirmed as being adequate to withstand horizontal and vertical loadings as per code. | 6-weeks |

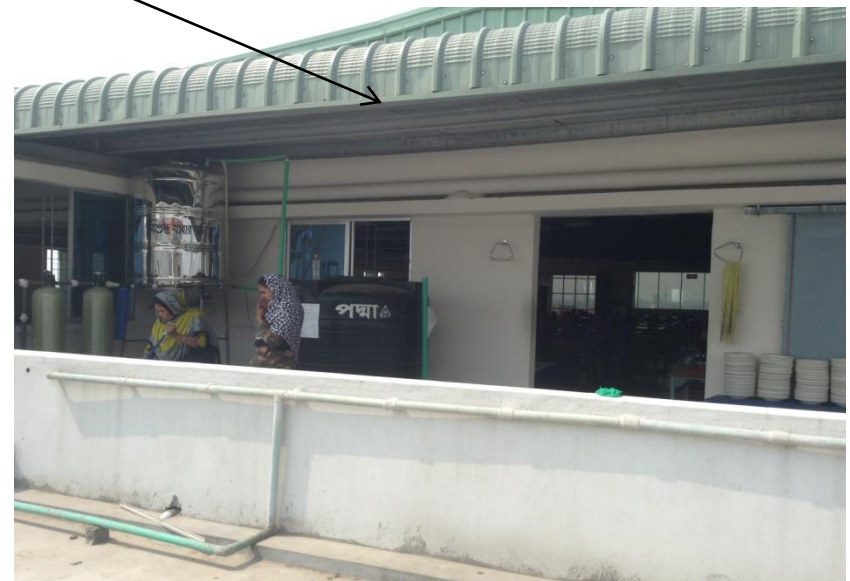
Steel structure not on permit drawing

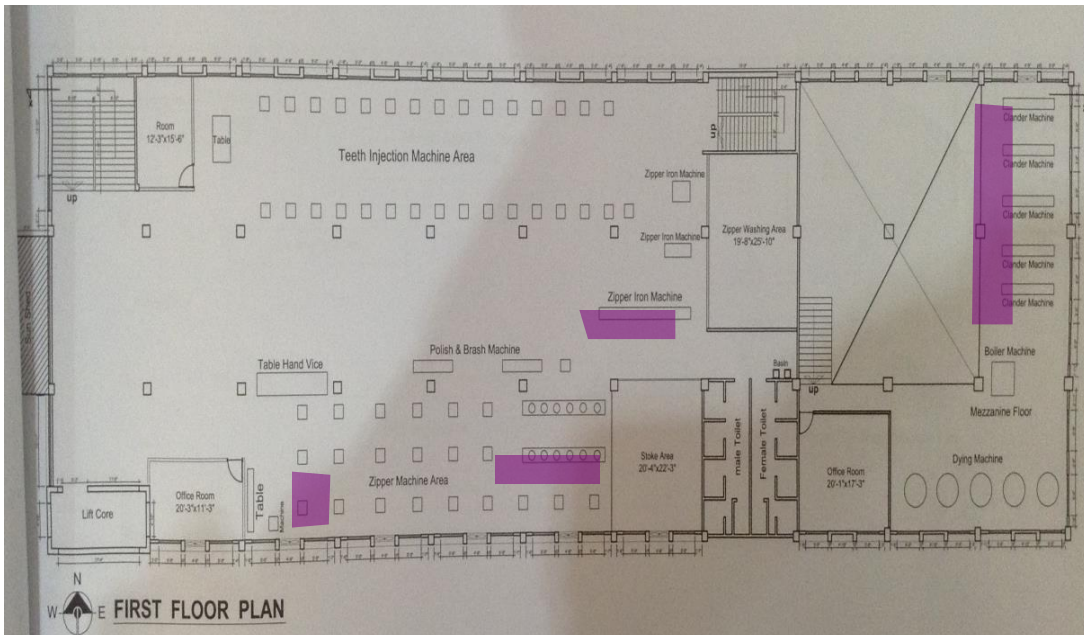
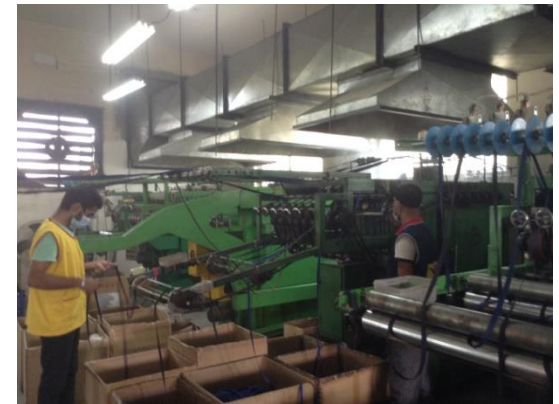
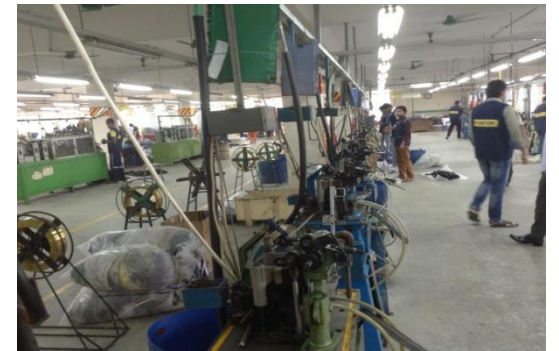
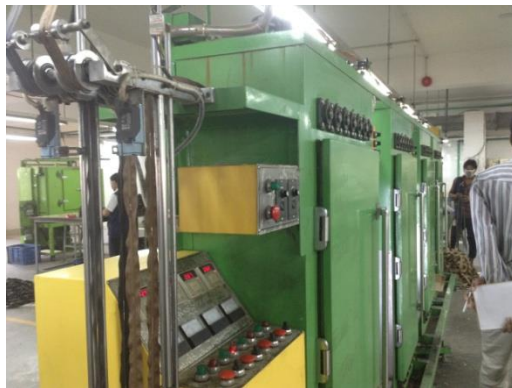
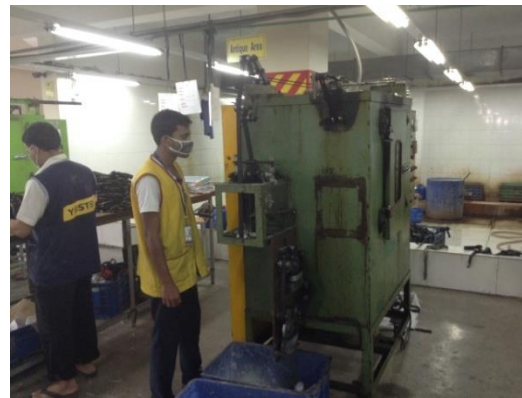
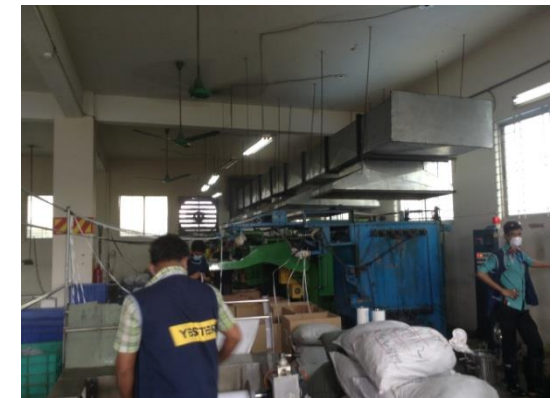
# Heavily loaded areas

**1<sup>st</sup> floor- machine loads**  
**Technical information on the machines was not provided**

| Item No. | Observation | Recommended Action Plan | Recommended Timeline |
|---|---|---|---|
| 12 | Heavily loaded areas | Building Engineer to confirm design loading of slabs and incorporate it into the loading plan for all floor plates within the Building. | 6-weeks |
| 13 | Heavily loaded areas | Produce a loading plan and actively manage the floor loading for all floor plates within the Building giving consideration to floor capacity and column capacity. | 6-weeks |
| 14 | Heavily loaded areas | Continue to implement the load management plan | 6-months |
