# **FIRE SAFETY INSPECTION REPORT**

## **NEO FASHION LTD.**

**ACCORD**  
on Fire and Building Safety in Bangladesh

March 11, 2014

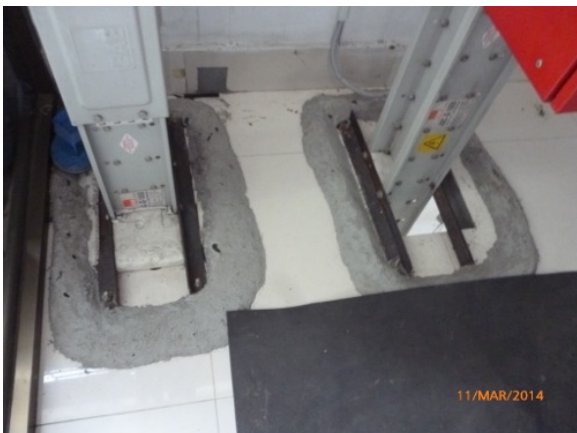
No.	Category	Finding	Recommendation	Remediation Timeframe
F-1	Fire Rated Construction	Unsealed penetrations and openings are located in the fire-rated floor/ceiling assemblies. (All floors).	Provide a minimum 2-hr fire-rated shaft to separate the utility risers from each floor level.	Within 3 months

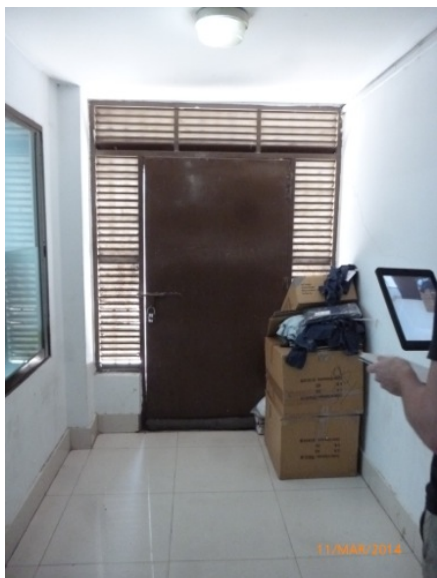
F-4

Dead-end egress path  
exceed 30 m.

Location: Ground floor  
office egress path way

Remove the door locks  
changes the to panic bar  
hardware,

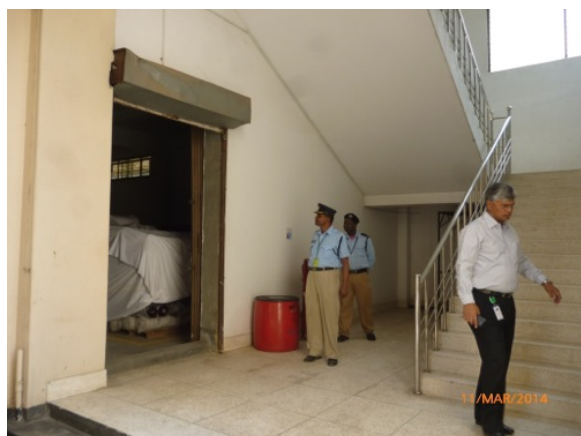
F-5	Egress	Secondary exit of storage was located in the exit stair.	Provide 2 hrs fire rated door or install additional separation room	Immediate
		Location: Landing of west stairwell on the ground floor.

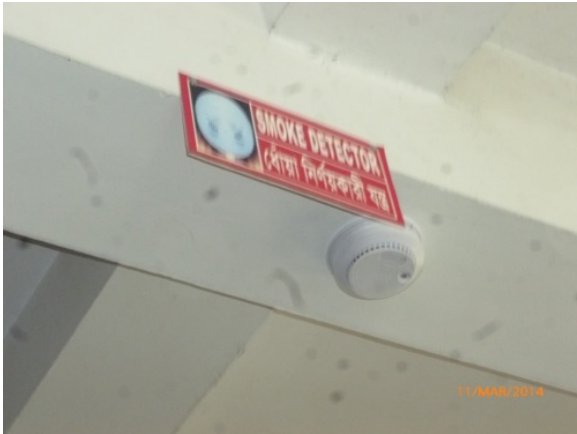
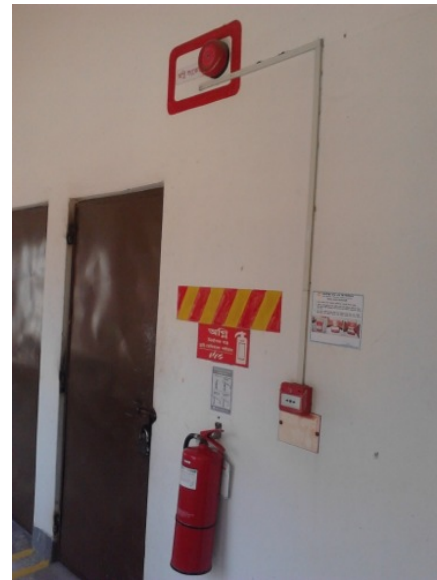
F-7	Fire Protection	The fire alarm system is antiquated, not a listed system, and does not provide alarm and notification features consistent with acceptable standards.	Replace the fire alarm system with a new, listed addressable fire alarm system in accordance with NFPA 72.	Design within 4 months, install within 9 months
-----	-----------------	--	--	---

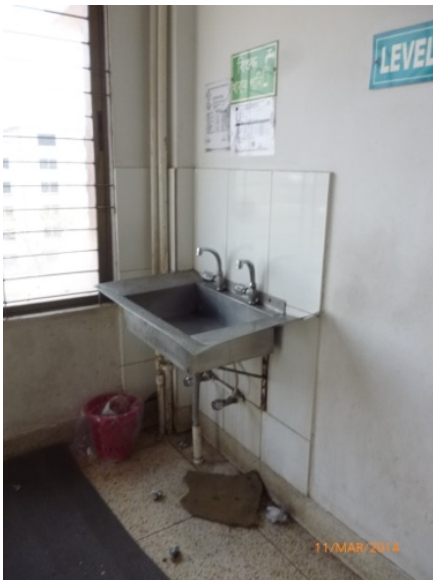
F-9 Fire Protection Drinking station on stairwell,

Remove all the drinking station Immediate on both stairwell, Stairwell should be free from any obstruction.

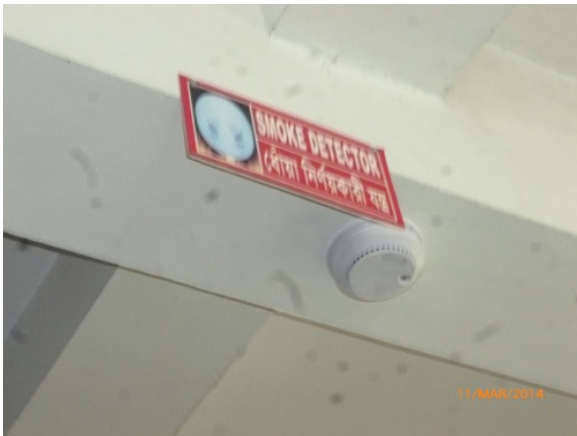
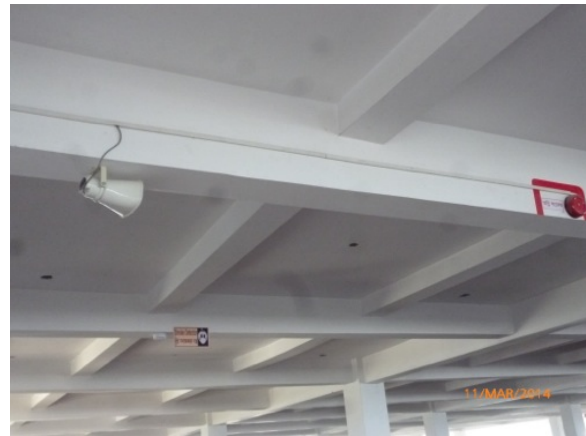
F-11	Fire Protection	The building is equipped with single-station smoke alarms. Smoke alarm activation sounds only a local alarm and does not provide automatic fire alarm notification of occupants.	Remove single station smoke alarms. Provide automatic smoke detection throughout the building in Accordance with NFPA 72.	Within 6 months
------	-----------------	--	---	-----------------

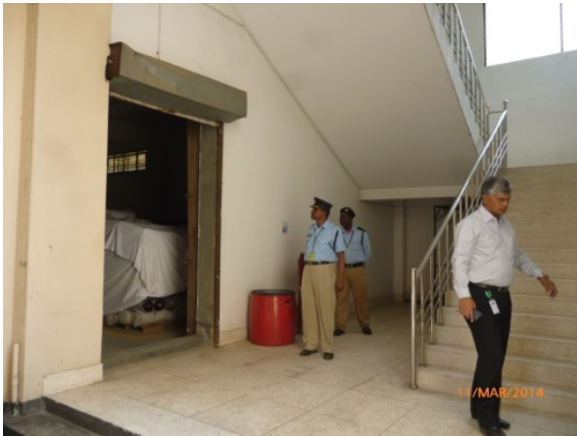
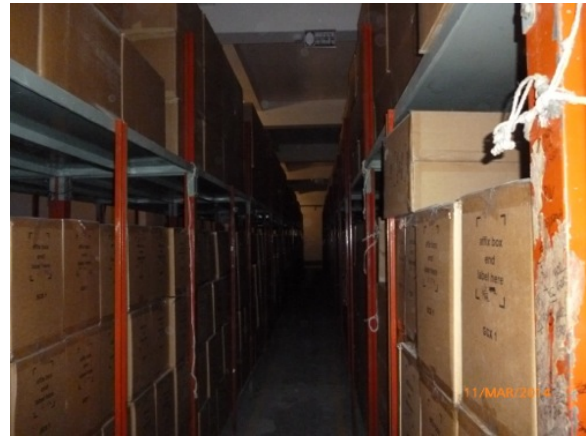
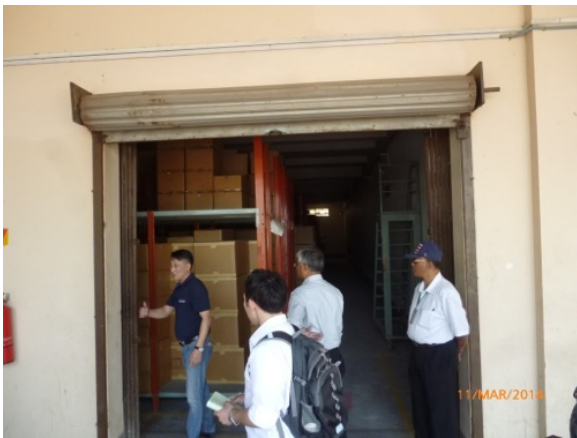
F-12	Egress Lighting	The warehouse in ground floor did not have any emergency lights and exit signs	Provide Emergency lights and exit signs.	Within 3 months
------	-----------------	--	--	-----------------
