# Teen Age Modern Fashion Ltd Matri Ghor Ltd

Aajan Tower, Purbahati, Hemayetpur, Savar, Dhaka

3<sup>rd</sup> March 2015

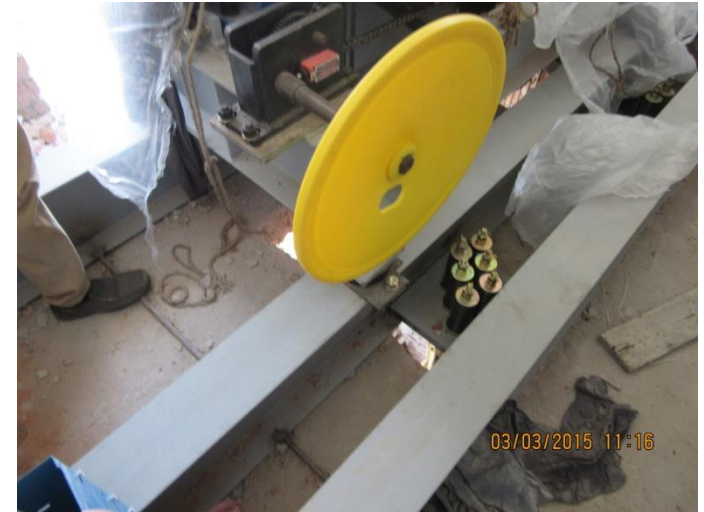
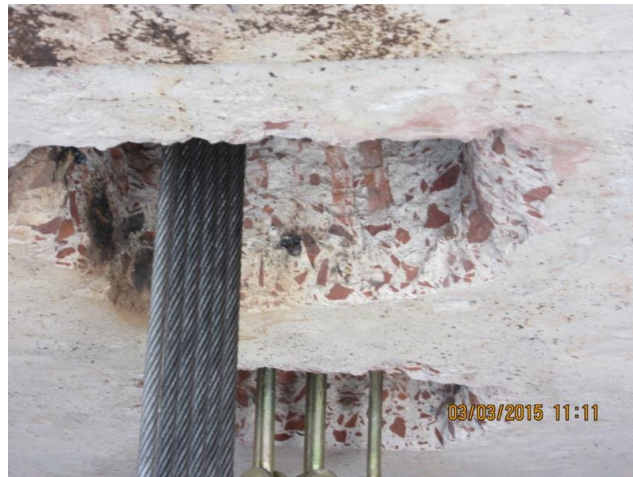
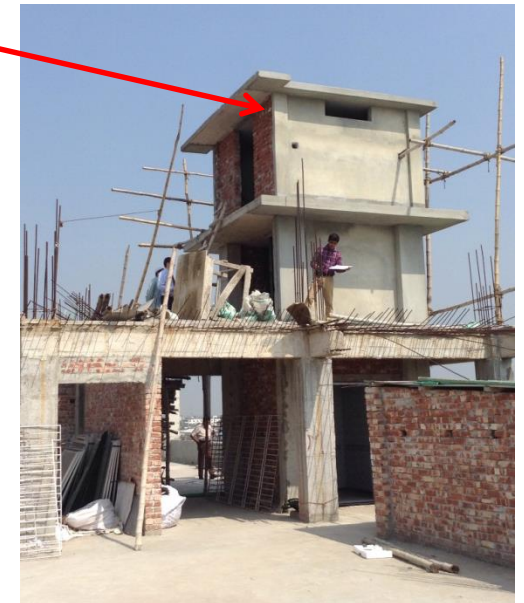
# Heavily-loaded lift roof slab and additional lift room

- The lift plant room is situated on the top of the lift.
- The heavy lift machinery is sitting on the slab without connections to the main vertical load bearing structure.
- The slab is also weakened by many openings.
- Large brick aggregate was noted.

| Item No. | Observation | Recommended Action Plan | Recommended Timeline |
|---|---|---|---|
| 1 | Heavily-loaded lift roof slab and additional lift room | Before the commissioning of the lift, Building Engineer to assess the capacity of the slab, the design loading of the lift and incorporate the existing openings in the design of the lift slab and load transfer system. | 6-months |
| 2 | Heavily-loaded lift roof slab and additional lift room | Carry out any necessary structural works arising from assessment | 6-months |

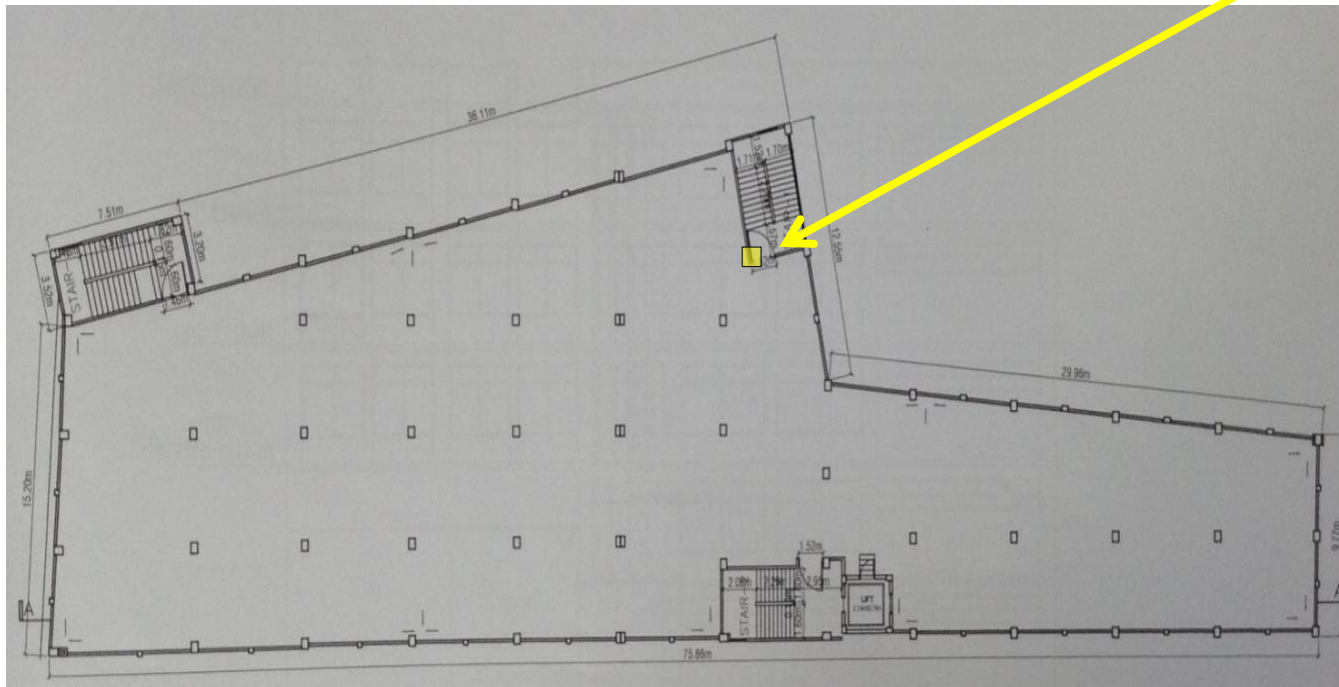
Typical column layout plan

This column is not shown on the as-built drawing.

On the Ground floor the Columns are bigger than shown on the drawings.

| Item No. | Observation | Recommended Action Plan | Recommended Timeline |
|---|---|---|---|
| 3 | Discrepancies between drawings and on-site observations | Building engineer to survey the as-constructed building. | 6-months |
| 4 | Discrepancies between drawings and on-site observations | Updated drawings to be prepared showing the accurate as-built layout. | 6-months |
| 5 | Discrepancies between drawings and on-site observations | The column not currently shown on drawings is to be included and its characteristics verified. | 6-months |

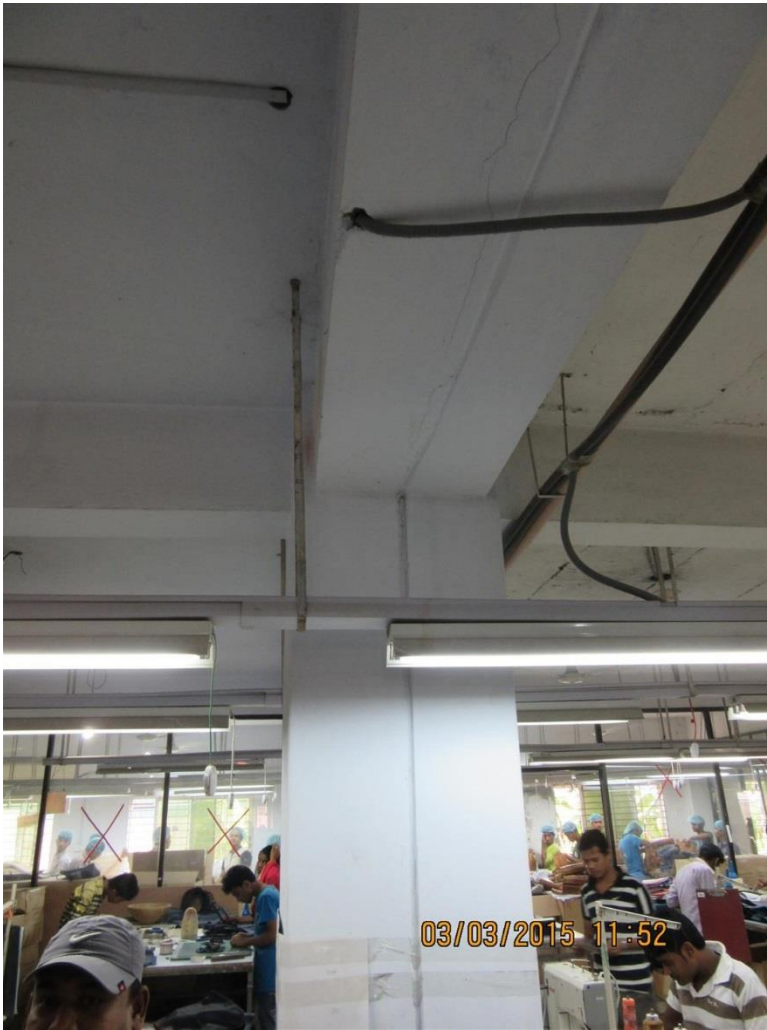
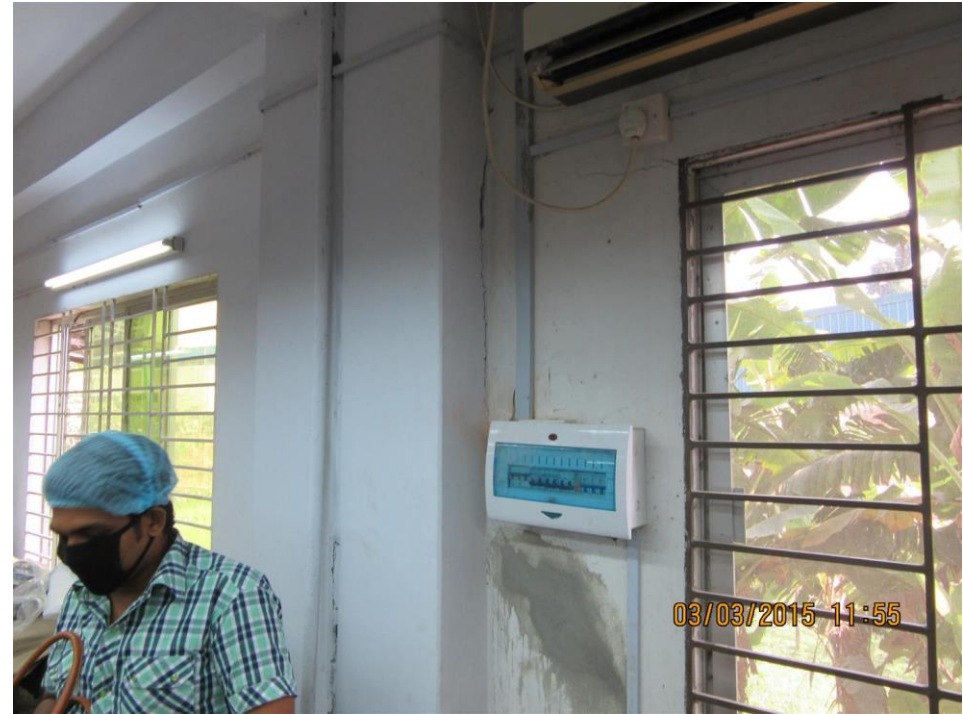
Expansion joint at Ground floor level

It appears that the expansion joint is connected at this level, which is possibly the reason that there are a lot of small cracks in the elements around the joint.

| Item No. | Observation | Recommended Action Plan | Recommended Timeline |
|---|---|---|---|
| 6 | Poorly-constructed expansion joint at ground floor level | Building Engineer to investigate top of column and beam connections in the zone of the expansion joint at the soffit of the 1st floor, as well as the materials used in the joint. | 6-weeks |
| 7 | Poorly-constructed expansion joint at ground floor level | Building Engineer to assess the design and detailing of the expansion joint. | 6-weeks |
| 8 | Poorly-constructed expansion joint at ground floor level | Carry out any remedial structural and finishing works to the expansion joint, including any measures required at roof level to ensure the joint is watertight. | 6-months |

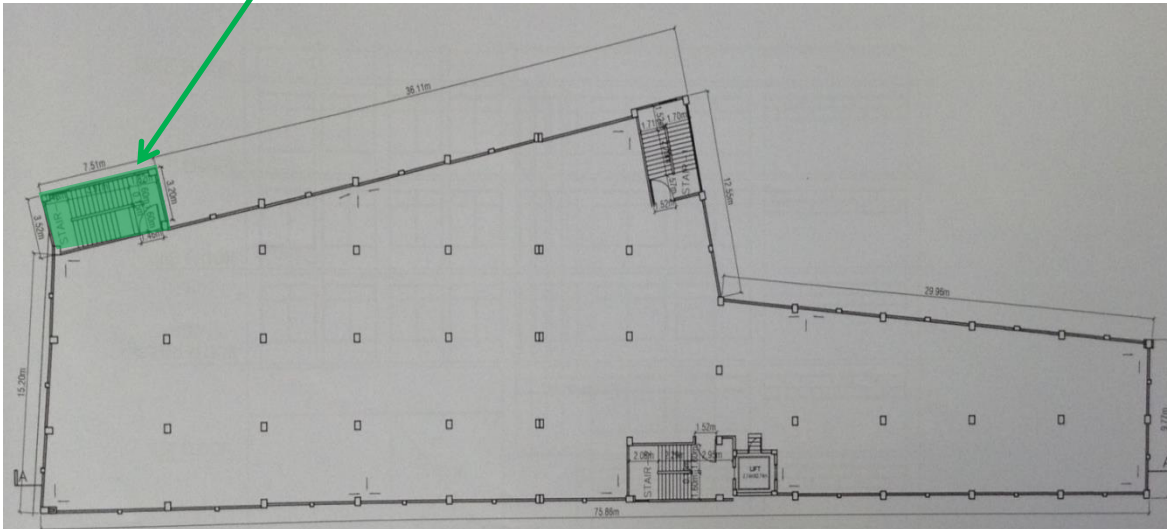
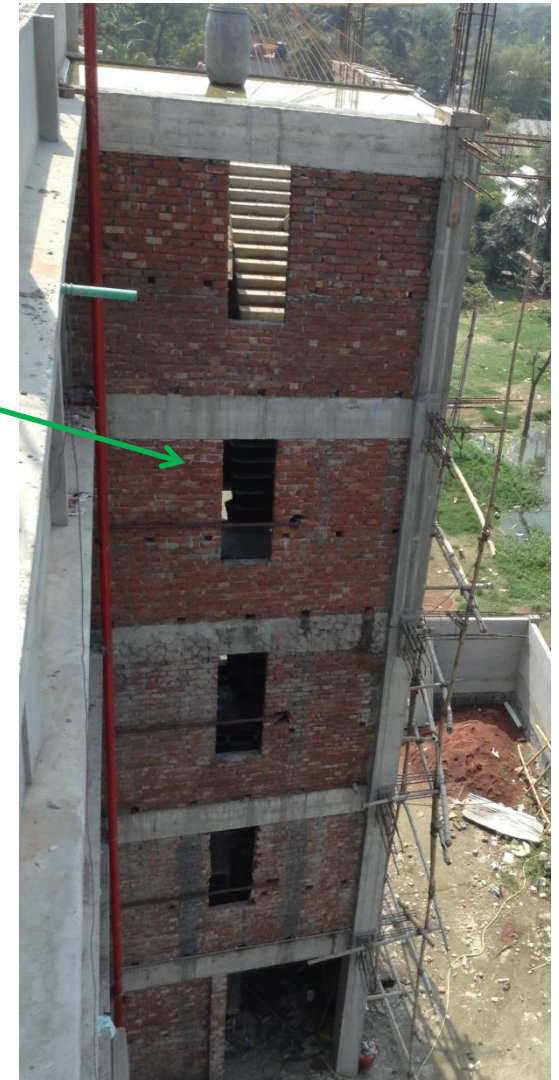
## Typical layout plan

No permit and no as-built drawing  
for this stair core

| Item No. | Observation | Recommended Action Plan | Recommended Timeline |
|---|---|---|---|
| 9 | Apparently non-engineered escape stair core | Before the escape stair core is opened for use, Building Engineer to check its load bearing capacity, its lateral stability and its connection to the main building. | 6-months |
| 10 | Apparently non-engineered escape stair core | Stair core to be included as part of the as-built drawings (see Item 2). | 6-months |
