FIRE SAFETY INSPECTION REPORT

**VERTEX WEAR LIMITED
VARARI, RAJFULBARIA, TETULJHORA, SAVAR,
DHAKA**

ACCORD
on Fire and Building Safety in Bangladesh

March 11, 2014

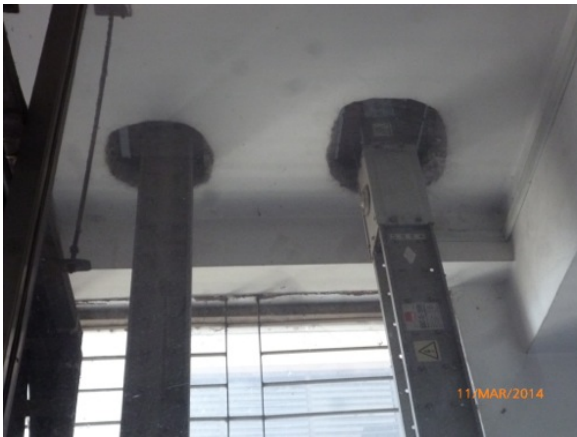
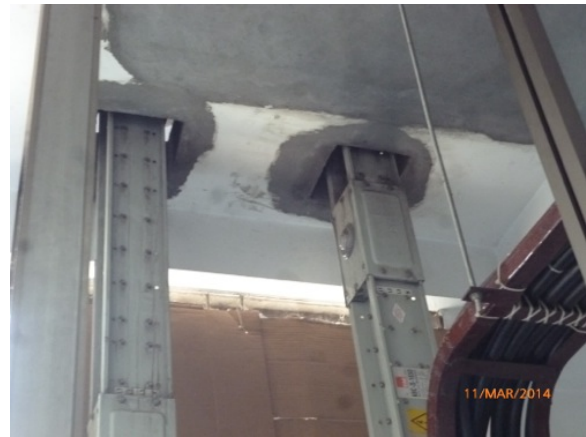
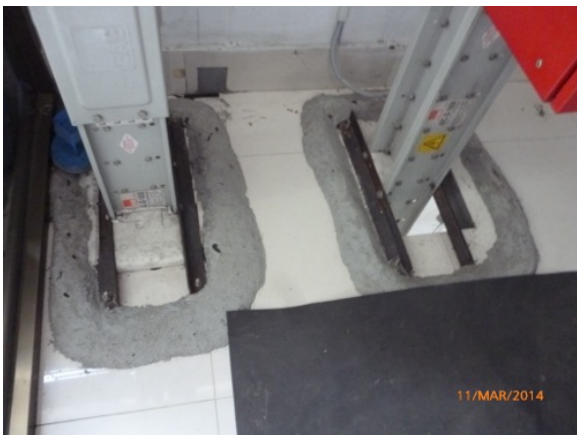
No.	Category	Finding	Recommendation	Remediation Timeframe
F-1	Fire Rated Construction	Unsealed penetrations and openings are located in the fire-rated floor/ceiling assemblies. (All floors).	Provide a minimum 2-hr fire- rated shaft to separate the utility risers from each floor level.	Within 3 months

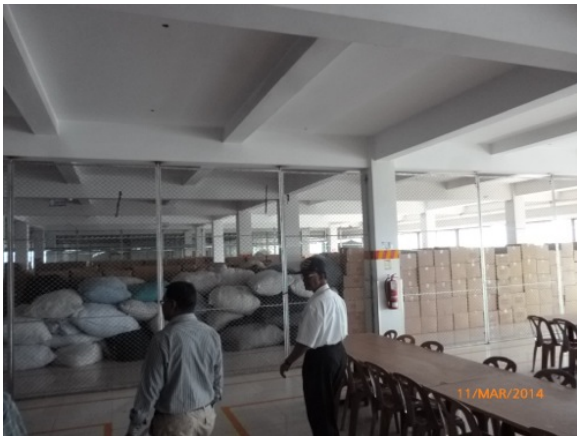
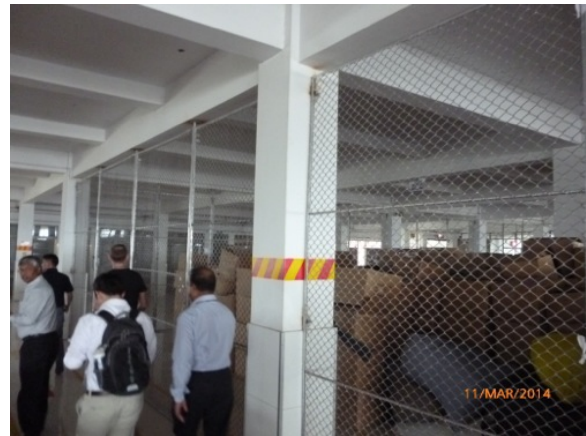
F-2	Fire Rated Construction	<p>Areas used for combustible storage are not separated by fire-rated construction.</p> <p>Location: 5th floor storages used fence wire as separation on their storages.</p>	<p>Provide dedicated storage rooms separated by minimum 1-hr fire-rated construction.</p>	<p>Within 3 months</p>
-----	-------------------------	--	---	------------------------

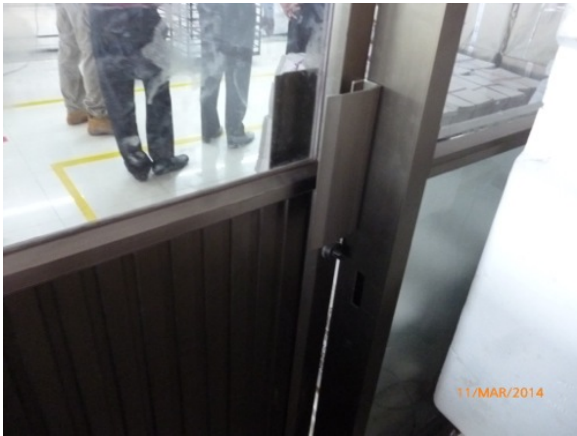
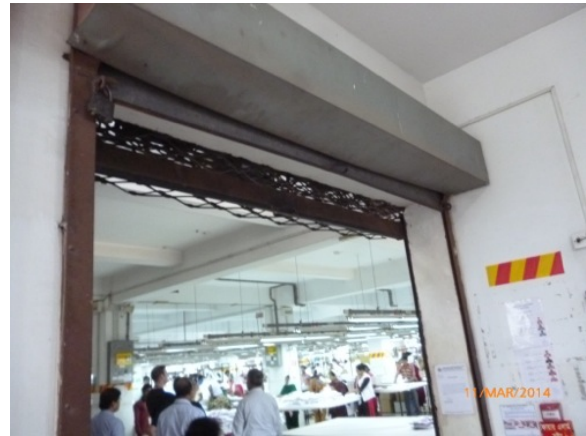
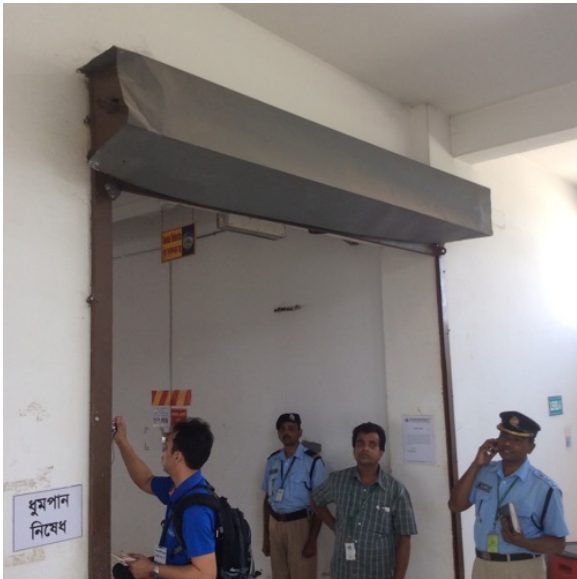
F-3	Egress	<p>Egress doors and gates with locking features are provided at building exits, exit stairs, along egress routes, exit discharge.</p> <p>All gates/doors were open and unlocked during the inspection.</p>	<p>Remove locking features from all egress doors and gates.</p> <p>If locks are required for security reasons, utilize special door locking features complying with NFPA 101.</p>	<p>Immediate</p>
-----	--------	--	---	------------------

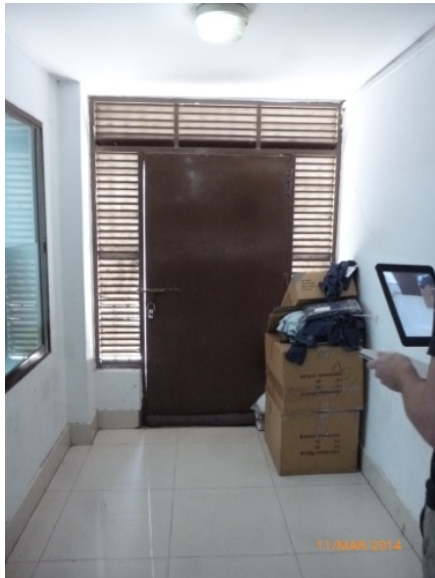
F-4

Dead-end egress path exceed 30 m.

Location: Ground floor office egress path way

Remove the door locks changes the to panic bar hardware,

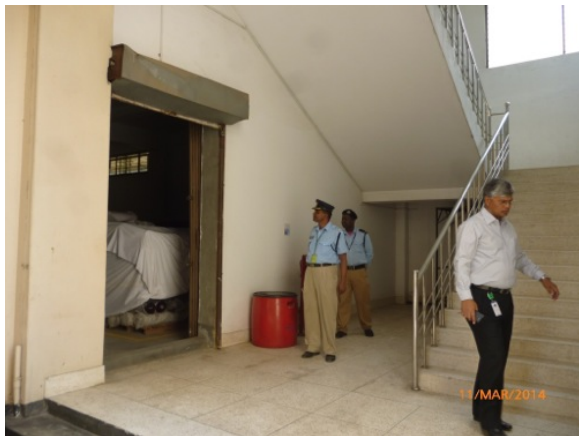
F-5	Egress	Secondary exit of storage was located in the exit stair.	Provide 2 hrs fire rated door or install additional separation room	Immediate
		Location: Landing of west stairwell on the ground floor.

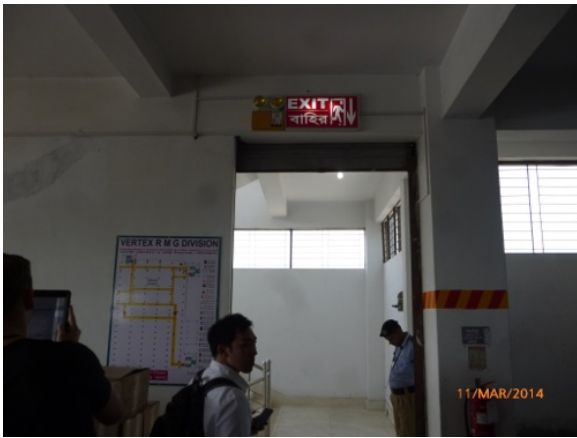
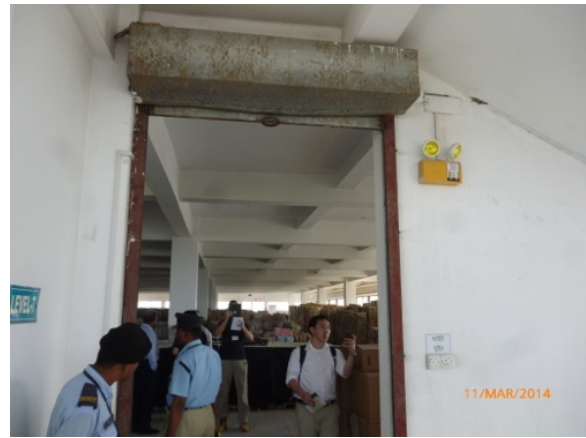
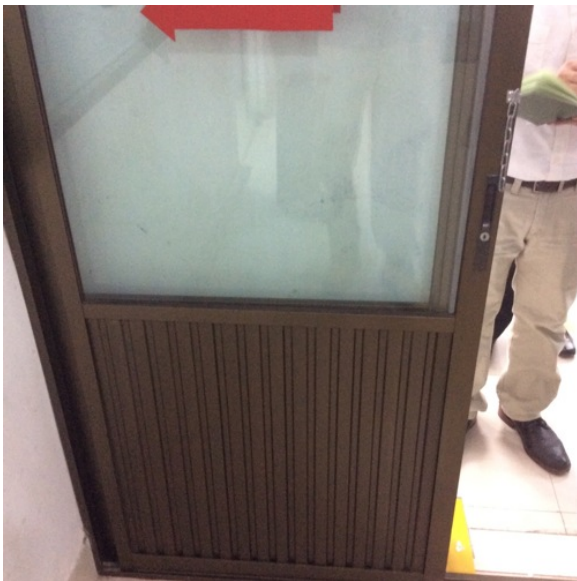
F-6	Egress	Collapsible gates and sliding doors are provided at building exits, exit stairs, along egress routes and exit discharge.	<p>Replace all gates and sliding doors along the means of egress with side-hinged, swinging egress doors.</p> <p>If locks are required for security reasons, utilize special door locking features complying with NFPA 101.</p>	Within 1 month
-----	--------	--	---	----------------

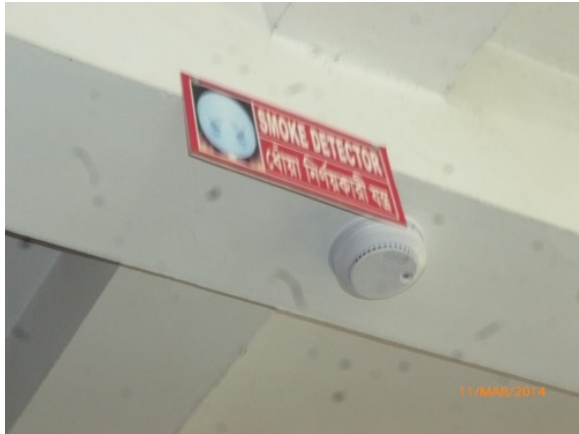
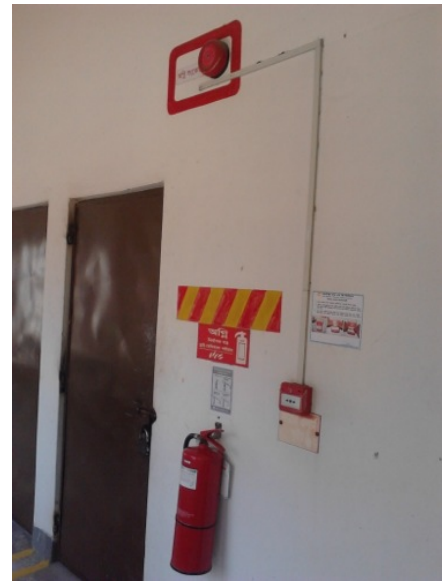
F-7	Fire Protection	The fire alarm system is antiquated, not a listed system, and does not provide alarm and notification features consistent with acceptable standards.	Replace the fire alarm system with a new, listed addressable fire alarm system in accordance with NFPA 72.	Design within 4 months, install within 9 months
-----	-----------------	--	--	---

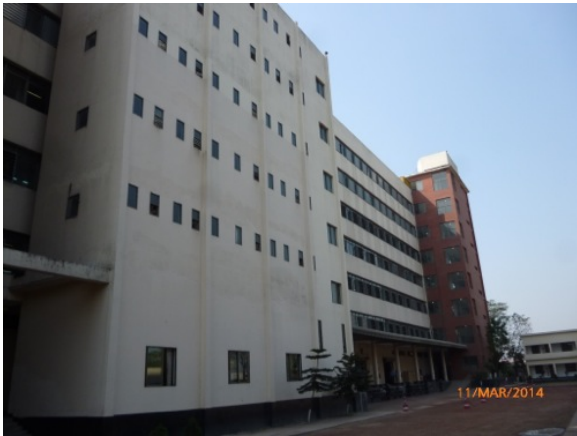
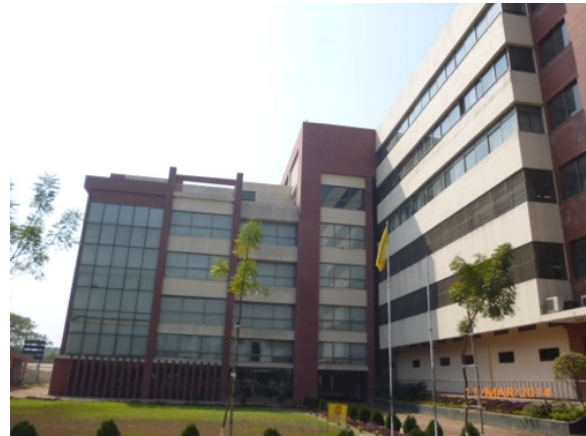
F-8	Fire Protection	The high-rise building has an occupied floor greater than 23m (75 ft) and is not provided with automatic sprinkler protection. The large occupant loads, heavy fuel loading, and anticipated extended egress times warrant sprinkler protection.	Provide automatic sprinkler protection throughout the building in accordance with NFPA 13.	Design within 6 months, install within 12 months
-----	-----------------	--	--	--

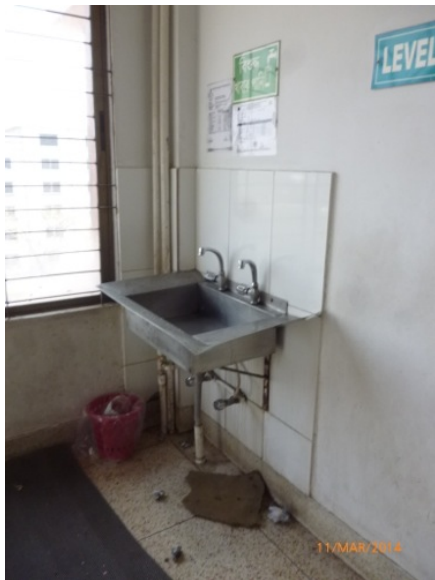
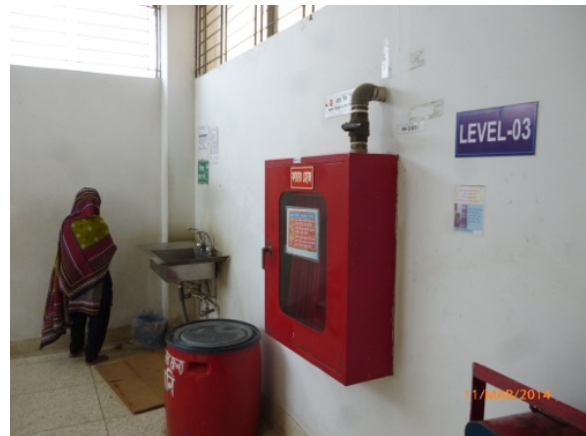
F-9 Fire Protection Drinking station on stairwell,

Remove all the drinking station Immediate on both stairwell, Stairwell should be free from any obstruction.

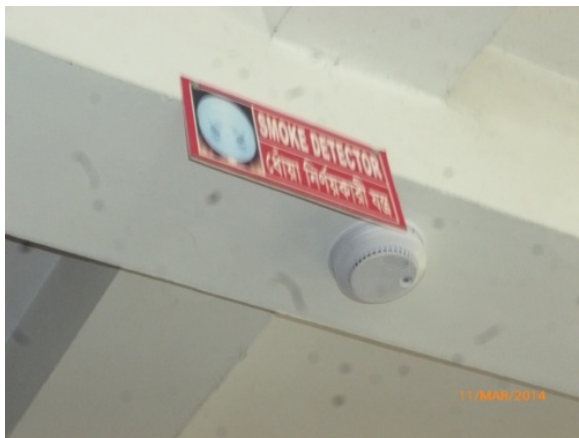
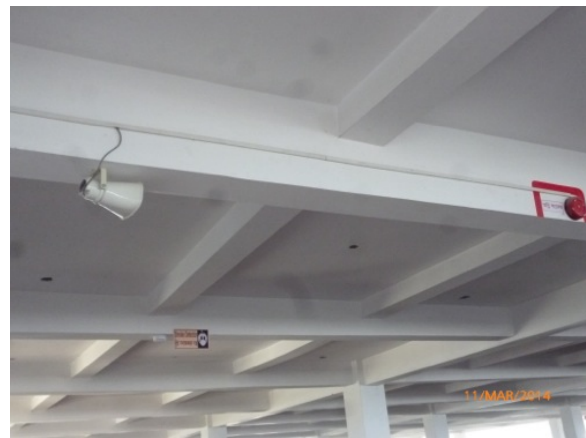
F-11	Fire Protection	The building is equipped with single-station smoke alarms. Smoke alarm activation sounds only a local alarm and does not provide automatic fire alarm notification of occupants.	Remove single station smoke alarms. Provide automatic smoke detection throughout the building in Accordance with NFPA 72.	Within 6 months
------	-----------------	--	---	-----------------

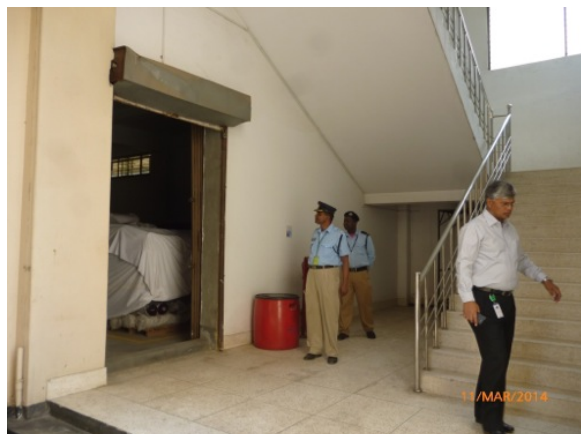
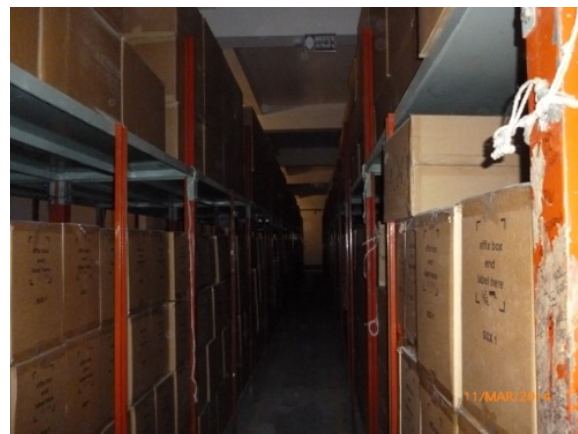
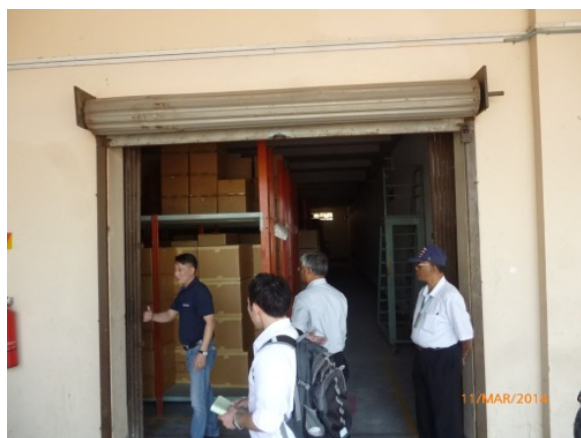
F-12	Egress Lighting	The Warehouse in ground floor did not have any emergency lights and exit signs	Provide Emergency lights and exit signs.	Within 3 months
------	-----------------	--	--	-----------------
