# **FIRE SAFETY INSPECTION REPORT**

**RADIANCE FASHION LTD.  
KHAJUR BAGAN, ASHULIA, SAVAR, DHAKA**

**ACCORD**  
on Fire and Building Safety in Bangladesh

April 27, 2014

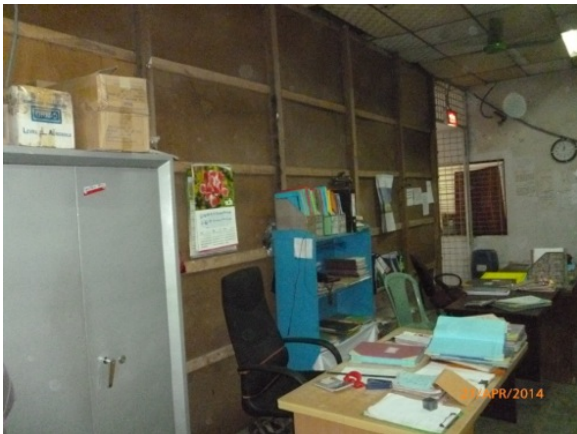
| No. | Category | Finding | Recommendation | Remediation Timeframe |
|---|---|---|---|---|
| F-1 | Fire Rated Construction | Combustible construction materials are provided in the storage building. (Wooden wall and doors) | Remove all combustible construction materials and replace by non-combustible materials. | Within 1 month |

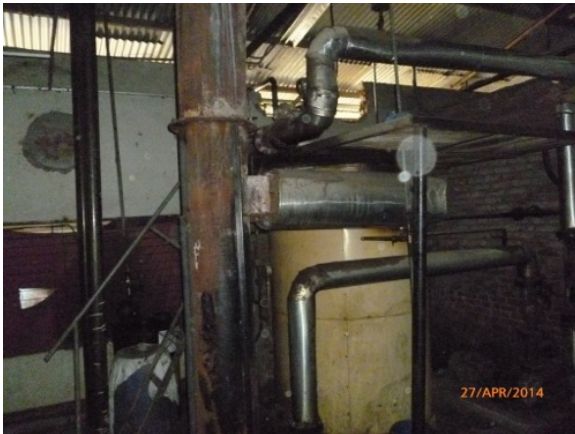
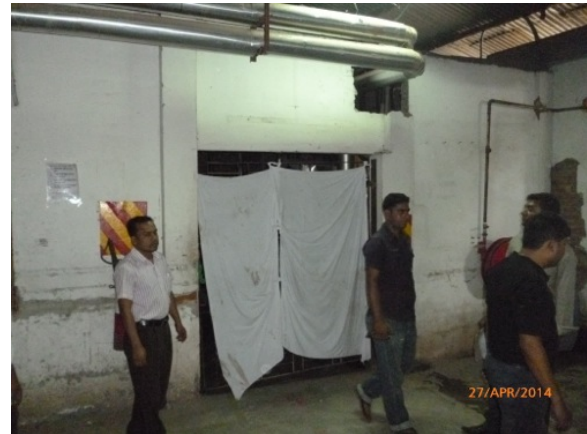
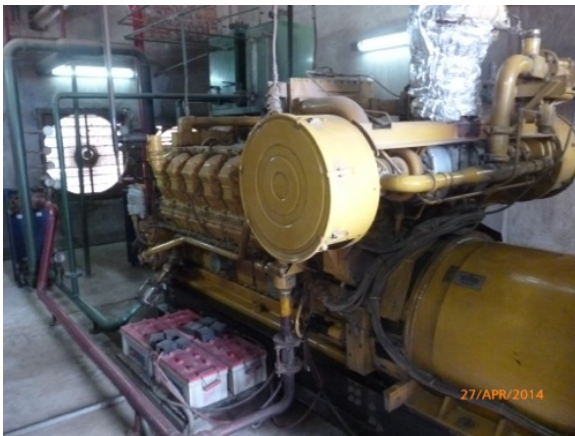
| No. | Category | Finding | Recommendation | Remediation Timeframe |
|---|---|---|---|---|
| F-2 | Fire Rated Construction | The boiler and generator rooms are not separated by fire-rated construction (openings, non-rated doors, penetrations). | Separate the boiler and generator rooms by a minimum 2-hr fire-rated construction. Seal and/or protected all openings to maintain the required fire separations | Within 3 months |

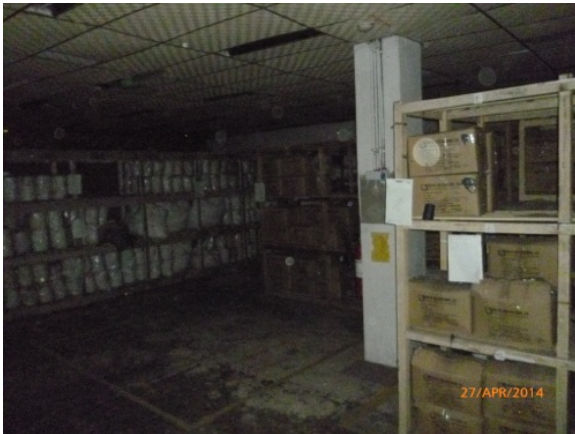
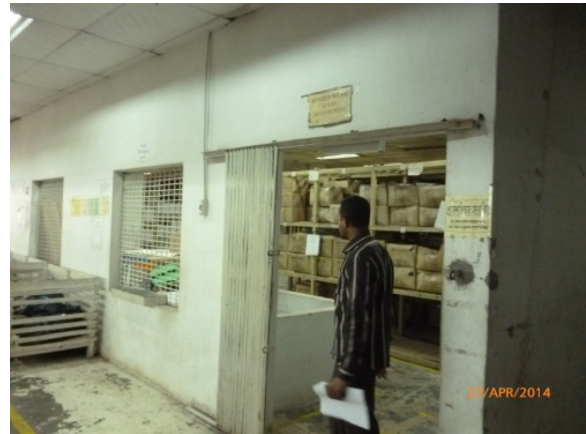
| F-3 | Fire Rated Construction | Areas used for combustible storage are not separated by fire-rated construction. | Provide dedicated storage rooms separated by minimum 1-hr fire-rated construction. | Within 3 months |

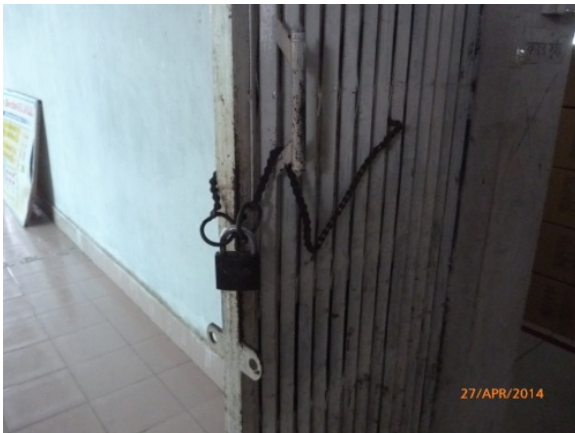
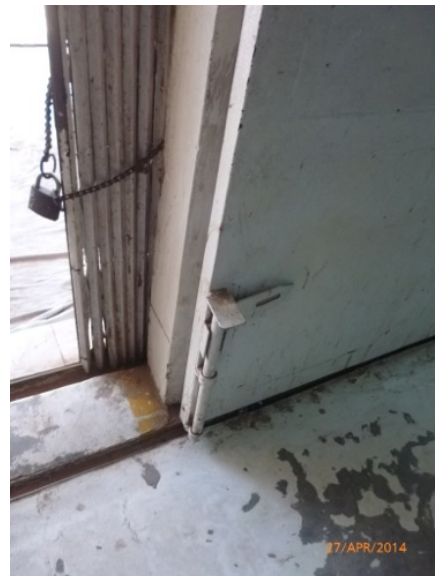
| F-4 | Egress | Egress doors with locking features are provided at building exits. | Remove locking features from all egress doors. | Immediate |
| | | All doors were open and unlocked during the inspection. | If locks are required for security reasons, utilize special door locking features complying with NFPA 101. | |

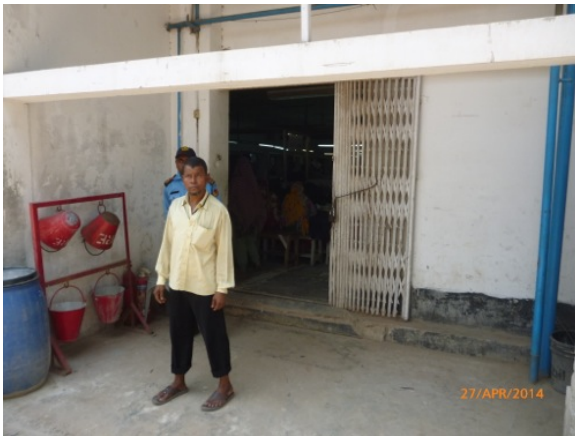
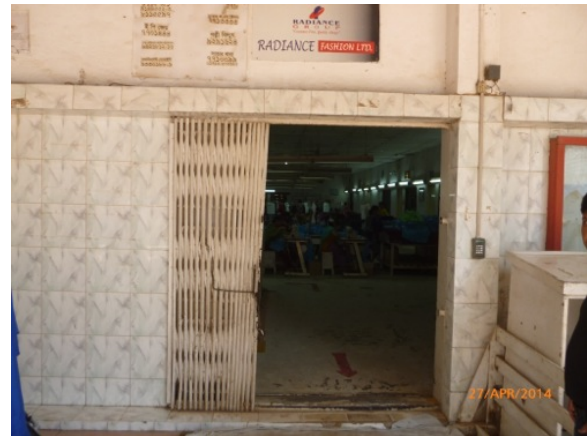
| F-5 | Egress | Sliding doors are provided at building exits. | Replace all sliding doors along the means of egress with side-hinged, swinging egress doors.<br><br>If locks are required for security reasons, utilize special door locking features complying with NFPA 101. | Within 1 month |

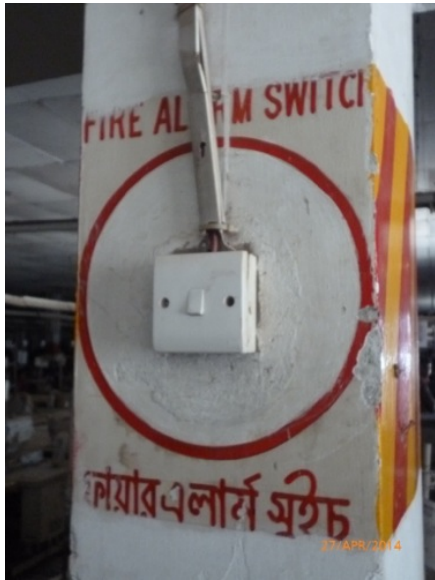
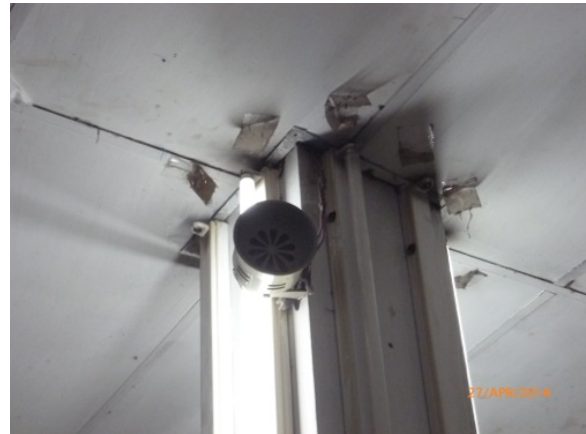
| F-6 | Fire Protection | The fire alarm system is antiquated, not a listed system, and does not provide alarm and notification features consistent with acceptable standards. | Replace the fire alarm system with a new, listed addressable fire alarm system in accordance with NFPA 72. | Design within 4 months, install within 9 months |

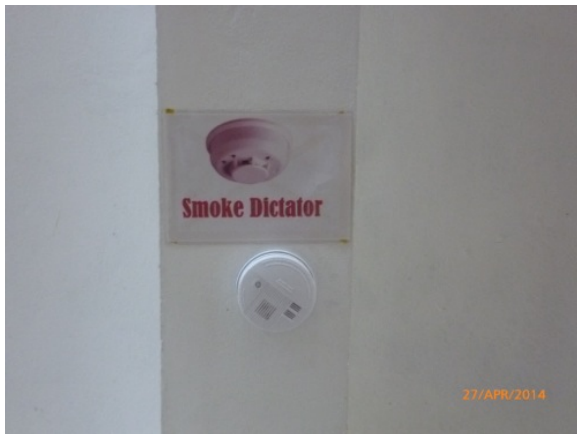
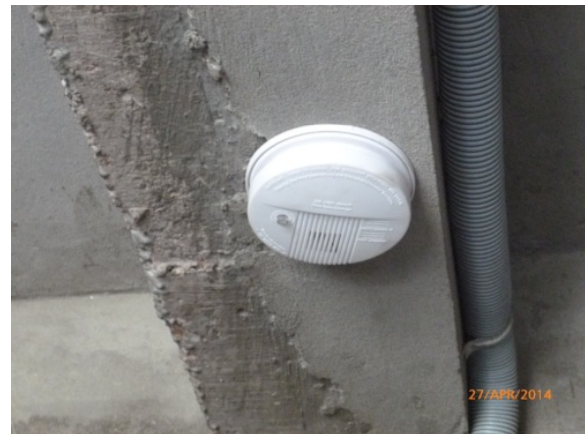
| F-8 | Fire Protection | The building is equipped with single-station smoke alarms. Smoke alarm activation sounds only a local alarm and does not provide automatic fire alarm notification of occupants. | Remove single station smoke alarms. Provide automatic smoke detection throughout the building in Accordance with NFPA 72. | Within 6 months |

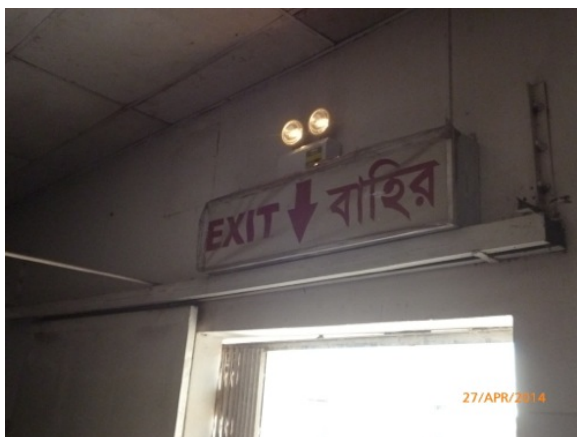
| F-9 | Egress Lighting | Exit signage are not connected to "IPS" or generator back-up. | Provided alternate back up power to all exit signage. | Within 1 month |
