# **FIRE SAFETY INSPECTION REPORT**

**RIPON KNITWEAR LTD.  
JARUN, KONABARI, GAZIPUR**

**ACC**   **RD**  
on Fire and Building Safety in Bangladesh

April 29, 2014

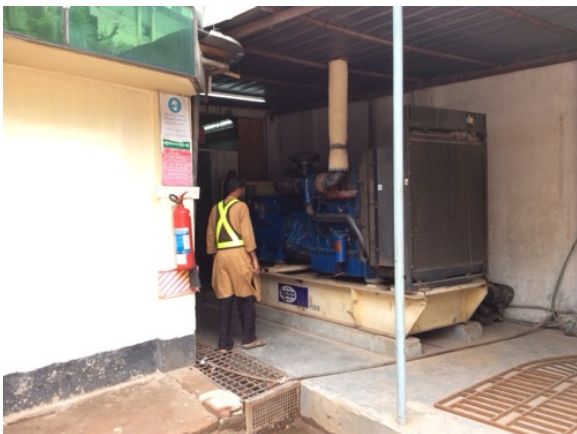
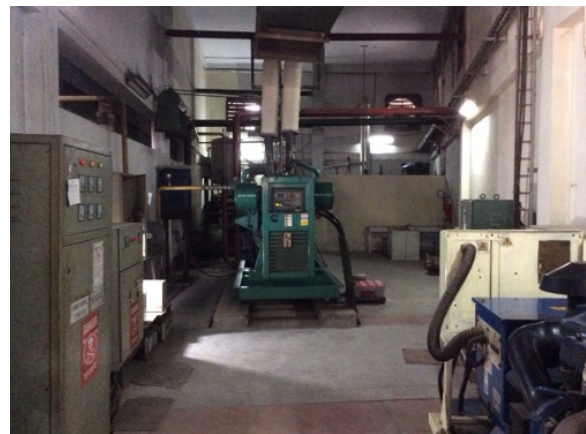
No.	Category	Finding	Recommendation	Remediation Timeframe
F-1	Fire Rated Construction	The generator and boiler rooms on the ground floors are not separated from the south eastern exit discharge by means of fire-rated construction (fire rated doors and unprotected openings).	Separate the boiler, generator from the working areas and egress routes by a minimum 2-hr fire-rated construction. Seal and/or protected all openings to maintain the required fire separations.	Within 3 months

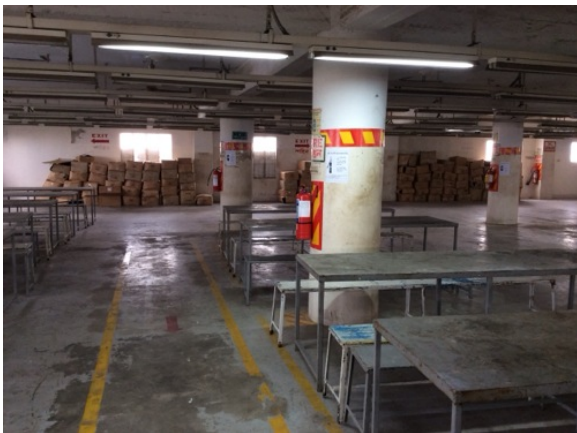
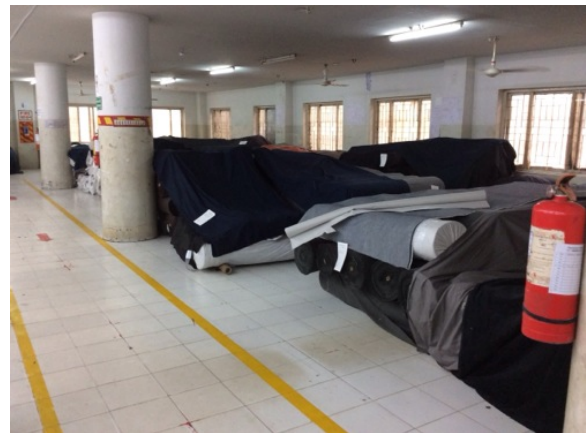
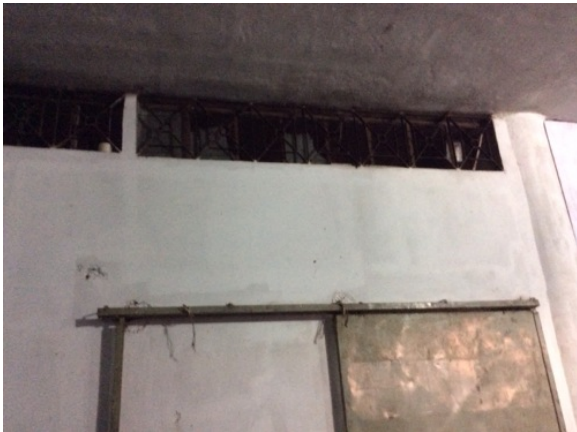
F-2	Fire Rated Construction	<p>Areas used for combustible storage are not separated by fire-rated construction.</p> <p>The dedicated storage areas on the 3rd floor (Bonded warehouse, Finished fabrics store), 2nd floor (Accessories store, Knitting section store), 1st floor (Metal free zone) and the ground floor (Godown areas) were not separated by fire-rated construction (unprotected openings and fire rated doors).</p> <p>The transient storage areas on the 3rd floor (Fabrics relaxing area) and 2nd floor (Knitting section) exceeded the permitted limits and was open to the working areas.</p>	<p>Provide dedicated storage rooms separated by minimum 1-hr fire-rated construction.</p> <p>Where separate storage rooms are not feasible, provide defined storage areas and limit the storage arrangement as follows:</p> <ul style="list-style-type: none"><li>- Maximum height of 2.4m and maximum area of 23m<sup>2</sup></li><li>- If sprinkler protected: maximum height of 3.66m and maximum area of 93m<sup>2</sup></li></ul> <p>Separate areas of unenclosed combustible storage by a minimum clear distance of 3m.</p>	Within 3 months

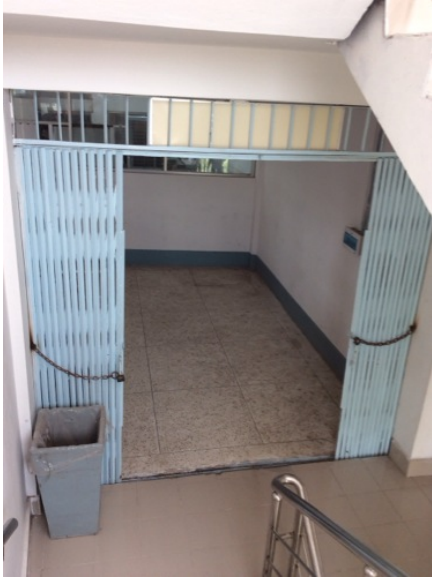
F-3	Fire Rated Construction	The exit stairs were not separated from work areas on each floor by fire-rated construction.	Provide minimum 1.5-hr fire rated doors and seal all unprotected openings to separate the exit stairs from work areas and other building spaces on all floor levels. Ensure that the fire doors are self-closing and positive latching and that they are provided with fire exit (panic) hardware where serving production floors.  If fire doors are required to be held open for functional reasons, provide automatic-closing devices tied to the fire alarm system.	Within 3 months
-----	-------------------------	--	---	-----------------

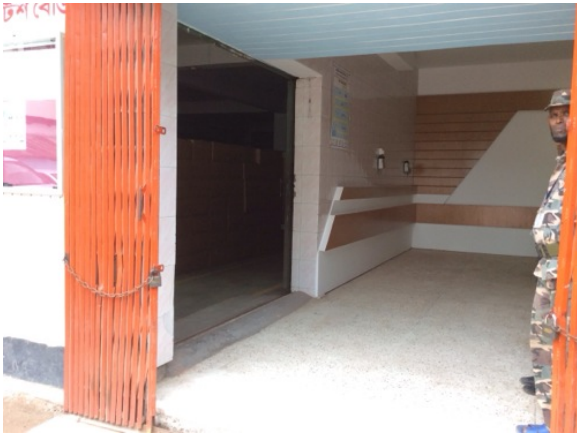
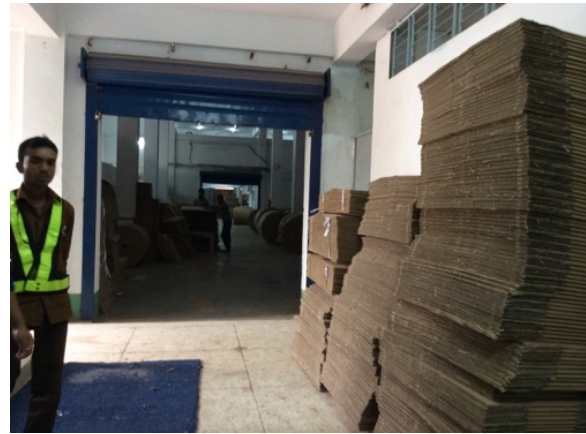
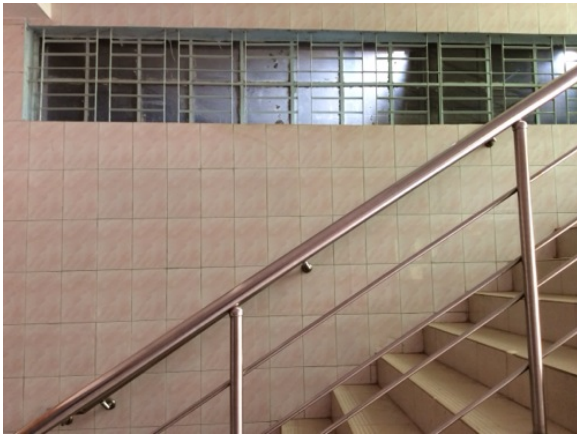
F-4	Fire Rated Construction	Various penetrations and openings were located in the south western and south eastern exit stair enclosures. Example: On the ground floor, the landing of both the stairs are used to access the storage areas. The south western exit stair enclosure was exposed to the generator room by means of unprotected openings.	Seal all penetrations and openings in exit stair enclosure walls to maintain the fire separation.	Within 3 months
-----	-------------------------	--	---	-----------------

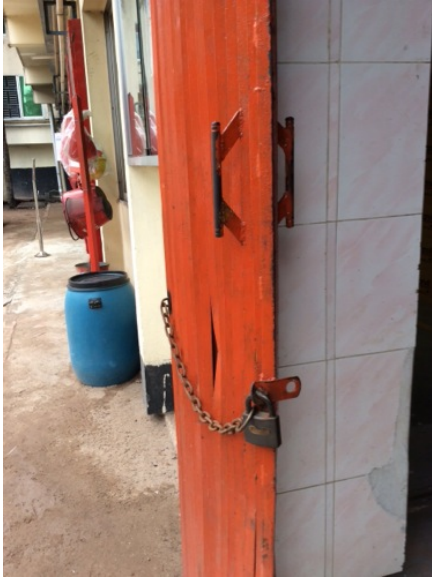
F-5	Egress	Egress doors / gates with locking features were found in building exits, along egress routes and in the exit discharges on all floors. All gates/doors were found to be open and unlocked during the inspection.	Remove locking features from all egress doors / gates.  If locks are required for security reasons, utilize special door locking features complying with NFPA 101.	Immediate
-----	--------	--	--	-----------

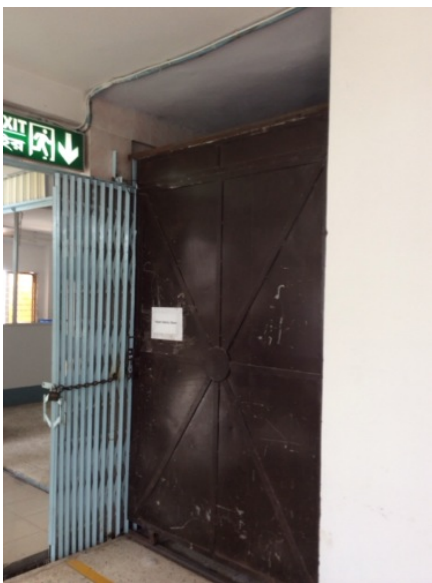
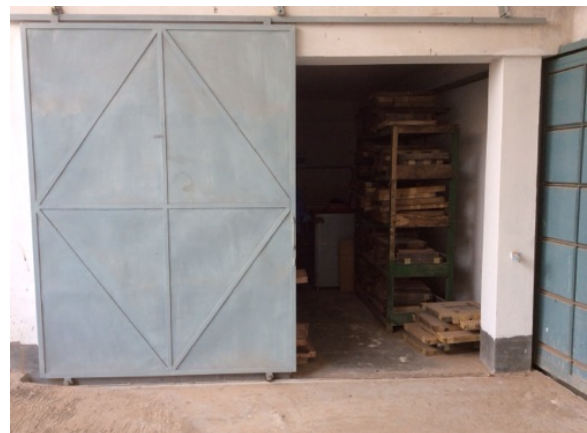
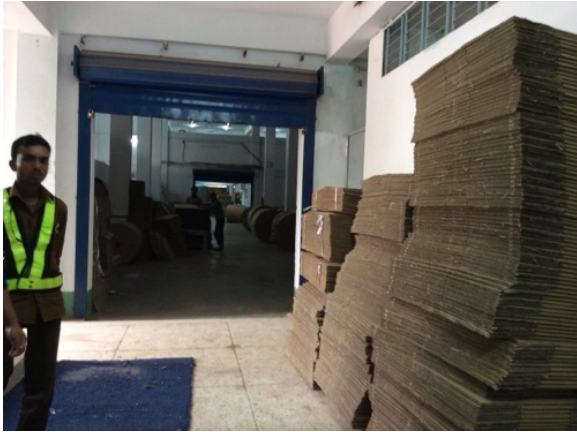
F-6 Egress

Collapsible gates / sliding doors are provided at all building exits, exit stairs and at exit discharges.

Replace all gates / sliding doors along the means of egress with side-hinged, swinging egress doors.

If locks are required for security reasons, utilize special door locking features complying with NFPA 101.

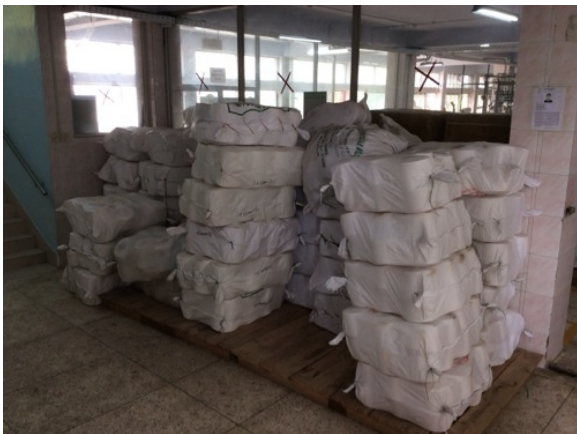
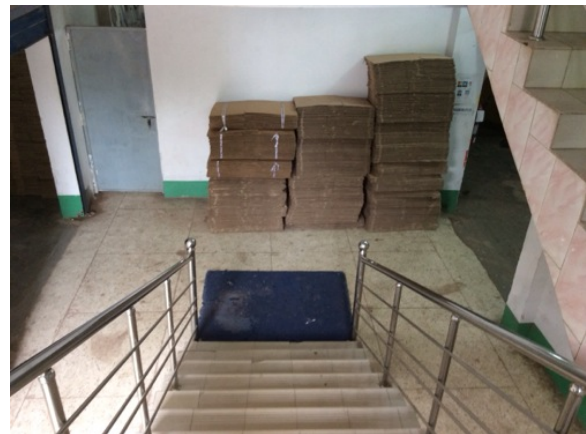
F-7 Egress

General storage was located inside the north eastern exit stair enclosures on the 2nd floor and ground floor.

Remove all storage from exit stairs and egress paths.

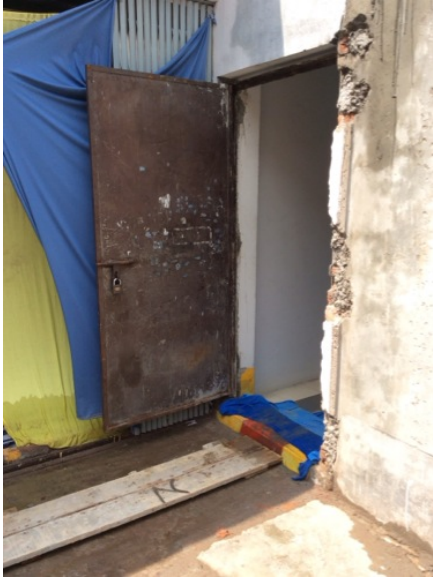
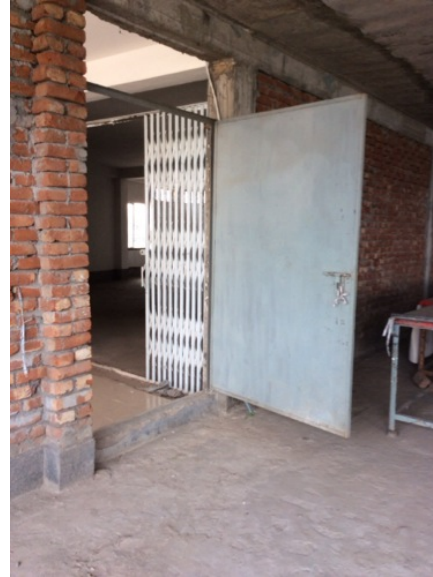
F-8 Egress

The north and south eastern exit stair doors on the 4th floor did not swing in the direction of egress travel.

Modify the egress door to swing in the direction of egress travel.
