GK Garments Ltd (10378)
Global Fashion Garments Ltd (10380)
Global Outerwear Ltd (9991)
Savar Shirts (10394)

89, Berulia Road, Tati, Savar, Dhaka, Bangladesh.

20.MARCH.2014

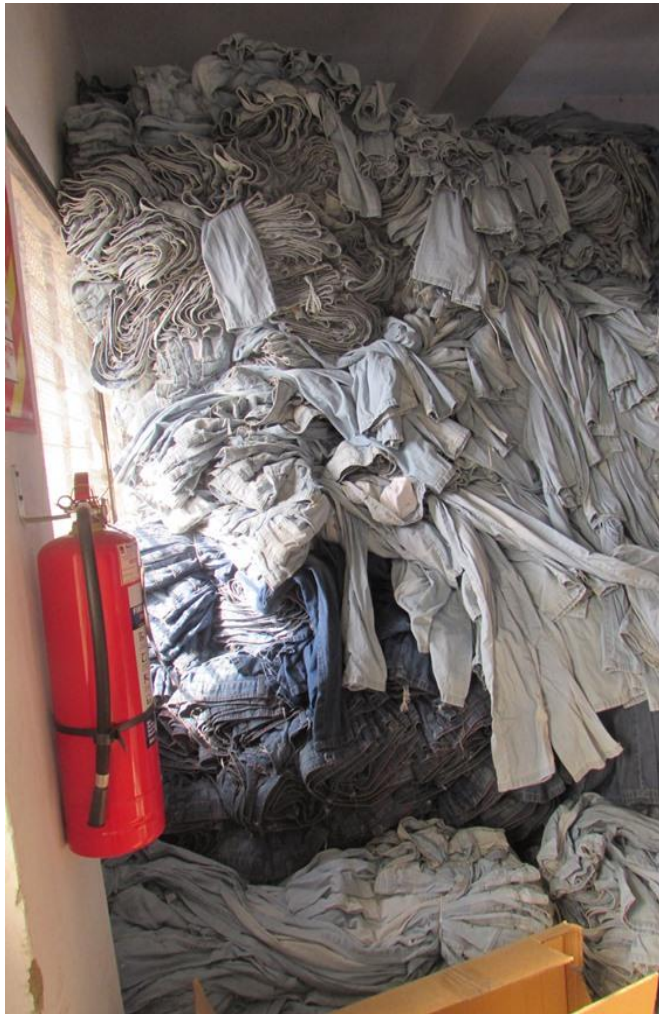
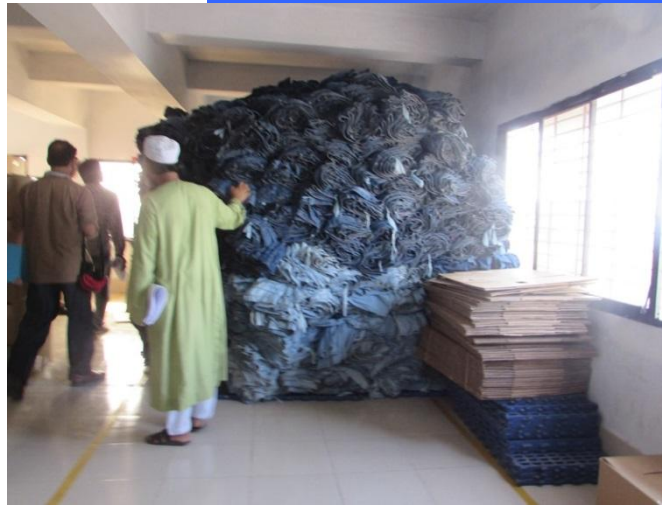
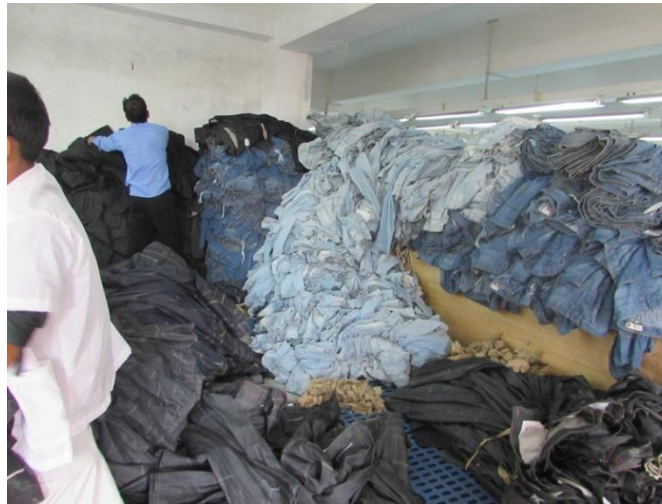
Excessive Storage Height of Garments

In many areas of the building, clothes have been stacked to unreasonably high levels despite there being plenty of space available to stack the clothes over a wider area.

The clothes should be stored such that the live load does not exceed 3kPa for any particular slab panel.

- Redistribute garments around the floor area to ensure that no stack exceeds 300kg/m²

- Implement loading plan and oversee that storage of finished goods and raw materials are stored in accordance with the loading plan.

- Maintain loading plan

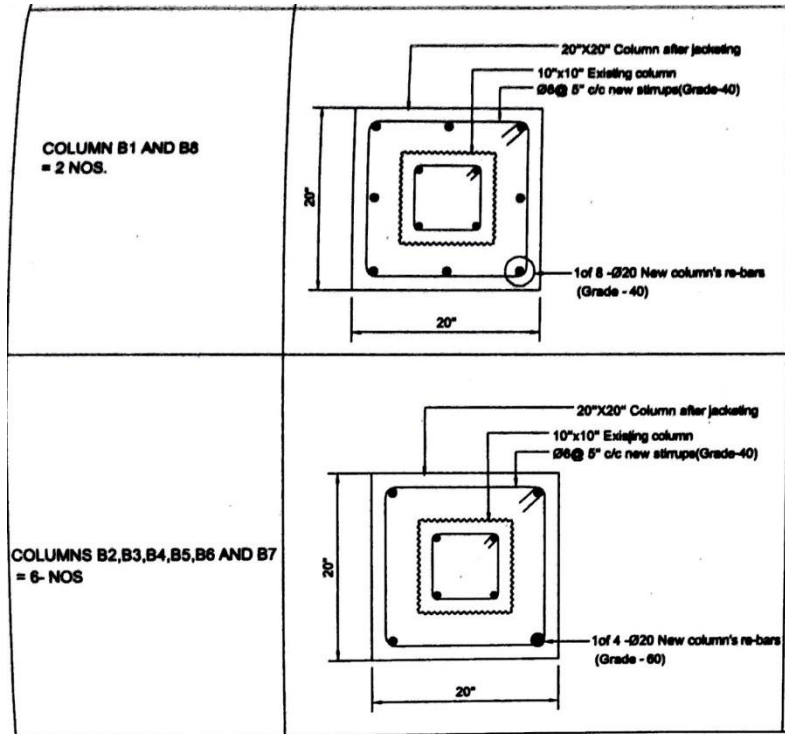
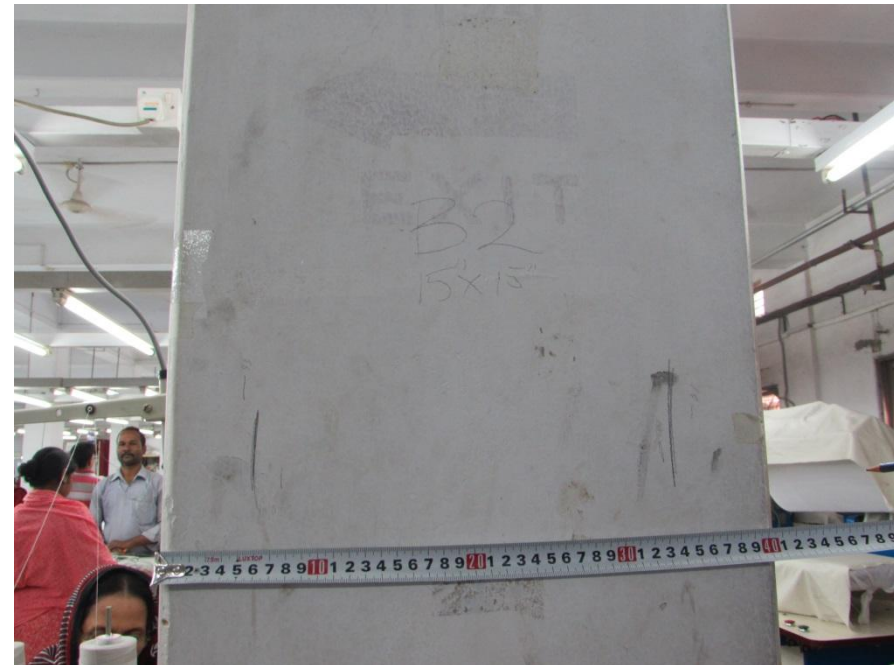
Size of column B2 of Block B differs between site and drawings

The drawings show that column B2 is a 508x508mm column, but the dimension on site only shows 381x381mm. As this is a supposedly “strengthened” column, we cannot see any evidence of this, even if the original column size was perceived to be 254x254mm. However, the building engineer has assured us that strengthening works have taken place.

- Factory Engineer to review design, loads and columns stresses in all areas
- Verify insitu concrete stresses either by 100mm dia. cores or existing cylinder strength data.

- A full structural survey of the building is to be carried out using intrusive and non-intrusive methods to ascertain the overall accuracy of the existing record drawings.

- Prepare new as-built drawings and a new loading plan for each floor which should be maintained and monitored regularly

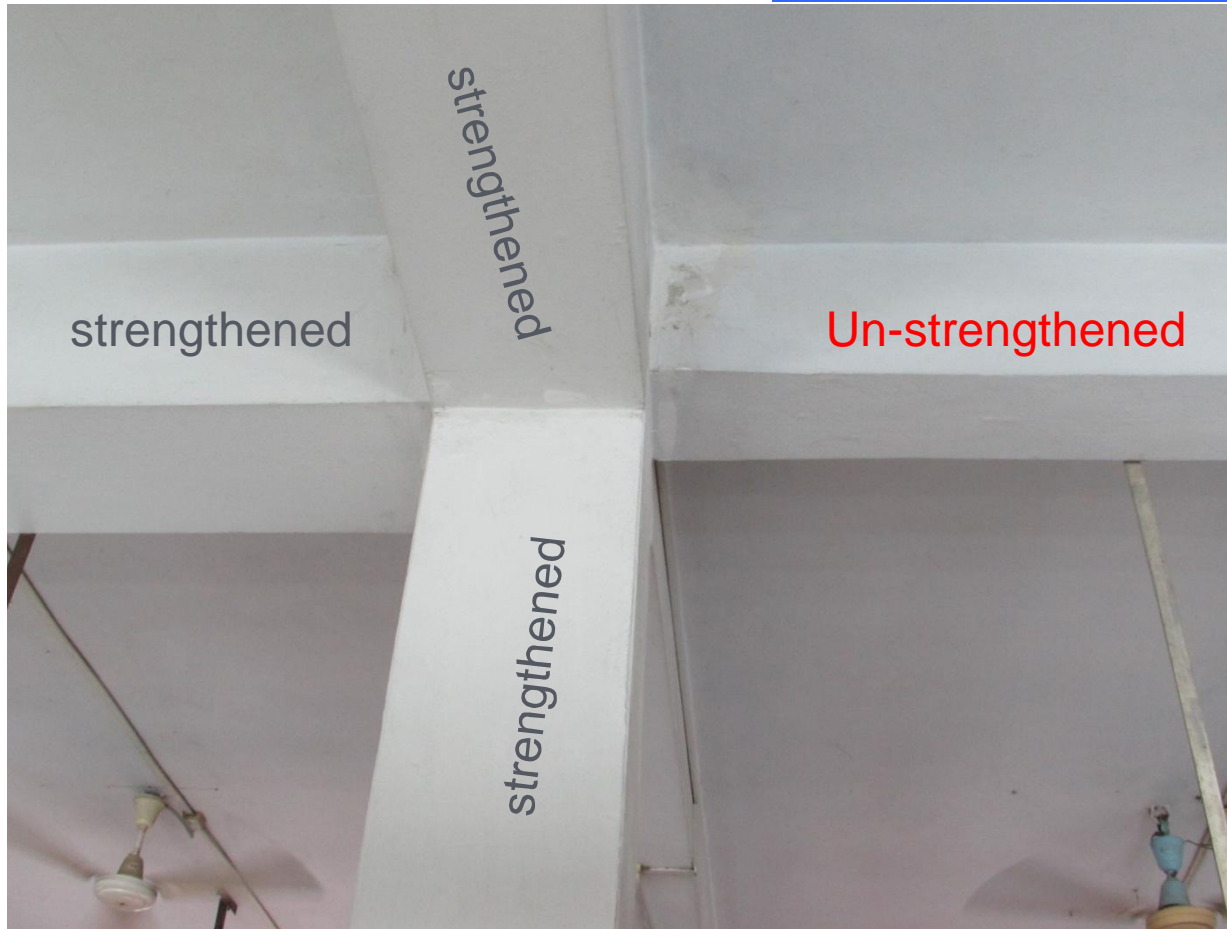
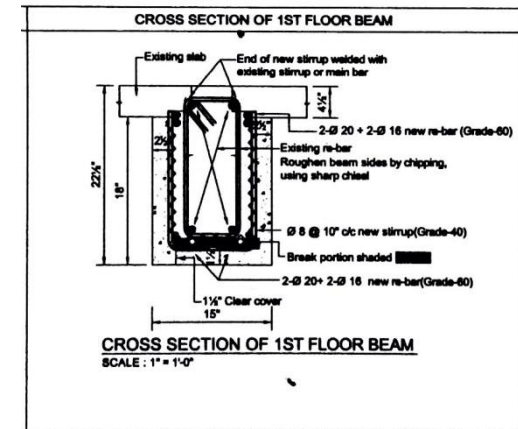
The upgrade of the existing Block B included the strengthening of all the existing beams to upgrade the imposed load capacity, and to strengthen them to due to the increase in building height and increase lateral load resistance from wind and seismic forces. However, there are some beams on G/F ceiling which have been selectively omitted from strengthening, and there seems to be no reason for this.

- Building Engineer to carry out full assessment of structure to ascertain reason for the beam not strengthened.
- A full structural survey of the building is to be carried out using intrusive and non-intrusive methods to ascertain the overall accuracy of the existing record drawings.
- Carry out strengthening works if found necessary

- Update drawings in accordance with the as-built details

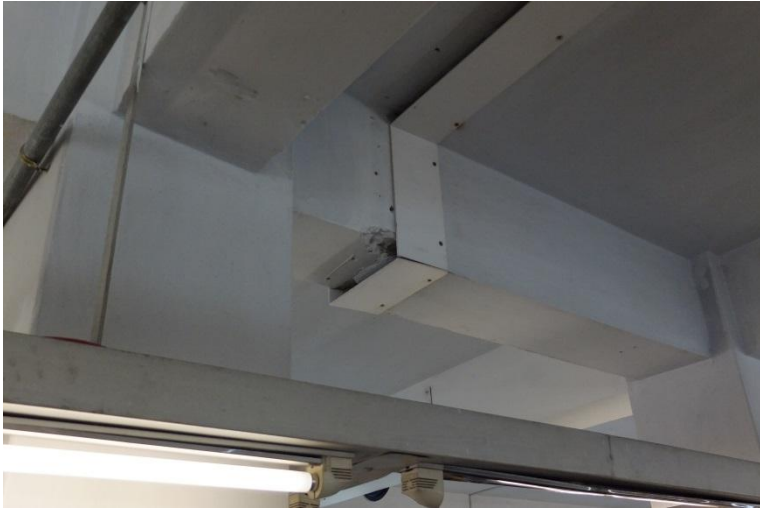
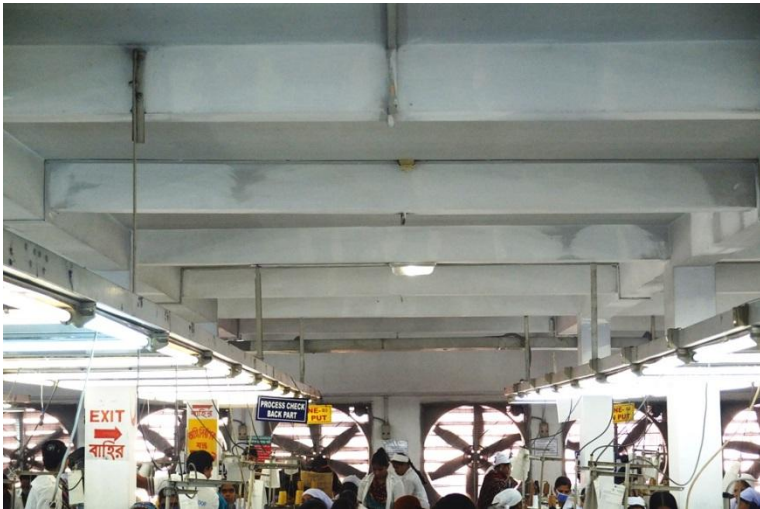
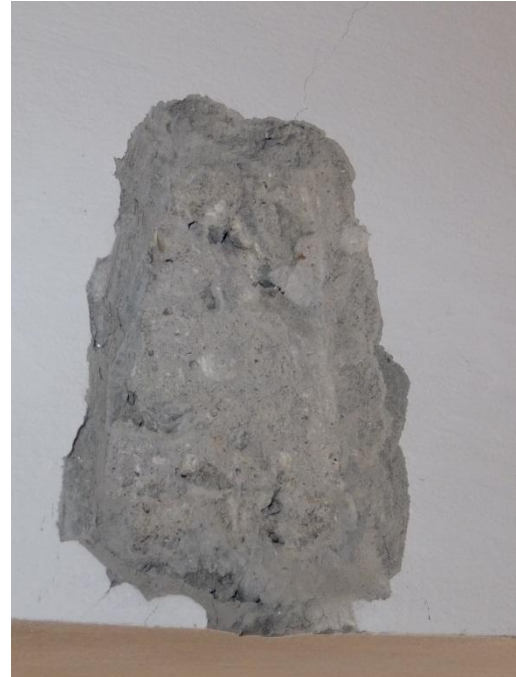
Numerous Structural Defects have Appeared in Block B

This building has a total of three buildings joined together. Each building is separated by a movement joint. However, it can be seen at several locations that excessive deflection of the structure has caused significant differential settlement.

In other areas, the upper floors have smaller beams than the lower floors, and also thinner slabs (some as thin as 88mm). The upper floor beams of Block B only show significant signs of cracks.

Exposing one of the beams revealed that honeycombing of the concrete could be a reason for some cracks appearing.

- In accordance with the actions in Item 2, carry out survey to ascertain the reasons for the defects observed,
- Propose remedial measures for the defects

- Carry out remedial works
- Observe structure for continuing appearance of structural defects

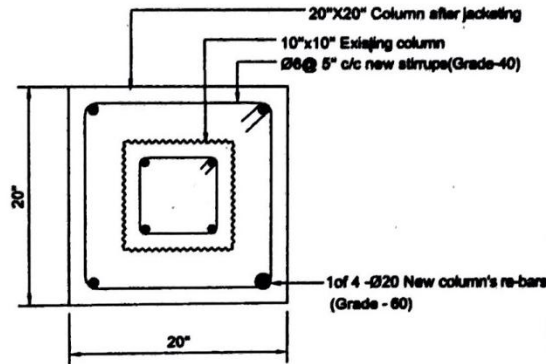
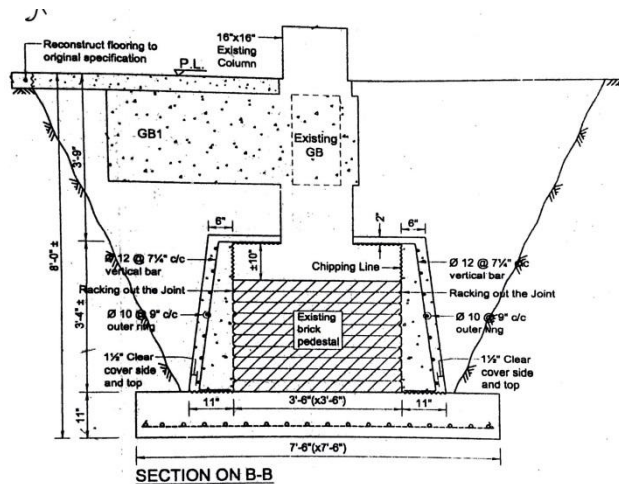
Strengthening Design Works Appear Fundamentally Flawed

The perceived quality of the drawings, in particular for the strengthening works for Block B appear to be unsatisfactory. Although strengthening works have been proposed, it is felt that the design of the strengthening works is fundamentally flawed.

- Rebar spacing exceeds maximum
- Concrete grade of new concrete and steel grade of new rebar maybe significantly stronger than the original concrete and rebar causing unbalanced stiffness distribution and possible concentration of stress at concrete interface
- It is considered that brick and mortar is not a suitable medium to transfer column loads from the original pad footing to the new pad footing.
- It is also considered that 11 inches for the new footing is too thin given that it would be almost impossible to guarantee even ground compaction underneath the footing

- Building engineer required to produce full calculations and justifications for the entire strengthening works design

- If strengthening works are found to be unsatisfactory, then remedial proposals to be immediately discussed and implemented.

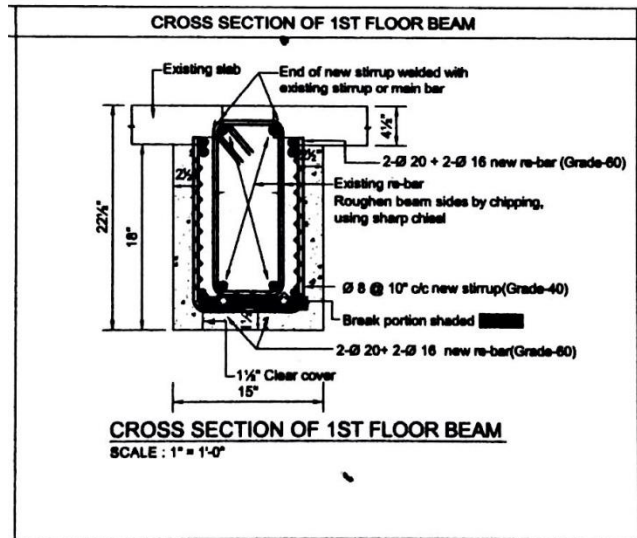
Strengthening Design Works Appear Fundamentally Flawed

- The new concrete jacket around the existing beam as well as the rebar may be significantly stronger than that of the existing beam, thus causing unbalanced stress distribution throughout the beam.
- The stirrup does not enclose the whole beam, and the jacket only relies on the bond between the old and new concrete, which may develop overstress due to the unbalanced stress distribution.
- There is insufficient bond length of the stirrup into the slab.

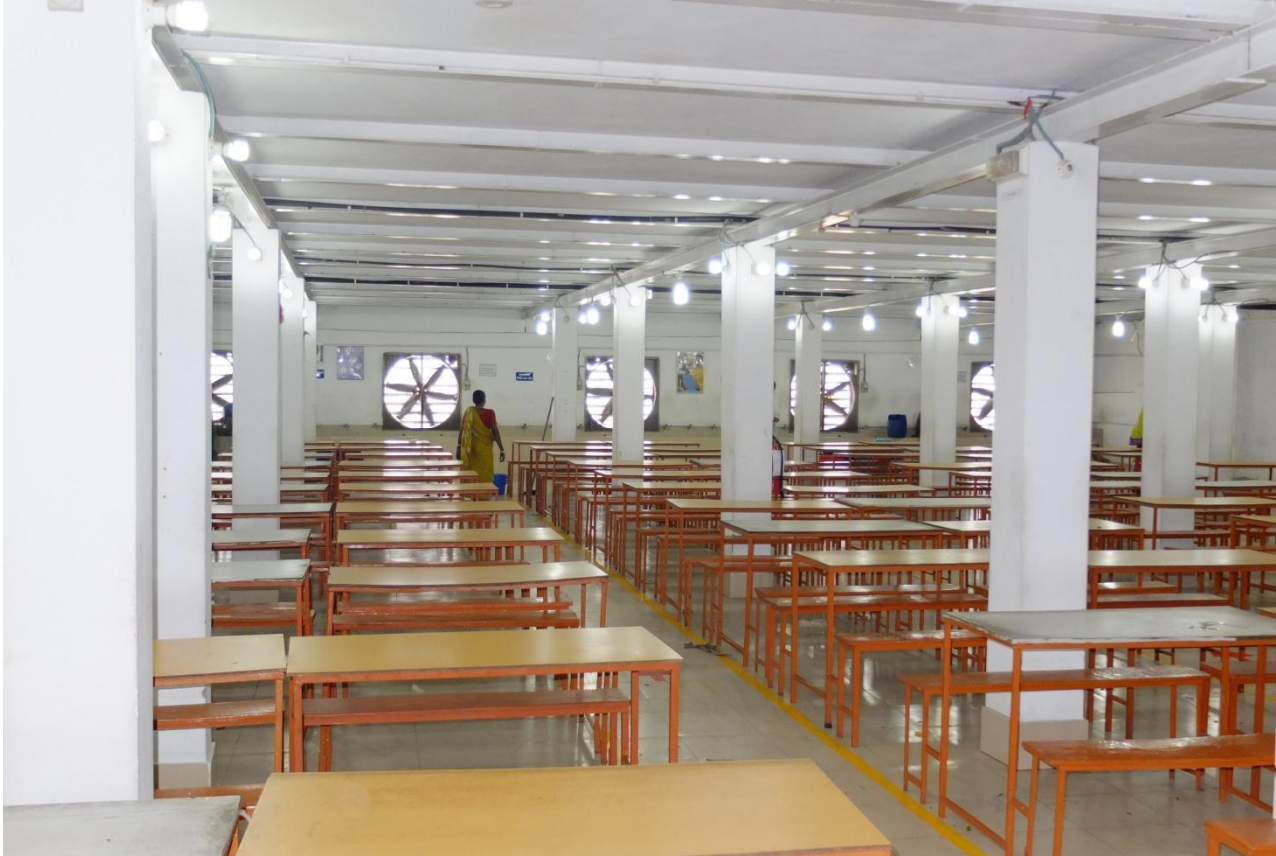
The roof slab of Block B is a 88mm concrete slab supported on steel members.

It appears that the steel members have not been treated with any fireproofing system.

In addition, it was noticed that some of the movement joints had disappeared from the roof floor.

- Apply suitable fire-proofing system to the steel structure to protect it from fire for a period of 120 minutes.
