# COTTON CLOTHING LTD-

## NEW Extension unit

Plot No. 27 (p) & 28 (p). Sataish Road, Gazipura, Tongi, Gazipur 1712.  
(23.919936, 90.388819)  
13<sup>th</sup> January, 2019

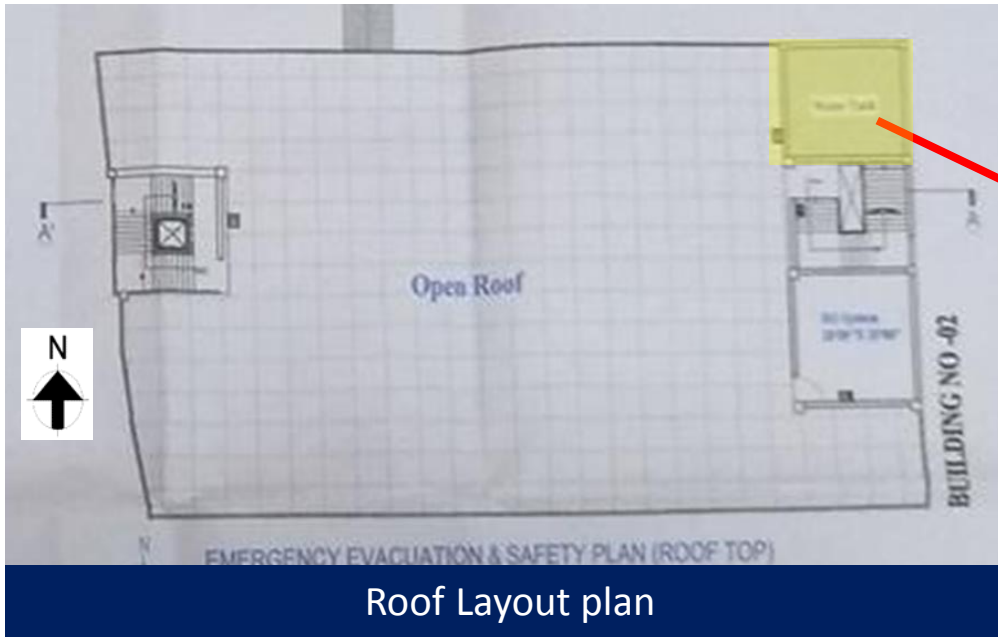
Roof Layout plan

Cursory calculations indicate that columns under water tank would appear to be stressed in excess of normal design limits, assuming minimum concrete strength (stone chips aggregate). Building Engineer to review design, loads and columns stresses.

| Item No. | Observation | Recommended Action Plan | Recommended Timeline |
|---|---|---|---|
| 1 | Column to be stressed above normal design limits (Building-2) | Factory Engineer to review design, loads, columns stresses. | 6-weeks |
| 3 | Column to be stressed above normal design limits (Building-2) | Produce and actively manage a loading plan for all floor plates within the factory, giving consideration to floor, column and foundation capacity. | 6-weeks |

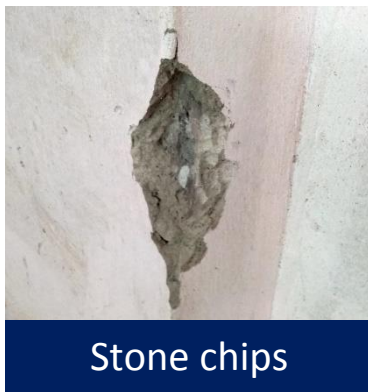
Stone chips

Two types of aggregate (Brick and stone chips) had been used in column construction. Most of the test report was available for brick chips concrete. Building engineering is required to confirm the aggregate type and concrete strength of ground floor columns.

| Item No. | Observation | Recommended Action Plan | Recommended Timeline |
|---|---|---|---|
| 2 | Column to be stressed above normal design limits (Building-2) | Verify in-situ concrete strength and aggregate type by taken min. 4 nos. 100mm dia. core samples from ground floor columns. | 6-weeks |

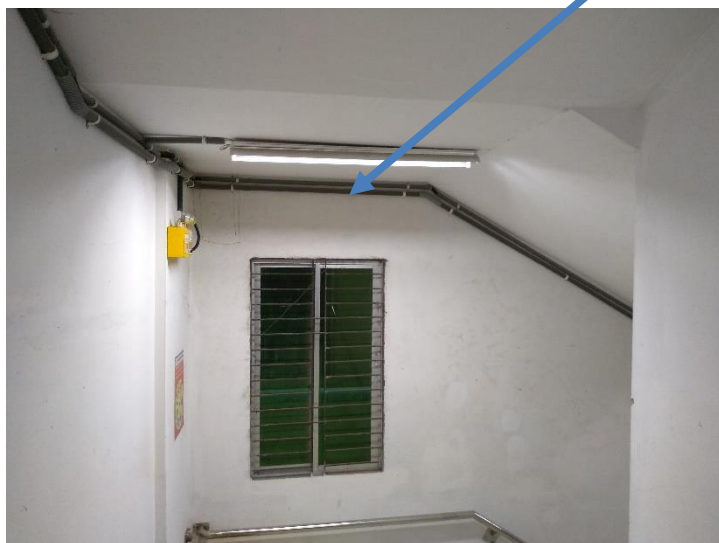
Missing beam

Periphery beam at west stair was missing but which is shown in beam layout. Also depth of longitudinal beams were found 500 mm instead of 450 mm.

| Item No. | Observation | Recommended Action Plan | Recommended Timeline |
|---|---|---|---|
| 6 | Discrepancies between provided drawing and on site condition. (Building-2) | Building engineer to survey the building and produce as-built documentation reflecting the as constructed condition. | 6-weeks |

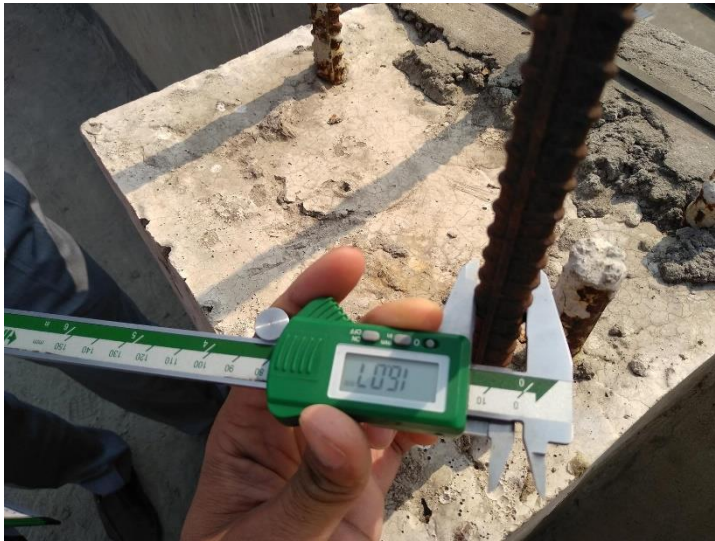
Rebar Diameter

Rebar dia. of few columns were measured 16 mm at roof level whereas column schedule shows 20 mm at all level.

| Item No. | Observation | Recommended Action Plan | Recommended Timeline |
|---|---|---|---|
| 5 | Discrepancies between provided drawing and on site condition. (Building-2) | Building engineer to verify the strength and diameter of column reinforcement. | 6-weeks |

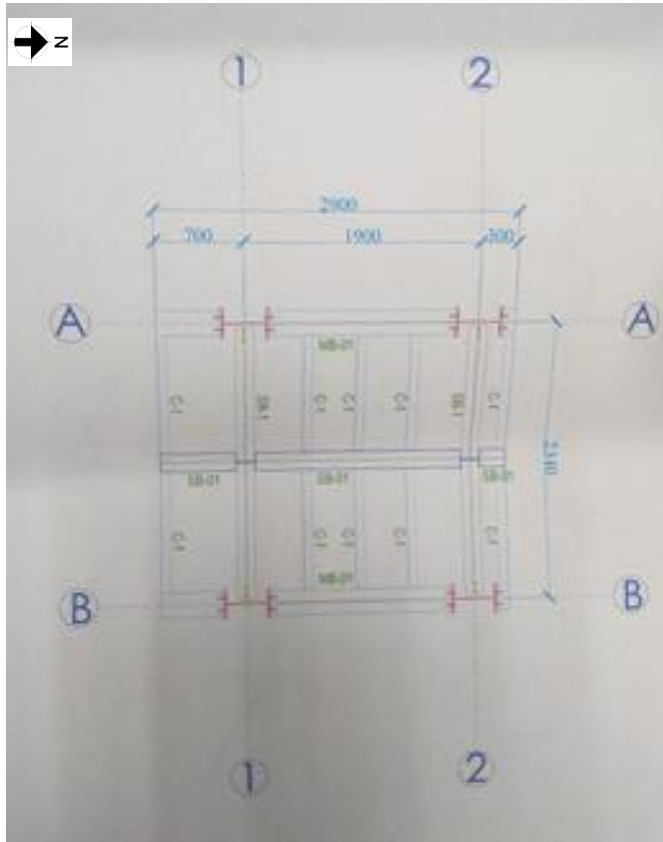
Column & Beam Layout

Column & beam layout were not match with existing condition. Orientation of column and location of MB-01 are found different. Flange thickness of MB-1 was found 8 mm instead of 12 mm.

| Item No. | Observation | Recommended Action Plan | Recommended Timeline |
|---|---|---|---|
| 7 | Lack of Information in Provided Drawing. (Connecting Bridge) | Factory engineer to survey the building and produce as-built documentation reflecting the as constructed condition. | 6-weeks |
| 8 | Lack of Information in Provided Drawing. (Connecting Bridge) | Make any structural alteration as advised by Engineer. | 6-months |

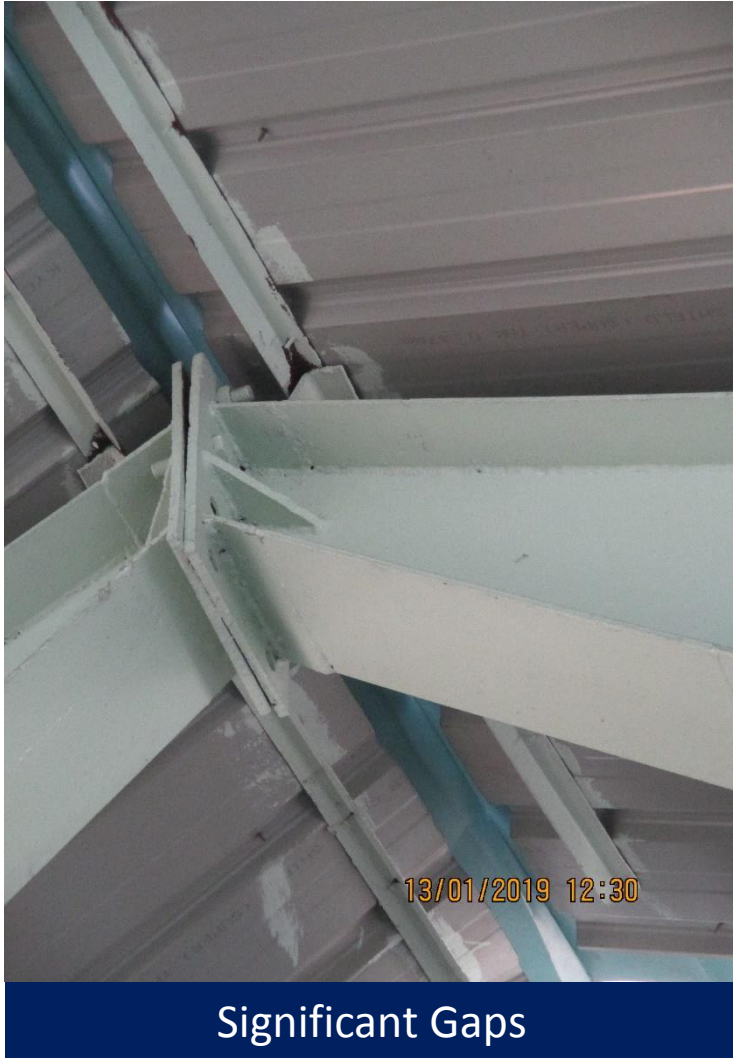
Significant Gaps

Significant gaps were observed in column rafter joint at several location. Building engineer is required to carry out suitable remedial works.

| Item No. | Observation | Recommended Action Plan | Recommended Timeline |
|---|---|---|---|
| 9 | Existence of significant gaps at steel connection. (Connecting Bridge) | Identify all the locations and carryout suitable repair works where necessary . | 6-weeks |
