# **FIRE SAFETY INSPECTION REPORT**

## **TAQWA FABRICS**

**ACCORD**  
on Fire and Building Safety in Bangladesh

April 26, 2014

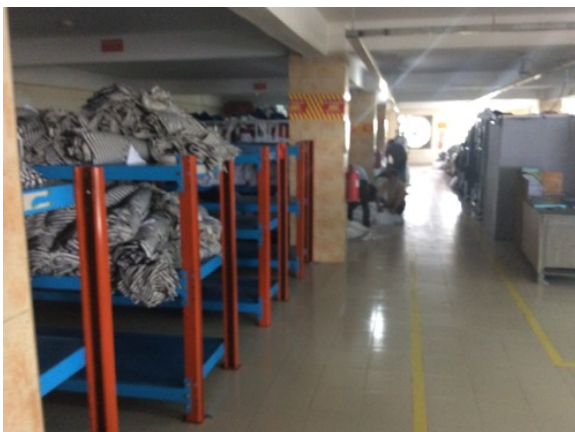
| No. | Category | Finding | Recommendation | Remediation Timeframe |
|---|---|---|---|---|
| F-1 | Fire Rated Construction | Storage rooms and process areas throughout the building used for combustible storage are not separated by fire-rated construction. | <p>Provide dedicated storage rooms separated by minimum 1-hr fire-rated construction.</p> <p>Where separate storage rooms are not feasible, provide defined storage areas and limit the storage arrangement as follows:</p> <ul style="list-style-type: none"> <li>- Maximum height of 2.4m and maximum area of 23m<sup>2</sup></li> <li>- If sprinkler protected: maximum height of 3.66m and maximum area of 93m<sup>2</sup></li> </ul> <p>Separate areas of unenclosed combustible storage by a minimum clear distance of 3m.</p> | Within 3 months |

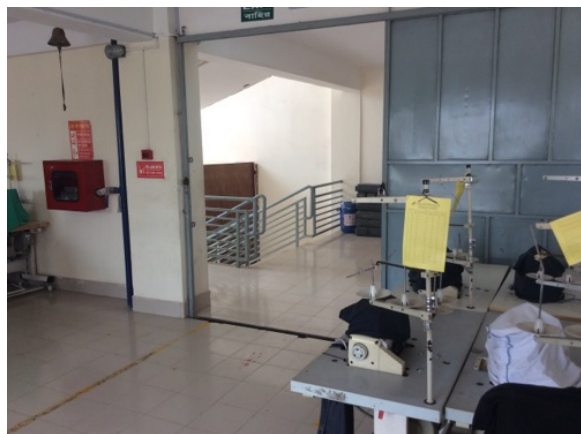
| F-2 | Fire Rated Construction | The exit stairs are not separated from work areas on each floor by fire-rated construction. | Provide minimum 1.5-hr fire rated doors and seal all unprotected openings to separate the exit stairs from work areas and other building spaces on all floor levels. Ensure that the fire doors are self-closing and positive latching and that they are provided with fire exit (panic) hardware where serving production floors. | Within 3 months |

| | | | If fire doors are required to be held open for functional reasons, provide automatic-closing devices tied to the fire alarm system. | |

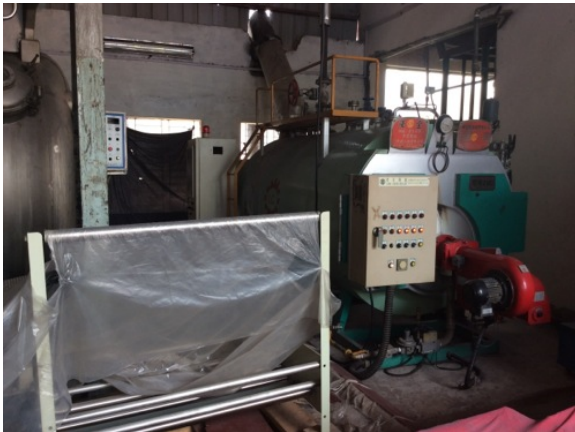
| F-3 | Fire Rated Construction | The secondary boiler room is not separated by fire-rated construction. | Separate the secondary boiler room by a minimum 1-hr fire-rated construction. Seal and/or protected all openings to maintain the required fire separations | Within 3 months |

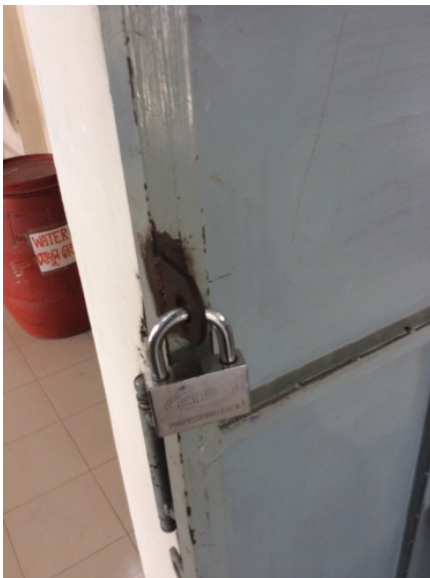
| F-4 | Egress | Egress doors and gates with locking features are provided throughout the stairwells. | Remove locking features from all egress doors / gates.<br><br>If locks are required for security reasons, utilize special door locking features complying with NFPA 101. | Immediate |

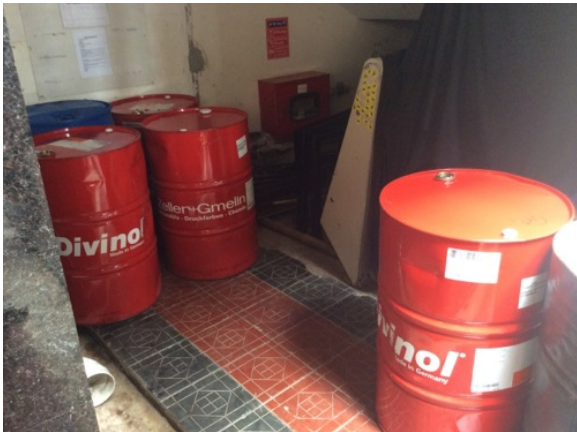
| F-5 | Egress | Storage was located in the SE exit stair. | Remove all storage from exit stairs and egress paths. | Immediate |

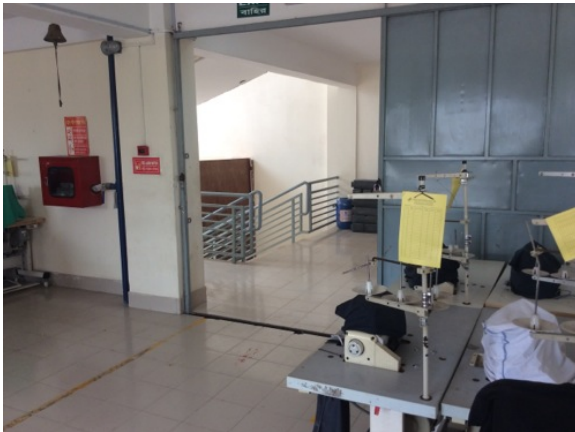
| F-7 | Egress | Sliding doors are provided at exit stairs. | Replace all sliding doors along the means of egress with side-hinged, swinging egress doors.<br><br>If locks are required for security reasons, utilize special door locking features complying with NFPA 101. | Within 1 month |

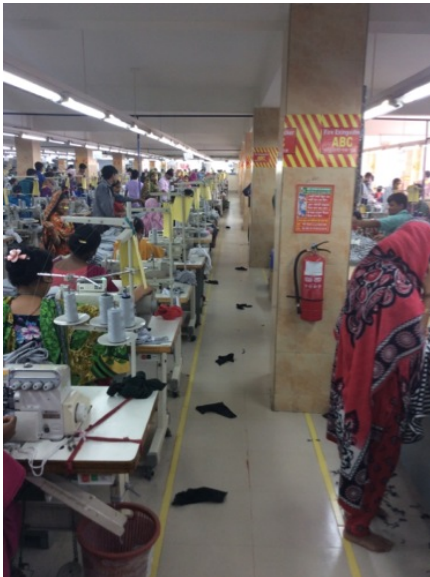
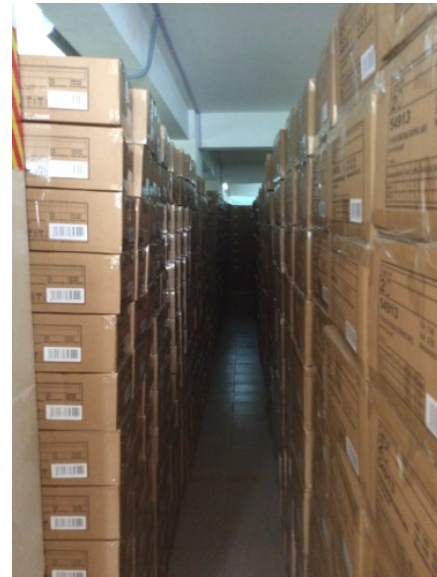
| F-8 | Egress | The width of egress aisles is less than 36-in. on floor 5. | Provide minimum aisle widths of 36-in. | Within 3 months |

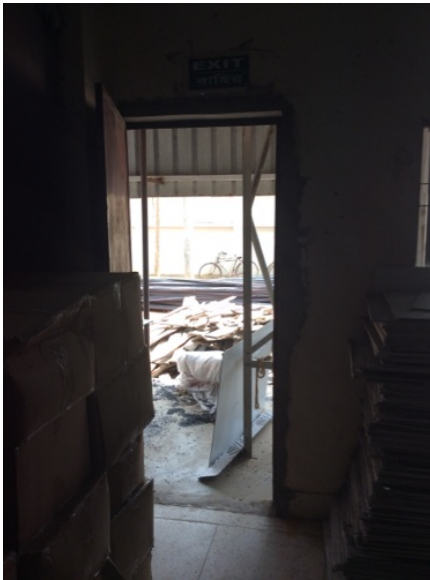
| F-9 | Egress | Exit door does not swing in the direction of egress travel on the East side of the ground floor of Building 1. | Modify the egress door to swing in the direction of egress travel | Within 3 months |

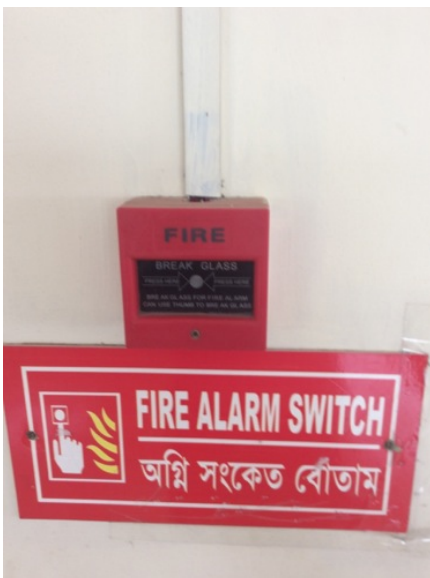
| F-10 | Fire Protection | The fire alarm system is antiquated, not a listed system, and does not provide alarm and notification features consistent with acceptable standards. | Replace the fire alarm system with a new, listed addressable fire alarm system in accordance with NFPA 72. | Design within 4 months, install within 9 months |

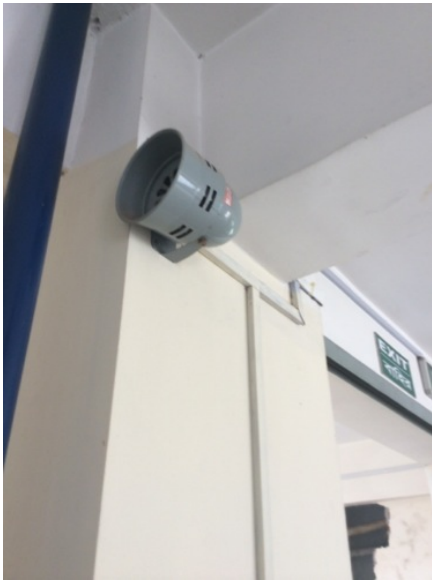
| F-11 | Fire Protection | Inspection, testing, and maintenance for the fire alarm system were not in accordance with NFPA 72. | Inspect, test and maintain the fire alarm system, and keep written records on-site, in accordance with NFPA 72. | Within 3 months |

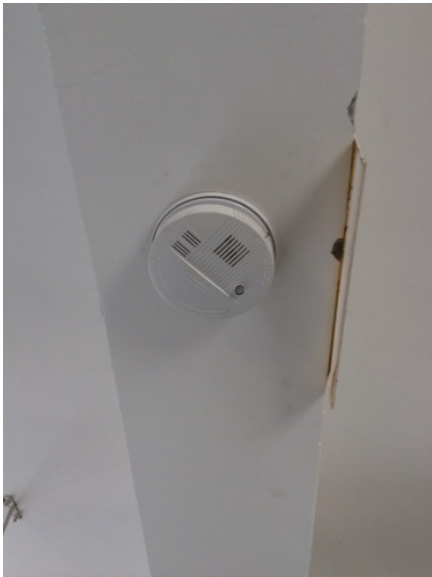
| F-12 | Fire Protection | Smoke detectors are not installed in Boiler room or dyeing shed | Install smoke detectors in all areas of the factory. | Within 6 months |

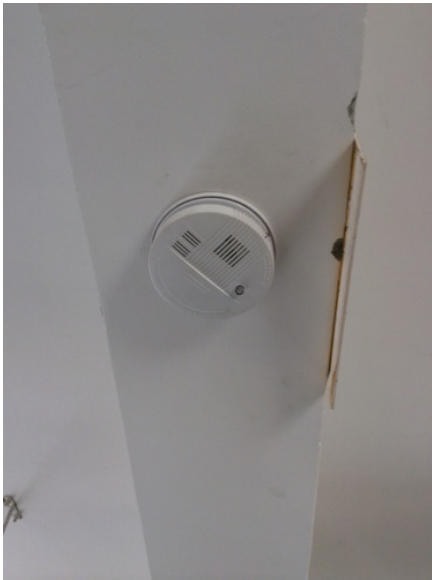
| F-13 | Fire Protection | The building is equipped with single-station smoke alarms. Smoke alarm activation sounds only a local alarm and does not provide automatic fire alarm notification of occupants. | Remove single-station smoke alarms. Provide automatic smoke detection throughout the building in accordance with NFPA 72. | Within 6 months |

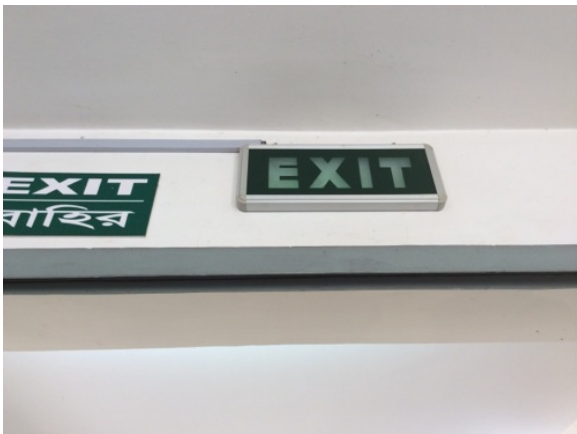
| F-14 | Egress Lighting | Exit signage was not illuminated in multiple places throughout the factory. | Regularly inspect all exit signage and replace/install lights as needed to illuminate signs. | Within 3 months |
