FIRE SAFETY INSPECTION REPORT

Muazuddin Textile Limited (New Unit)

ACCORD ID: 23225

Date: 21 May, 2018

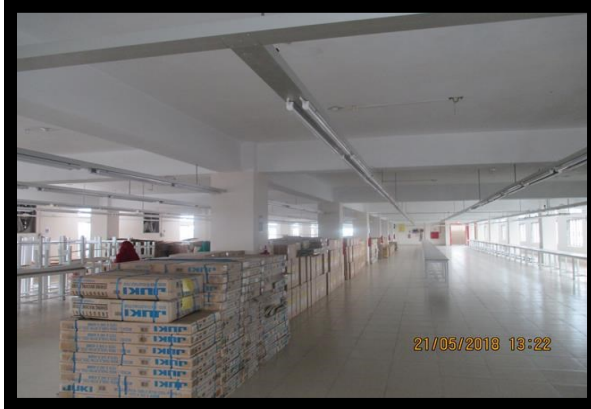
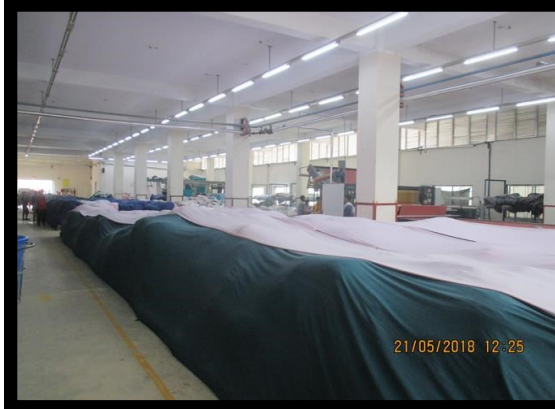
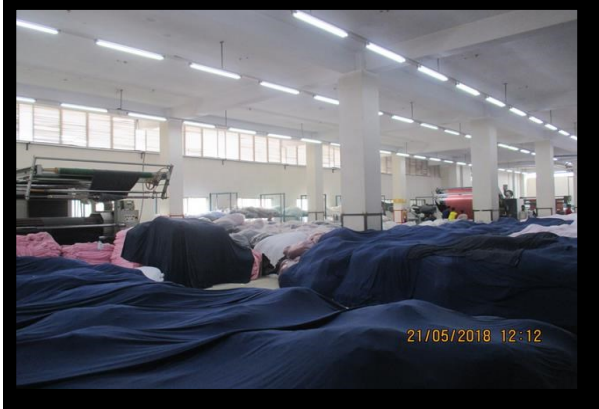
Sl No.	Category	Findings	Required Action	Remediation Time Frame
F-1	Fire Rated Construction	Areas used for in-process storage of combustible materials are open to the surrounding occupancy .	<p>Provide defined storage areas and limit the storage arrangement as follows:-</p> <ol style="list-style-type: none"> 1. General Condition: Maximum height of 2.4m and maximum area of 23m². Separate areas of unenclosed combustible storage by a minimum clear distance of 3m. 2. If sprinkler protected: maximum height of 3.66m and maximum area of 93m². Separate areas of unenclosed combustible storage by a minimum clear distance of 3m. <p>OR</p> <ol style="list-style-type: none"> 3. Enclose the storage area from the surrounding occupancy with a minimum 1 hour construction. 	Within 3 months

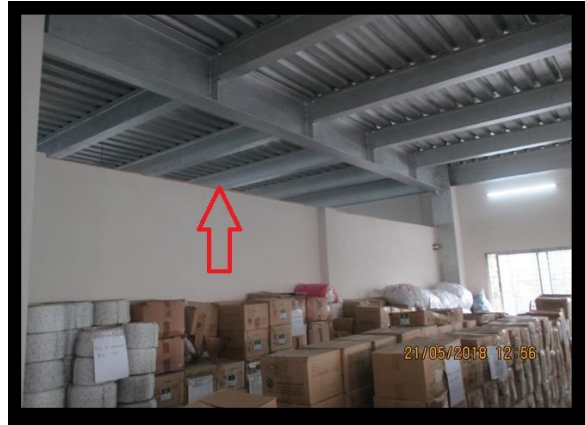
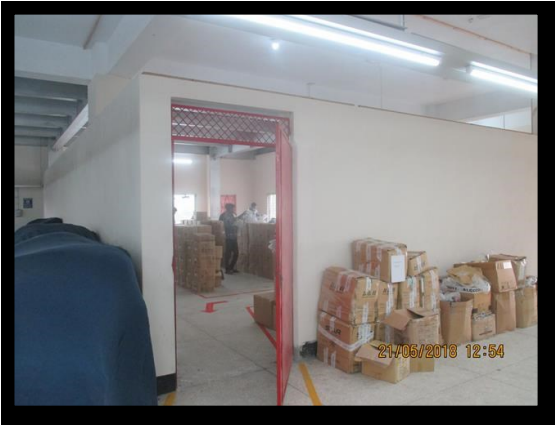
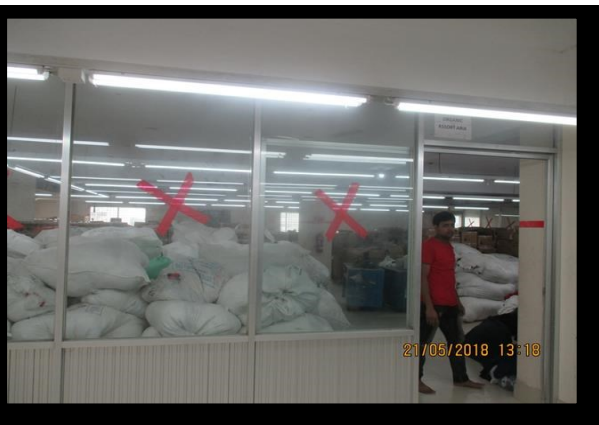
F-2	Fire Rated Construction	Rooms used for storage of combustible materials are not separated from the surrounding occupancy/areas (Location: 1st floor, 3rd floor packing section, 6th floor)	Rooms used for storage of combustible materials shall be separated from the surrounding occupancy with a minimum 1 hour construction.	Within 3 months
-----	-------------------------	--	---	-----------------

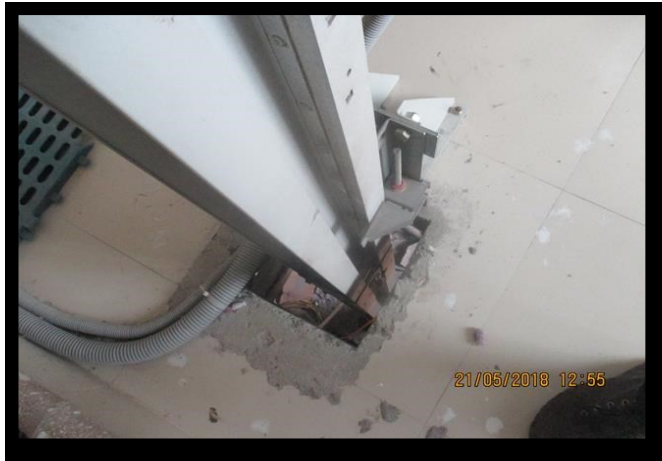
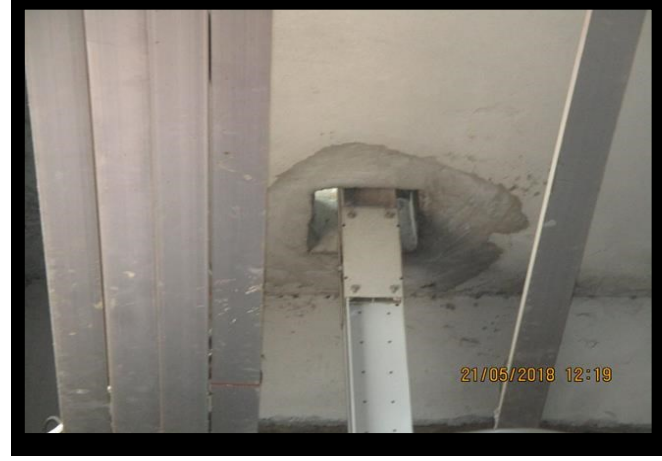
F-4	Fire Rated Construction	Penetrations through floor/ceiling assemblies are found unsealed. Location: Electrical riser.	Seal all penetrations and openings in floor/ceiling (full thickness of the floor/ceiling) assemblies by fire rated materials to maintain the fire resistance rating. Provide a minimum 2-hr fire rated shaft to separate the utility risers from each floor if required.	Within 3 months

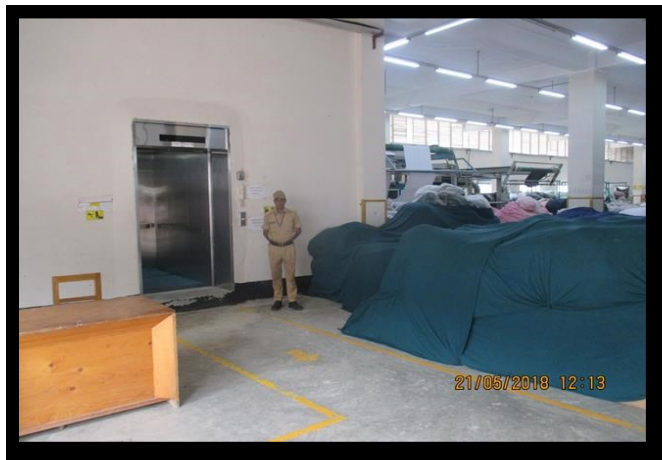
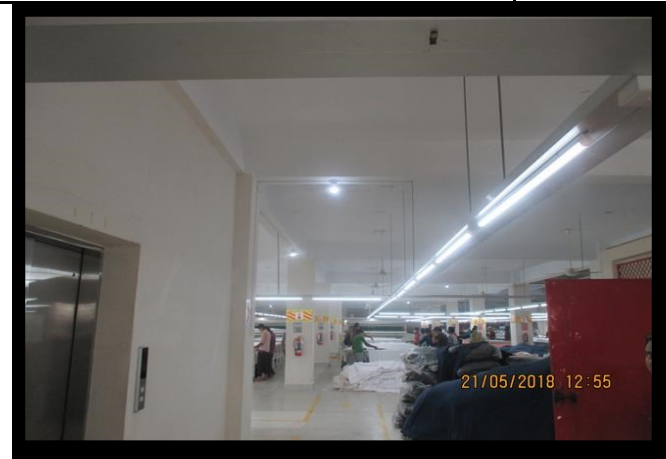
F-5	Fire Rated Construction	Unsealed elevator shafts are located inside the working place at all floors of production building.	Provide a minimum 2-hr fire-rated elevator shaft to separate from each floor level and seal all penetrations in floor/ceiling assemblies to maintain the fire separation.	Within 3 months
-----	-------------------------	---	---	-----------------

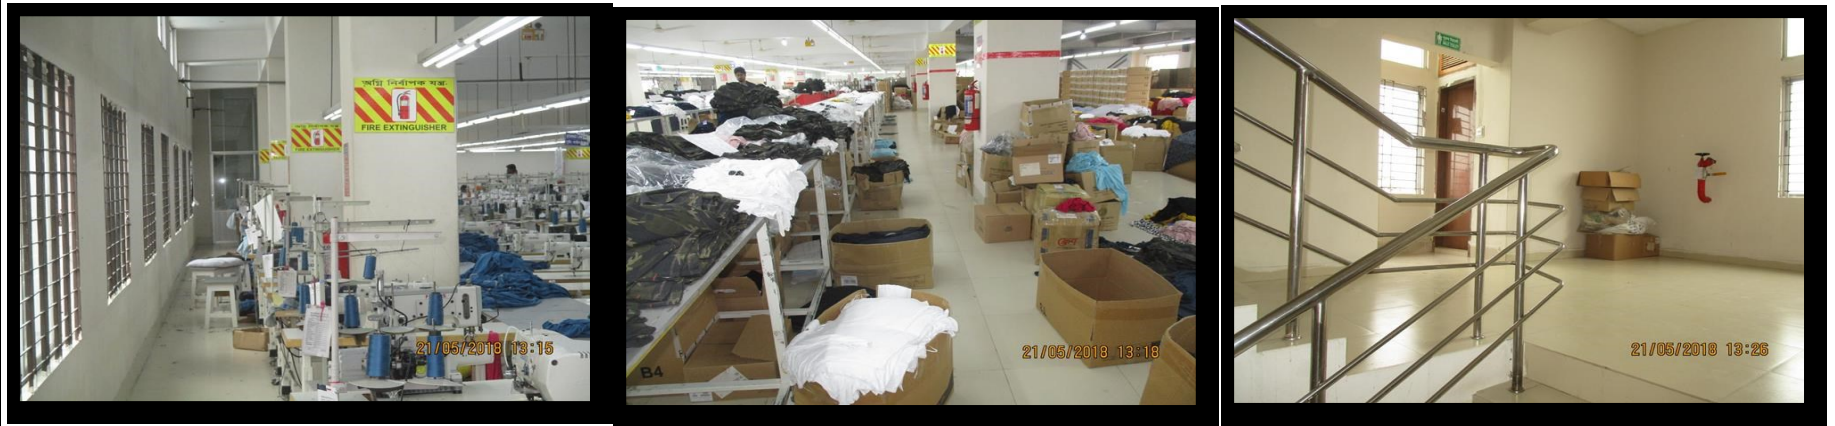
F-6	Exit Capacity	Exit capacity is not adequate for the occupant load. Location: Second Floor (Sewing Section), Available exit capacity: 387 & occupant load: 459	1. Reduce occupant load to not more than available exit capacity. Or 2. Provide additional exits to increase exit capacity.	Immediate
F-7	Egress	Storage was located in the exit stair & egress paths. Location: Stair, production floor	Remove all storage from exit stairs and egress paths.	Immediate

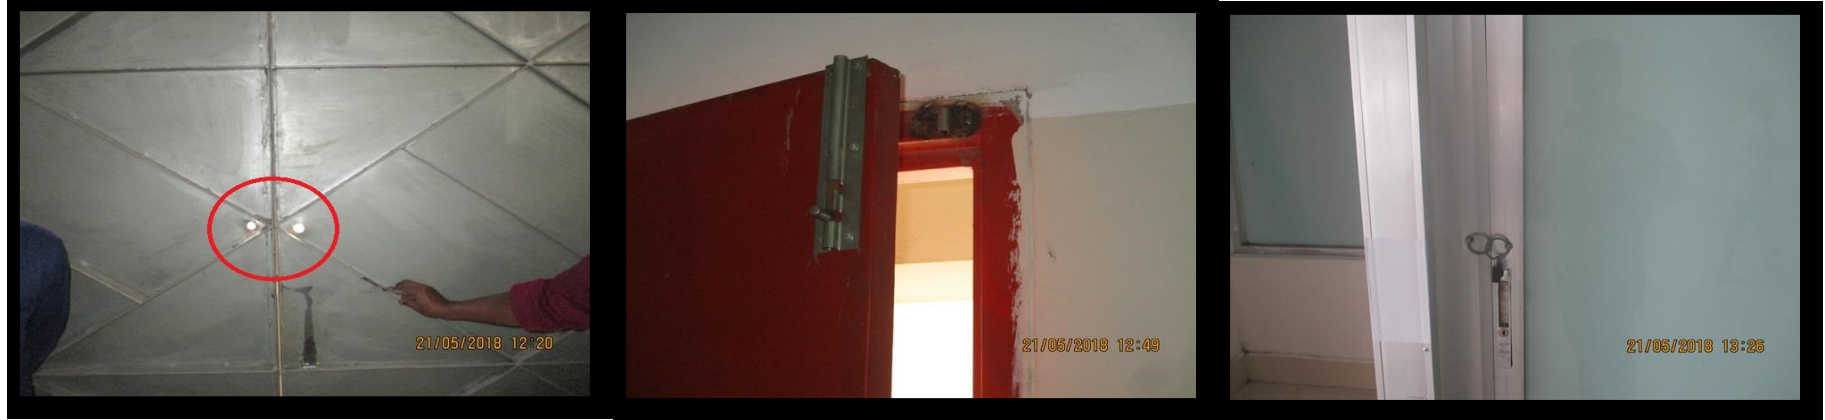
F-8	Egress	Egress doors/gates with locking features not complying with NFPA 101 are provided at [building exits, along egress routes, exit discharge]	Remove locking features from all egress doors/gates. If locks are required for security reasons, utilize specialized door locking features complying with NFPA 101.	Immediate
-----	--------	--	--	-----------

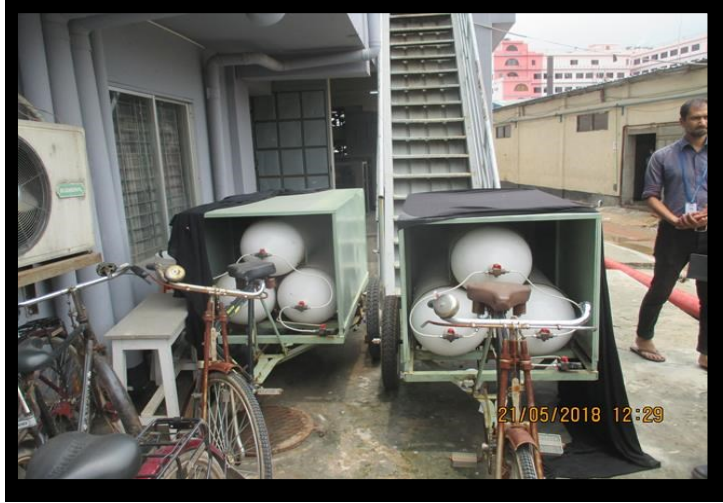
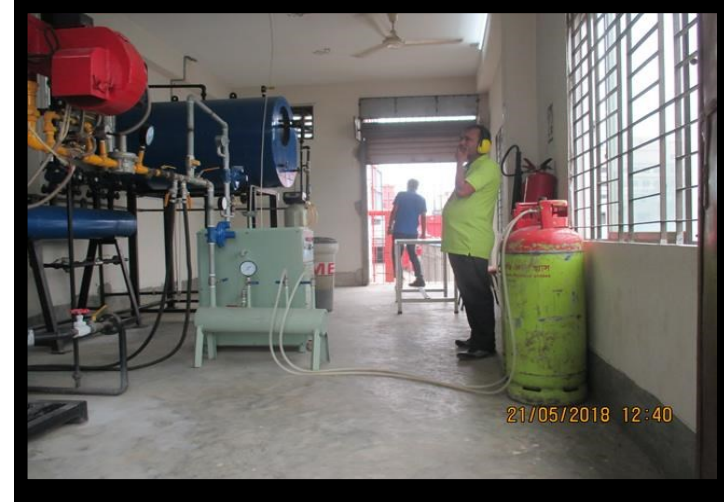
F-09	Egress	Stair designation, occupant load signage are not posted properly on each stair door & location.	Install signage adjacent to each stair door indicating the stair name and the floor level at the noted locations in both English and Bengali language. Post the occupant load for every assembly and production floor in a facility in a conspicuous space near the main exit or exit access doorway for the space.	Within 1 month
F-10	Hazardous Storage Area	Hazardous materials / flammable liquid storage area is not separated by fire-rated construction . Location: beside utility building (Unit-02)	Separate the hazardous materials / flammable liquid storage room by a minimum 2-hr fire-rated construction. Seal and/or protect all openings to maintain the required fire separations	Within 3 months

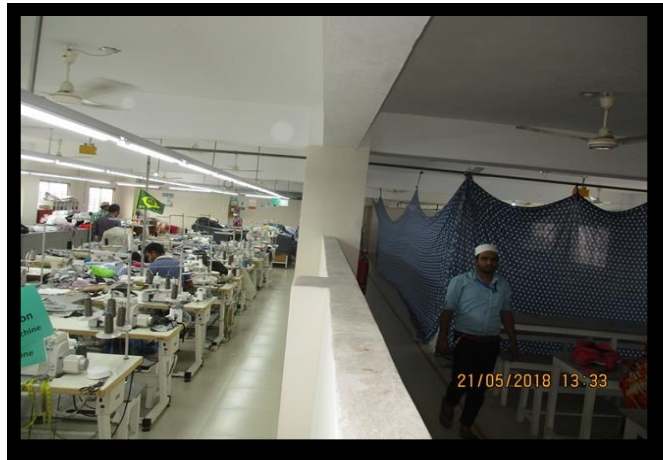
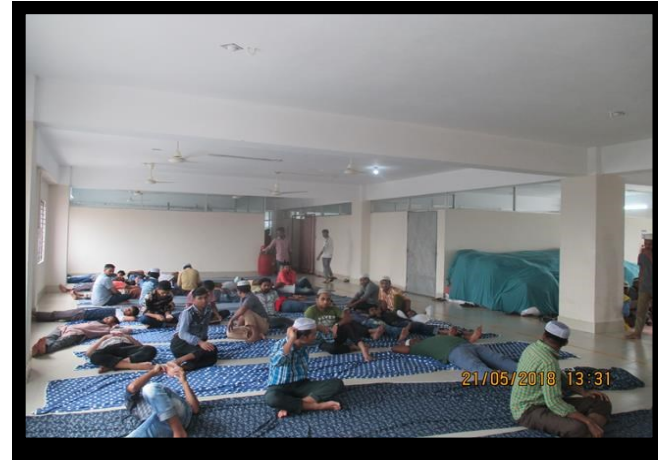
F-11	Fire Rated Construction	Prayer room and dining area is not separated from the production area with fire rated assemblies Location: 6th Floor.	Remove the assembly area from the production floor & relocate it in a safe location OR provide 2-hr fire-rated separation with production area having minimum 2 direct exit access.	Within 3 Months
------	-------------------------	--	---	-----------------

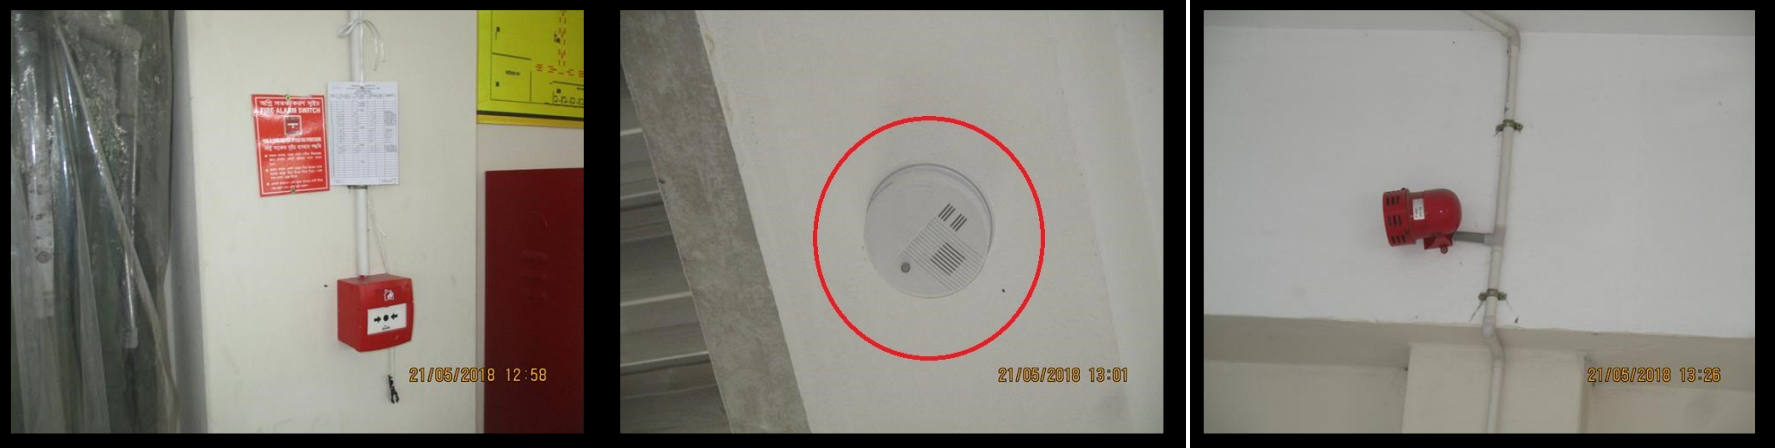
F-12	Fire Alarm System	The existing fire alarm system is not a listed system and does not provide automatic alarm and notification features consistent with acceptable standards.	Replace the fire alarm system with a new, listed addressable fire alarm system in accordance with NFPA 72.	Design within 2 month and installation within 6 months

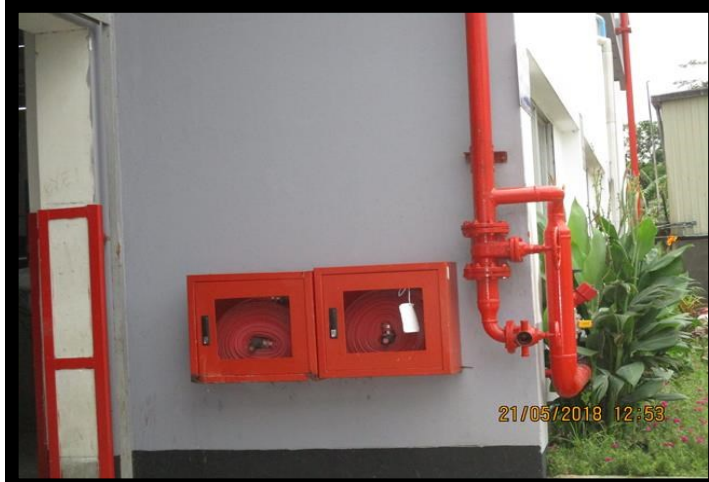
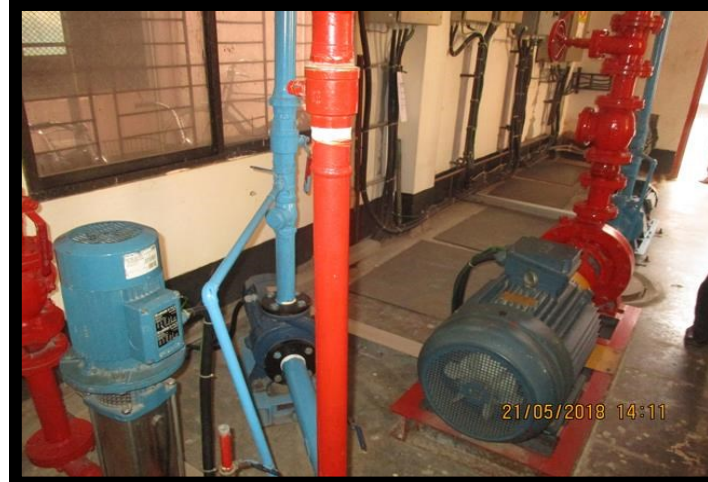
F-13	Fire Protection System	The existing high-rise building with an occupiable floor greater than 23 m (75 ft) above the finished grade is not protected with an approved automatic sprinkler system.	Provide an automatic sprinkler protection throughout the building in accordance with NFPA 13.	Design with in 02 months & Installation within 9 months.
F-14	Fire Protection System	Standpipe system installation required as per NFPA 14, 20 and ACCORD standards	Provide standpipe & hose system throughout the building in accordance with NFPA 14, 20 and accord standard.	Design with in 02 months & Installation within 9 months.

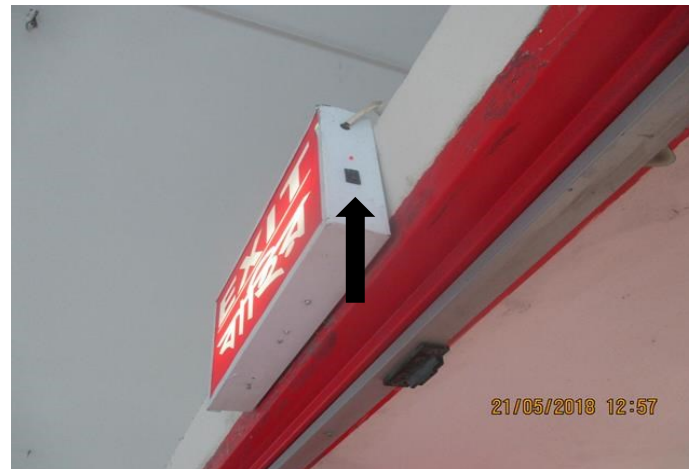
F-15	Egress Lighting	Manual on-off switch facility available for emergency lights	Remove manual on/off switches from emergency lighting units to prevent them from being switched off.	Within 1 month
------	-----------------	--	--	----------------

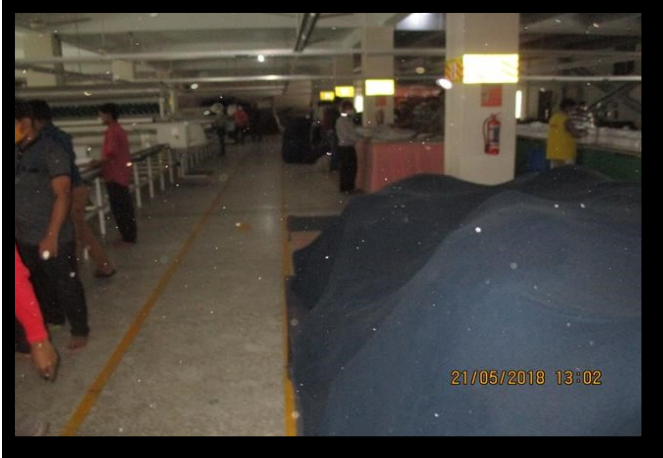
F-16	Egress Lighting	Based on the number and location of emergency lights observed, adequate illumination levels are not anticipated along egress routes.	Test the emergency lighting system on each floor and provide additional emergency fixtures to provide adequate illumination along the means of egress. Provide a minimum illumination of 10 lux at the floor level within exit stairs and exit discharge paths and minimum 2.5 lux along exit access aisles.	Within 3 months

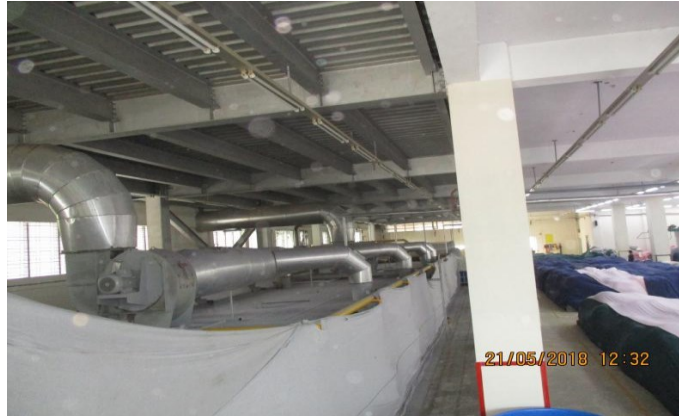
F-19	Fire Rated Construction	Heat producing equipment is not separated by fire-rated construction. Location: Ground floor [Stanter Machine (gas fuel fired)]	Separate heat producing machine by a minimum 1-hr fire-rated construction. Seal and/or protected all openings to maintain the required fire separations	Within 3 months
------	-------------------------	--	---	-----------------

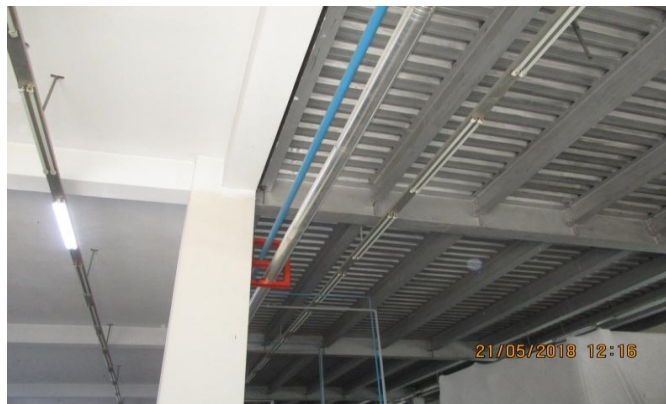
F-20	Fire Rated Construction	Main building has 2 parts. One part is RCC construction, which is continued ground to top & another part is non-rated structures, which is continued from ground to forth floor and does not provide fire resistance rated barrier.	Provide fire-resistive rated construction barriers between floors following section 4.4 and Table 4.4.1 of the Accord Standard or Table 3.3.1 and Table 4.1.1 from BNBC part 4, Consult a qualified fire protection engineer to design the rated construction barriers.	Within 3 months
------	-------------------------	---	---	-----------------
