# **FIRE SAFETY INSPECTION REPORT**

**Factory Name: Target Denim & Casual Wear Ltd.**

**ACCORD ID: 23548**

**Date: 27 January 2019**

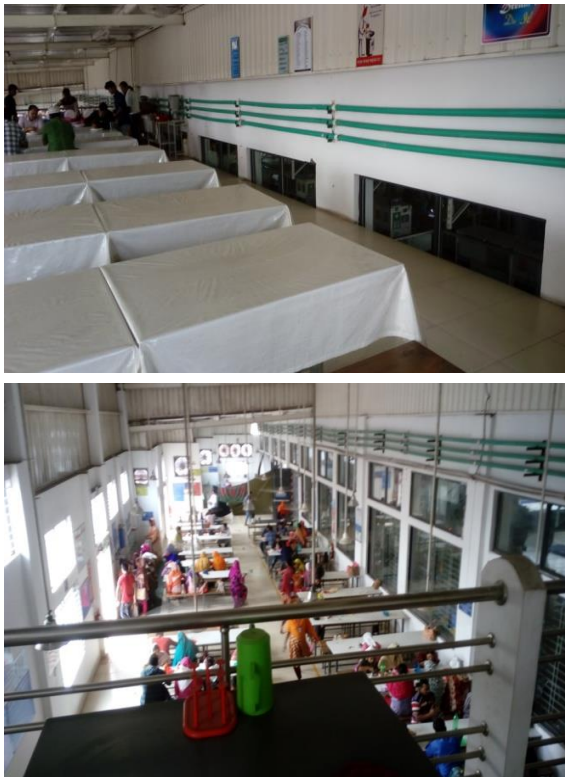
| Sl No. | Category | Findings | Required Action | Remediation Time Frame | Pictorial Evidence |
|---|---|---|---|---|---|
| 1 | Fire Rated Construction | <p>Dining building adjacent to shed-1 and internally not separated from each other. Un-protected openings and non-rated construction has observed.</p> <p><b>Location: S-E corner, shed-1</b></p> | <p>Separate the dining area from shed-1 by a minimum 1-hr. fire rated construction. Seal all penetrations and openings in wall/floor/ceiling (full thickness of the wall/floor/ceiling) assemblies by fire rated materials to maintain the fire resistance rating.</p> | Within 03 Months | <p>The top photograph shows a long, narrow dining area with several long tables covered in white cloths. The bottom photograph shows a view from an elevated position looking down into the dining area, which is filled with people and colorful items. The area is separated from the shed-1 by a wall with green and white horizontal stripes.</p> |

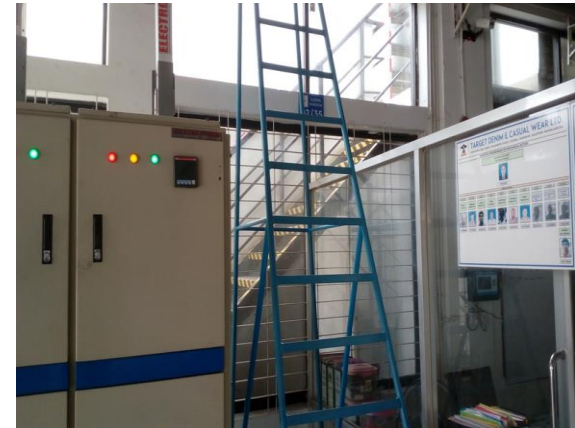
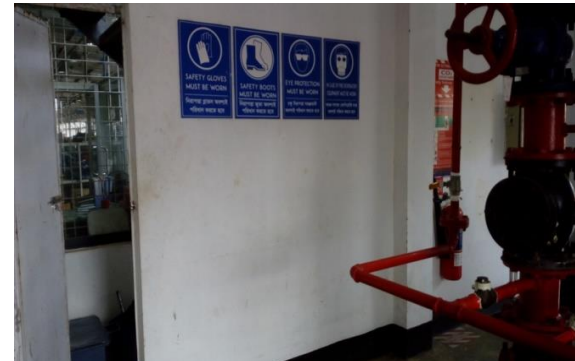
2

S-E exit stair of dining building is not separated from shed-1 & fire pump room. Un-protected openings have observed to exit stair.

**Location: S-E corner, shed-1**

Stair shall be enclosed with a minimum 1-hr fire-rated construction. Seal all unprotected openings and provide minimum 1-hr fire rated doors to separate the exit stairs from work areas and other building spaces on all floor levels. Ensure that the fire doors are self-closing, positive latching and that they are provided with fire exit (panic) hardware where serving production floors.

If fire doors are required to be held open for functional reasons, provide automatic-closing devices tied to the fire alarm system.

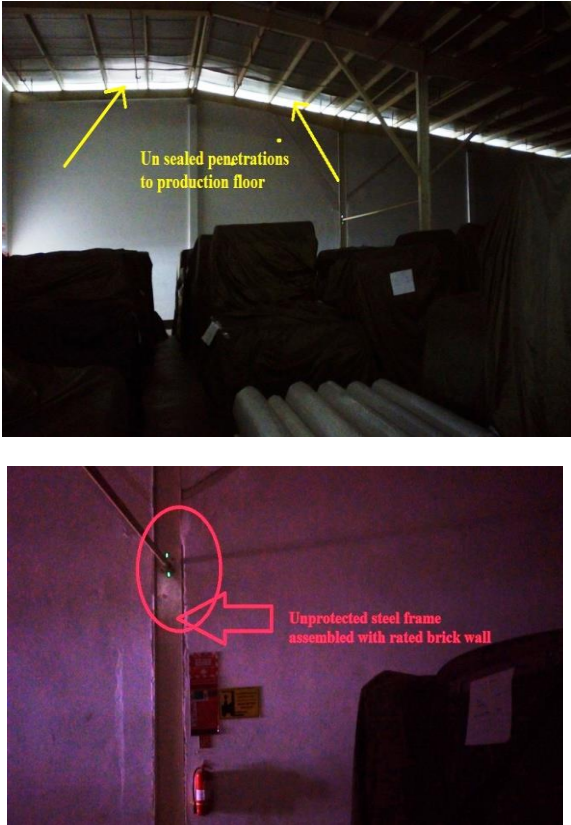
| Sl No. | Category | Findings | Required Action | Remediation Time Frame | Pictorial Evidence |
|---|---|---|---|---|---|
| 3 | Fire Rated Construction | <p>Dedicated store rooms are not properly separated from other occupancies/areas.</p> <p><b>Location: Shed-2, south side</b></p> | <p>Rooms used for storage of combustible materials shall be separated from the surrounding occupancy with a minimum 1 hour construction.</p> <p>Seal all penetrations and openings in wall/floor/ceiling (full thickness of the wall/floor/ceiling) assemblies by fire rated materials to maintain the fire resistance rating.</p> | Within 03 Months | |

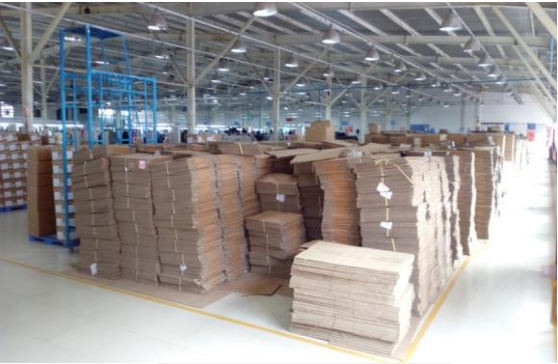
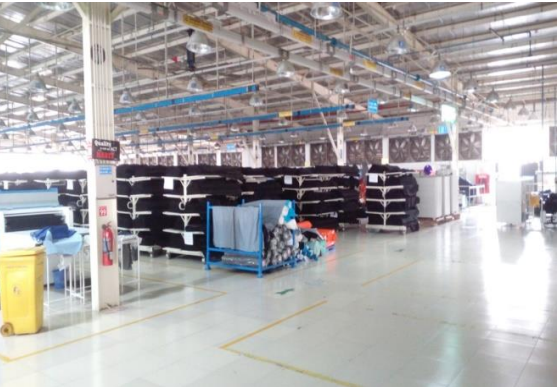
| Sl No. | Category | Findings | Required Action | Remediation Time Frame | Pictorial Evidence |
|---|---|---|---|---|---|
| 4 | Fire Rated Construction | <p>Areas used for in-process storage of combustible materials are open to the surrounding occupancy.</p> <p><b>Location: Shed-1 &amp; 2</b></p> | <p>Provide defined storage areas and limit the storage arrangement as follows:-</p> <p>1. General Condition:<br/>Maximum height of 2.4m and maximum area of 23m<sup>2</sup>.<br/>Separate areas of unenclosed combustible storage by a minimum clear distance of 3m.</p> <p>2. If sprinkler protected:<br/>maximum height of 3.66m and maximum area of 93m<sup>2</sup>.<br/>Separate areas of unenclosed combustible storage by a minimum clear distance of 3m.</p> <p>or</p> <p>3. Enclose the storage area from the surrounding occupancy with a minimum 1 hour construction.</p> | Within 03 Months | |

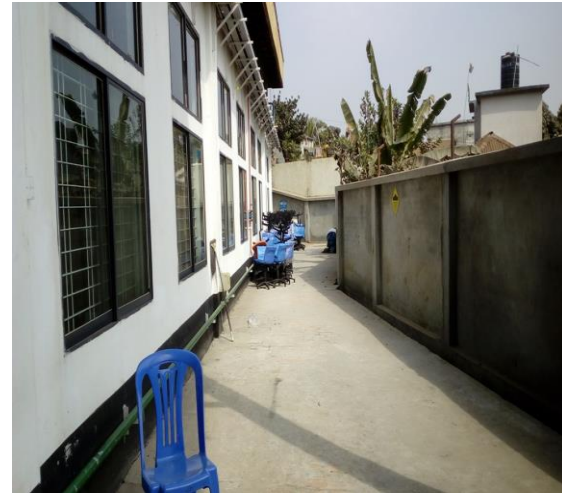
| 5 | Egress | <p>The egress path along means of egress has interrupted by obstruction/storage.</p> <p><b>Location: East Side, Shed-2</b></p> | <p>Means of egress shall be maintained continuously free and clear of all obstructions/storage.</p> <p>Or</p> <p>Keep egress paths and stairs clear of storage.</p> | Immediate | |

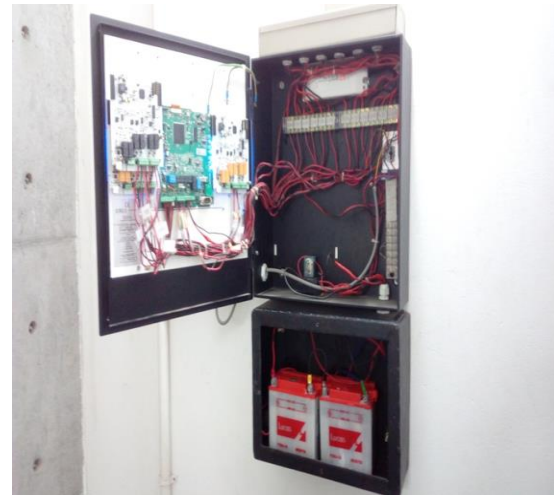
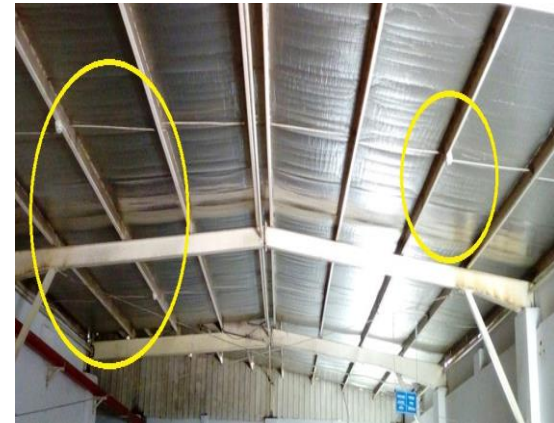
6

The factory has installed fire alarm & detection system in all buildings and sheds, design has not been reviewed by any AHJ including installation.

Submit as-built design of fire alarm system to Accord for review. Modify/Replace the system in accordance with NFPA 72. All materials shall be 3rd party certified/listed.

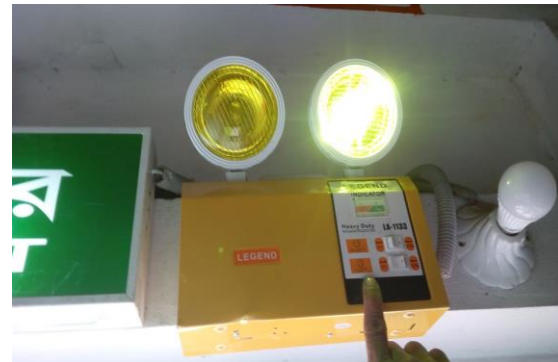
| 10 | Egress Lighting | Manual on-off switch is provided for [emergency lighting / exit signage] units. | Remove manual on/off switches from emergency lighting / exit signage units to prevent them from being switched off. | Within 01 Month | |

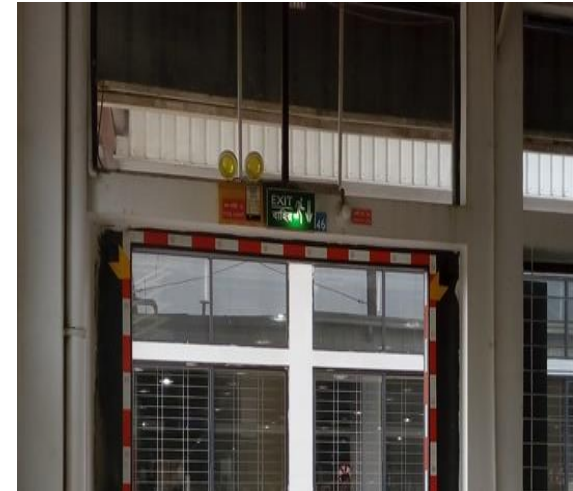
| 11 | Egress Lighting | Exit signage not illuminated properly during testing (burned out, broken, etc.). | Regularly inspect all exit signage as per Accord standard and replace/install lights as needed to illuminate signs. | Immediate | |

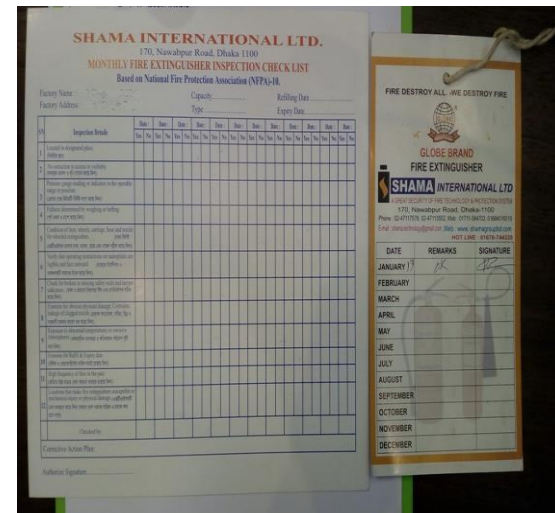
| 12 | Portable Fire Extinguisher | Maintenance of fire extinguishers are not as per NFPA 10 | Inspect, test and maintain the fire extinguishers, and keep written records on-site, in accordance with NFPA 10 | Within 01 Month | |
