FIRE SAFETY INSPECTION REPORT

Factory Name: MNR Design Ltd.

ACCORD ID: 23628

Inspected By: Mahfuza Khanom & Md. Tarif Raihan
Date: 20th February, 2019

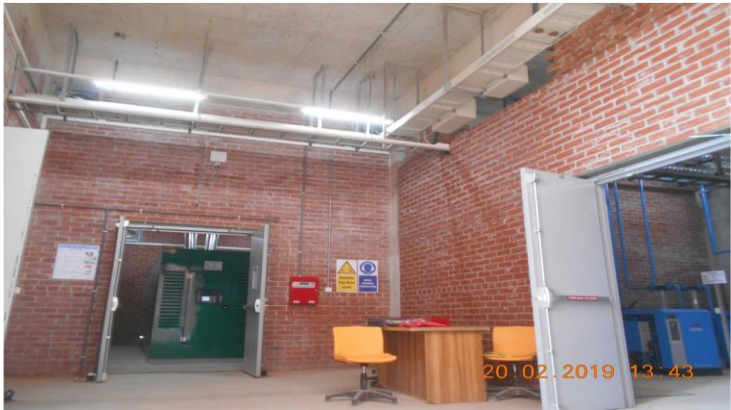
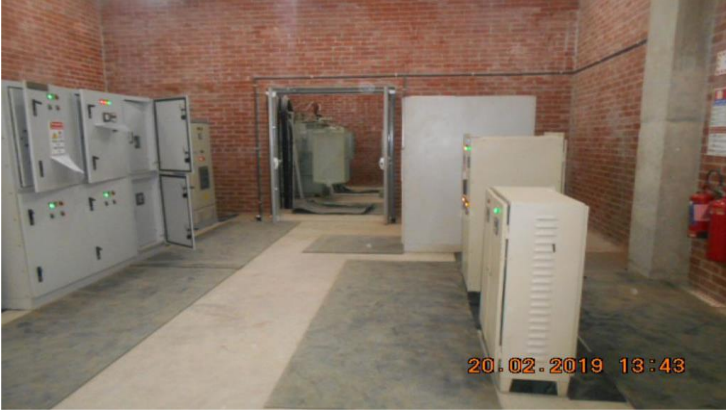
10	Egress	<p>Doors along means of egress are provided with non compliant locking system. Location: Main Building</p>	<ol style="list-style-type: none"> 1. Remove all non compliant locking features from egress doors. 2. If locks are required for security reasons, utilize special door locking features complying with NFPA 101. 3. Doors may be locked where the latch and lock are disengaged with one motion where the occupant load does not exceed 49 persons. 4. Doors may be provided with locking hardware from the ingress side provided that a panic bar is installed on any door with an occupant load exceeding 49 persons. 	<p>Immediate</p>

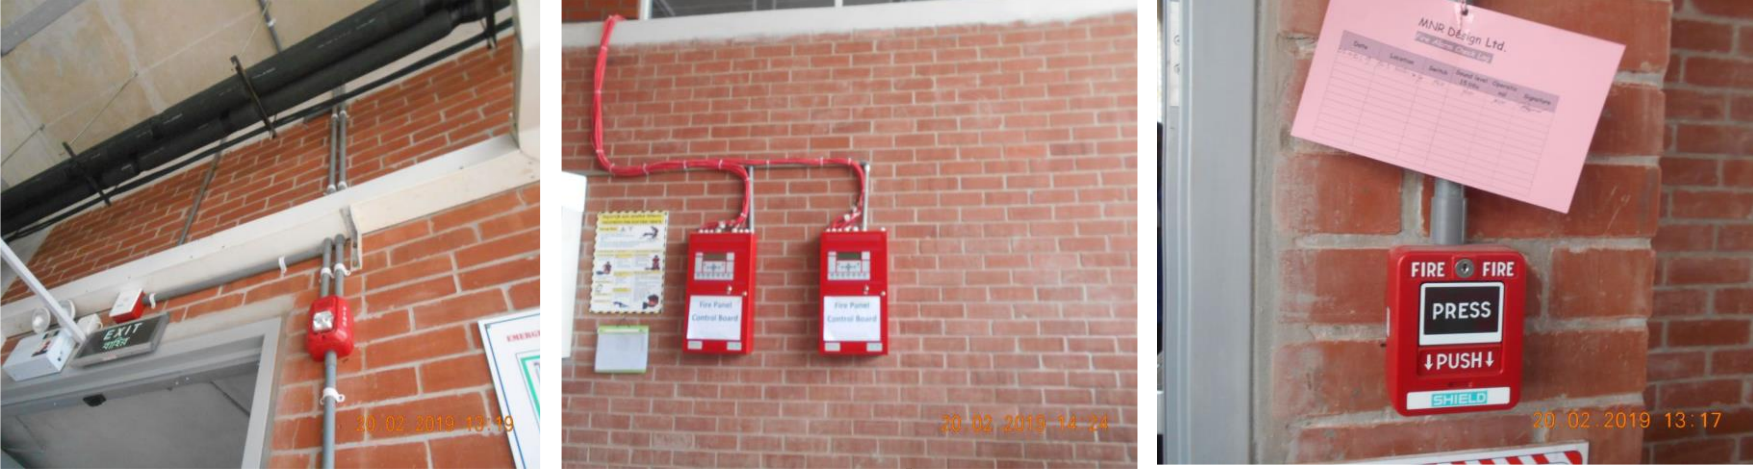
SI No.	Category	Findings	Required Action	Remediation Time Frame
14	Fire Detection & Alarm System (ITM)

<p>Inspection, testing, and maintenance for the fire alarm system is not in accordance with NFPA 72 or as per Accord standard.</p>	<p>Inspect, test and maintain the fire alarm system, and keep written records on-site, in accordance with NFPA 72 or as per Accord standard.</p>	<p>Within 7 months</p>

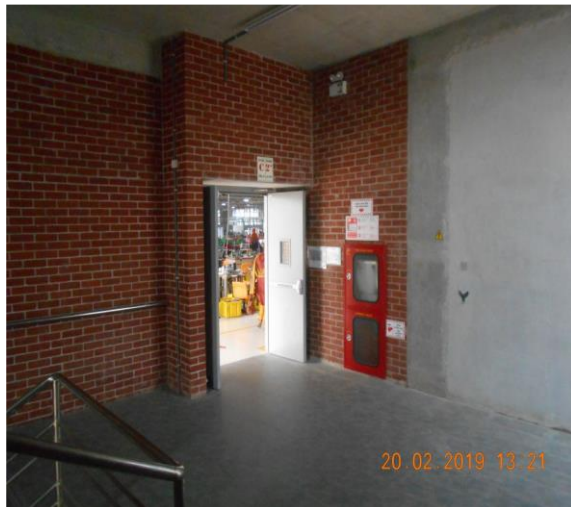
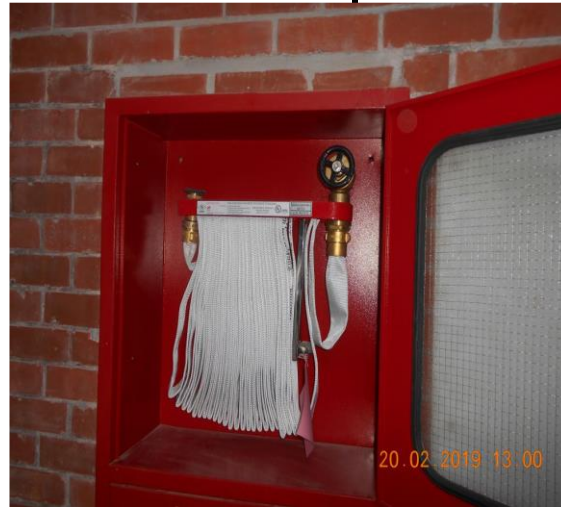
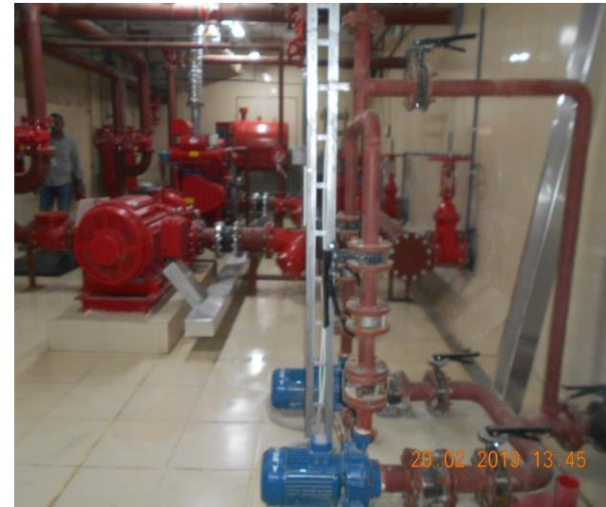
SI No.	Category	Findings	Required Action	Remediation Time Frame
15	Fire Protection	Fire pump, water supply & standpipe system installation requires detailed review to confirm compliance with NFPA 14, 20, 22, 25 and ACCORD standards.	Submit as built drawings, testing records, listing information and other relevant documentation to the ACCORD for review and approval, modification shall have to done as per the reviewed design (if required).	Design within 2 months, Install/Modify within 4 months

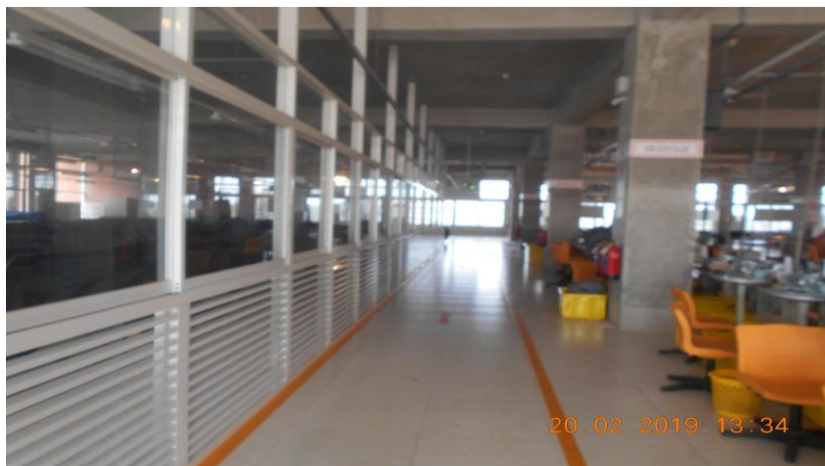
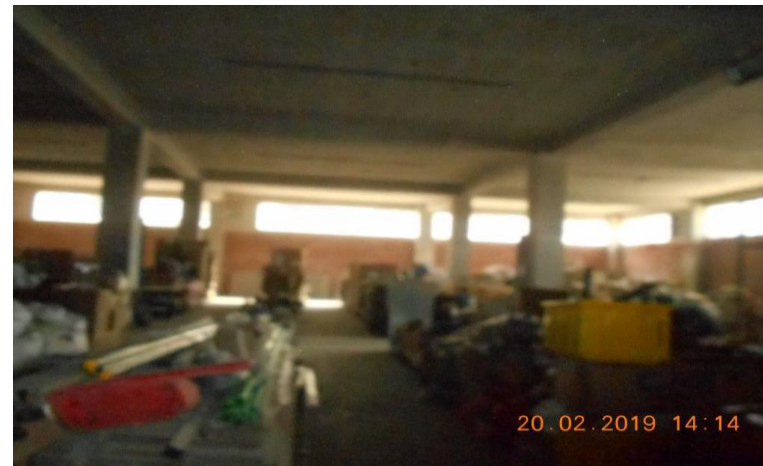
SI No.	Category	Findings	Required Action	Remediation Time Frame
18	Egress Lighting	Based on the number and location of emergency lights observed, adequate illumination levels are not anticipated along egress routes.	Test the emergency lighting system on each floor and provide additional emergency fixtures to provide adequate illumination along the means of egress. Provide a minimum illumination of 10 lux at the floor level within exit stairs and exit discharge paths and minimum 2.5 lux along exit access aisles.	Within 3 months

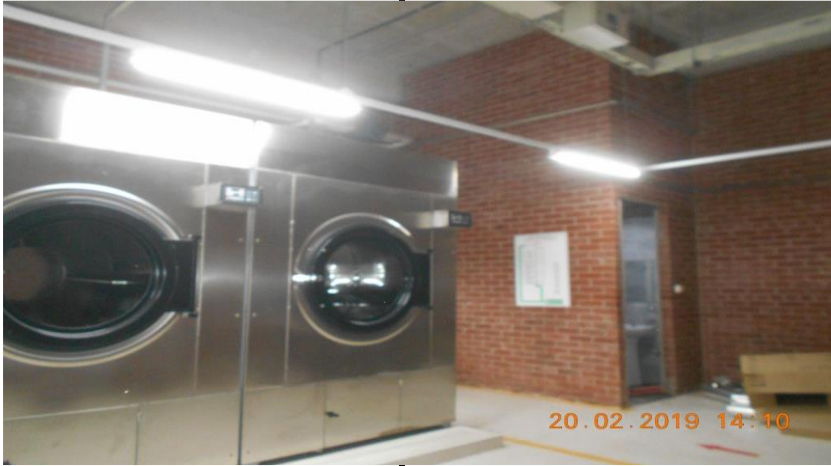
SI No.	Category	Findings	Required Action	Remediation Time Frame
19	Egress Lighting	Directional signs are not provided where direction of the path of travel to an exit has changed.	Illuminated directional signs shall be provided where there is a change in the direction for the path of travel and the direction to an exit is not obvious.	Within 3 months
<div style="display: flex; justify-content: space-between; align-items: center;"> <div style="background-color: #e0e0e0; padding: 10px; border: 1px solid #ccc;">ADD PHOTO</div>

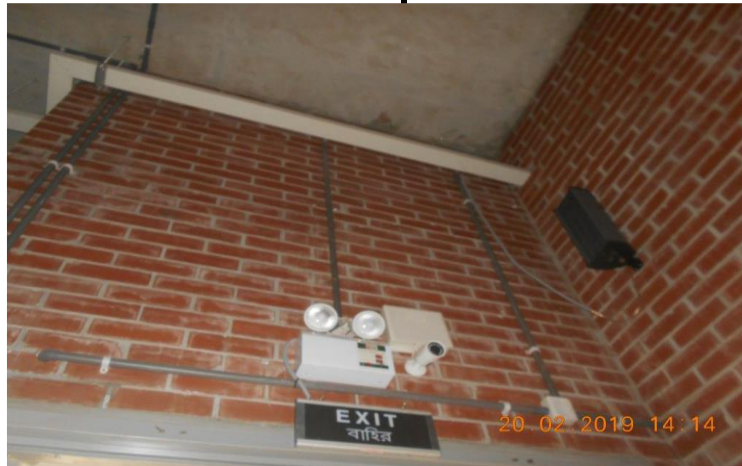
SI No.	Category	Findings	Required Action	Remediation Time Frame
20	Egress Lighting	Exit signage not illuminated (burned out, broken, etc.).	Regularly inspect all exit signage and replace/install lights as needed to illuminate signs.	Within 1 month
