# **FIRE SAFETY INSPECTION REPORT**

**Factory Name: Aboni Knitwear (New Shed)**

**ACCORD ID: 23602**

**Inspected By: Md Anayet Hossain & Noshin Tabassum  
Date: 3 February, 2019**

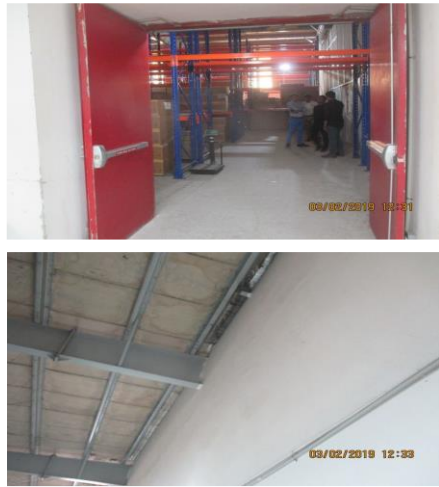
| SI No. | Category | Findings | Required Action | Remediation Time Frame | Pictorial Evidence |
|---|---|---|---|---|---|
| 1 | Fire rated construction | Rooms used for combustible storage are not separated by fire-rated construction. | Provide dedicated storage rooms separated by minimum 1-hr fire-rated construction. Where separate storage rooms are not feasible, provide defined storage areas and limit the storage arrangement as follows:- Maximum height of 2.4m and maximum area of 23m <sup>2</sup> - If sprinkler protected: maximum height of 3.66m and maximum area of 93m <sup>2</sup> Separate areas of unenclosed combustible storage by a minimum clear distance of 3m. | Within 3 months | |

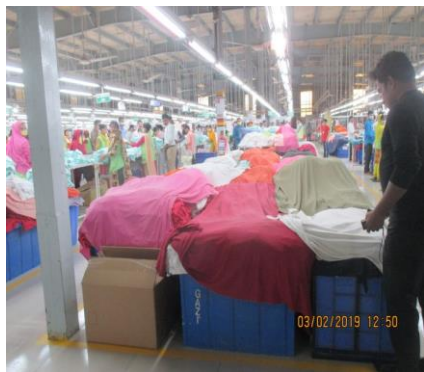
| SI No. | Category | Findings | Required Action | Remediation Time Frame | Pictorial Evidence |
|---|---|---|---|---|---|
| | Fire rated construction | Areas used for in-process storage of combustible materials are open to the surrounding occupancy | Provide defined storage areas and limit the storage arrangement as follows:-<br>1. General Condition: Maximum height of 2.4m and maximum area of 23m <sup>2</sup> . Separate areas of unenclosed combustible storage by a minimum clear distance of 3m.<br>2. If sprinkler protected: maximum height of 3.66m and maximum area of 93m <sup>2</sup> . Separate areas of unenclosed combustible storage by a minimum clear distance of 3m. or<br>3. Enclose the storage area from the surrounding occupancy with a minimum 1 hour construction. | Within 3 months | |

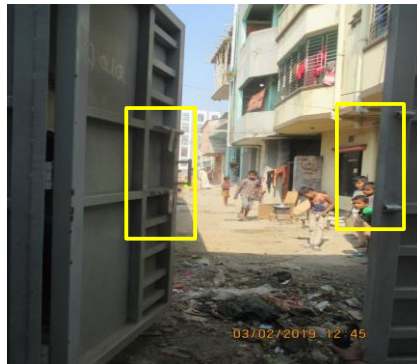
| SI No. | Category | Findings | Required Action | Remediation Time Frame | Pictorial Evidence |
|---|---|---|---|---|---|
| 2 | Egress | Doors along means of egress are provided with non compliant locking system. | <ol style="list-style-type: none"> <li>1. Remove all non compliant locking features from egress doors.</li> <li>2. If locks are required for security reasons, utilize special door locking features complying with NFPA 101.</li> <li>3. Doors may be locked where the latch and lock are disengaged with one motion where the occupant load does not exceed 49 persons.</li> <li>4. Doors may be provided with locking hardware from the ingress side provided that a panic bar is installed on any door with an occupant load exceeding 49 persons.</li> </ol> | Immediate | |

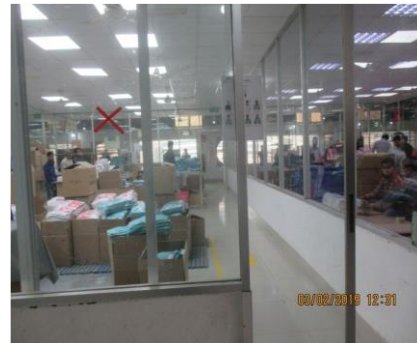
| SI No. | Category | Findings | Required Action | Remediation Time Frame | Pictorial Evidence |
|---|---|---|---|---|---|
| 3 | Egress | Collapsible/sliding/shutter type doors have provided along means of egress [building exits, exit stairs, along egress routes, exit discharge]. | <p>Replace all collapsible/sliding/shutter type doors &amp; gates by the side-hinged swinging type doors.</p> <p>If locks are required for security reasons, utilize special door locking features complying with NFPA 101.</p> | Immediate | |

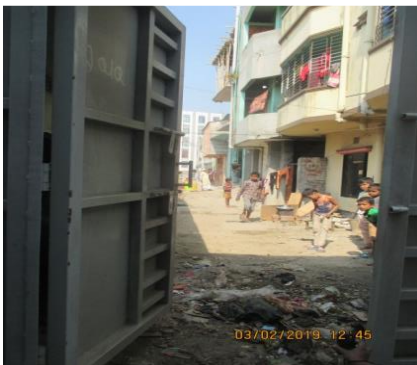
| SI No. | Category | Findings | Required Action | Remediation Time Frame | Pictorial Evidence |
|---|---|---|---|---|---|
| 4 | Egress | Uneven path of travel and blockage in exit access. (Secondary exit discharge.) | Remove unnecessary items and level exit path to the public way. | Within 1 month | |

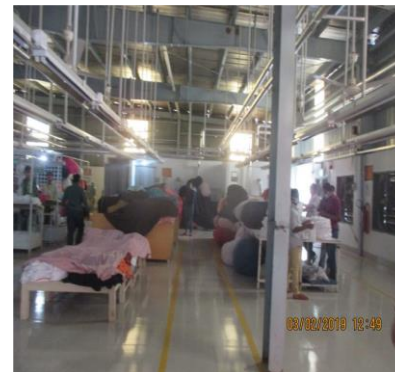
| SI No. | Category | Findings | Required Action | Remediation Time Frame | Pictorial Evidence |
|---|---|---|---|---|---|
| 6 | Egress Lighting | Based on the number and location of emergency lights observed, adequate illumination levels are not anticipated along egress routes. | Test the emergency lighting system on each floor and provide additional emergency fixtures to provide adequate illumination along the means of egress. Provide a minimum illumination of 10 lux at the floor level within exit stairs and exit discharge paths and minimum 2.5 lux along exit access aisles. | Within 1 month | |

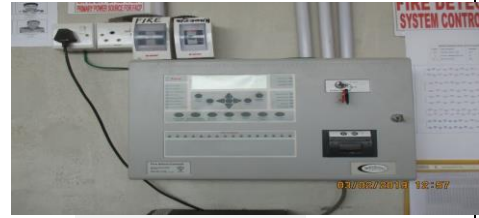
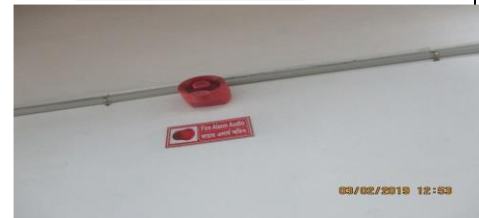
| SI No. | Category | Findings | Required Action | Remediation Time Frame | Pictorial Evidence |
|---|---|---|---|---|---|
| 8 | Fire Alarm & Detection System | Fire detection & alarm system installation requires detailed review to confirm compliance with NFPA 72 and ACCORD standards | Submit as-built drawings, testing records, listing information and other relevant documentation to the ACCORD for review and approval, modification shall have to be done as per the reviewed design (if required) Upon approval & installation/modification the owner shall contact the Accord prior to conducting the final acceptance testing of the fire detection & alarm system installation.<br>Also inspect, test and maintain the fire detection & alarm system and keep written records on-site, in accordance with NFPA 72 and ACCORD standards. | Design submission 2 months;<br>Modification/ installation within 4 months. | |
