# JK Knit Composite Ltd

## Tanima Composite

Savar, 1340 , South Dariapur, Dhaka  
(+23.834782N, 90.255388E)

29 September 2013

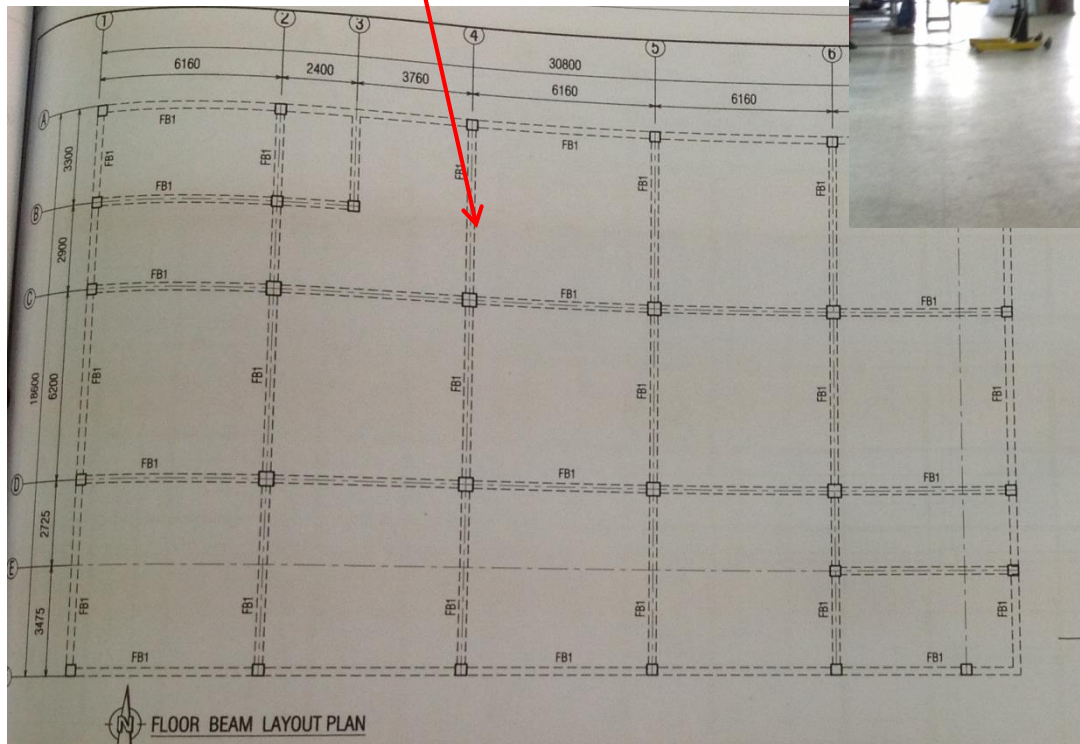
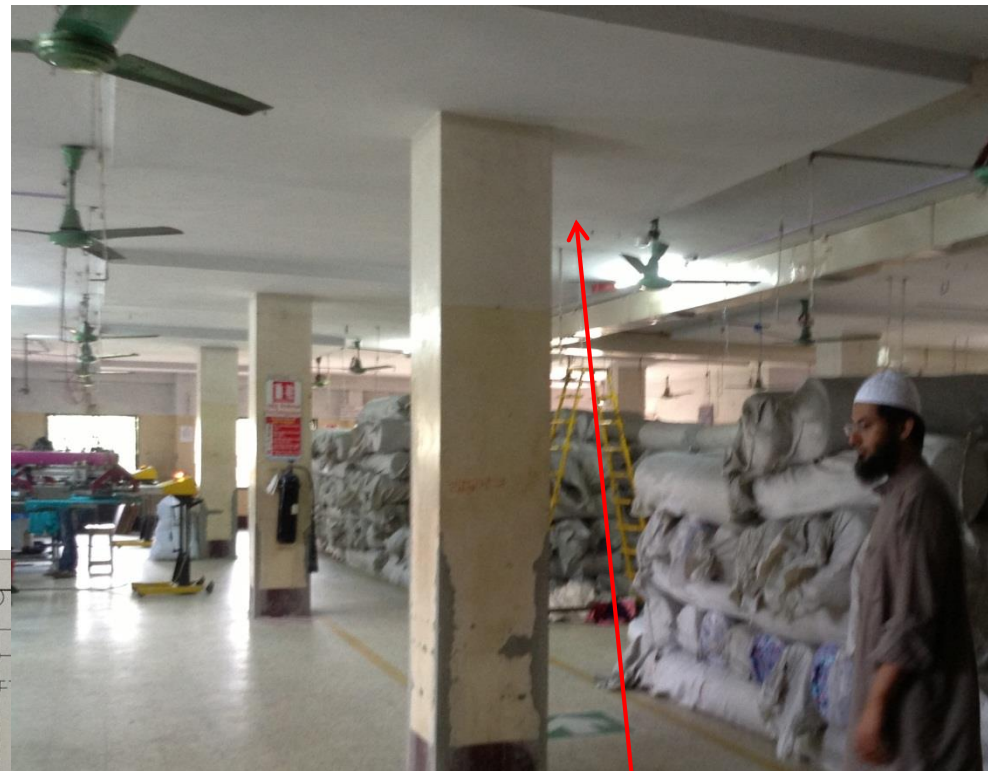
# **Structural drawings do not match as-built Building #1**

As-builts indicate beam and slab construction with 500x500 internal columns

Structure is flat slab with column heads on 450x450 cols

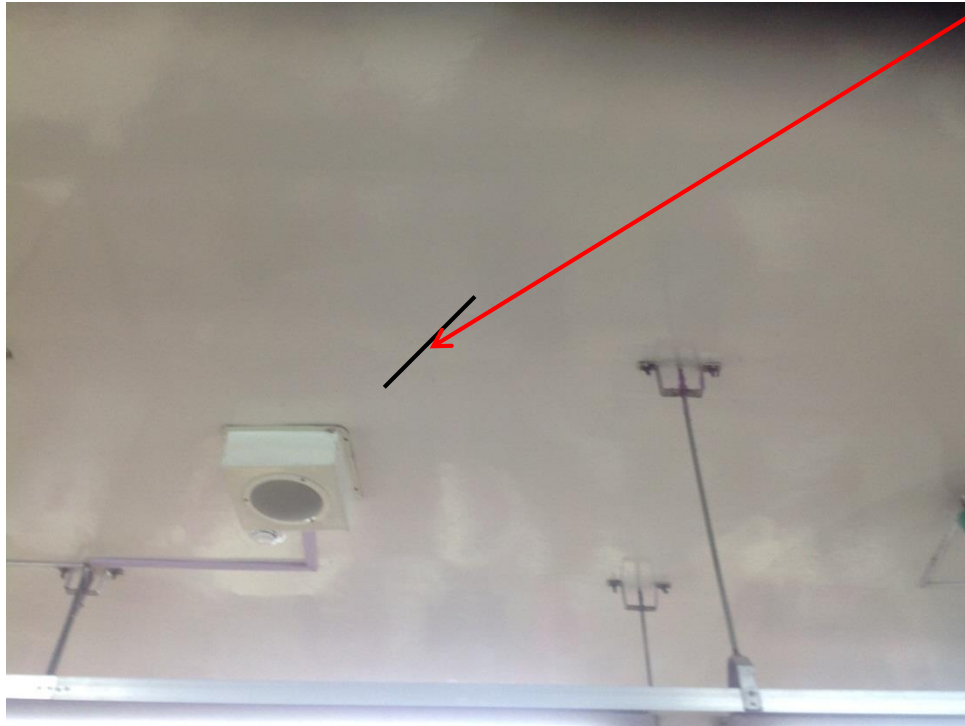
# **Flexural cracking observed in slab soffits in Building #1 and Building #3**

**Crack on underside of slab**

**Check for design code loading and  
justify/reduce allowable loads**

| Item No. | Observation | Recommended Action Plan | Recommended Timeline |
|---|---|---|---|
| 9 | Flexural cracking observed in slab soffits in Building #1 and Building #3 | Building Engineer to check design for code loading and justify/reduce allowable load as necessary | 6-weeks |

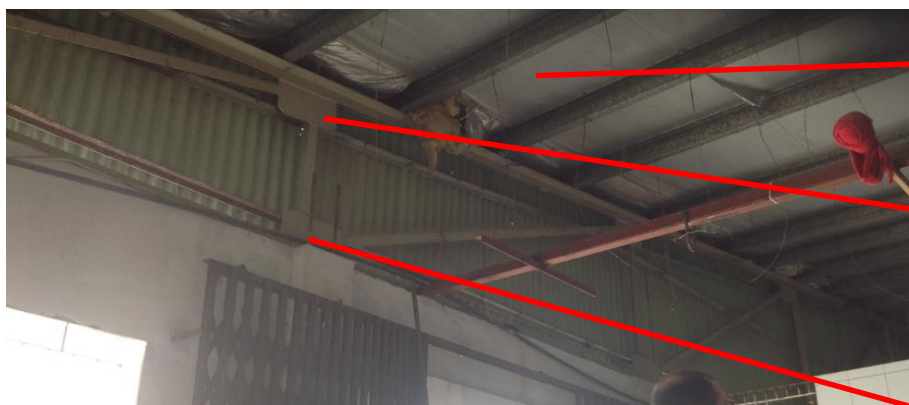
# **Check on roof tie-downs in Building #3**

**Lightweight steel roof**

**Steel roof truss**

**Steel truss connection to  
column to be verified**

**Check adequacy of roof  
tie-down**

| Item No. | Observation | Recommended Action Plan | Recommended Timeline |
|---|---|---|---|
| 10 | Lightweight steel roof to Building #3 to be adequately tied down for severe wind events | Addition structures should be Designed and upgraded to support code vertical and wind loads by the building Engineer, or they should be vacated and removed. | 6-Months |

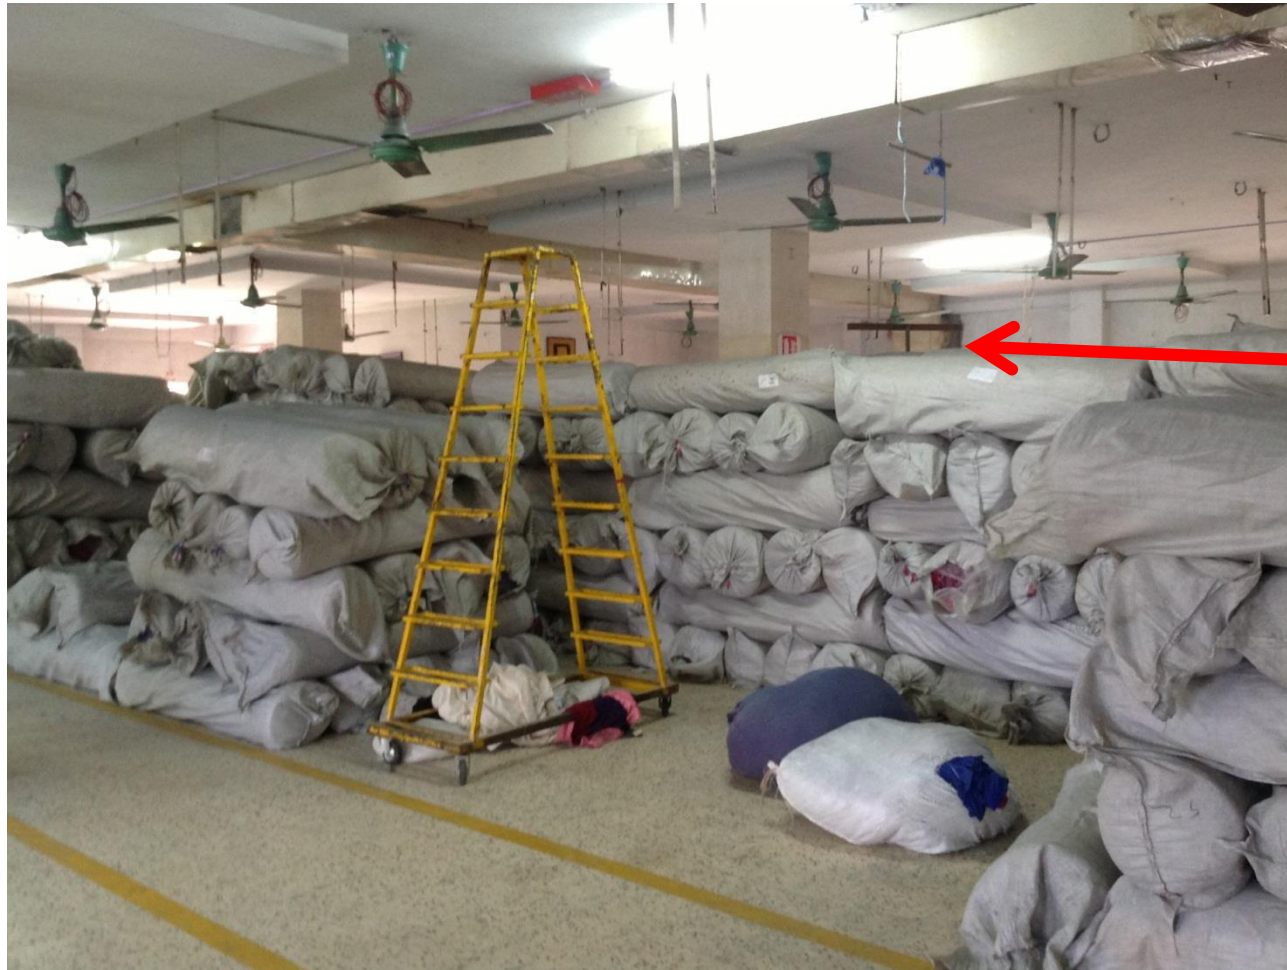
# **Limit density of loading in Building #1 suspended levels**

**Material stacked to  
2m on Level 2**

**Plan and height  
restrictions to be  
introduced to  
prevent future  
overloading.**

| Item No. | Observation | Recommended Action Plan | Recommended Timeline |
|---|---|---|---|
| 11 | Materials stacked in densely spaced piles within Building #1 | Building Engineer to create controlled loading plans for all floors in all Buildings designating where storage can be placed and can not be placed. | 6-Months |

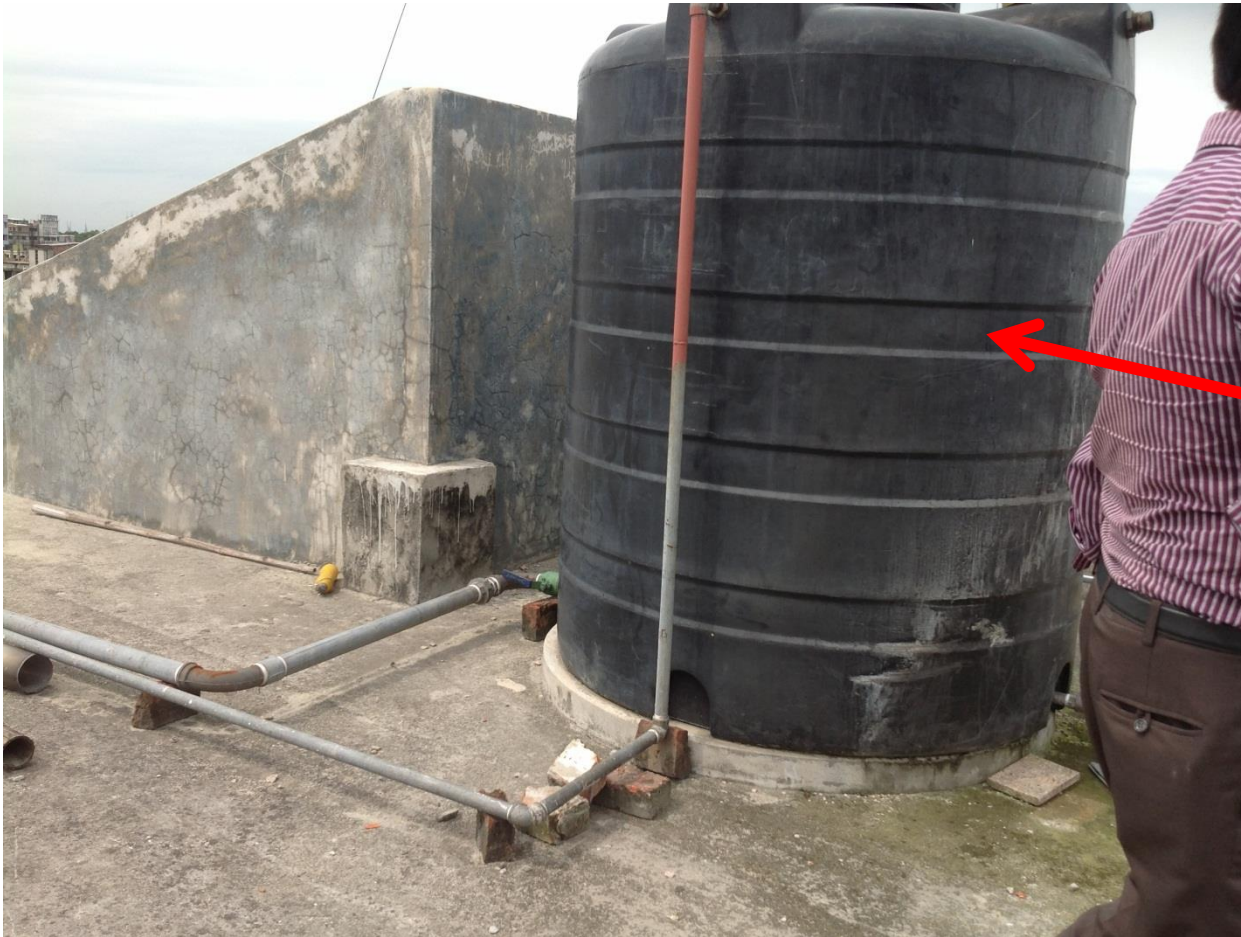
**Check on roof structure to Building #2 with  
Water Tank partially on cantilever**

**Water tanks mounted  
on concrete plinths**

**Engineer to check that  
beam and cantilever  
slab have been  
designed to  
accommodate loads.**

| Item No. | Observation | Recommended Action Plan | Recommended Timeline |
|---|---|---|---|
| 12 | Water tank located on Building #2 partially on cantilever | Verify that beam/slab has sufficient capacity to support fully filled water tank plus concrete plinth | 6-Months |

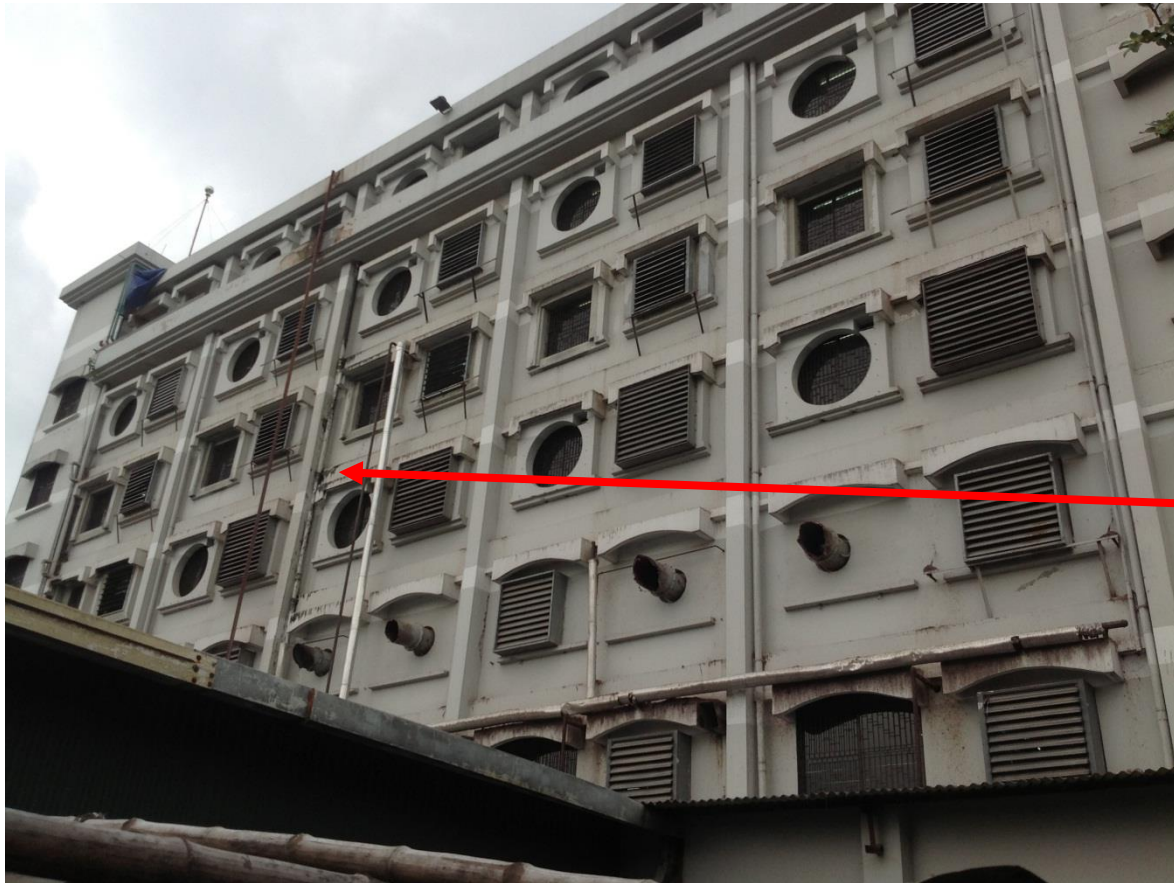
**Building 1 unmanaged  
roof drainage causing  
damage to façade and  
structure**

**Water causing damage  
to building facade**

| Item No. | Observation | Recommended Action Plan | Recommended Timeline |
|---|---|---|---|
| 13 | Water causing damage to building exterior | Engineer to inspect water damaged exterior and propose a suitable repair. | 6-Months |

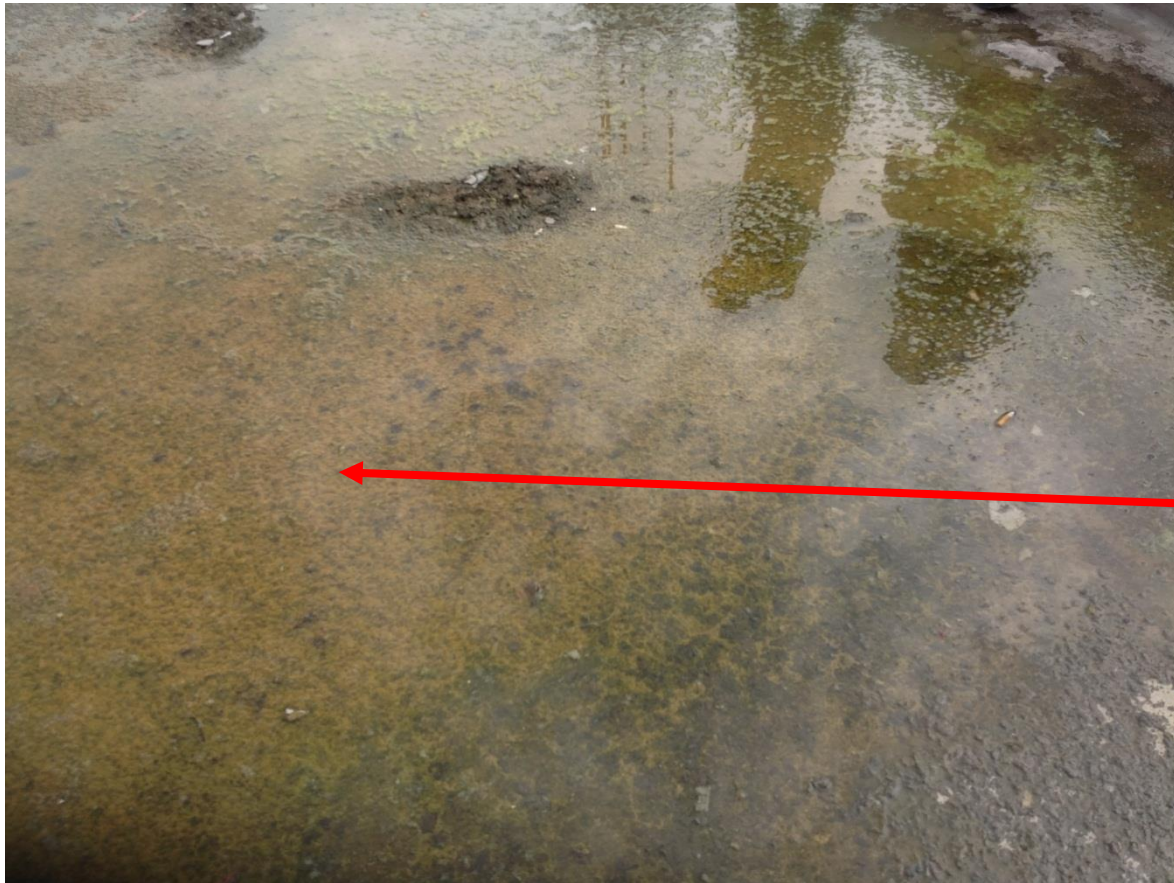
**Building 4 roof water not  
draining and possibly  
causing corrosion to  
structure**

**Water possibly causing  
damage and corrosion**

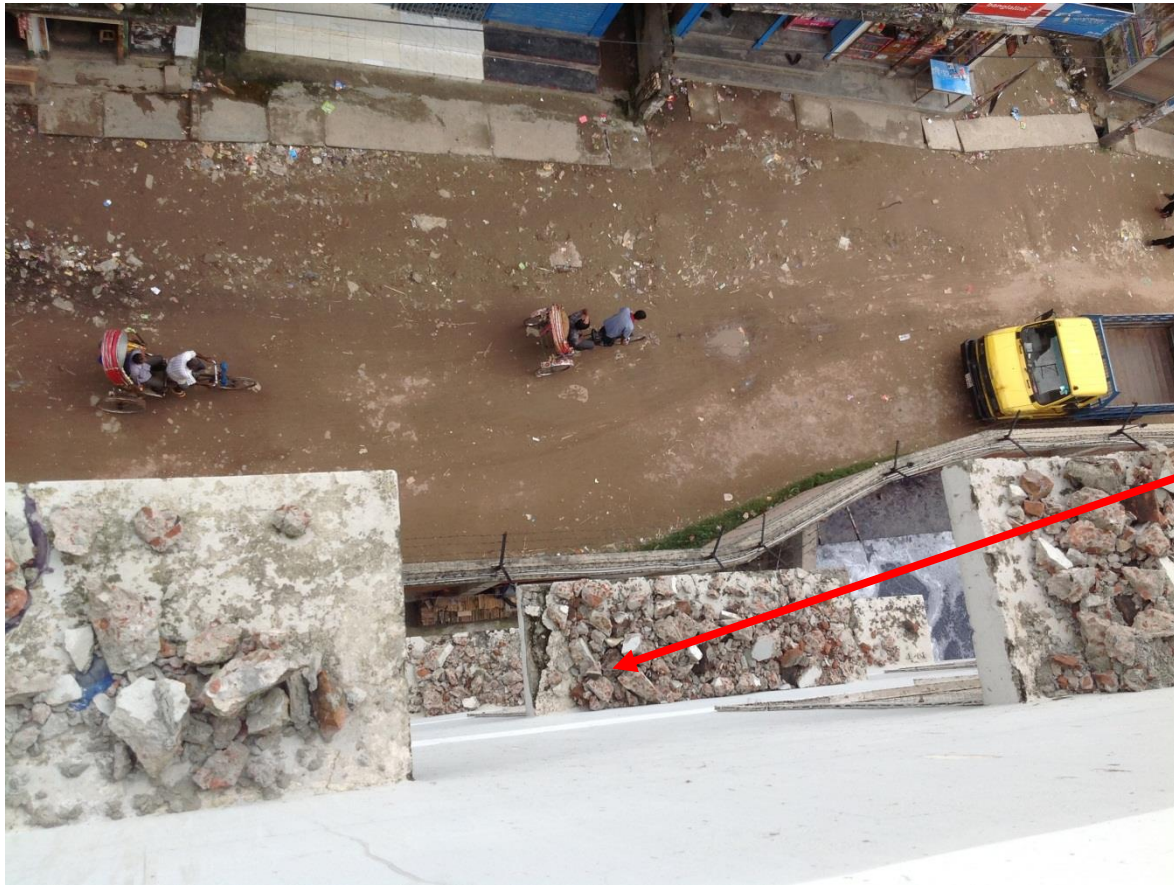
# **Uncontrolled debris from demolition of concrete structure at roof of Building #1**

**No debris protection for  
Building 1 roof demolition**

**No debris protection for  
structure and adjacent street**

| Item No. | Observation | Recommended Action Plan | Recommended Timeline |
|---|---|---|---|
| 14 | Uncontrolled debris from demolition of concrete structure at roof of Building #1 | Ensure safety net/ crash decks in place prior to demolition continuing | 6-weeks |
| 15 | Uncontrolled debris from demolition of concrete structure at roof of Building #1 | Continue to carry out demolition works in safe manner | 6-weeks |
