# INITIAL STRUCTURAL INTEGRITY ASSESSMENT REPORT (SIAR)

Factory Name: **HKD International (CEPZ) Ltd**

Assessor: **Bureau Veritas**

Date: **15 May 2014**

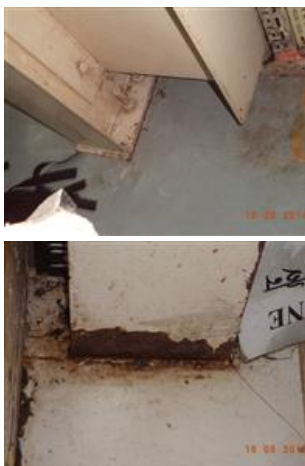
| Question: | Are structural steel members free of corrosion, physical damage or other types of deterioration? | |
| Description: | Building-A: Corrosion has been found in base plate of column of ground floor.<br>Building-C: Corrosion has been found in column of ground floor. | |

| Suggested Plan of Action: | Complete further testing on areas of deterioration and have a qualified structural engineer develop a remediation plan | |
