# Aboni Knitwear (New Shed)

169-171, 195-196, Tatulzhora, Hemayetpur, Savar, Dhaka

3<sup>rd</sup> February 2019

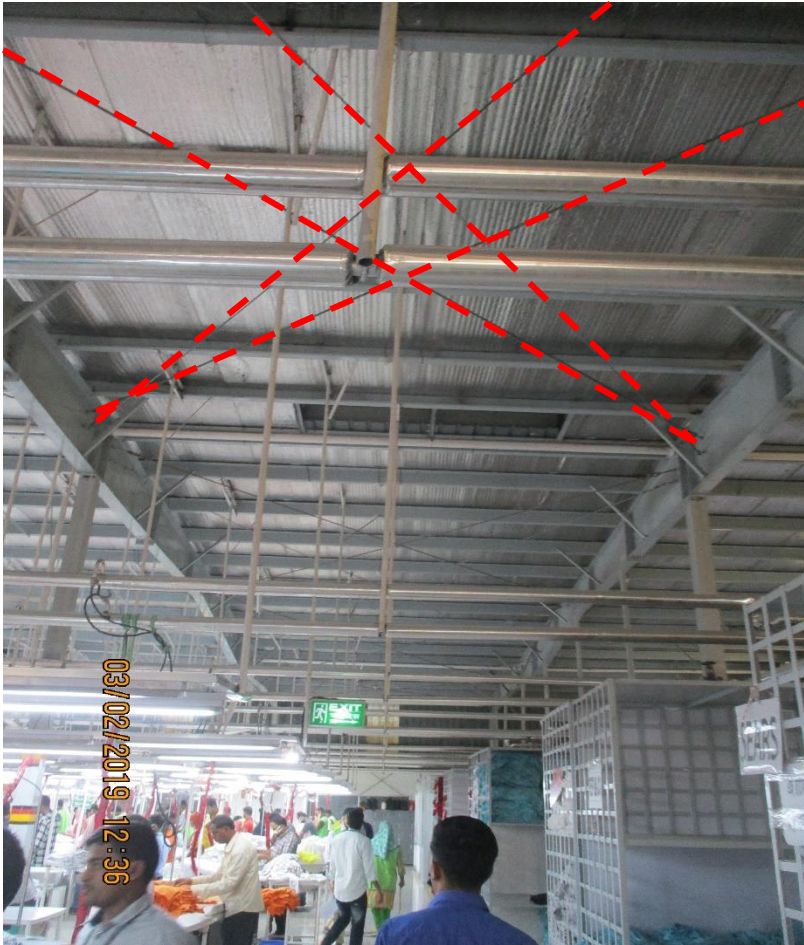
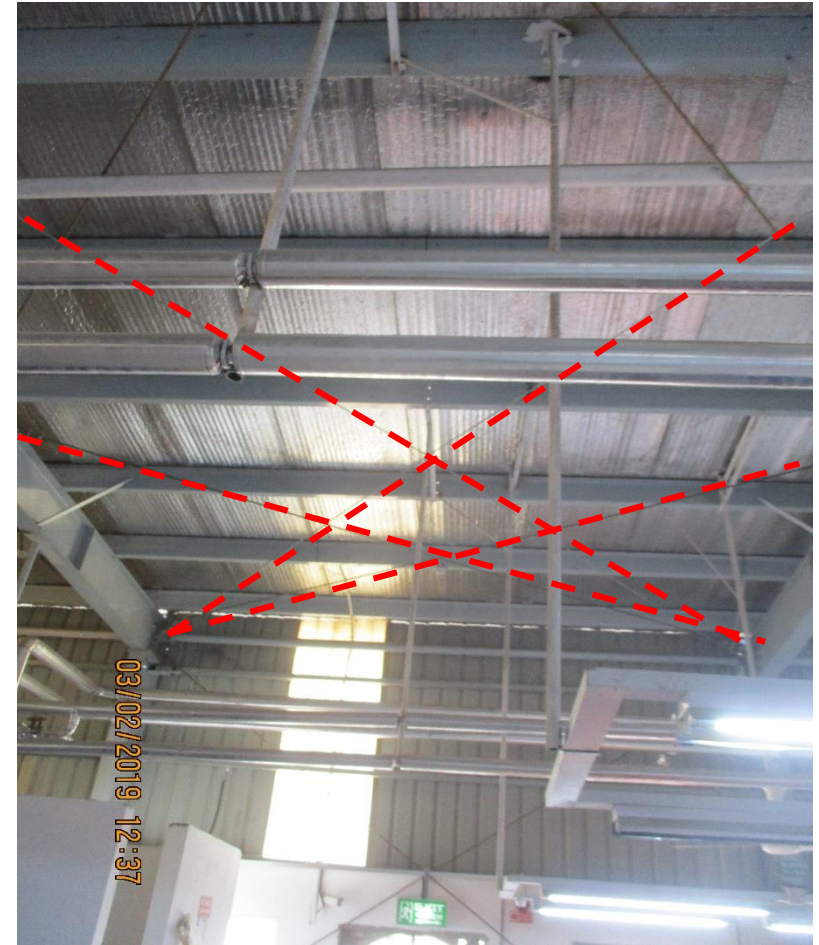
# Inconsistency in roof bracing system

Inconsistency observed in roof bracing system. Building engineer is required to review the existing bracing system for the lateral stability.

| Item No. | Observation | Recommended Action Plan | Recommended Timeline |
|---|---|---|---|
| 1 | Inconsistency in roof bracing system | Building engineer is required to review the existing bracing system for the lateral stability. | 6-weeks |
| 2 | Inconsistency in roof bracing system | Carryout any remedial actions suggested by factory engineer. | 6-months |

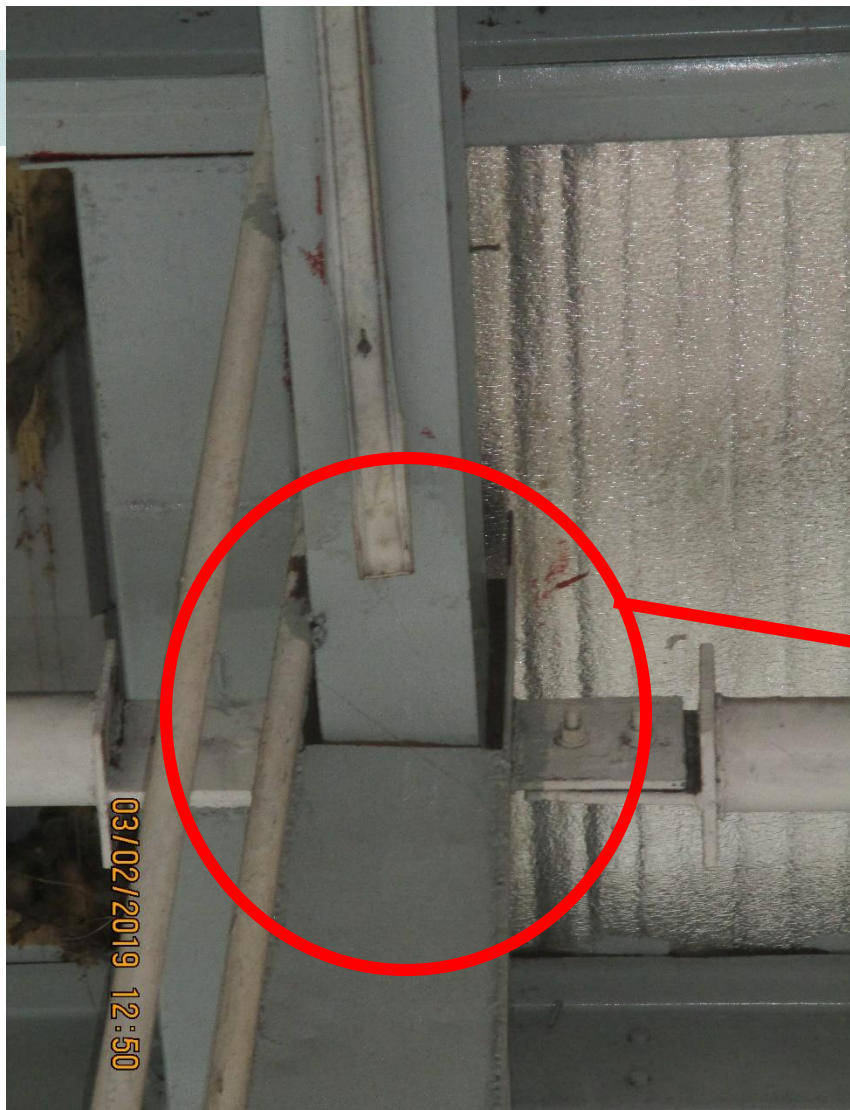
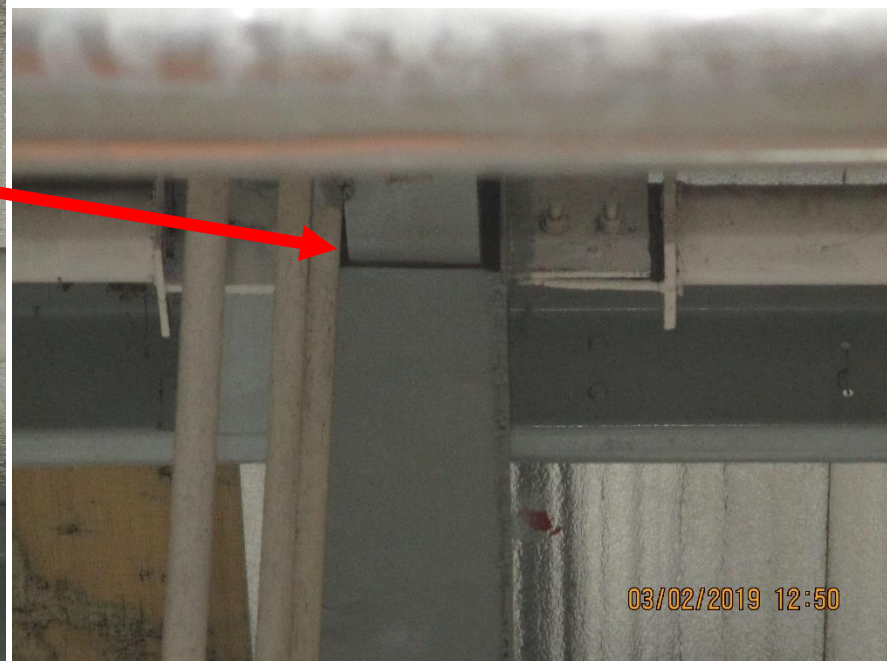
# Presence of gaps in remedial works

Significant gap between retrofitted column & rafter were observed in several locations. Building engineer is required to carry out remedial works.

| Item No. | Observation | Recommended Action Plan | Recommended Timeline |
|---|---|---|---|
| 3 | Presence of gaps in remedial works | Factory engineer is required to carry out the remediation work of the connections. | 6-weeks |
