# **FIRE SAFETY INSPECTION REPORT**

**BELAMY TEXTILES LIMITED**  
**KHOWAJNAGAR, AZIMPARA, KARNAFULY,**  
**CHITTAGONG**

**ACCORD**  
on Fire and Building Safety in Bangladesh

May 5, 2014

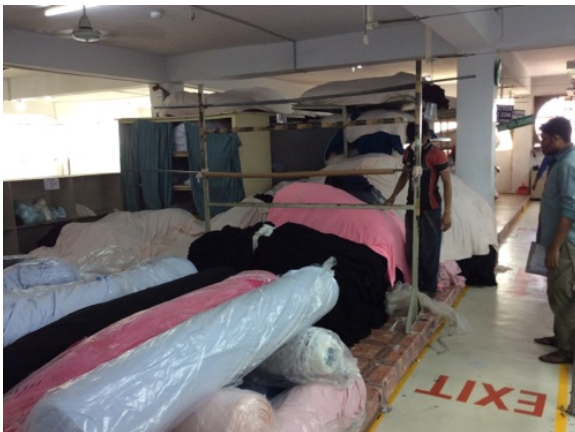
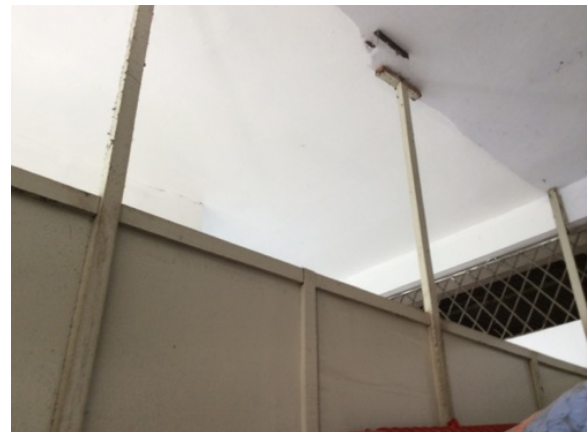
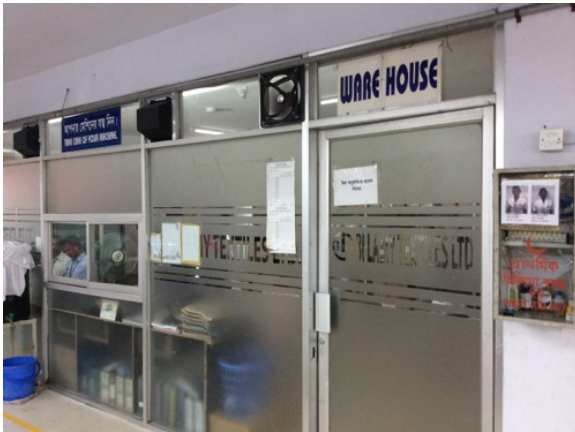
| No. | Category | Finding | Recommendation | Remediation Timeframe |
|---|---|---|---|---|
| F-1 | Fire Rated Construction | In all the floors areas used for combustible storage were not separated by fire-rated construction. | <p>Provide dedicated storage rooms separated by minimum 1-hr fire-rated construction.</p> <p>Where separate storage rooms are not feasible, provide defined storage areas and limit the storage arrangement as follows:</p> <ul style="list-style-type: none"> <li>- Maximum height of 2.4m and maximum area of 23 sq.m.</li> </ul> <p>Separate areas of unenclosed combustible storage by a minimum clear distance of 3m.</p> | Within 3 months |

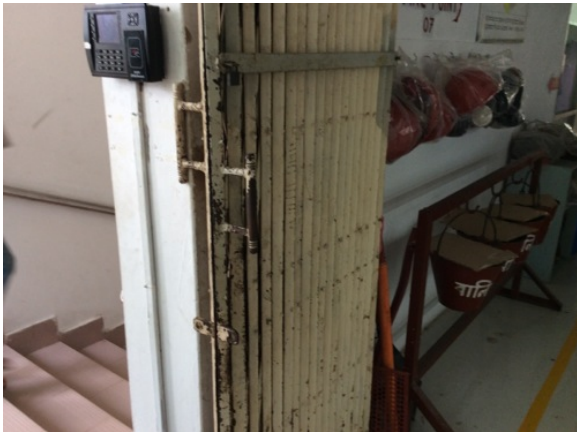
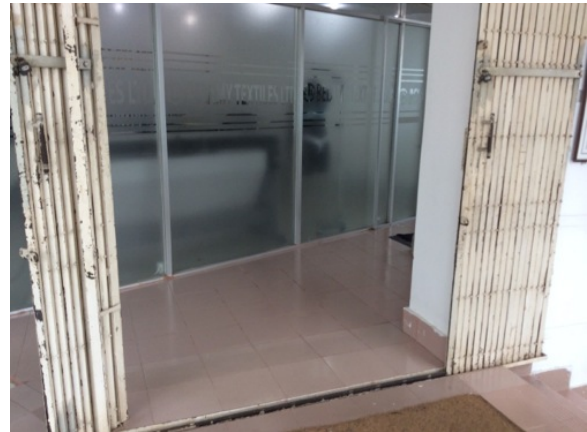
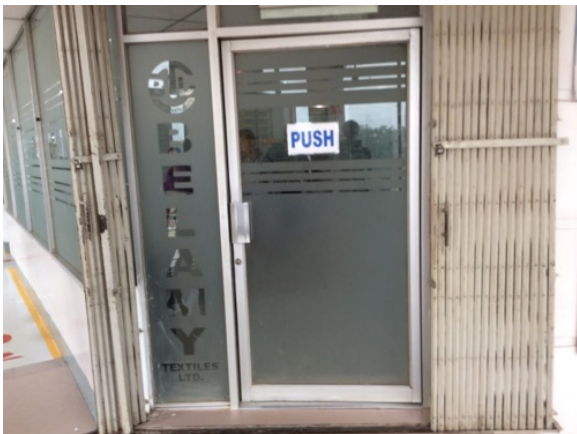
| F-2 | Fire Rated Construction | The exit stairs were not separated from work areas and other spaces on each floor by fire-rated construction. | <p>Provide minimum 1.5-hr fire rated doors and seal all unprotected openings to separate the exit stairs from work areas and other building spaces on all floor levels. Ensure that the fire doors are self-closing and positive latching and that they are provided with fire exit (panic) hardware where serving production floors.</p> <p>If fire doors are required to be held open for functional reasons, provide automatic-closing devices tied to the fire alarm system.</p> | Within 3 months |

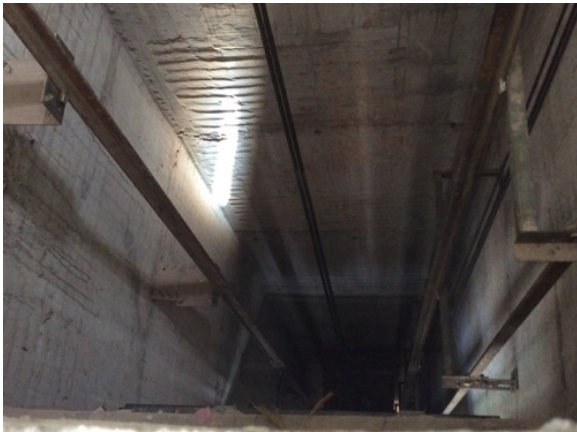
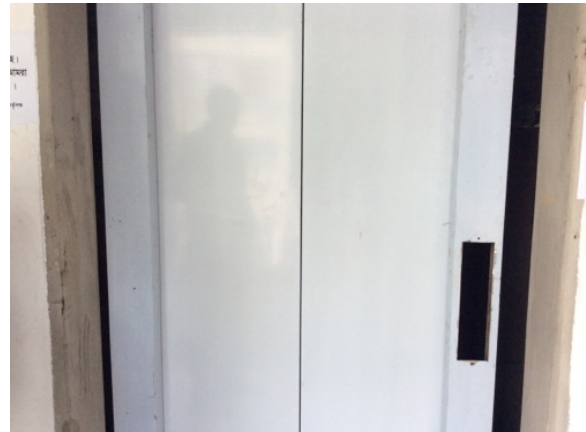
F-3

The elevator shaft present in the building was not provided with adequate fire-rated separation between floors.

Provide a minimum 2-hr fire-rated shaft to separate the elevator shaft from each floor level.

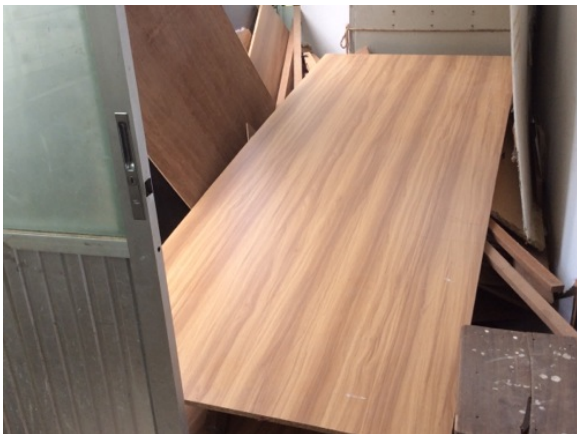
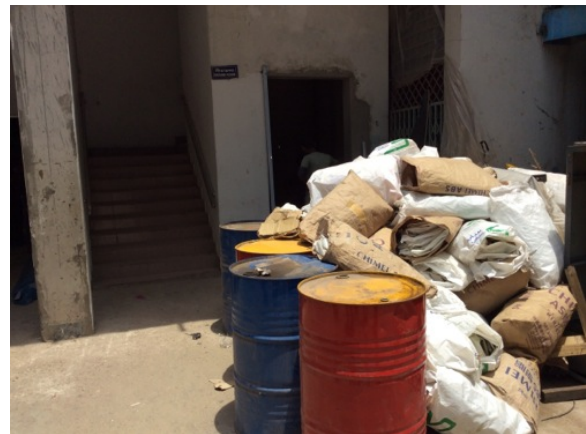
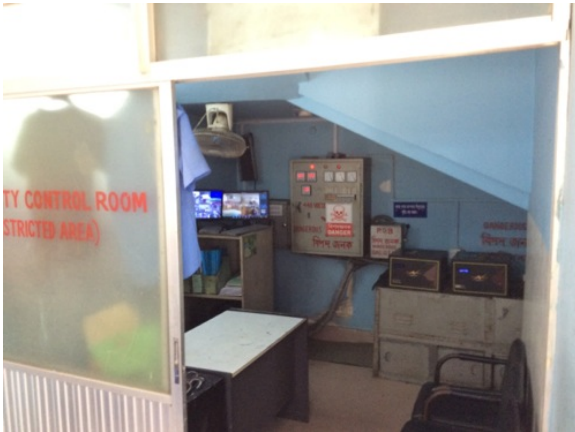
| F-4 | Egress | Storage was located in the East exit stair on ground and fifth floor and in the west exit stair in the ground floor. | Remove all storage from exit stairs and egress paths. | Immediate |

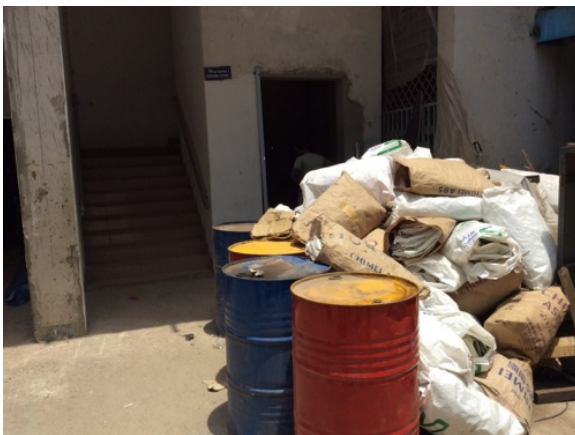
| F-5 | Egress | Storage was located in the exit discharge from the East exit stair. | Keep egress paths and stairs clear of storage. | Immediate |

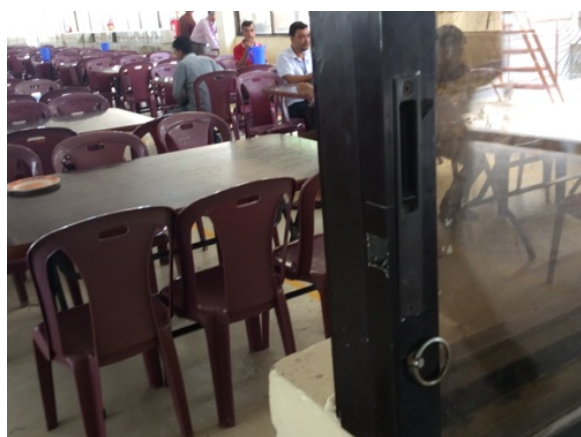
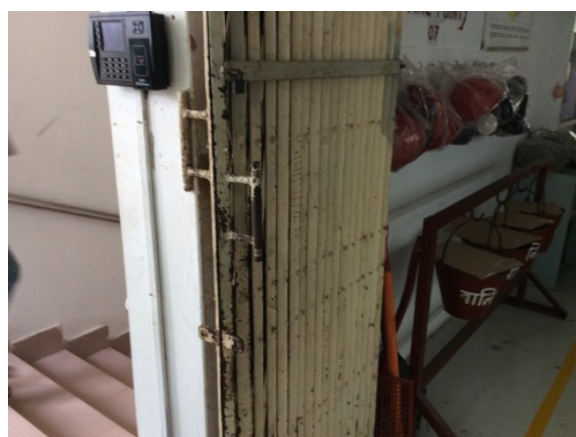
| F-7 | Egress | Egress doors and gates with locking features were provided at building exits, exit stairs, along egress routes and exit discharges. All gates and doors were open and unlocked during the inspection. | Remove locking features from all egress doors and gates.<br><br>If locks are required for security reasons, utilize special door locking features complying with NFPA 101. | Immediate |

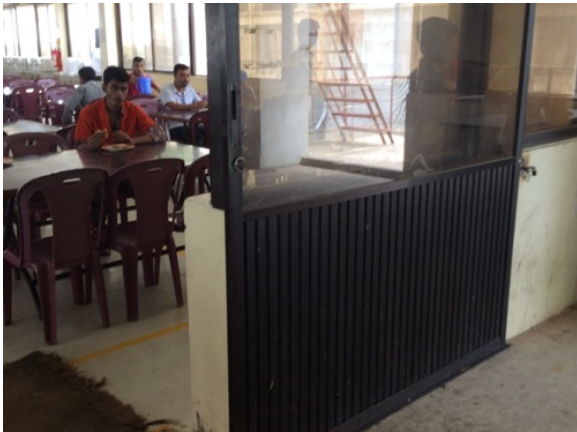
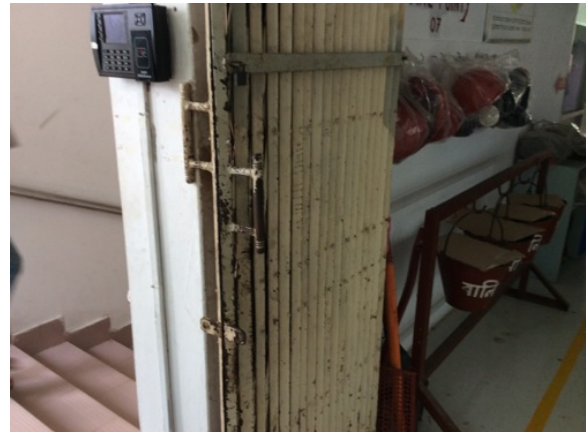
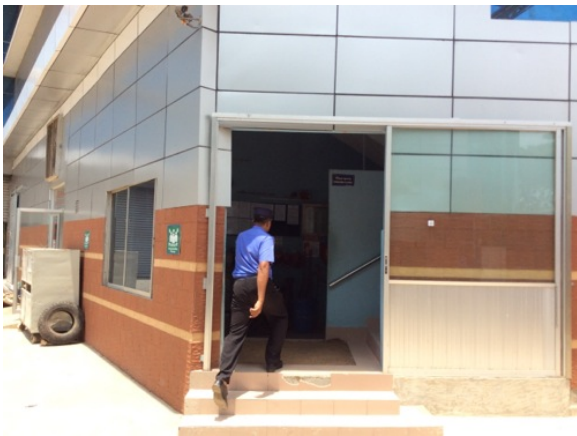
| F-8 | Egress | Collapsible gates and sliding doors are provided at building exits, exit stairs, along egress routes and exit discharge. | Replace all gates / sliding doors along the means of egress with side-hinged, swinging egress doors.<br><br>If locks are required for security reasons, utilize special door locking features complying with NFPA 101. | Within 1 month |

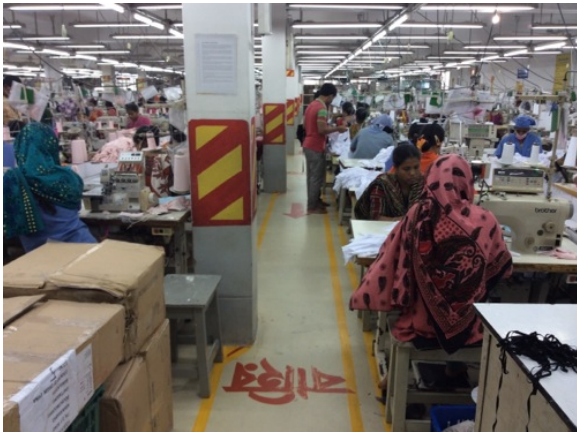
| F-9 | Egress | The width of egress aisles were less than 36-in. on the third floor. | Provide minimum aisle widths of 36-in. | Within 3 months |

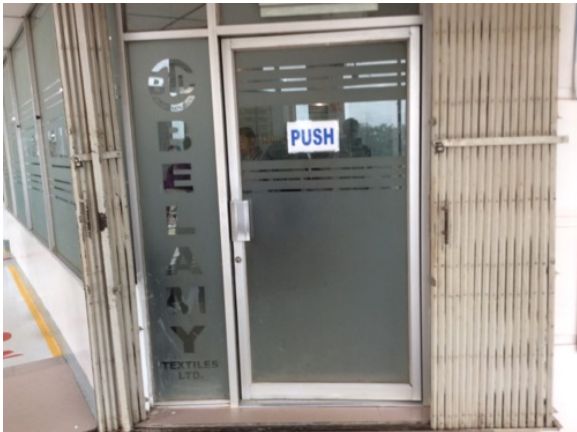
| F-10 | Egress | Exit stair door and egress door serving 50 or more occupants did not swing in the direction of egress travel on the third floor. | Modify the egress door to swing in the direction of egress travel. | Within 3 months |

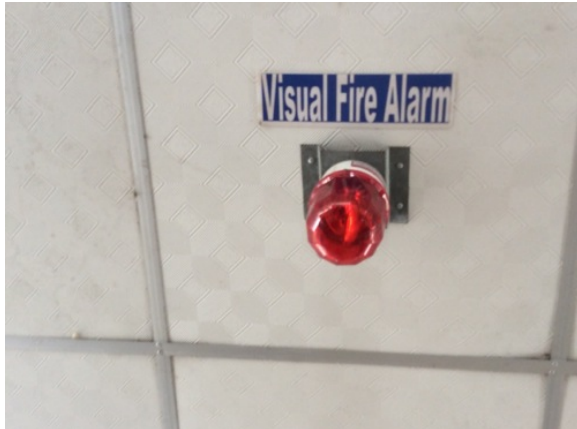
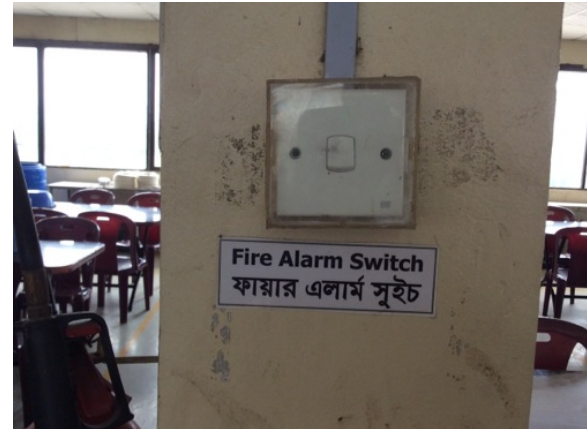
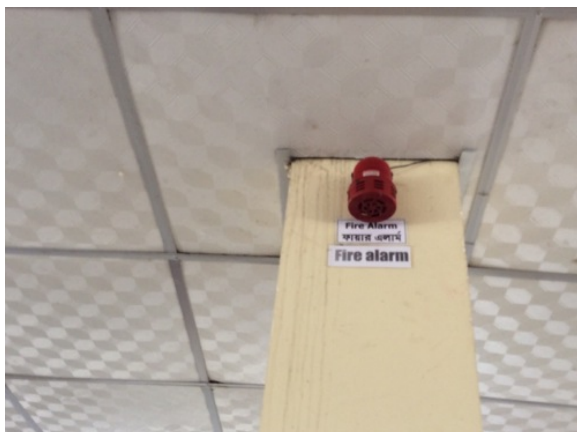
| F-11 | Fire Protection | The fire alarm system was antiquated, not a listed system, and did not provide alarm and notification features consistent with acceptable standards. | Replace the fire alarm system with a new, listed addressable fire alarm system in accordance with NFPA 72. | Design within 4 months, install within 9 months |

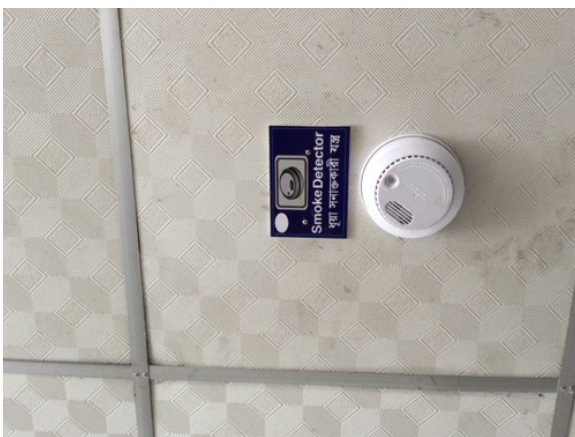
| F-13 | Fire Protection | The building was equipped with single-station smoke alarms. Smoke alarm activation sounds only a local alarm and does not provide automatic fire alarm notification of occupants. | Remove single-station smoke alarms. Provide automatic smoke detection, tied to the fire alarm system, throughout the building in accordance with NFPA 72. | Within 6 months |
