# **FIRE SAFETY INSPECTION REPORT**

## **ETTADE JEANS LTD.**

**1670/2091, BUILDING NO 03, WEST SHOLOSHAHR,  
ATURAR DEPOT, PANCHLAISH, CHITTAGONG.**

May 8, 2014

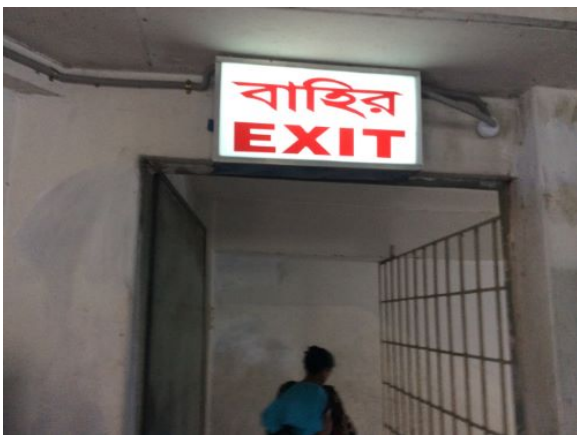
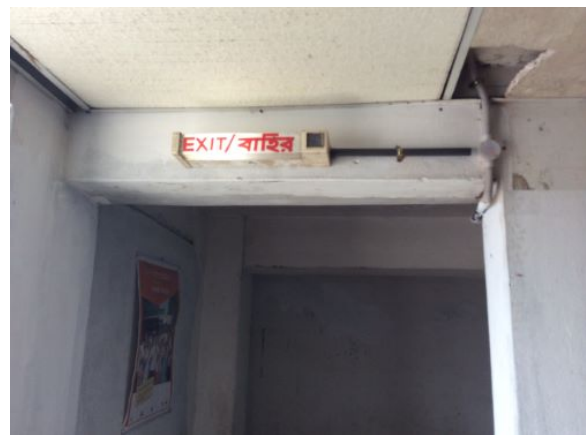
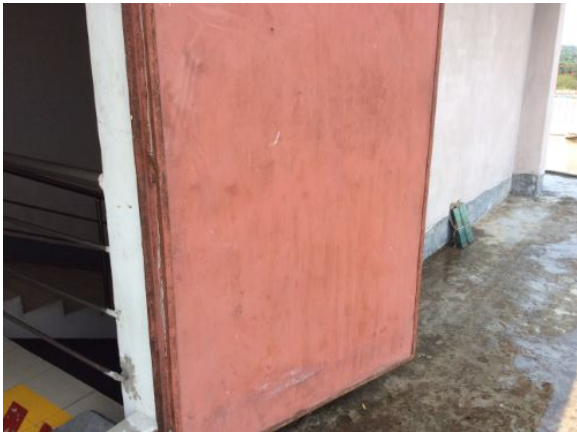
No.	Category	Finding	Recommendation	Remediation Timeframe
F-1	Fire Rated Construction	The exit stairs were not separated from work areas on each floor by fire-rated construction.	<p>Provide minimum 1.5-hr fire rated doors and seal all unprotected openings to separate the exit stairs from work areas and other building spaces on all floor levels. Ensure that the fire doors are self-closing and positive latching and that they are provided with fire exit (panic) hardware where serving production floors.</p> <p>If fire doors are required to be held open for functional reasons, provide automatic-closing devices tied to the fire alarm system.</p>	Within 3 months

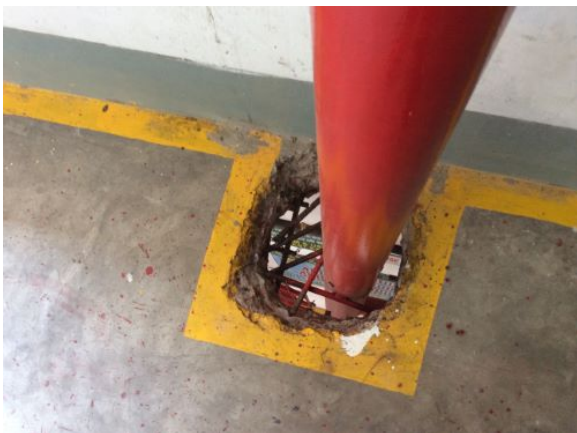
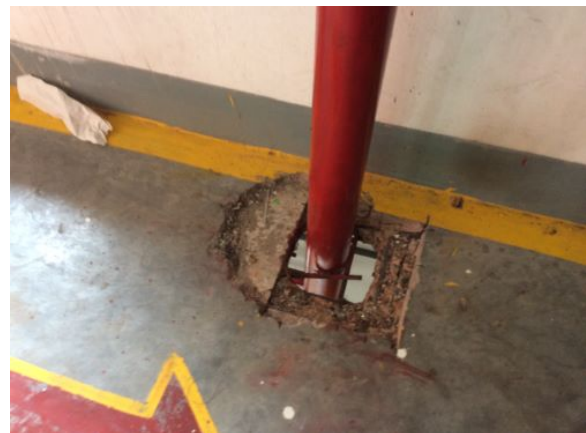
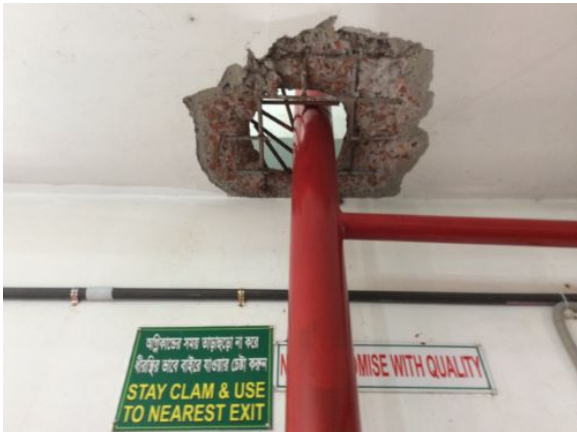
F-2	Fire Rated Construction	Unsealed penetrations and openings were located in the fire-rated floor and ceiling assemblies.	Provide a minimum 2-hr fire-rated shaft to separate the utility risers from each floor level.	Within 3 months
			Seal all penetrations and openings in floor/ceiling assemblies to maintain the fire separation.

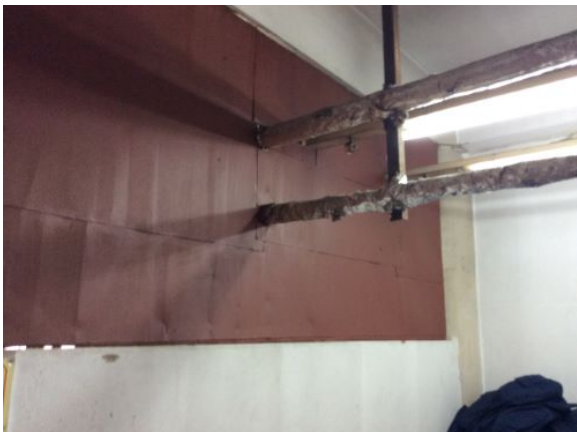
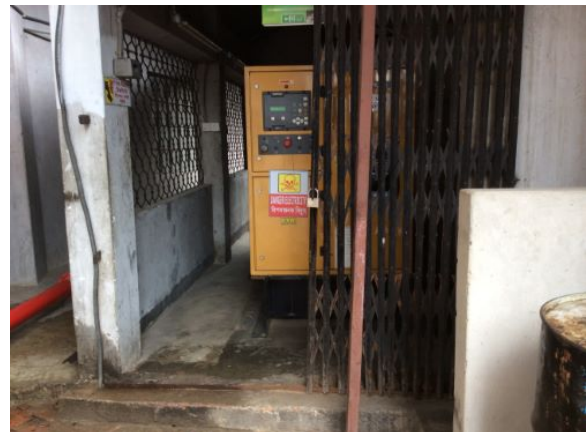
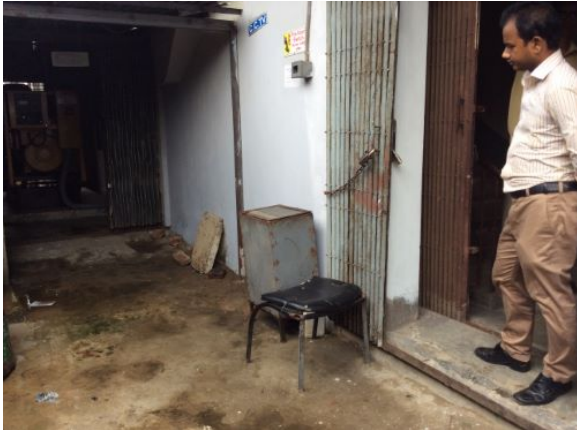
F-3	Fire Rated Construction	The boiler, generator and transformer rooms were not separated by fire-rated construction from the third floor, North and West exit stair discharges.	Separate the boiler, generator and transformer rooms by a minimum 2-hr fire-rated construction. Seal and protect all openings to maintain the required fire separations	Within 3 months
-----	-------------------------	---	---	-----------------

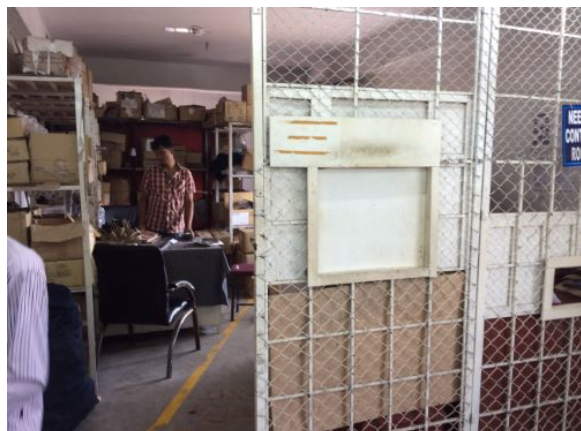
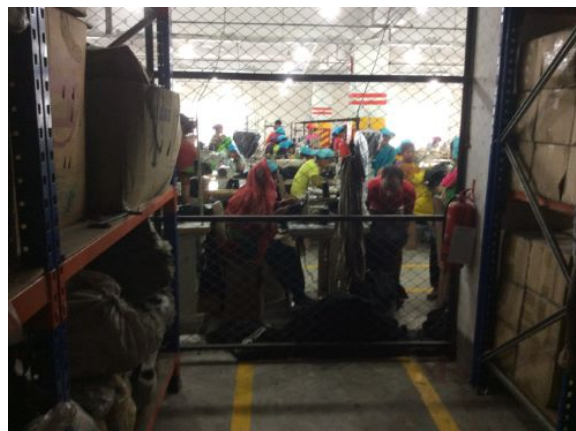
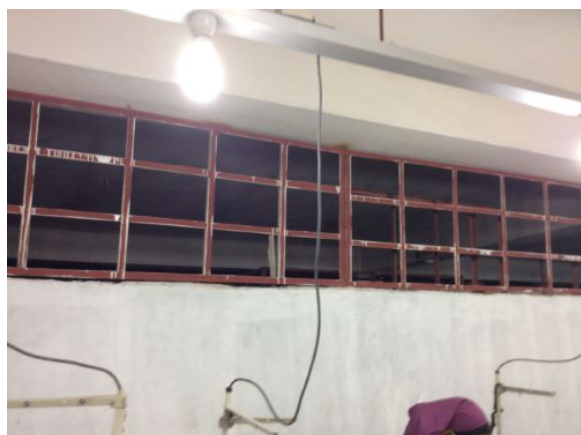
F-4	Fire Rated Construction	Areas used for combustible storage were not separated by fire-rated construction on all the floors except first, second and sixth floor.	Provide dedicated storage rooms separated by minimum 1-hr fire-rated construction.  Where separate storage rooms are not feasible, provide defined storage areas and limit the storage arrangement as follows: - Maximum height of 2.4m and maximum area of 23m <sup>2</sup> - If sprinkler protected: maximum height of 3.66m and maximum area of 93m <sup>2</sup>  Separate areas of unenclosed combustible storage by a minimum clear distance of 3m.	Within 3 months
-----	-------------------------	--	--	-----------------

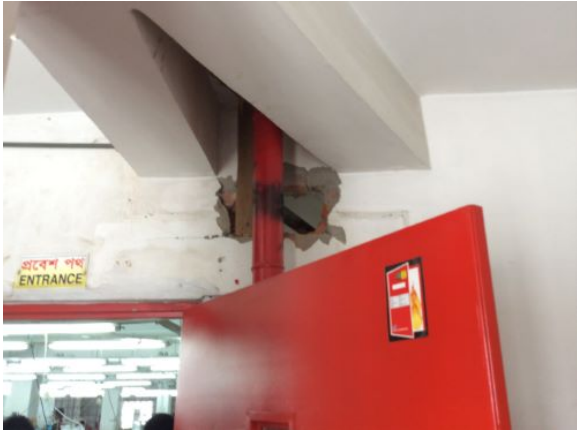
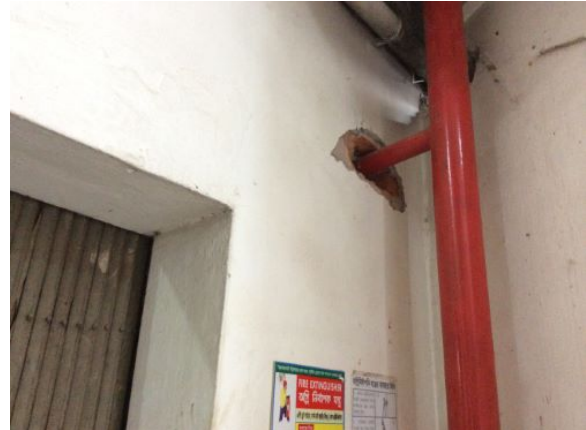
F-5	Fire Rated Construction	Unsealed penetrations and openings were located in exit stair enclosures.	Seal all penetrations and openings in exit stair enclosure walls to maintain the fire separation.	Within 3 months
-----	-------------------------	---	---	-----------------

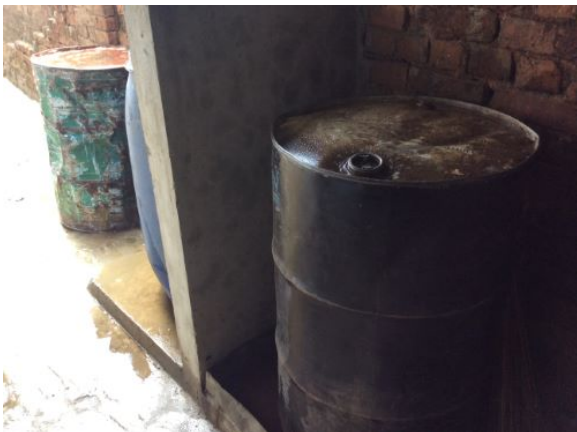
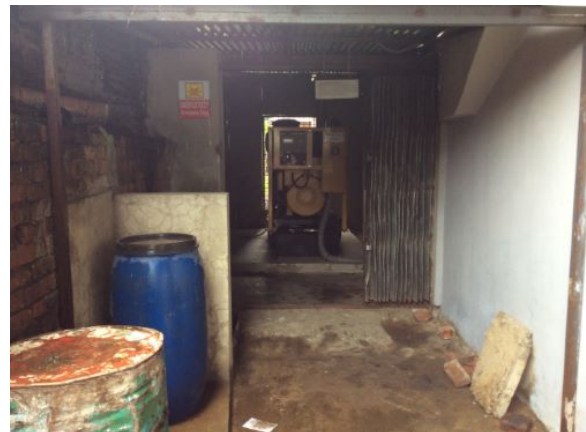
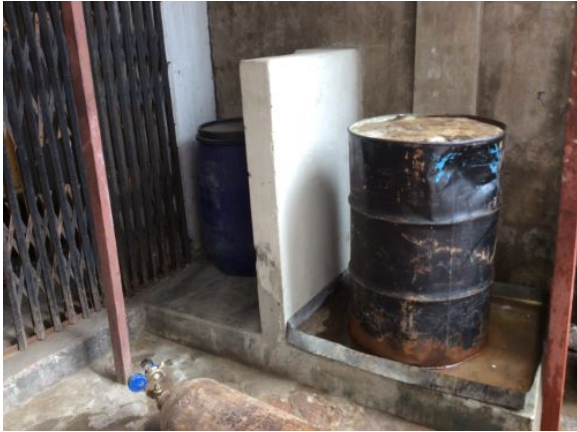
F-6	Fire Rated Construction	Hazardous materials and flammable liquid storage area was not separated by fire-rated construction from the generator.	Separate the hazardous materials and flammable liquid storage room by a minimum 2-hr fire-rated construction. Seal and protect all openings to maintain the required fire separations.	Within 3 months
-----	-------------------------	--	--	-----------------

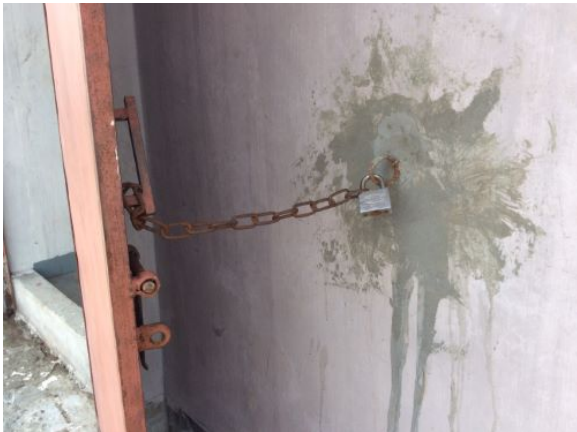
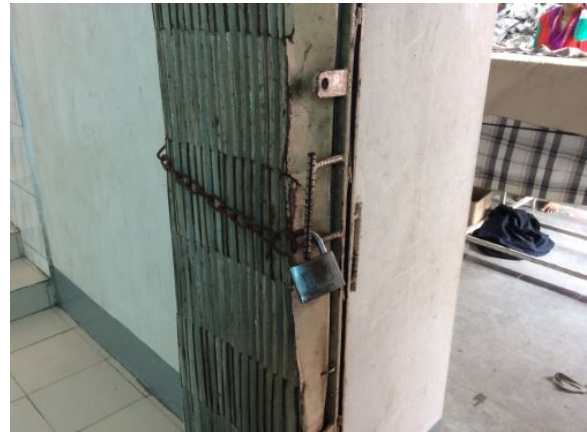
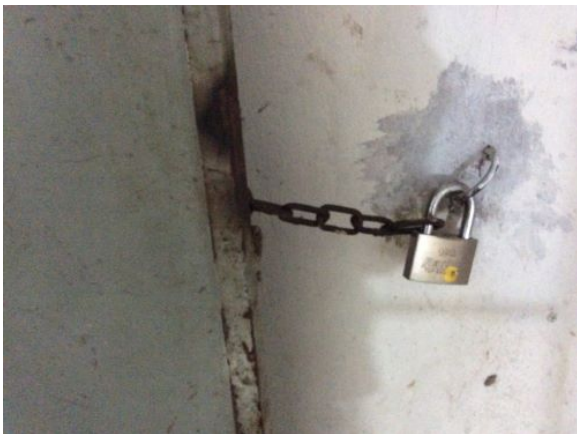
F-7	Fire Rated Construction	The exit discharge path serving West exit was less than 10 ft wide and was not separated from the building interior.	Seal all penetrations and openings to the interior of the building along the discharge path, up to a height of 10 ft., to provide a minimum 1-hr fire separation.	Within 6 months
F-8	Egress	Egress doors and gates with locking features were provided along egress routes, exit stairs, exit discharges and building exits.	Remove locking features from all egress doors and gates.  If locks are required for security reasons, utilize special door locking features complying with NFPA 101.	Immediate

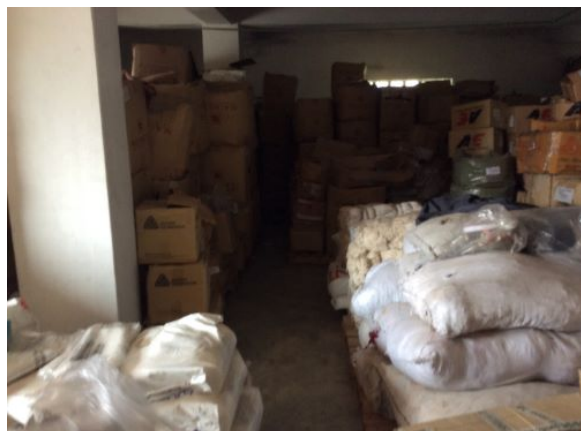
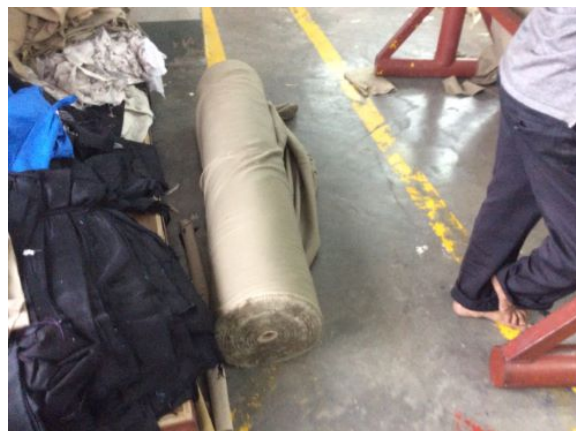
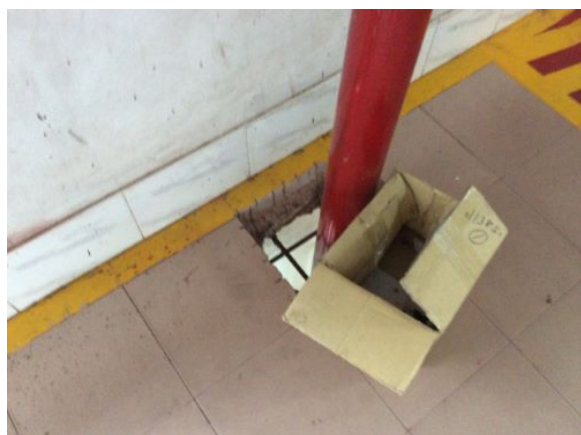
F-9	Egress	Storage was located in the egress path on all the floors except the sixth floor.	Keep egress paths and stairs clear of storage.	Immediate
-----	--------	--	--	-----------

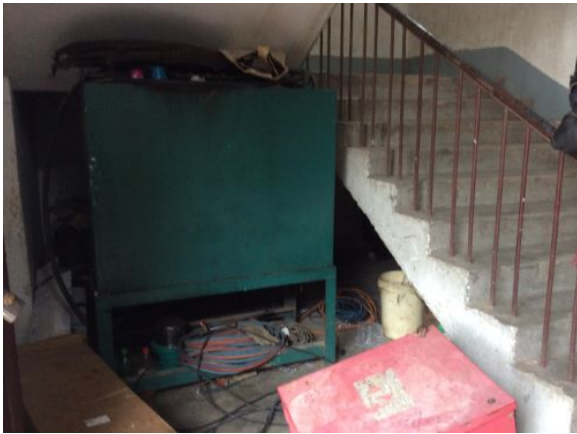
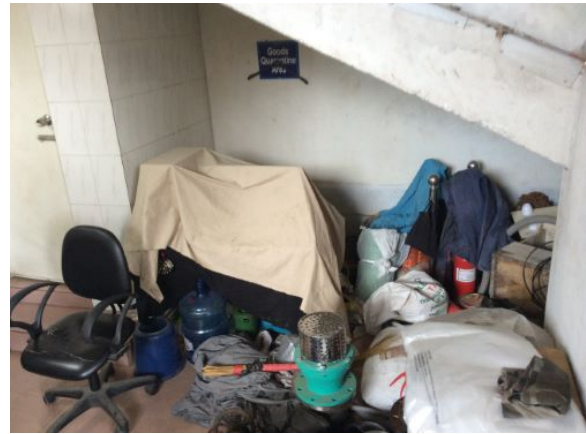
F-11	Egress	Storages were located in the North and South exit stair.	Remove all storage from exit stairs and egress paths.	Immediate
------	--------	--	---	-----------

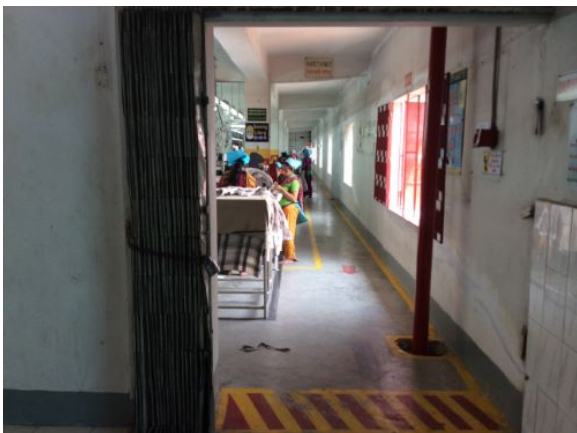
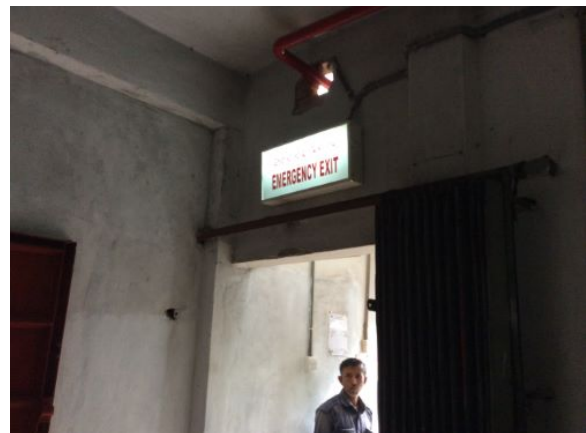
F-12	Egress	Collapsible gates and sliding doors were provided along egress routes, exit stairs, exit discharges and building exits.	Replace all gates / sliding doors along the means of egress with side-hinged, swinging egress doors.  If locks are required for security reasons, utilize special door locking features complying with NFPA 101.	Within 1 month
------	--------	---	--	----------------

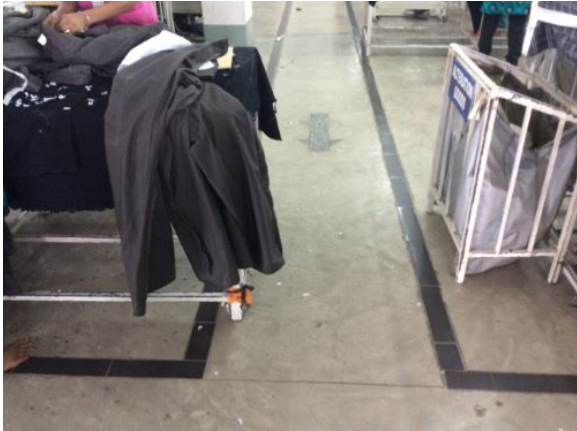
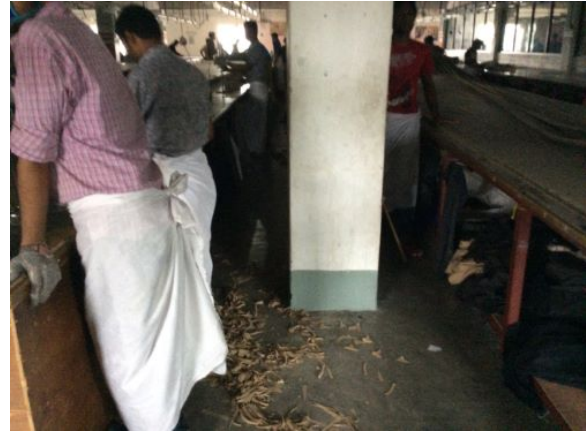
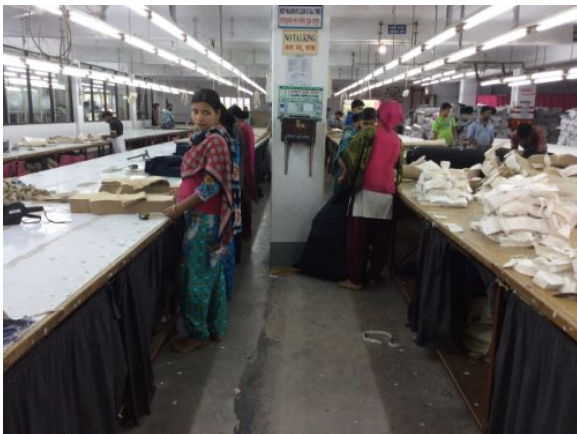
F-13	Egress	The width of egress aisles was less than 36-in. on all the floors except the fourth and sixth floor.	Provide minimum aisle widths of 36-in.	Within 3 months
------	--------	--	--	-----------------

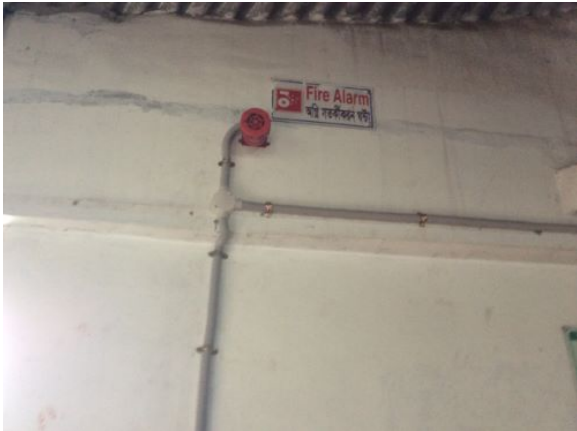
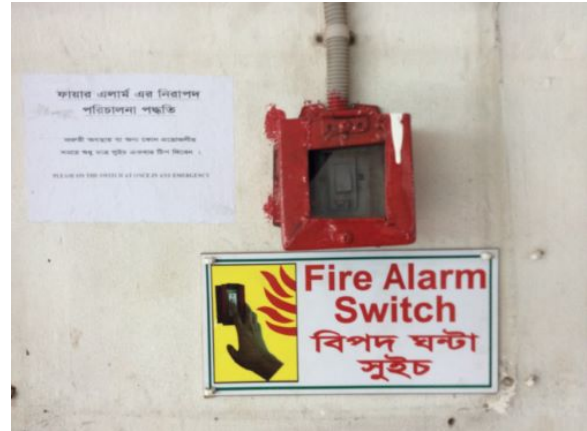
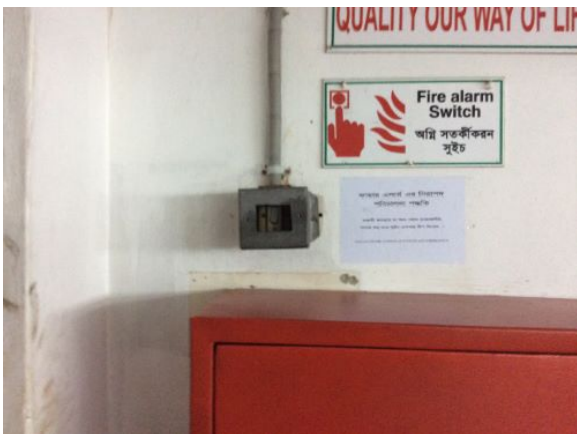
F-15	Fire Protection	The fire alarm system was antiquated, not a listed system, and did not provide alarm and notification features consistent with acceptable standards.	Replace the fire alarm system with a new, listed addressable fire alarm system in accordance with NFPA 72.	Design within 4 months, install within 9 months
------	-----------------	--	--	---

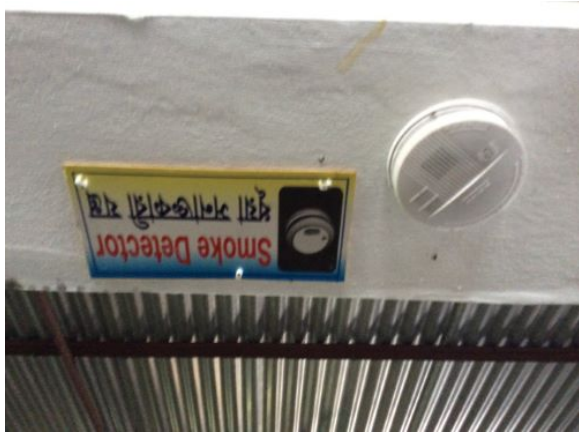
F-17	Fire Protection	The building was equipped with single-station smoke alarms. Smoke alarm activation sounds only a local alarm and did not provide automatic fire alarm notification of occupants.	Remove single-station smoke alarms. Provide automatic smoke detection, tied to the fire alarm system, throughout the building in accordance with NFPA 72.	Within 6 months
------	-----------------	--	---	-----------------

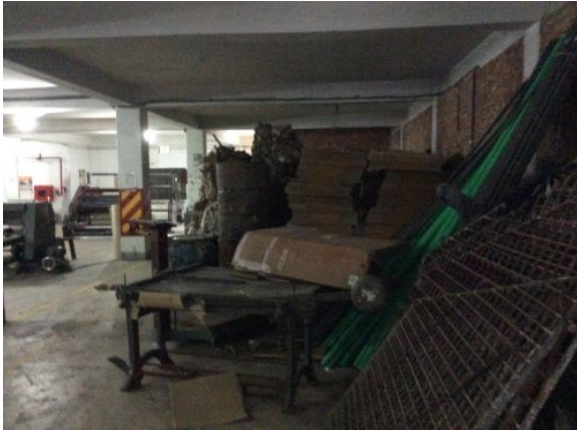
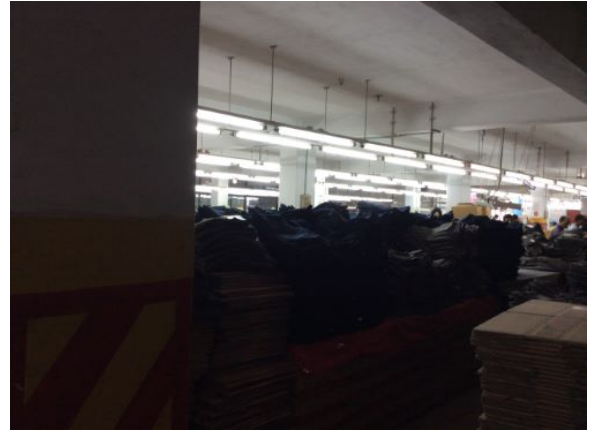
F-19	Egress Lighting	Based on the number and location of emergency lights observed, adequate illumination levels were not anticipated along egress routes inside the factory floors.	Test the emergency lighting system on each floor and provide additional emergency fixtures to provide adequate illumination along the means of egress. Provide a minimum illumination of 10 lux at the floor level within exit stairs and exit discharge paths and minimum 2.5 lux along exit access aisles.	Within 3 months
------	-----------------	---	--	-----------------
