# Masco Cottons Ltd

44, Redwan Complex, Gazipura Bustand, Tongi, Gazipur  
(23.921111N, 90.392778E)  
25 January 2015

# Observations

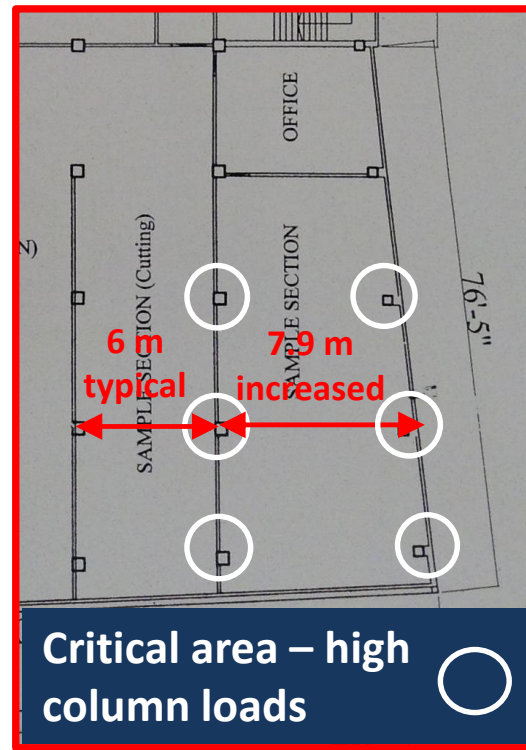
# Heavily-loaded columns in loading bay area

Columns heavily loaded for following reasons:

- Loaded tributary area increased due to larger grid dimension
- Cantilever introduced after design stage
- Loaded columns support storage loads from several floors

Storage load on several floors;  
Note: cardboard on 1<sup>st</sup> floor

| Item No. | Observation | Recommended Action Plan | Recommended Timeline |
|---|---|---|---|
| 1 | Heavily-loaded columns in loading bay area | Restrict Live load on 1st to 7th floors to 2 kPa in area over the loading bays. | Immediate - Now |
| 5 | Heavily-loaded columns in loading bay area | Revise current loading plan for all floor plates within the Factory and actively manage it, giving consideration to floor capacity and column capacity, particularly in the extended bays over the loading dock. | 6-weeks |

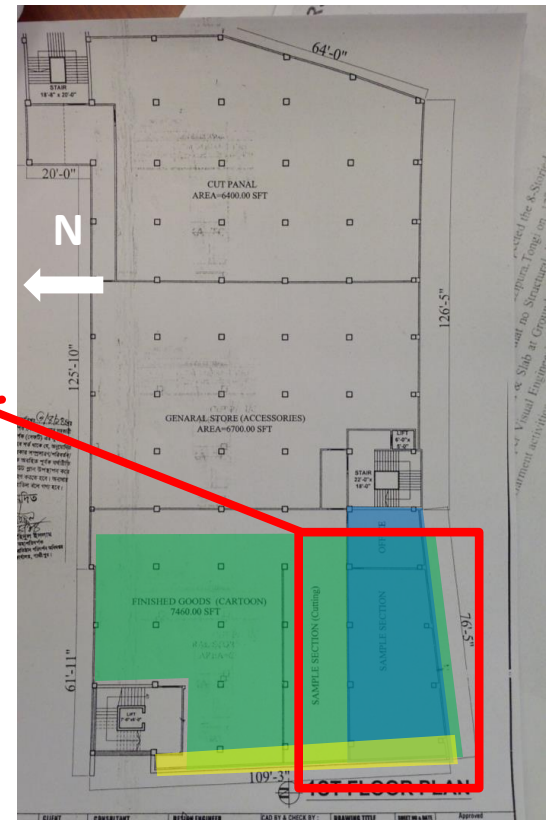
Larger as-built grid dimension  
than designed

| Item No. | Observation | Recommended Action Plan | Recommended Timeline |
|---|---|---|---|
| 2 | Heavily-loaded columns in loading bay area | Factory Engineer to review design, loads and column stresses in all columns. | Immediate - Now |

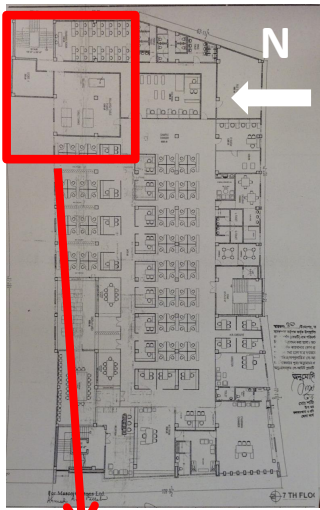
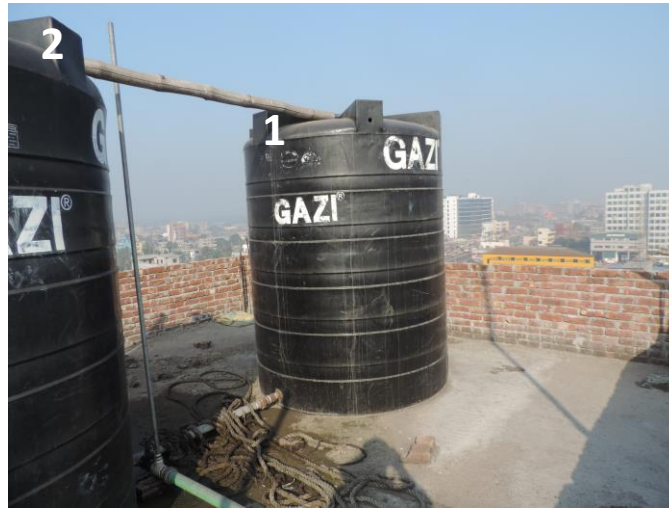
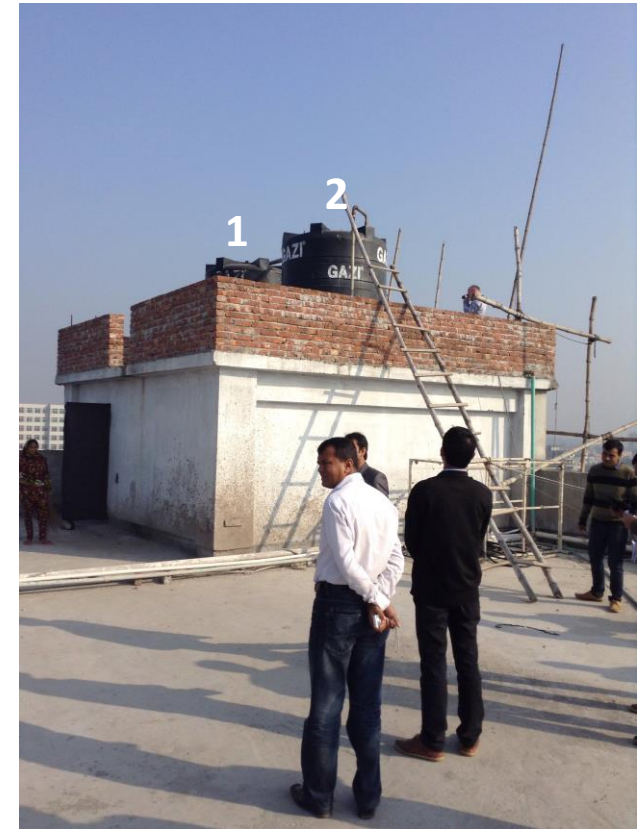
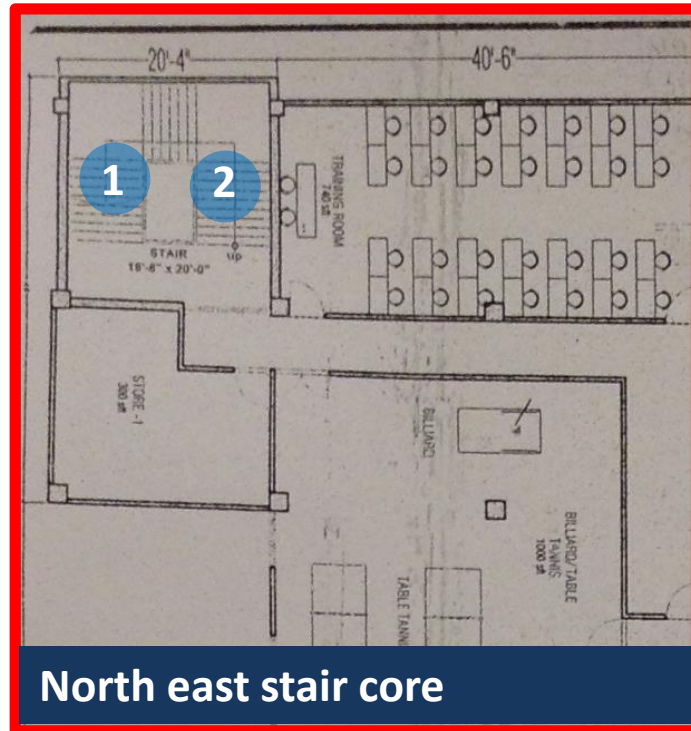
**5000 litre  
water tank**

# Water storage tanks on roof

**There are 2 no. water tanks  
located above the north east  
stair core on the roof. Each  
has a capacity of 5000 litres.**

| Item No. | Observation | Recommended Action Plan | Recommended Timeline |
|---|---|---|---|
| 10 | Water tanks on roof of north-east core | As part of the Detail Engineering Assessment (ref. Item 1), the slab supporting water storage tanks to have its design capacity verified by the Building Engineer. | 6-weeks |
| 11 | Water tanks on roof of north-east core | Remove water tanks if required by Detail Engineering Assessment. | 6-weeks |
| 12 | Water tanks on roof of north-east core | Carry out any remedial works required by the Detail Engineering Assessment. | 6-months |

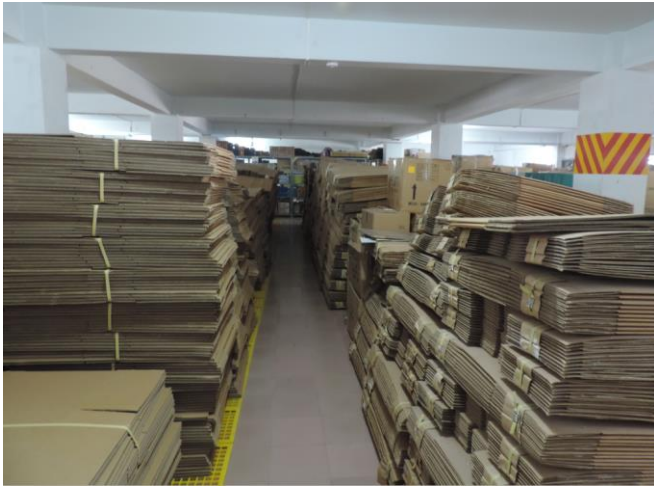
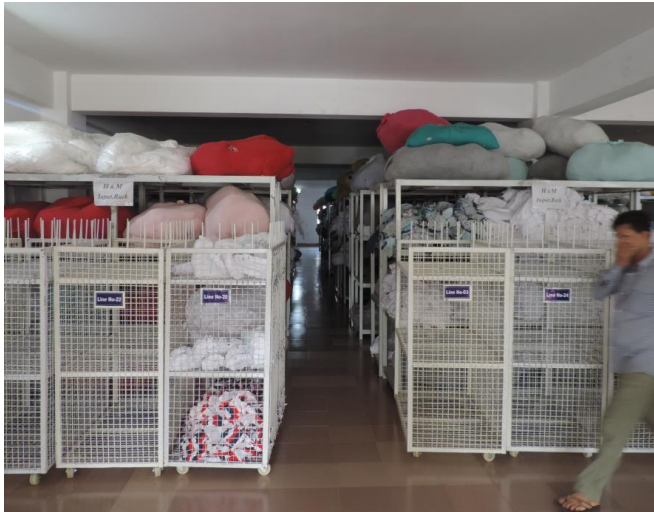
Uncontrolled loading 1<sup>st</sup> floor

High loading  
storage of  
cardboard and  
fabric on 1<sup>st</sup> floor

| Item No. | Observation | Recommended Action Plan | Recommended Timeline |
|---|---|---|---|
| 13 | Uncontrolled loading (in excess of loading plan) on 1st floor | As part of the Detail Engineering Assessment (ref. Item 1), reduce loading on first floor to conform to revised loading plans. | 6-weeks |
| 14 | Uncontrolled loading (in excess of loading plan) on 1st floor | Continue to implement revised load plan. | 6-months |

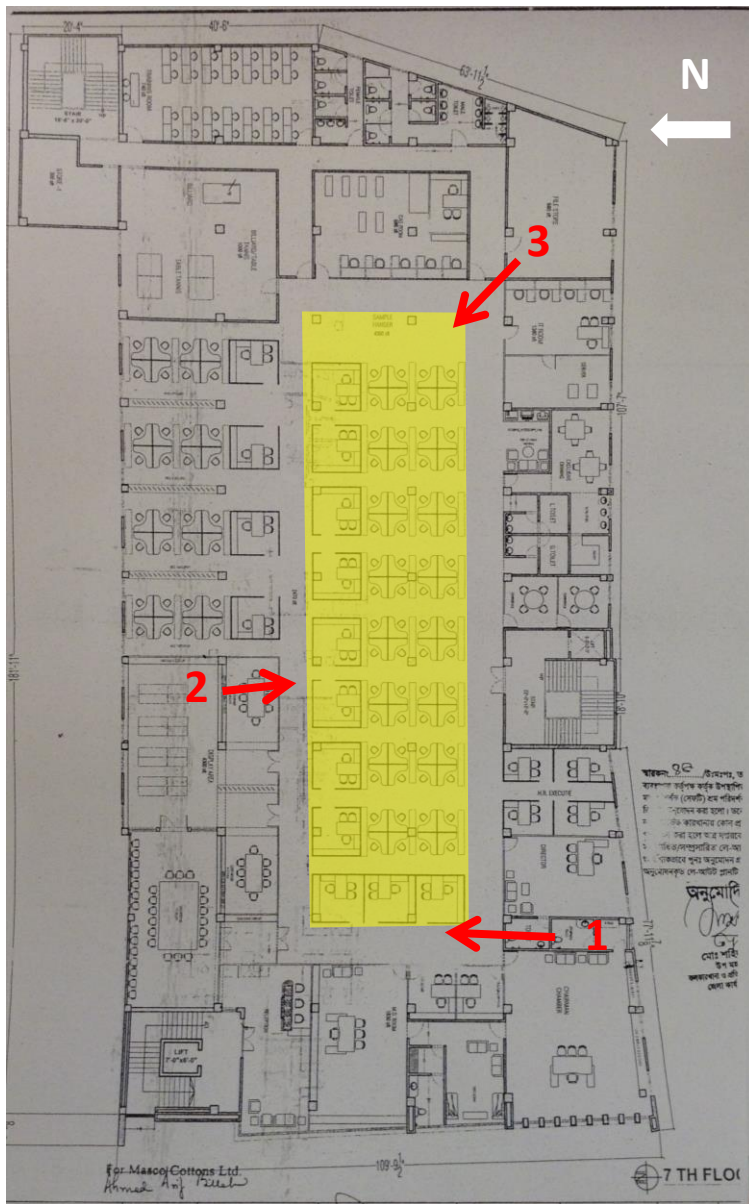
7<sup>th</sup> floor plan

**Raised floor level -  
100mm thick  
additional concrete  
(or similar) under  
current office  
accounts/admin area  
– additional dead  
load**

| Item No. | Observation | Recommended Action Plan | Recommended Timeline |
|---|---|---|---|
| 17 | 100mm thick solid screed on 7th floor in office area | As part of the Detail Engineering Assessment (ref. Item 1), Building Engineer to carry out an assessment on the slab / column capacity to carry the additional 100m screed applied on the 7th floor. | 6-weeks |
| 18 | 100mm thick solid screed on 7th floor in office area | Carry out remedial actions arising from Detail Engineering Assessment. | 6-months |

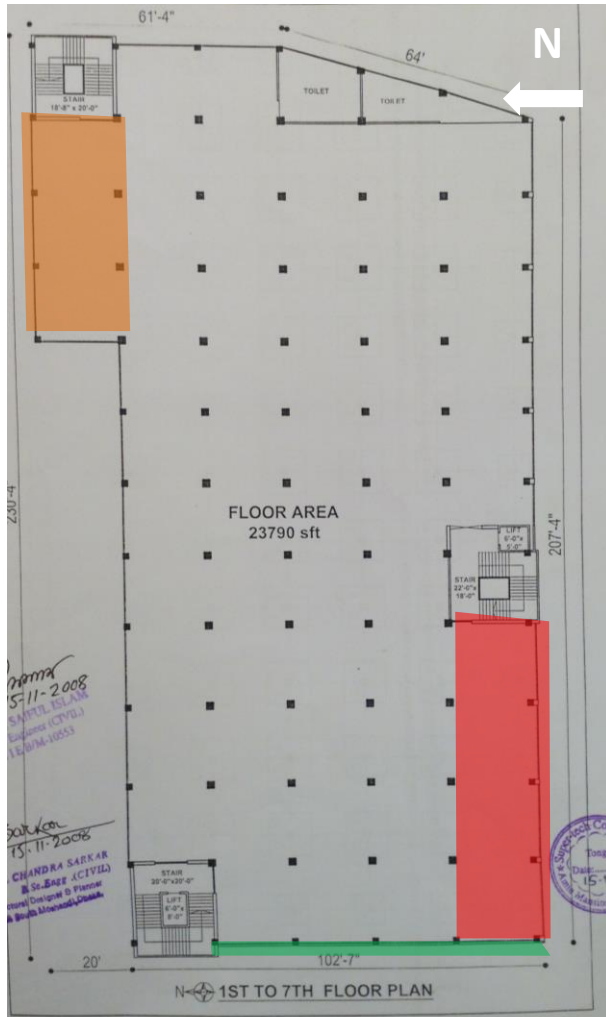
Structural drawing (design)

Differences observed between designed and as-built structure

- Column grid widens
- Floor plan reduced
- Cantilever added

| Item No. | Observation | Recommended Action Plan | Recommended Timeline |
|---|---|---|---|
| 19 | Discrepancies between drawings and actual observation | As part of the Detail Engineering Assessment (ref. Item 1), carry out survey to reflect as-built structure. | 6-weeks |
| 20 | Discrepancies between drawings and actual observation | Revise engineering drawings as part of Detail Engineering Assessment. | 6-months |
